Limited Conditions Assessment

For the Isle of Palms Marina

Isle of Palms, South Carolina

Prepared by: Applied Technology & Management, Inc.
941 Houston Northcutt Boulevard, Suite 201
Mount Pleasant, South Carolina 29464
(843) 414-1040

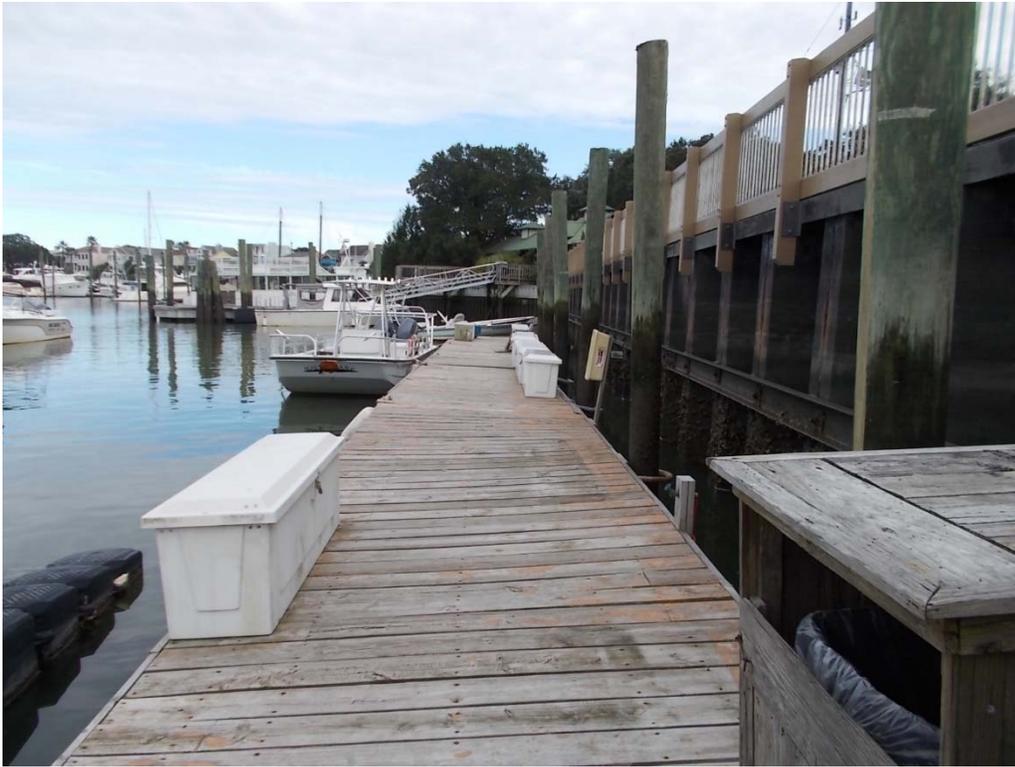
- The alongshore dock section shows evidence of undulating dock framing that has caused “waves” in the walking surface of the dock. The decking on this portion of the dock is very worn and gaps up to 1.5 inches in the walking surface were observed (0.5 inch is the maximum allowable under ADA guidelines).

Shore-Side Floating Dock (Note: wave in framing)

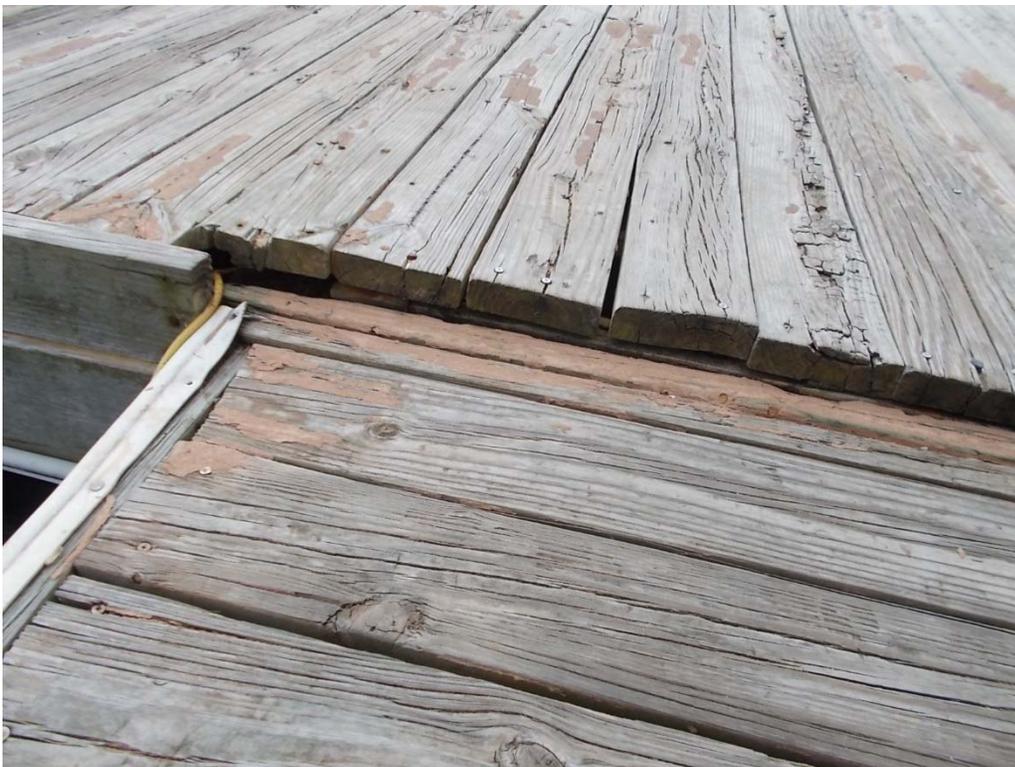
- The floating dock office appears to be in good, serviceable condition, but the connections between the floating dock that supports this structure and the adjacent floating docks appear to be stressed and/or compromised. Substantial height differentials in the walking surface were noted in this area.

Transition to Floating Dock Office

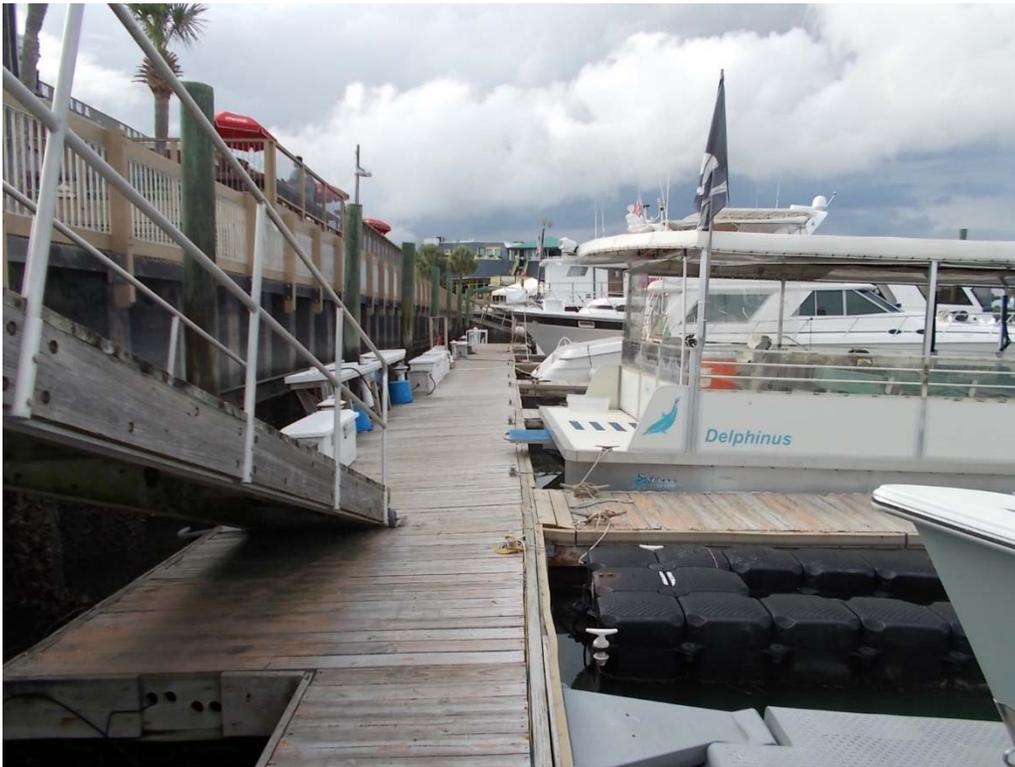
- The shore-parallel walkway exhibited a severe list (leaning) toward shore. This may be caused, in part, by the large amount of appurtenances located on this side of the dock (dock boxes, fish cleaning stations, etc.).

Shore-Parallel Main Walkway (Note: substantial landward listing)

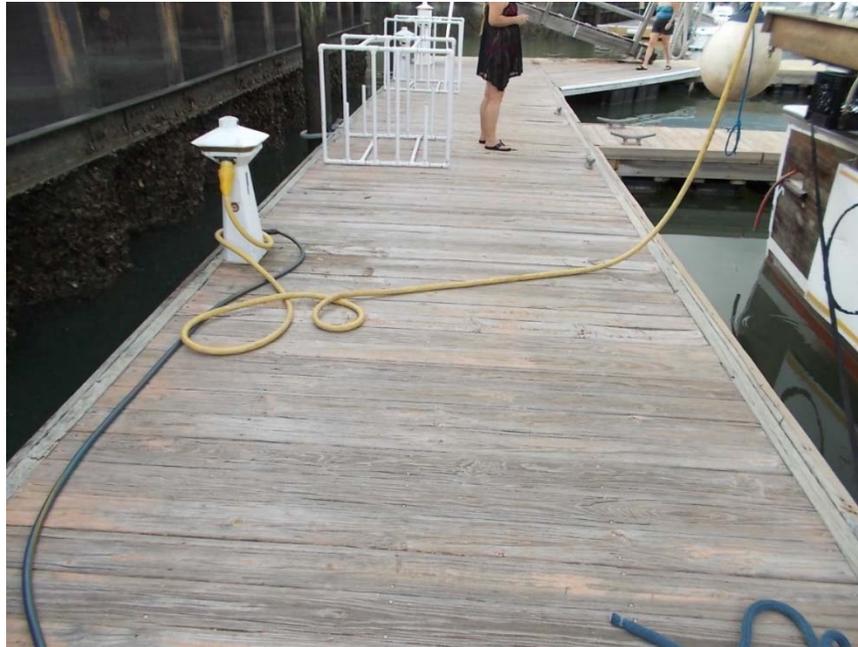
- The anchor pilings on this dock consist of timber piles along shore and at the end of the finger piers. One concrete pile was noted at the finger pier closest to the floating fuel building. While the piles appear to be in fair or good condition, ATM did note a missing pile guide at one pile location along shore.
- The power pedestals serving the vessels along this dock are located on the shore-side of the shore-parallel dock. This necessitates the routing of utility cords across the walking surface of the dock and presents a potential trip hazard.

Power Cables Routed Across Main Walkway

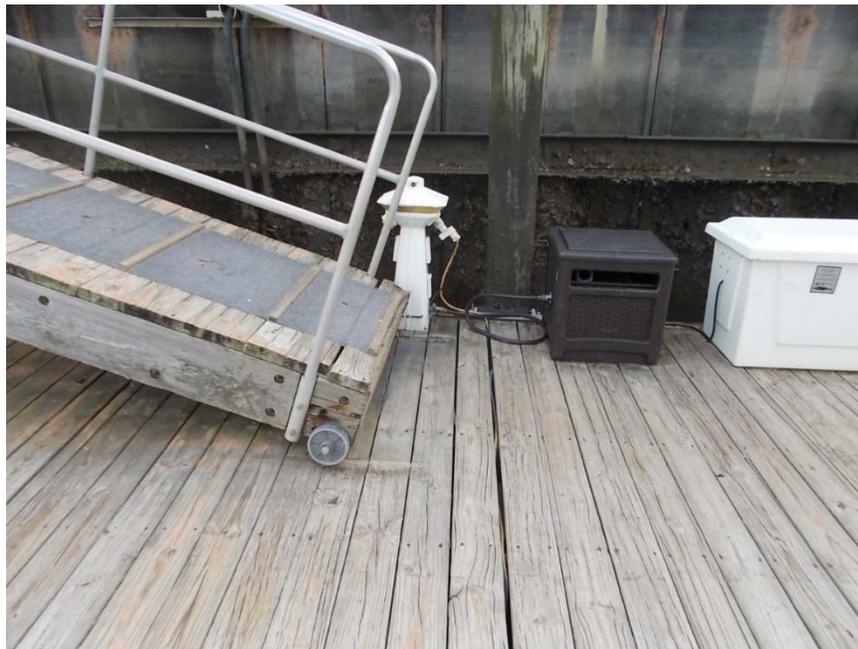
- The gangways serving this dock, one near the floating fuel building and the other adjacent to the boat ramp, are in fair or poor condition and are not ADA compliant. In fact, the gangway adjacent to the floating fuel building presents users with a 10-inch vertical drop from the gangway walking surface to the dock walking surface. A similar drop is present at the gangway near the boat ramp.

Gangway Landing (Note: vertical transition from gangway to deck surface)

- Repair/replace gangway and repair/replace boat ramp boarding dock on south side of boat ramp
 - Consider installation of permanent transition plates at all gangway landings
 - Include an appropriate transition plate at the boat ramp gangway
- Enlist the services of a qualified electrician to evaluate all circuits for shorts and conduct necessary repairs
 - Include evaluation/repair of junction boxes at fuel hose reel locations.
- Consult with local fire marshal or fire officials regarding marina fire protection on the docks. Evaluate fire extinguisher placement and size. Consider supplemental (e.g., portable fire cart) fire protection.

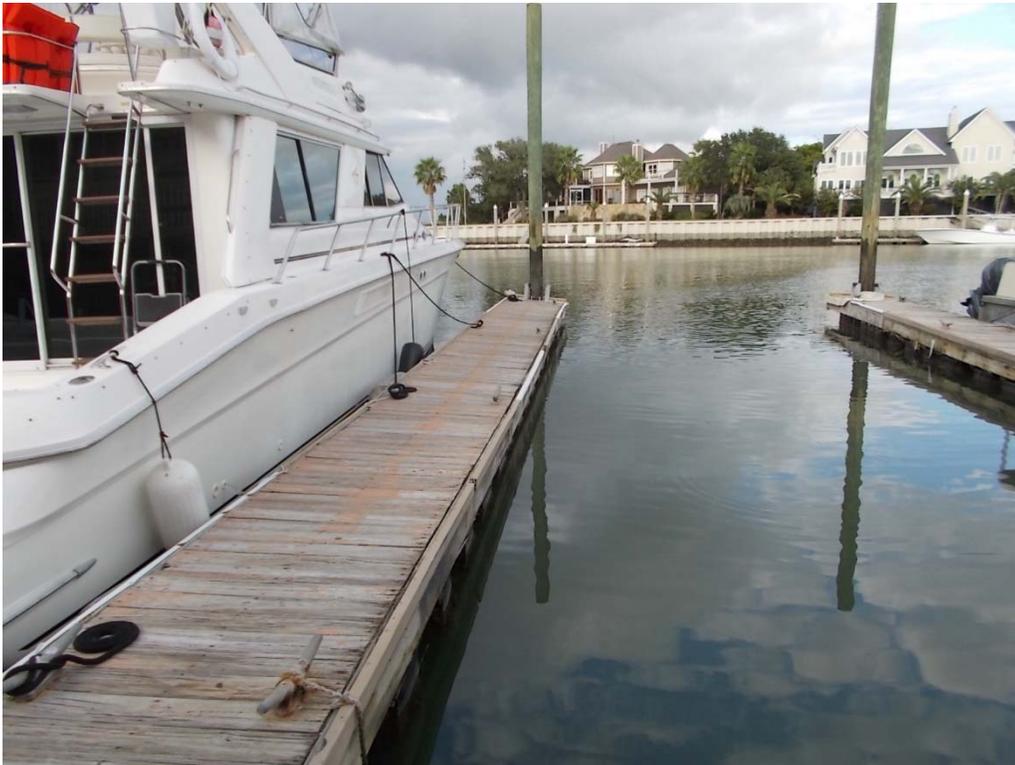
- The condition of the finger piers is generally poor, with areas of loose or separating waler boards, listing (in some cases severe), worn/loose decking, rusting/compromised connections, vessel impact damage, and overall instability common.

Typical Finger Pier

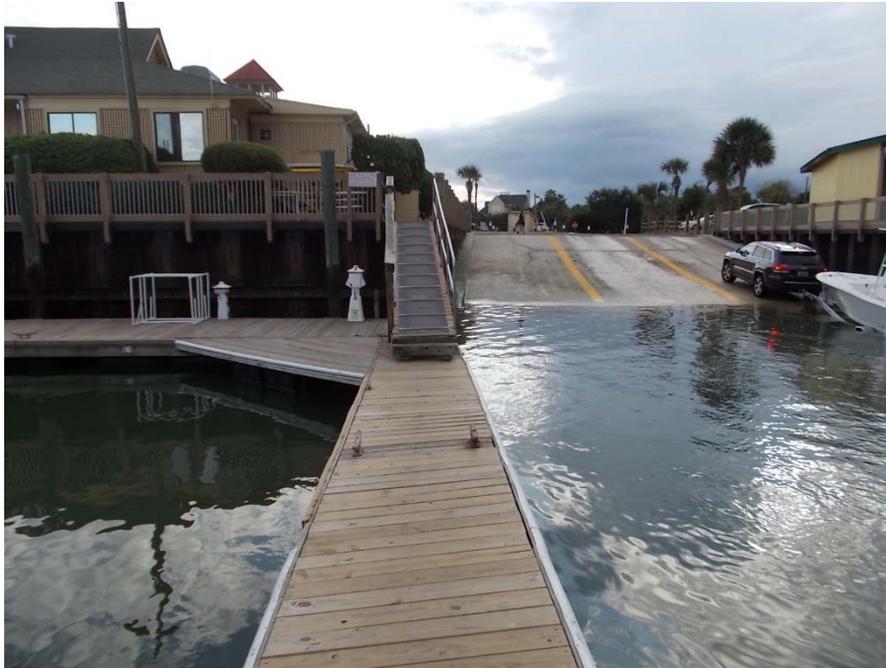
- Of critical note is the condition of the finger pier adjacent to the boat ramp in this dock section. While recently re-decked, this finger exhibits a severe (5-inch) list away from the ramp. Further, the gangway that services this dock is in poor condition and provides somewhat treacherous access to this heavily used area of the marina (loose handrail, large vertical transition from the gangway down to the dock, tight walking space, etc.). ATM considers the condition of this gangway and floating dock to be a potential threat to the life and safety of marina and, in particular, boat ramp users.

Finger Pier/Boarding Dock

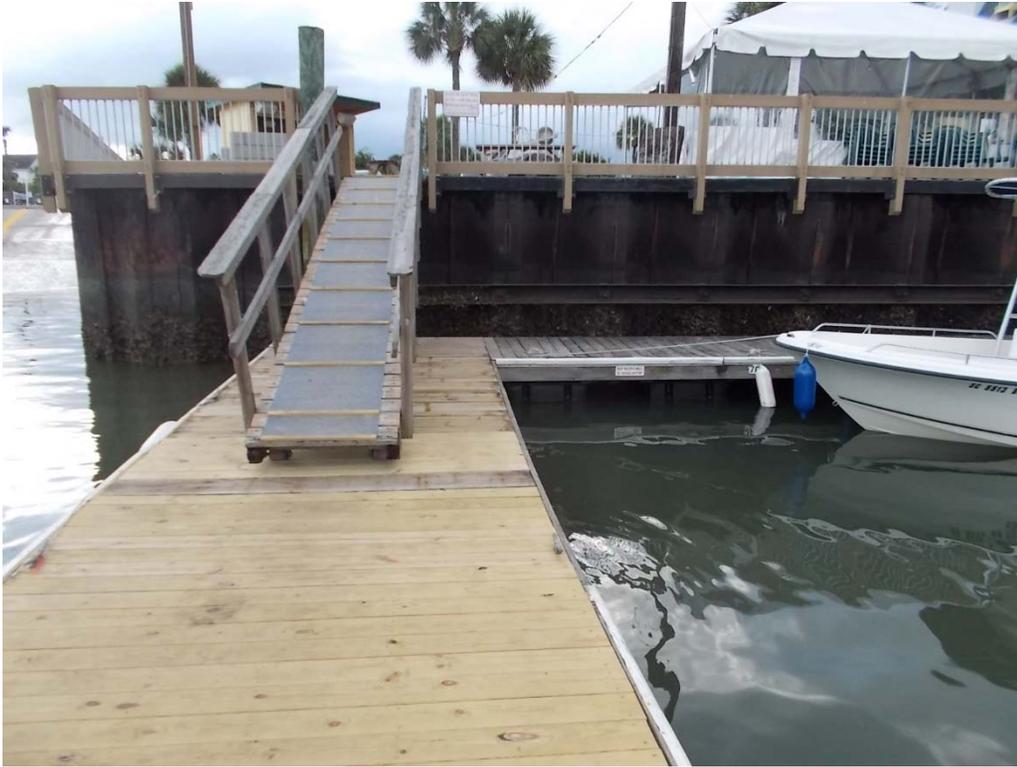
- The gangway servicing the dock adjacent to the boat ramp in this area appears to be in fair/poor condition with some rot noted. In addition, there is a substantial vertical transition from the gangway to the floating dock.
- The finger pier/boarding dock adjacent to the boat ramp has recently been re-decked and partially re-framed.
- The decking of the adjacent, shore-parallel dock to the boat ramp finger pier/boarding dock is very worn. ATM understands that this area is used for small boat dockage and no utilities are provided.
- The larger dock that comprises the remainder of Dock Area C is accessed from a secure gate adjacent to the Morgan Creek Grill restaurant. This includes two key areas: an inner (landward) shore-parallel side tie dock and an outer side tie dock.

Gangway Landing and Re-Decked Dock Section

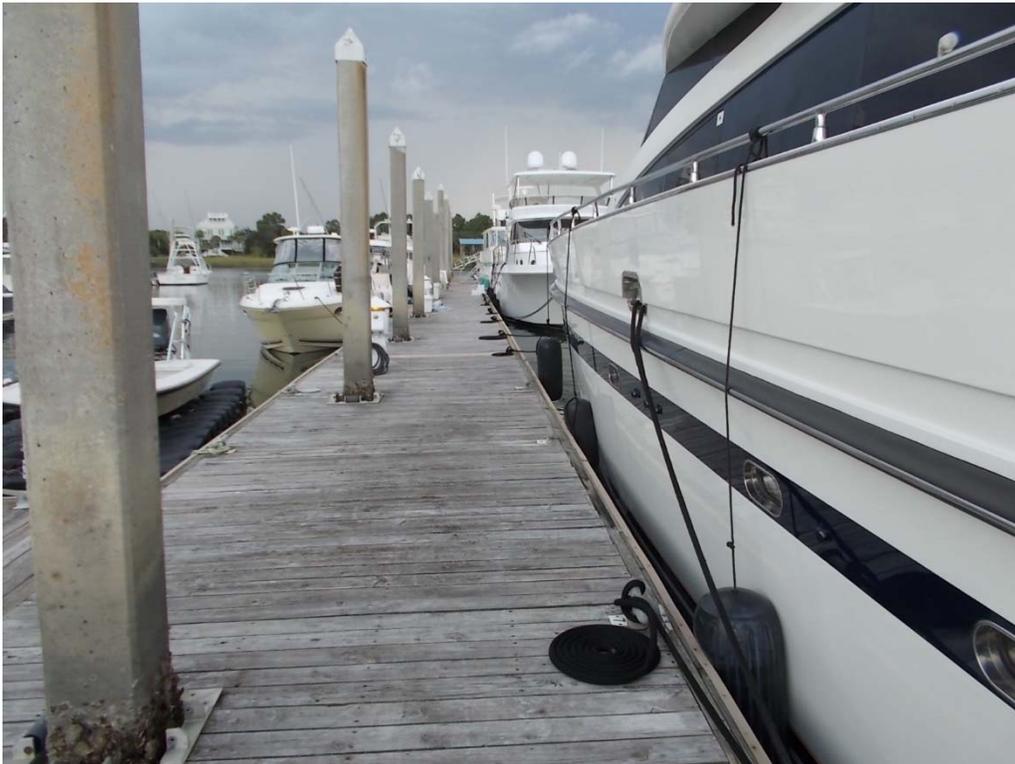
- Outer Dock – Dock Area C
 - The outer dock is accessed via an aluminum gangway that is in good condition. Marina personnel identified this as their ADA-accessible gangway.
 - A lone finger pier was observed on the dock section leading from the gangway out to the main outer dock run. This finger pier exhibited a severe list, had a missing pile guide, and was in generally poor condition.
 - This dock is anchored with concrete piling that appear to be in fair/good condition. A few missing pile guide rollers were noted.
 - The decking on this dock is aged and ATM noted some areas where it had been recently replaced.

Main Walkway Outer Dock

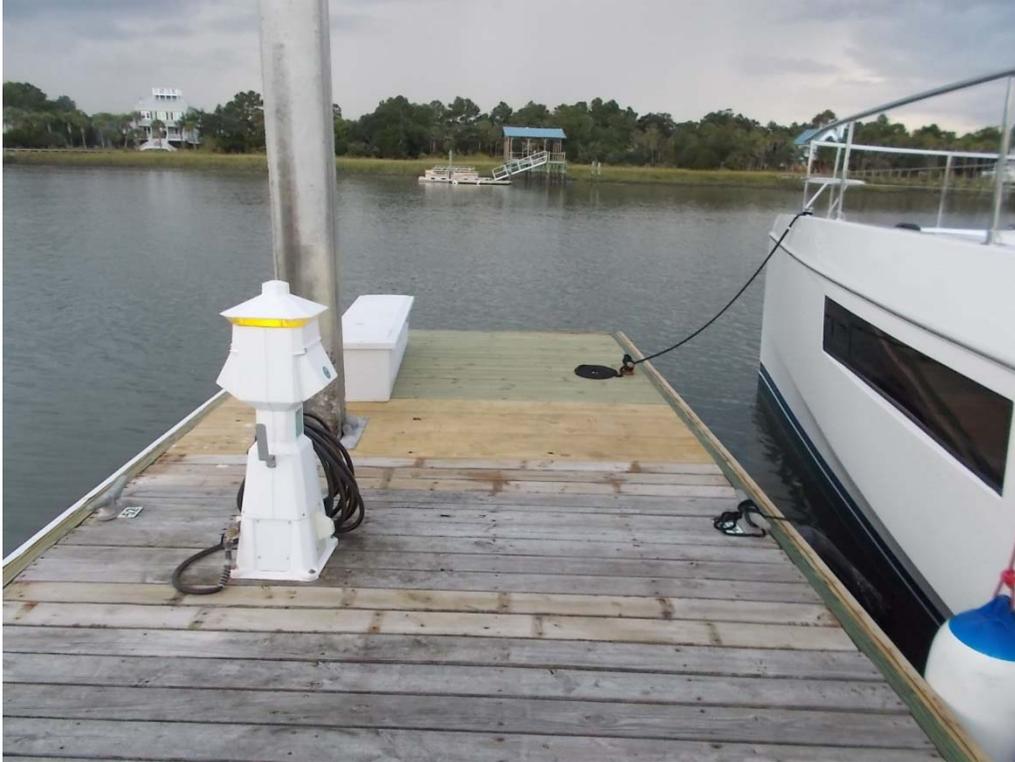
- The northern end of this dock protrudes out toward the Atlantic Intracoastal Waterway and is strongly affected by boat wake, particularly during the winter season when the no-wake designation for this area of the waterway is lifted. ATM observed some dock repairs in this area, including new walers, decking, etc. Rot and fungus growth on the northern end of this dock was still evident, likely caused by frequent wetting from passing vessel wakes.
- Inner Dock – Dock Area C
 - This dock is accessed via an aluminum gangway that is in good condition.

Terminus of Dock on Intracoastal Waterway

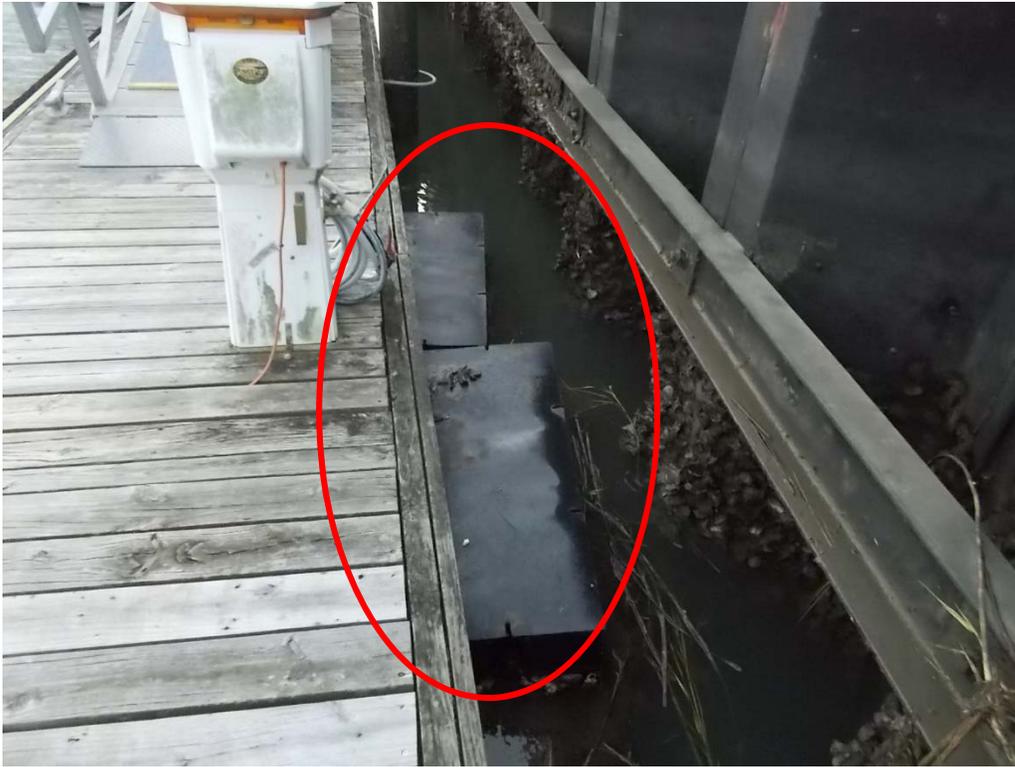
- ATM observed two displaced polytub flotation units (shore-side) at the base of the access gangway.

Displaced Polytub Flotation

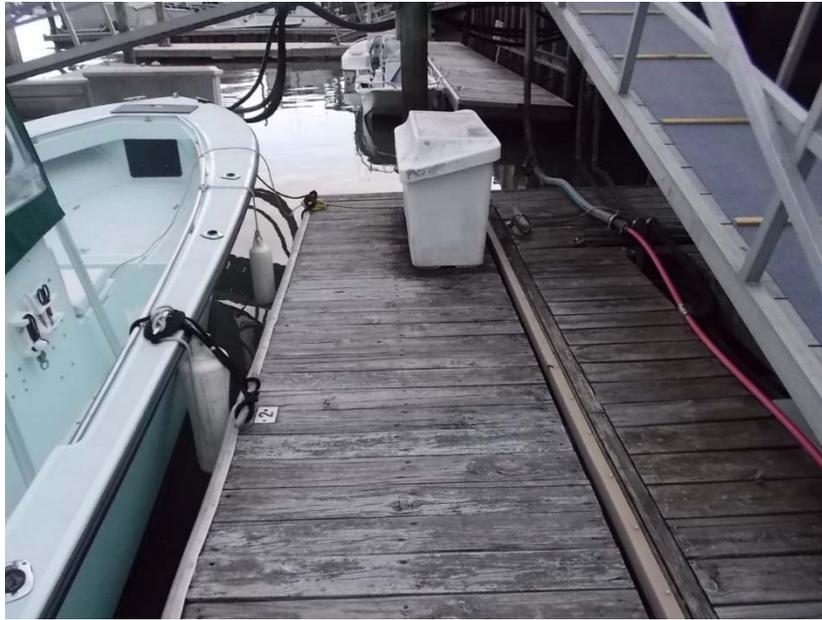
- ATM also observed an ancillary dock section that had been fastened to the main dock walkway to provide wider access for a charter boat. This ancillary dock section was very unstable. A 2-inch gap in the walking surface was measured between this ancillary dock and the main dock walkway.
- ATM also observed framing failures on the outside inflection points where this dock is angled to the west.

Ancillary Float and Gap

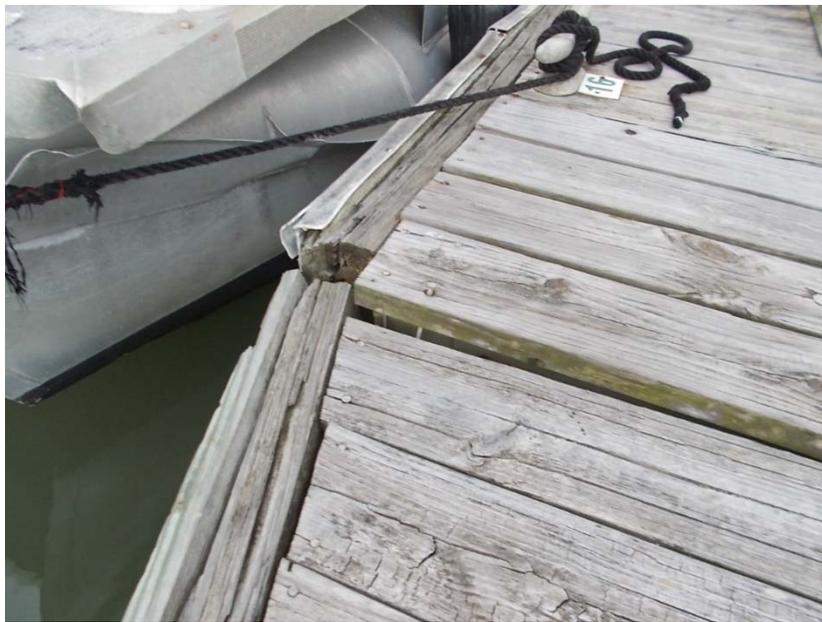
Framing Failure at Inflection Point

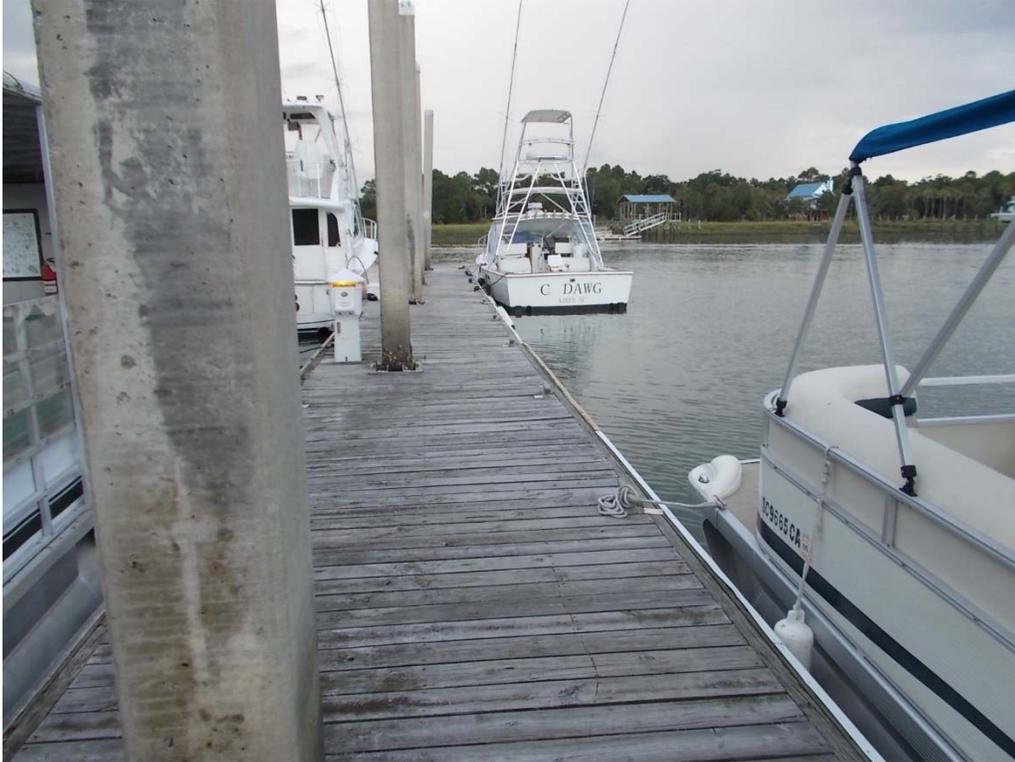
- The northern portion of this dock is anchored with concrete piling. These appeared to be in generally fair/good condition, although the northernmost piling on the dock was leaning substantially.

Typical Conditions and Listing Pile

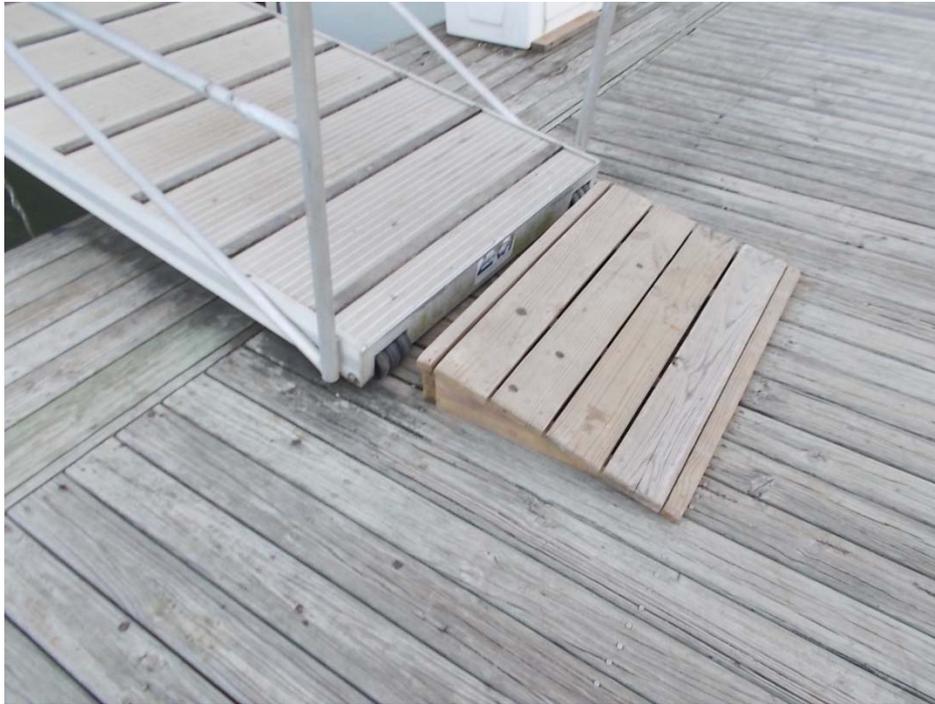
- A framed timber wedge is utilized in lieu of an affixed gangway transition plate. When not monitored, a gap develops between the wedge and the gangway, which can present a trip hazard.

Gangway Landing "Wedge"

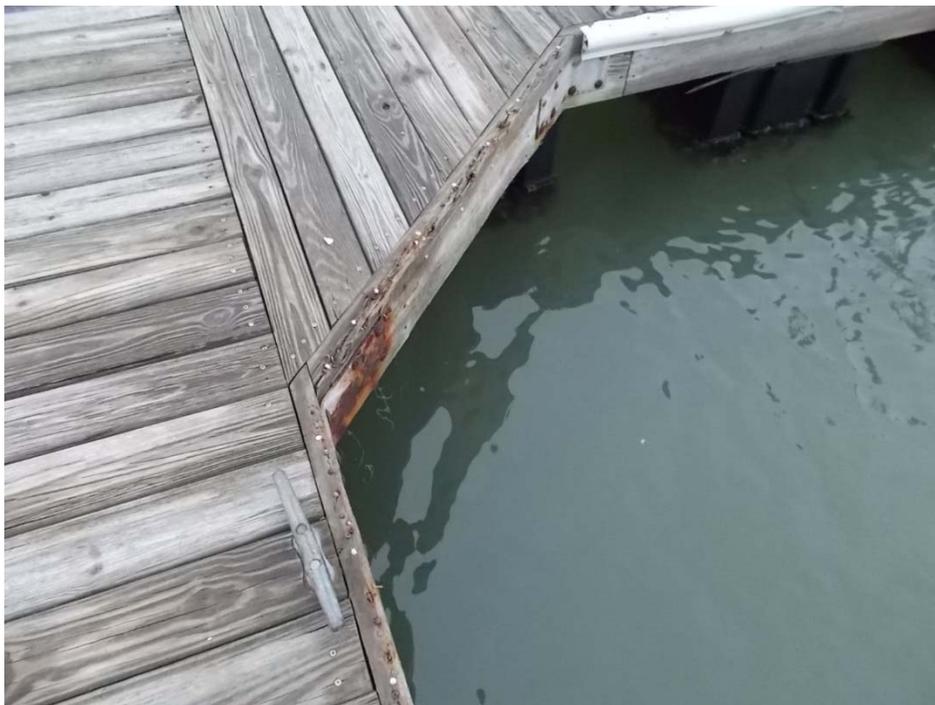
- Substantial damage to the vinyl bumper strip around this dock was noted. While not a structural element, the rub strip can help prevent damage to both visiting vessels and the dock by providing a bumper between the two.

Bumper Strip Damage and Corroded Connection Hardware

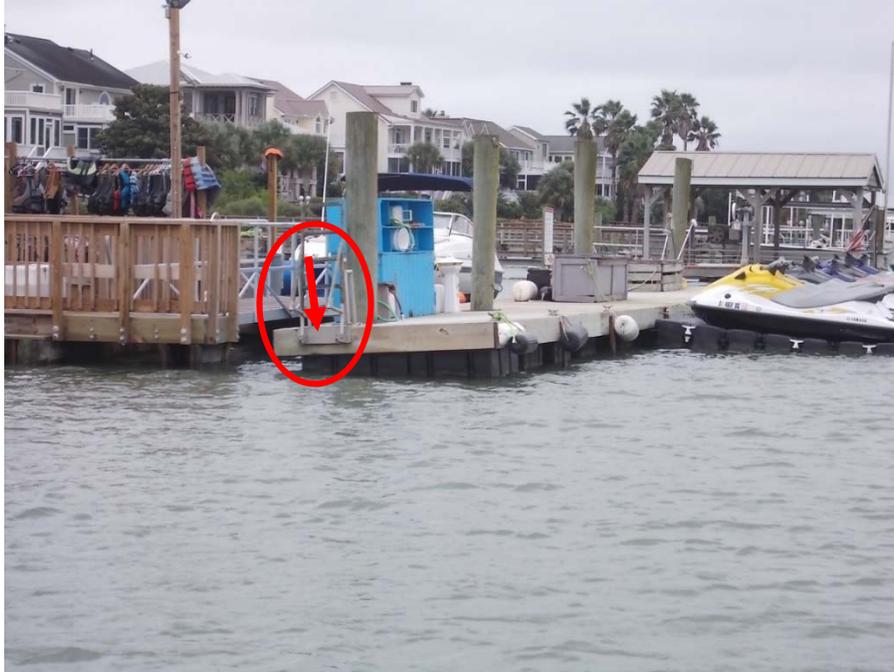
- The outer floating section exhibits a severe landward list. This may be due to the large storage boxes present on the docks or possibly the effects of the flotation of attached jet docks.

Severe Dock Listing

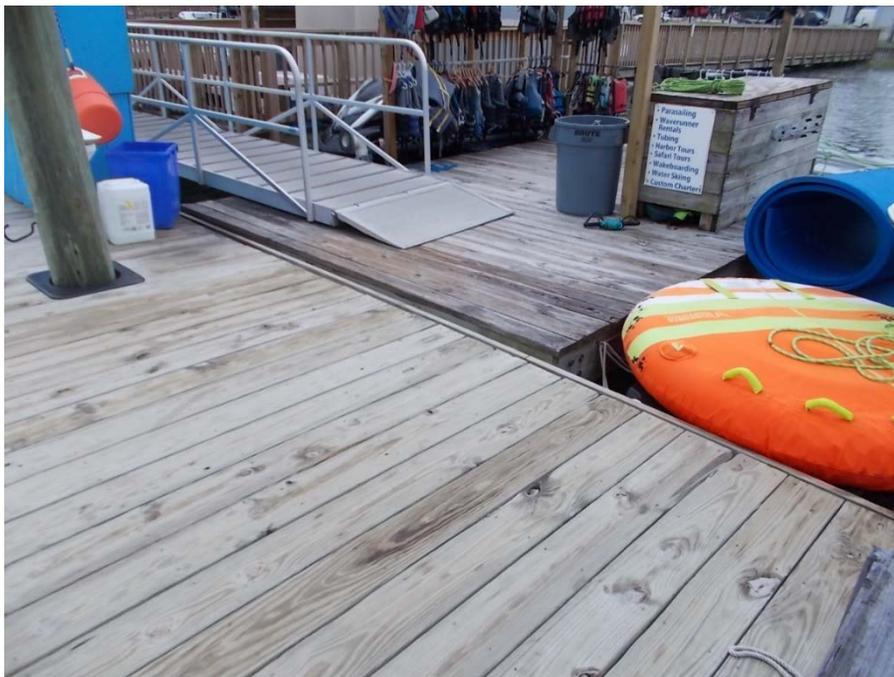
- The inner floating section appears older and weathered and is in fair condition.
- The connection between the inner and outer floating sections was measured at 2.25 inches. This exceeds ADA guidelines. Additionally, a separation in walers in this area creates a larger gap in the walking surface of up to 3.5 inches, presenting a potential trip hazard for dock users.

Gap between Dock Sections

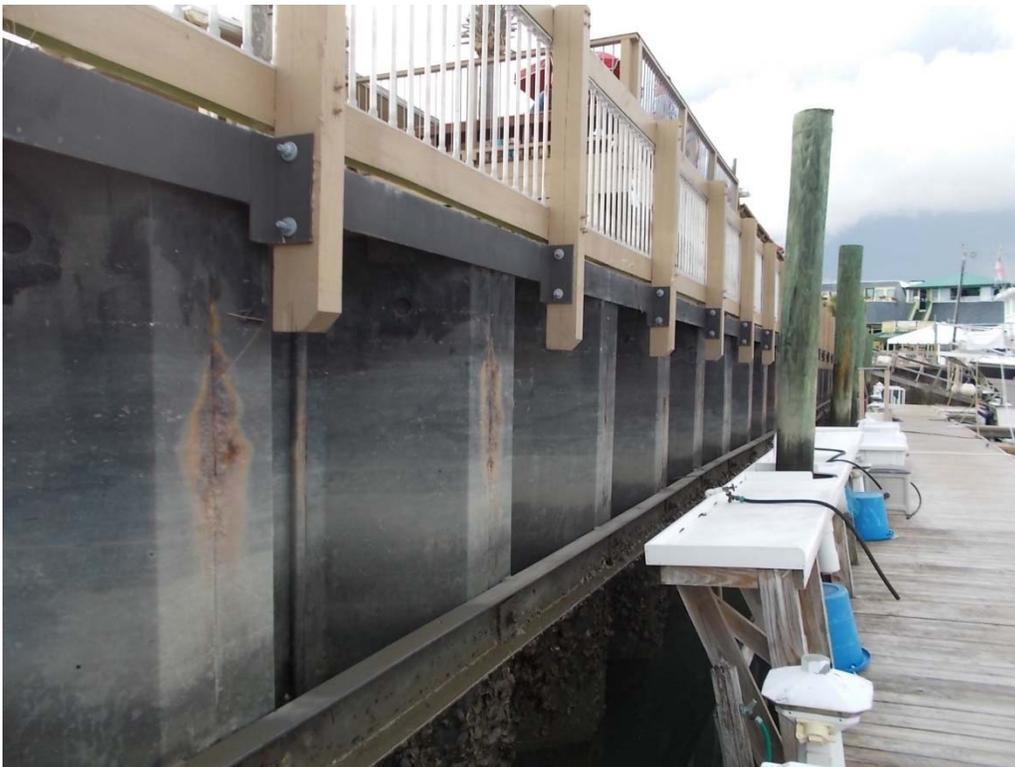
The steel sheet pile bulkhead was designed in 2008 and appears to be in good condition, with some corrosion occurring in the intertidal zone. No bowing, bending, or other obvious structural stresses or failures were apparent during this cursory visual assessment. However, marina management did report backfill loss occurring in the area of the bulkhead behind the marina store. Additionally, marina management identified movement and damage to the adjacent patio deck and building.

Steel Sheet Pile Bulkhead

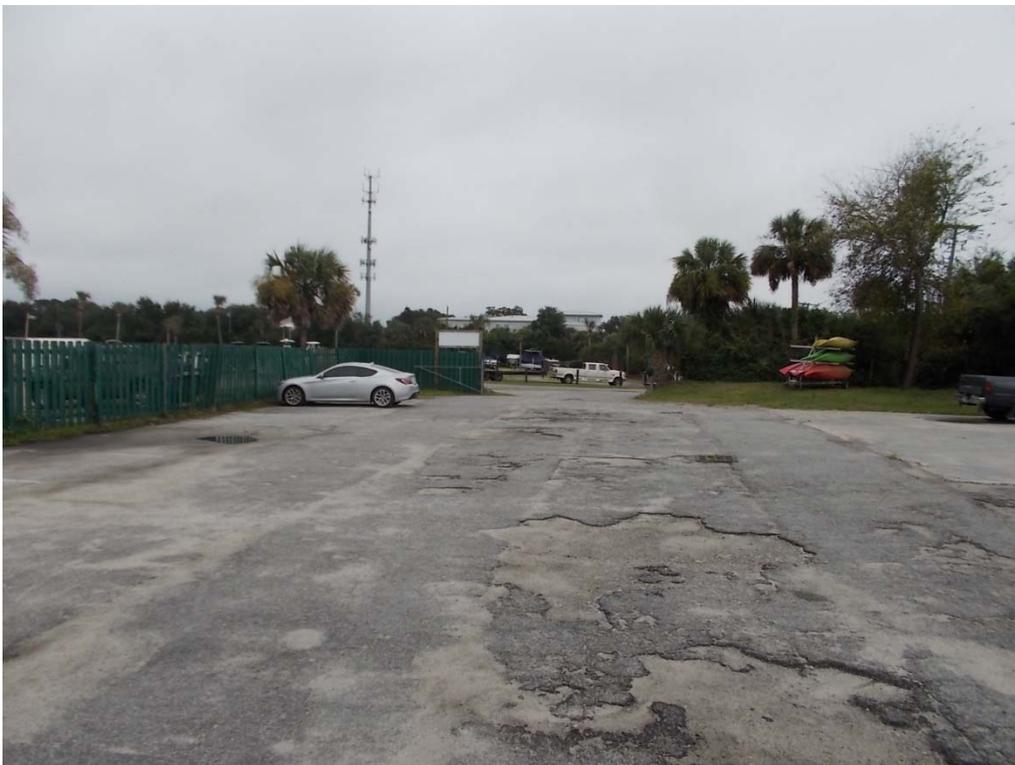
The entrance road and a substantial portion of the standard vehicular parking at the Isle of Palms Marina is paved asphalt. The asphalt paved main access road and parking spaces adjacent to the marina store and restaurant are in fair/good condition. The asphalt paving adjacent to the watersports dock is in very poor condition.

Watersports Dock Parking Area

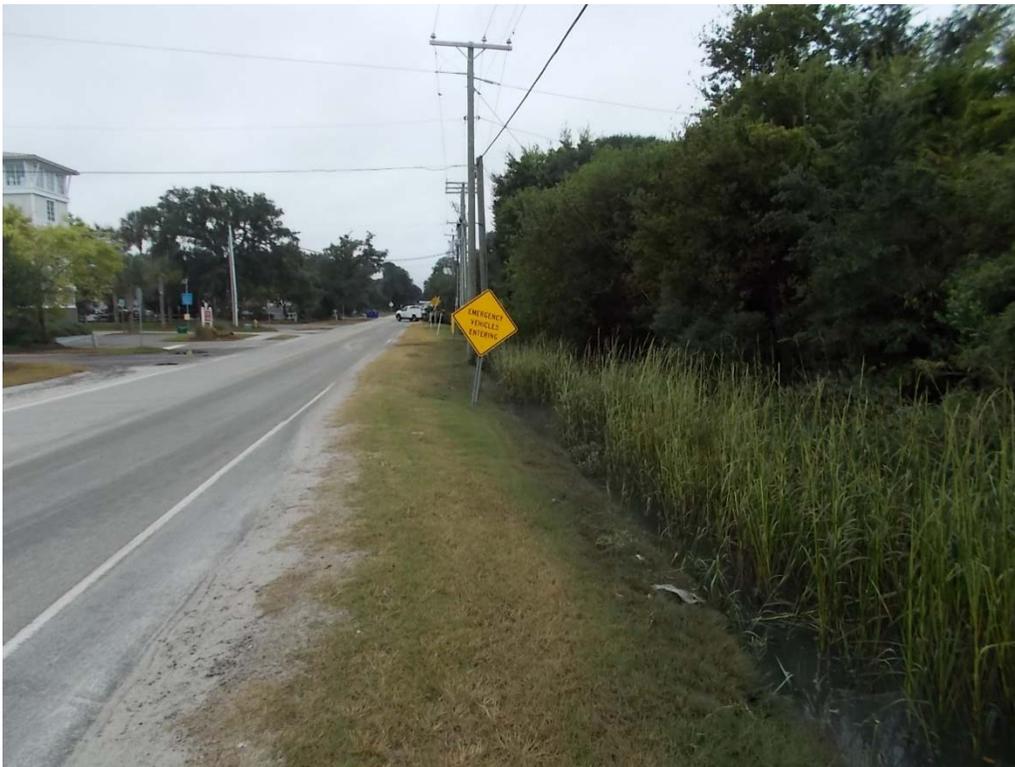
The Isle of Palms Marina site is accessed via 41st Avenue. The roadway essentially dead ends into the marina property and provides single lane access to and from the facility. A substantial shoulder on the west side of the roadway is currently being utilized as an overflow parking area for marina property visitors and employees. Parking along 41st Avenue often occurs down to Marginal Road (0.15 mile from the marina site). A large ditch on the west side of the shoulder appears to hold water that fluctuates with the tide.

41st Avenue, Shoulder, and Ditch

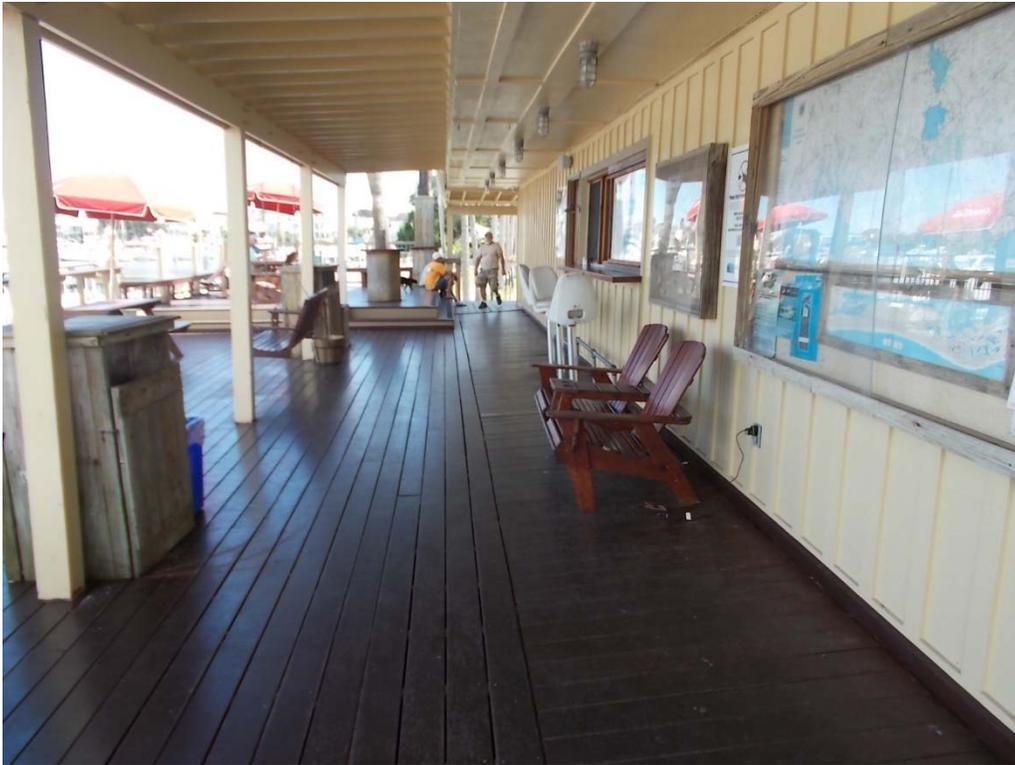
Since the installation of the steel sheet pile bulkhead along Morgan Creek, Mr. Berrigan has noticed a slight shift of several building elements adjacent to the bulkhead structure. Specifically, the deck adjacent to the building has developed a downward sloping angle (away from the marina store building). In addition, a number of small cracks have occurred in the ceiling and walls of Mr. Berrigan's office, which is located on the Morgan Creek side of the building.

While a detailed structural investigation is beyond the scope of ATM's current assignment, these observations are somewhat concerning. These conditions are generally consistent with Mr. Berrigan's other observation of backfill deposits on the outside/waterside of the bulkhead adjacent to the marina store.

Marina Store – Rear Patio (Note: Walking surface slope away from building)

- Shoreline stabilization at the site is in good condition with a few areas of concern noted.
 - ATM recommends that the backfill loss behind the marina store and restaurant be investigated more thoroughly and addressed as necessary.

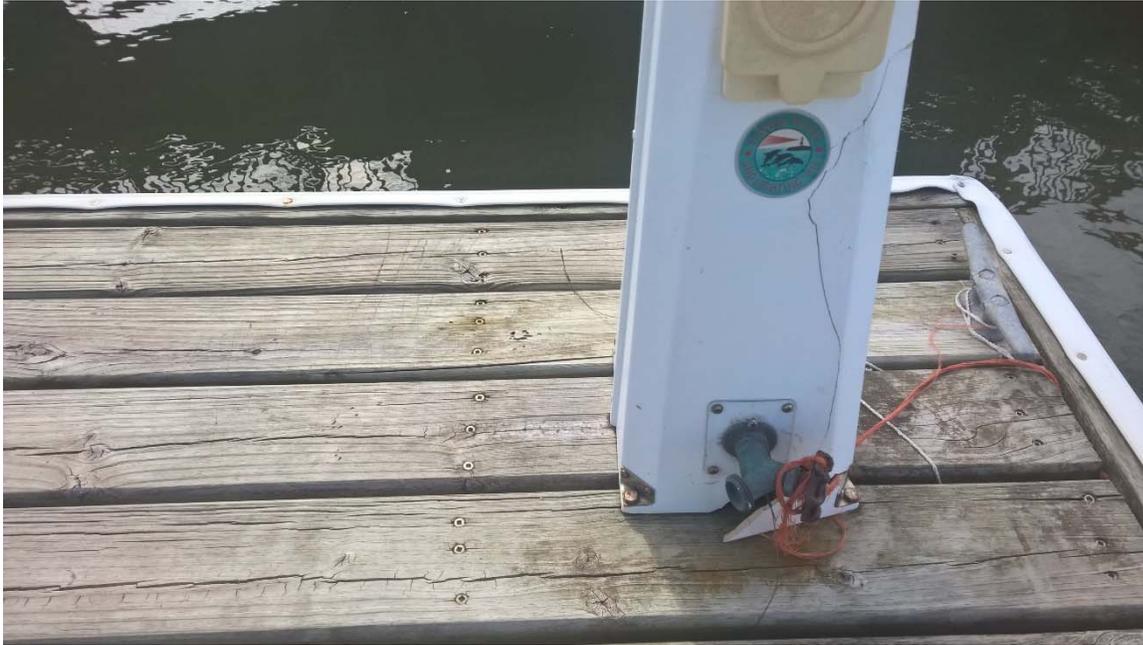
(Photo 1) Dock mounted pedestal damaged beyond repair.

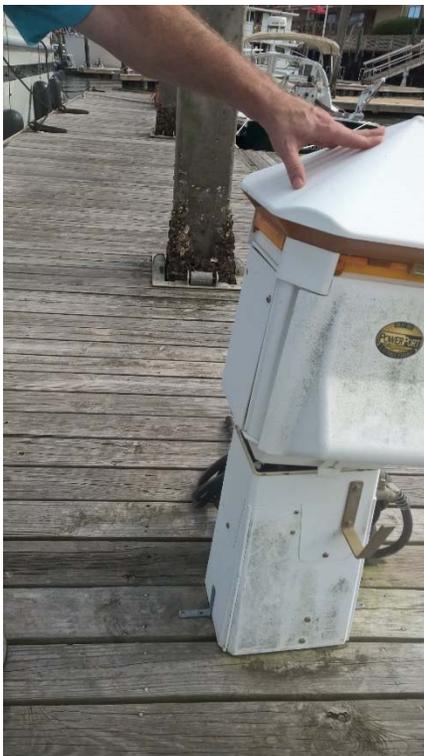
(Photo 2) Dock mounted pedestal missing fasteners and not mounted to dock.

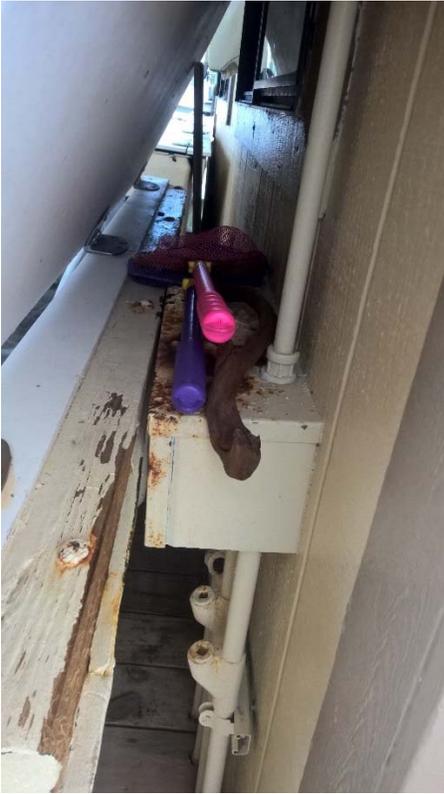
(Photo 3) Junction box rusted and in a wet location.

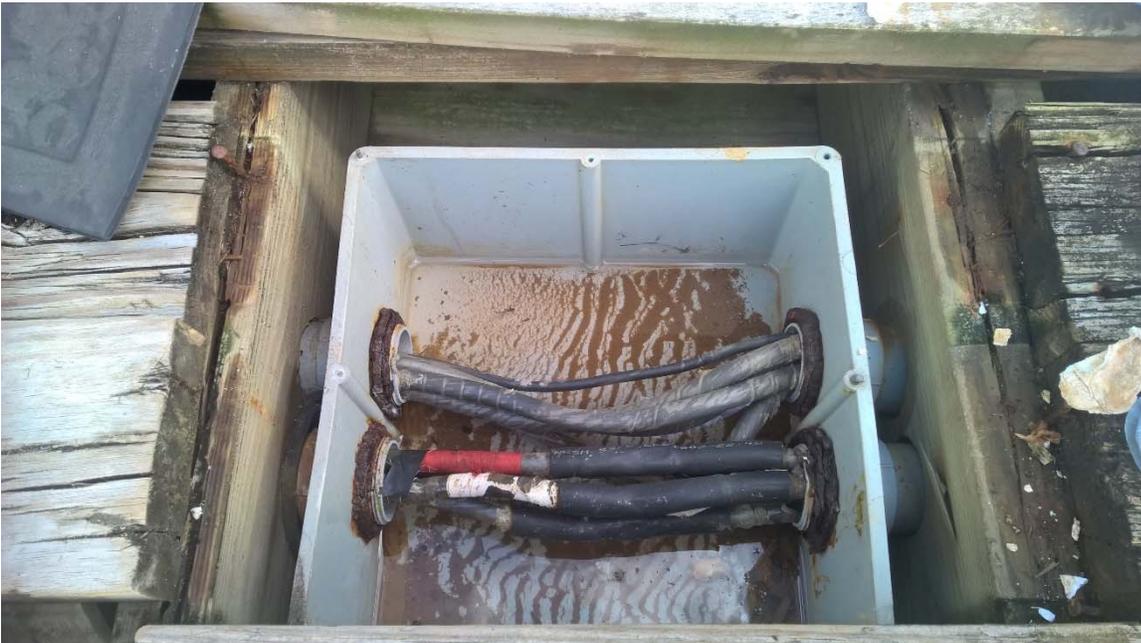
3. There are junction boxes with standing salt water and poorly insulated wires. Most of the dock mounted power supply towers are damaged and poorly mounted. (Photo 4)

(Photo 4) There are junction and pull boxes that are not sealed from the salt water.

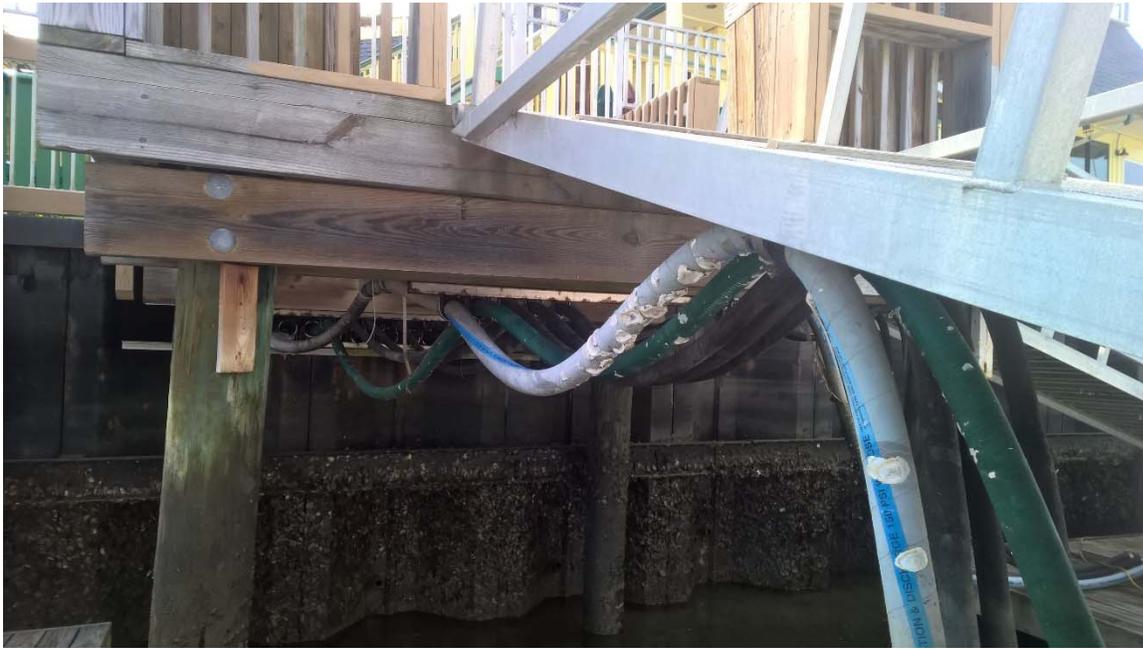
(Photo 5) The cabling to the marina is not properly supported.

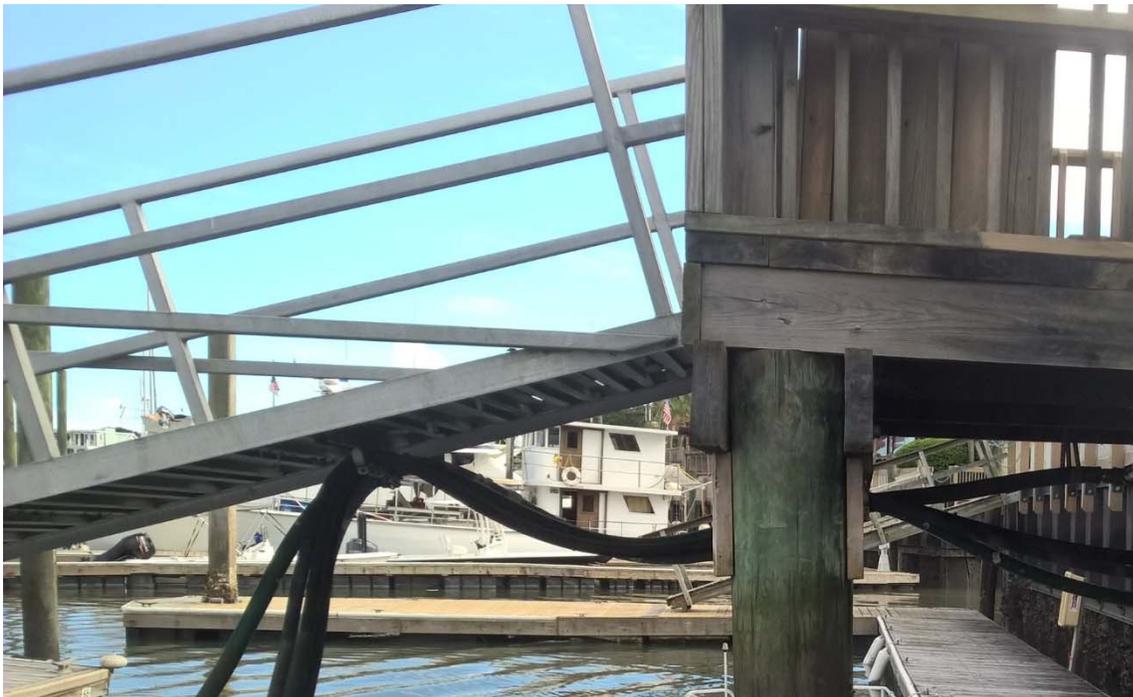
(Photo 6) The cabling to the marina is not properly supported.

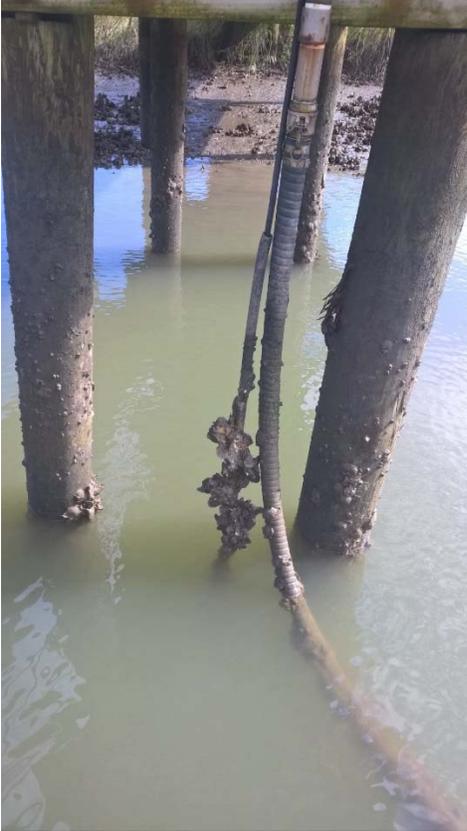
(Photo 7) Flexible conduit is burdened with shells and pulled free.
