# ***“TOP Marina Existing Bulkhead Structural Inspection” for City of Isle of Palms***

***Draft Report – May 26, 2022***

## **Isle of Palms Marina Structural Inspection of Existing Bulkhead**

D&F Job No. 032000.01

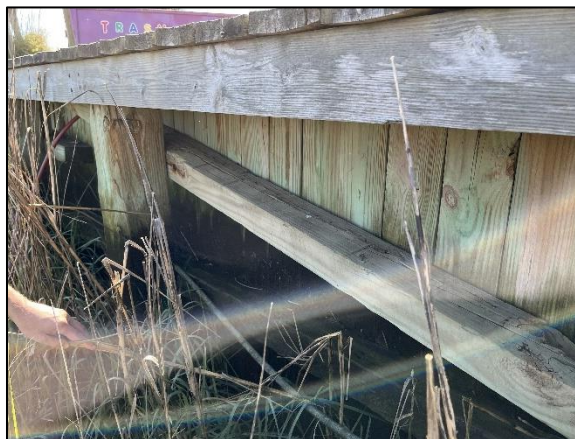
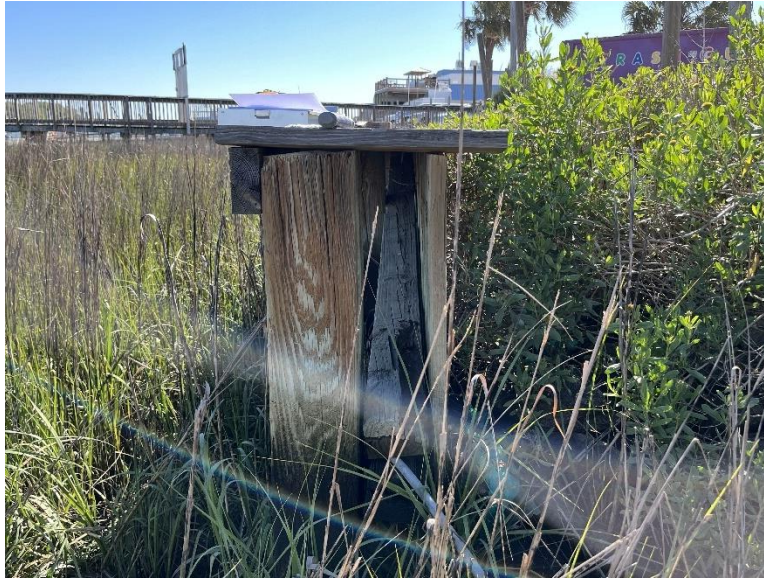
It was observed during the inspection that the top waler located at the west end of the bulkhead has collapsed (See Figure 3.1 and Figure 3.2).

**Figure 3.1. Collapsed Top Waler at West End of Bulkhead**

**Figure 3.2. Collapsed Top Waler at West End of Bulkhead**

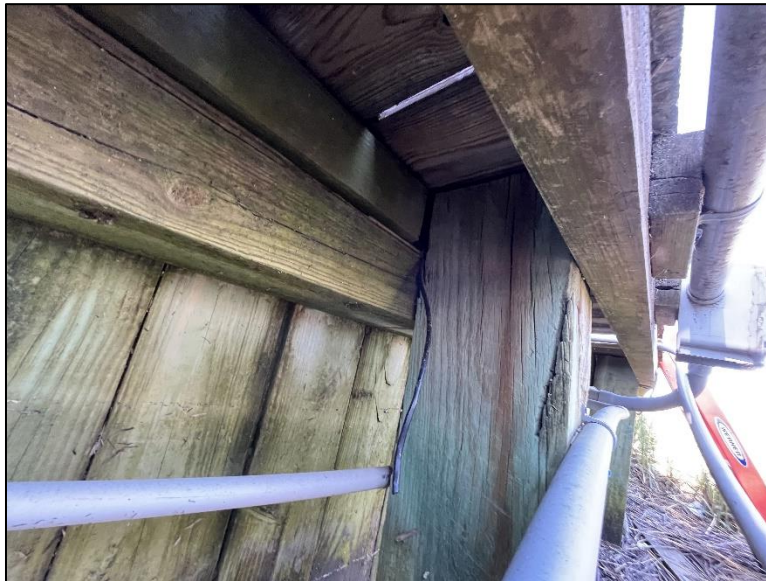
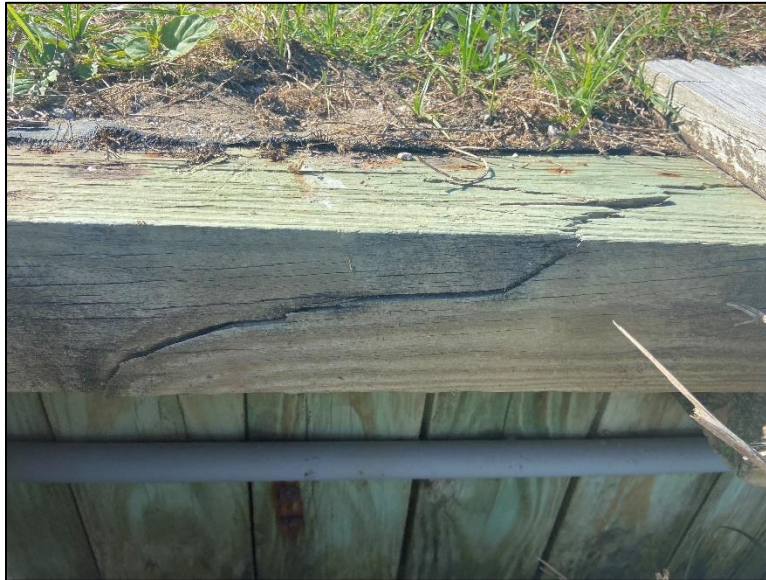
It was also observed that the top waler is split in several locations along the western section of the bulkhead (See Figure 3.3 and 3.4).

**Figure 3.3. Split Top Waler Near West End of Bulkhead**

**Figure 3.4. Split Top Waler Along West End of Bulkhead**

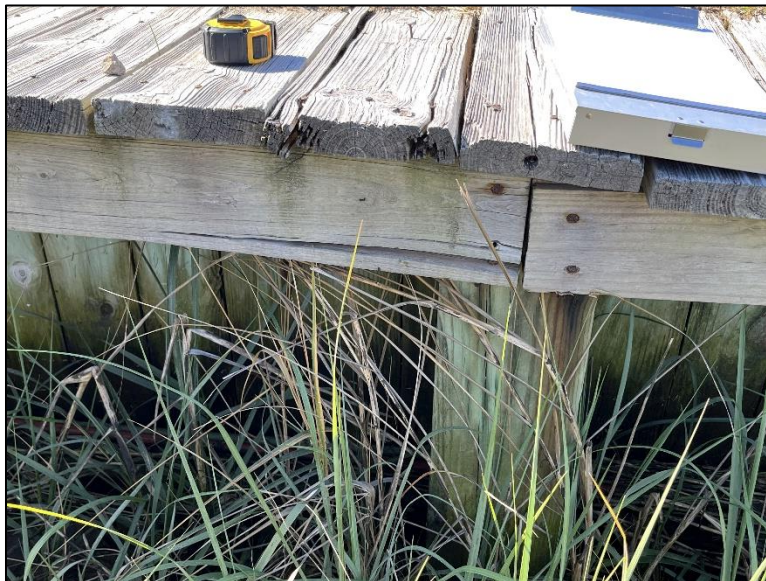
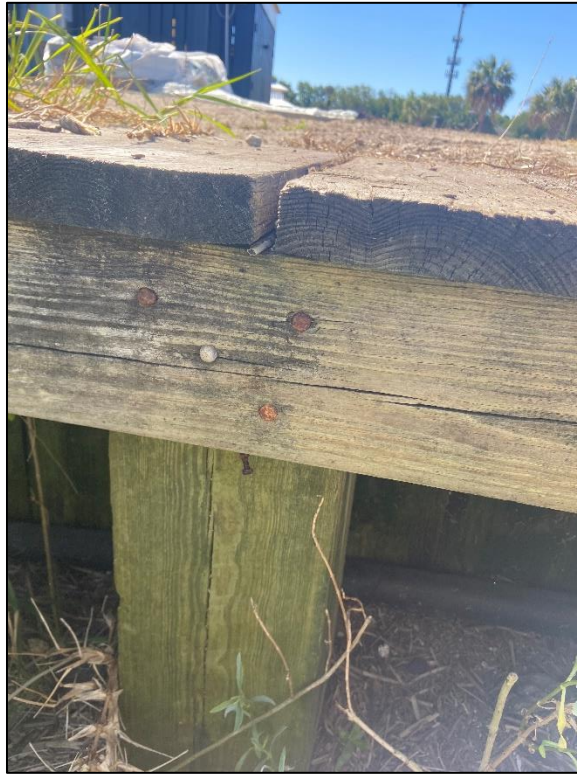
It was observed during the inspection that several of the front 3x6 nailer boards are split. Figures 3.5 and 3.6 show two of these locations.

**Figure 3.5. Split 3x6 Front Nailer Near Middle of Western Section of Bulkhead**

**Figure 3.6. Split 3x6 Front Nailer Near Eastern End of Bulkhead**

The splitting of the boards is caused by their continued exposure to wetting and drying.

- Removal of the existing deteriorated decking.
- The replacement of the existing 3x6 nailer beams with larger properly designed joists and bolted connections to the existing piles. Also, an additional support structure would need to be designed behind the existing bulkhead to support new floor joists and longer decking.
- Replace any split or deteriorated walers supporting the tongue and groove sheeting. Also, any deteriorated sheeting would need to be replaced.
- Replace any 8x8 piles that are damaged with new piles.
- The installation of new code compliant pedestrian railing bolted to the exterior joists with appropriate blocking between the joists to distribute the lateral railing loads.
- The installation of new wood or composite decking.

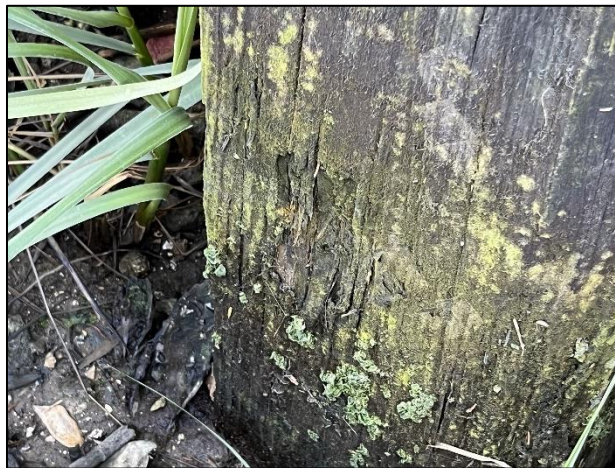
It was observed during the inspection that some of the 8x8 piles have some visible deterioration (See Figure 3.7).

**Figure 3.7. 8x8 Pile with Visible Deterioration Near Base at Mudline**

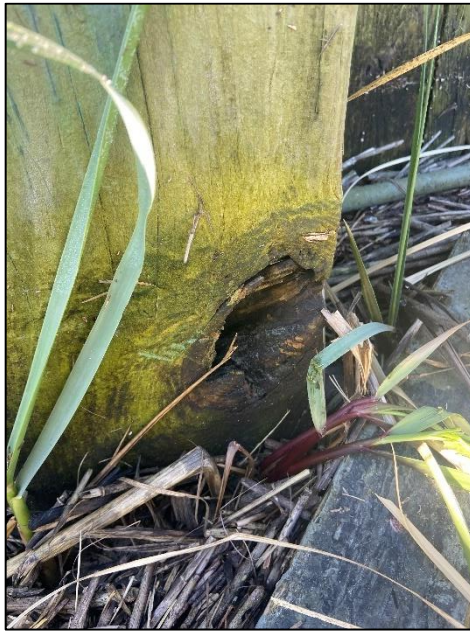
The third pile from the pier near the east end has a large knot near its base at the mudline (See Figure 3.8). The pile does not appear to be rotten at this time, but the knot will eventually cause deterioration in the pile.

**Figure 3.8. Knot in Third Pile from Pier**

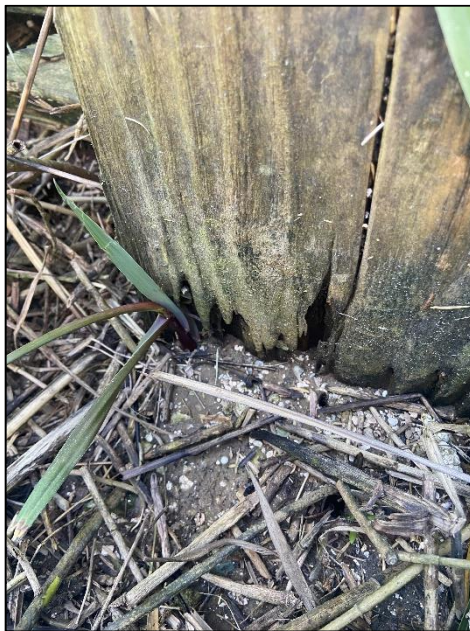
It was also observed that the first pile from the east side of the first pier is rotten at the mudline (See Figure 3.9).

**Figure 3.9. Rotten Pile at Base at Mudline**

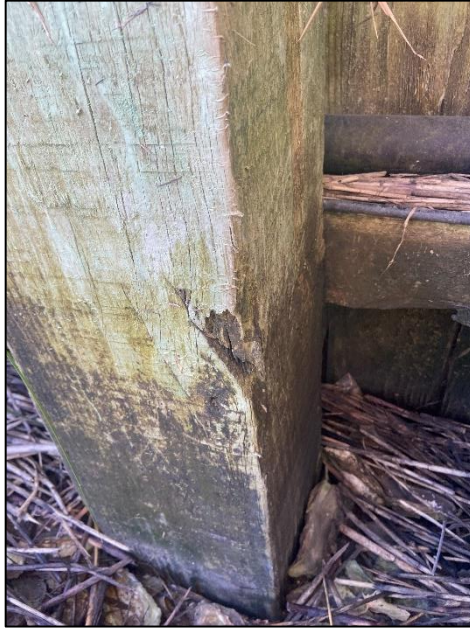
In addition, it was observed that there is some minor deterioration on the corner of the first pile from the second pier (See Figure 3.10).

**Figure 3.10. Minor Deterioration on Corner of Pile**

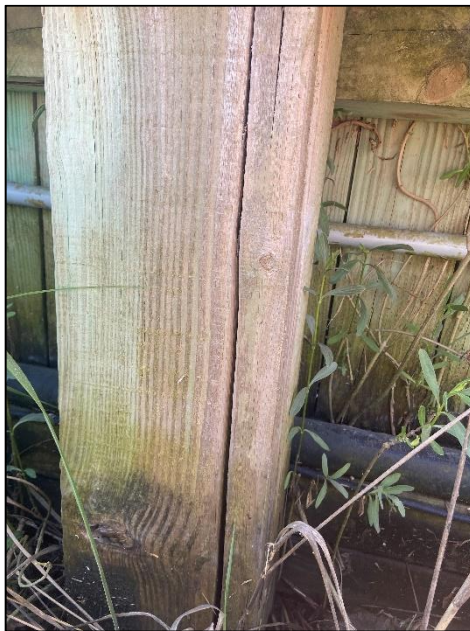
The fourth pile from the west end of the second pier has a large longitudinal split along its length (See Figure 3.11).

**Figure 3.11. Longitudinal Split in Pile**

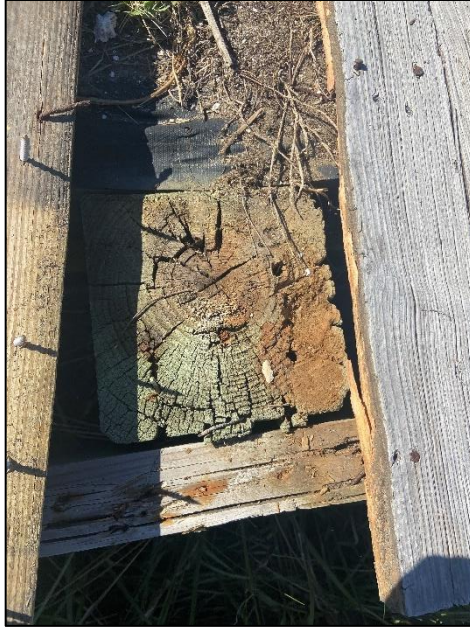
It was also observed that some of the piles have some minor deterioration in their tops (See Figure 3.12). Most of the piles are covered by the decking, so the total number of piles with this type of deterioration could not be observed during the inspection.

**Figure 3.12. Deterioration in Top of Pile**

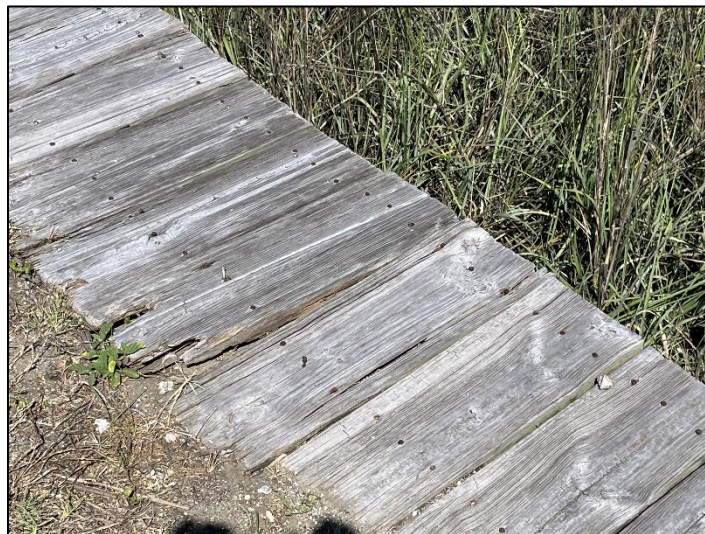
It was observed that most of the decking on top of the bulkhead is in poor condition (See Figure 3.13). The decking is split and deteriorated due to its constant exposure to wetting and drying.

**Figure 3.13. Deteriorated Decking**

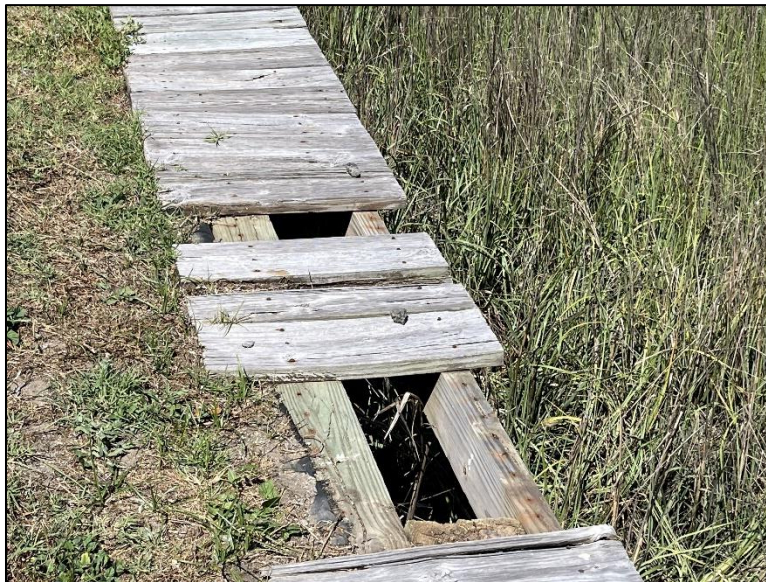
Some of the decking along the bulkhead is also missing in several locations (See Figure 3.14).

**Figure 3.14. Missing Decking**

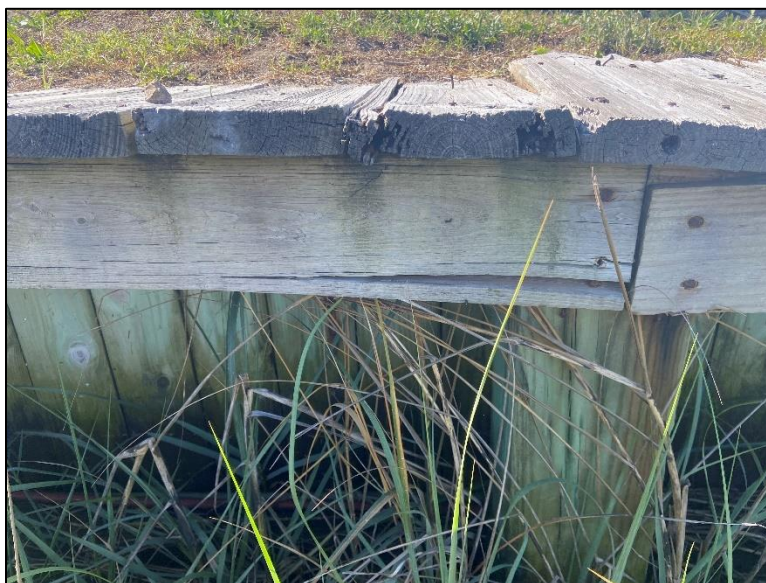
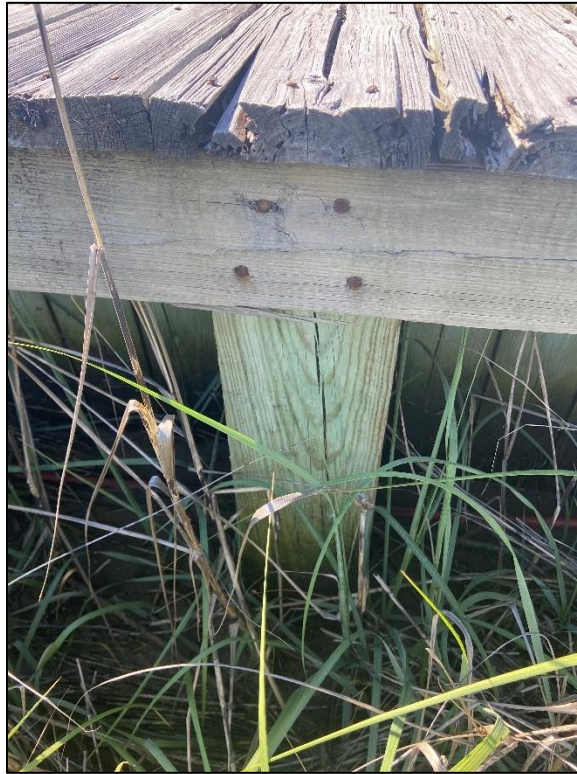
It was observed that the connections of the front 3x6 nailer to the piles consists of two or four nails (See Figure 3.15 and Figure 3.16) and that the nails are rusted and in poor condition.

**Figure 3.15. Connection with Two Rusted Nails**

**Figure 3.16. Connection with Four Rusted Nails**

The results of the structural evaluation indicated that the current 3x6 nailer boards were adequate for a vertical live load of 100 pounds per square foot but was found to be inadequate for the combined vertical live load and corresponding railing loads. These results also showed that the nailed connections do not have enough capacity for the combined loading.
