Corrected 11/15/2016

November 2, 2016

RE: Hurricane Matthew Beach Damage Assessment and Recommendations [CSE 2453]

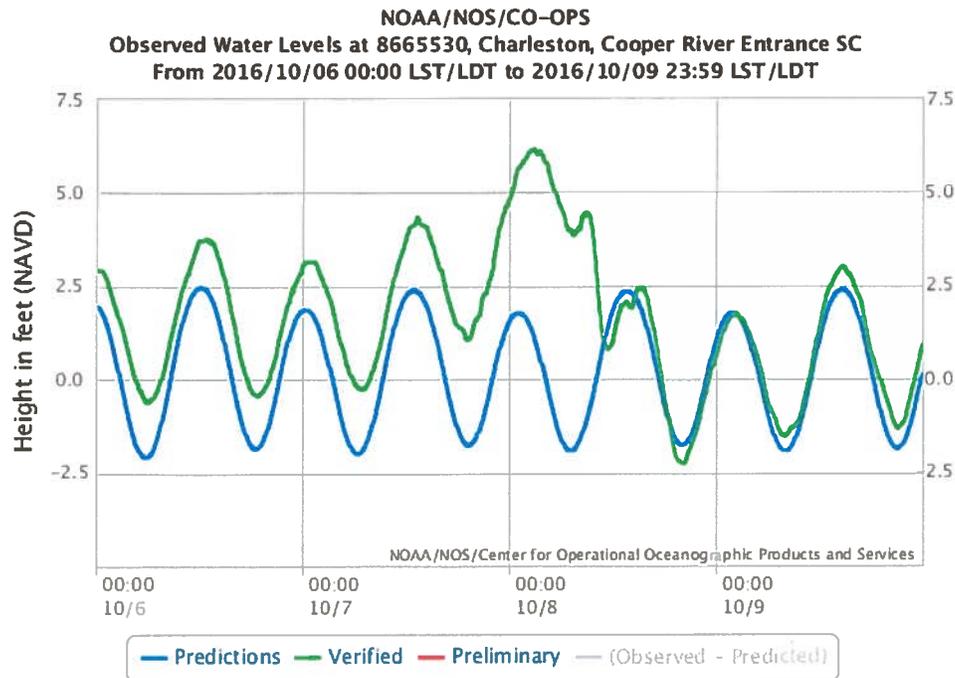
Figure 1 shows the water level record for Charleston Harbor around Hurricane Matthew. The tide station showed still water levels over +6.1 ft NAVD, which is ~3.5 ft above the normal high tide level. The maximum surge was ~5.9 ft recorded near 7:15 am at low tide. The surge was likely higher along the outer coast due to higher wave setup and larger wind fetch. For reference, the dry sand elevation at Isle of Palms is typically +6 ft NAVD, mean the still water elevation (without waves) overtopped the normal dry sand beach for a period of time during the storm. Fortunately, the maximum surge occurred during low tide, reducing the potential damage to the beachfront. In addition to the surge, wave energy created severe runup and overtopping of low dunes along the entire ocean-facing shoreline of the beach. Areas of high dunes eroded, leaving significant escarpments.

Figure 1. Water levels at the NOAA tide gauge in Charleston Harbor, SC.

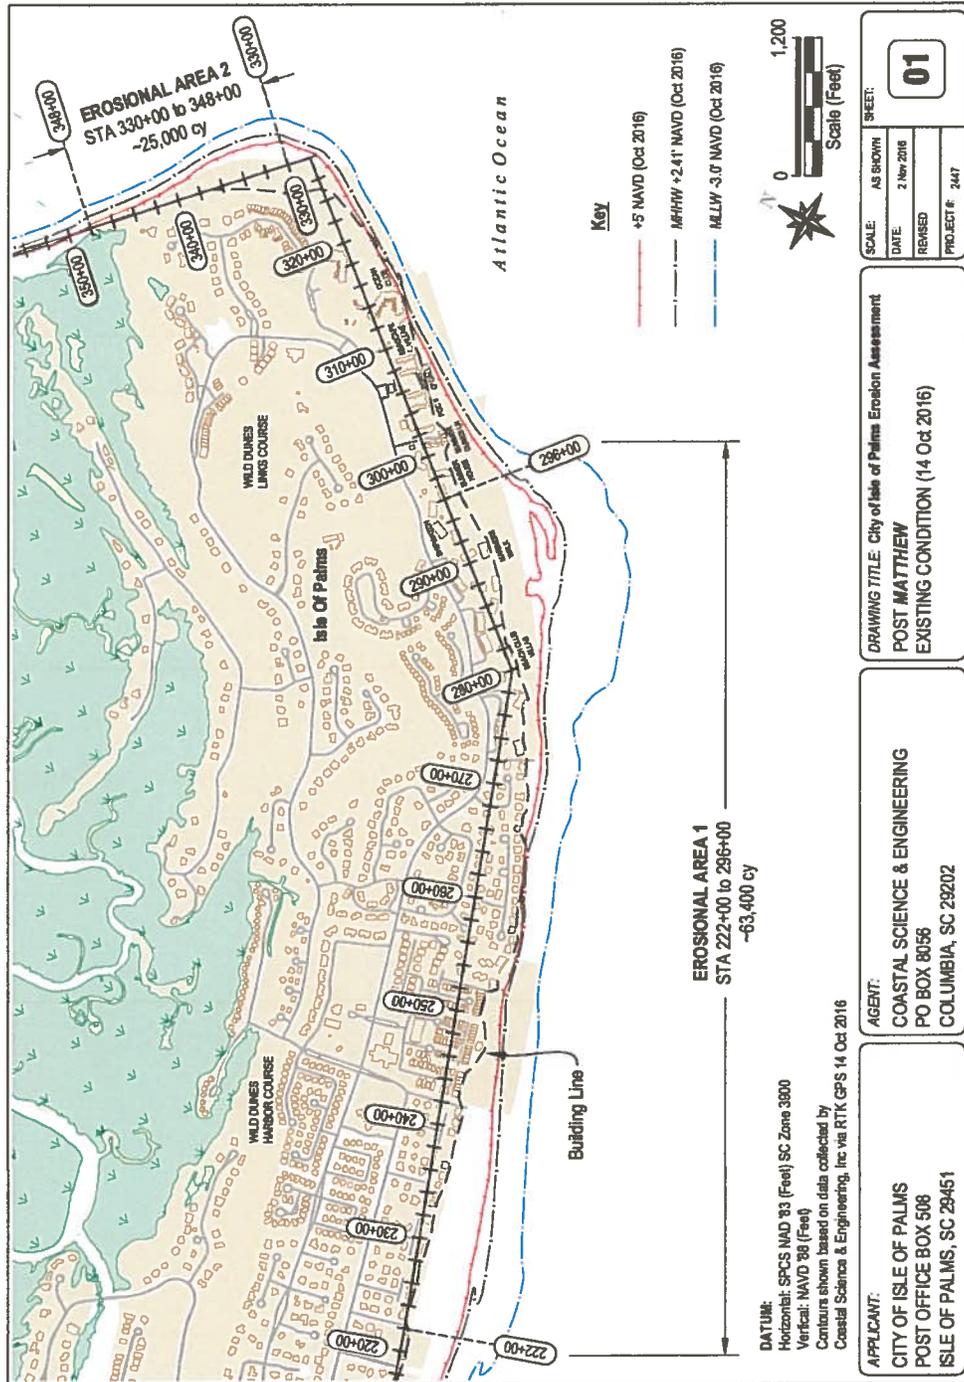
The total volume loss in two areas within the engineered beach boundary is 84,812 cy. This should be considered the reimbursement-eligible quantity for FEMA Category G assistance. This volume represents nearly 10% of the 2008 nourishment quantity, and is sufficient enough to warrant the City seeing FEMA reimbursement. CSE recommends the City pursue reimbursement in a manner similar to the process following Hurricane Joaquin. That storm resulted in 67,000 cy of eligible losses, and later coordination resulted in a plan to add this volume to a planned renourishment project the City is presently pursuing, with FEMA covering 67,000 cy worth of sand placement and a pro-rata share of mobilization, permitting, and engineering.

Figure 2. Erosional areas eligible for FEMA Category G Public Assistance Funds.

The City is presently pursuing a permit for a beach restoration project using an offshore borrow area. The project involves addition of 1,000,000 cy of sand between 53rd Ave and the 18th hole of the links course. The City should increase the planned nourishment volume to account for the volume lost during Hurricane Matthew. The 84,812 cy lost during Hurricane Matthew represents 7.8% of the total volume for this project. Table 2 outlines the anticipated project costs for the project, including breakdowns for FEMA reimbursement for Joaquin and Matthew. The estimated cost to restore the eroded volume, plus a pro rata share of engineering, construction administration, and monitoring is \$1,243,081. The City should apply to FEMA for this amount for Category G PA funds.

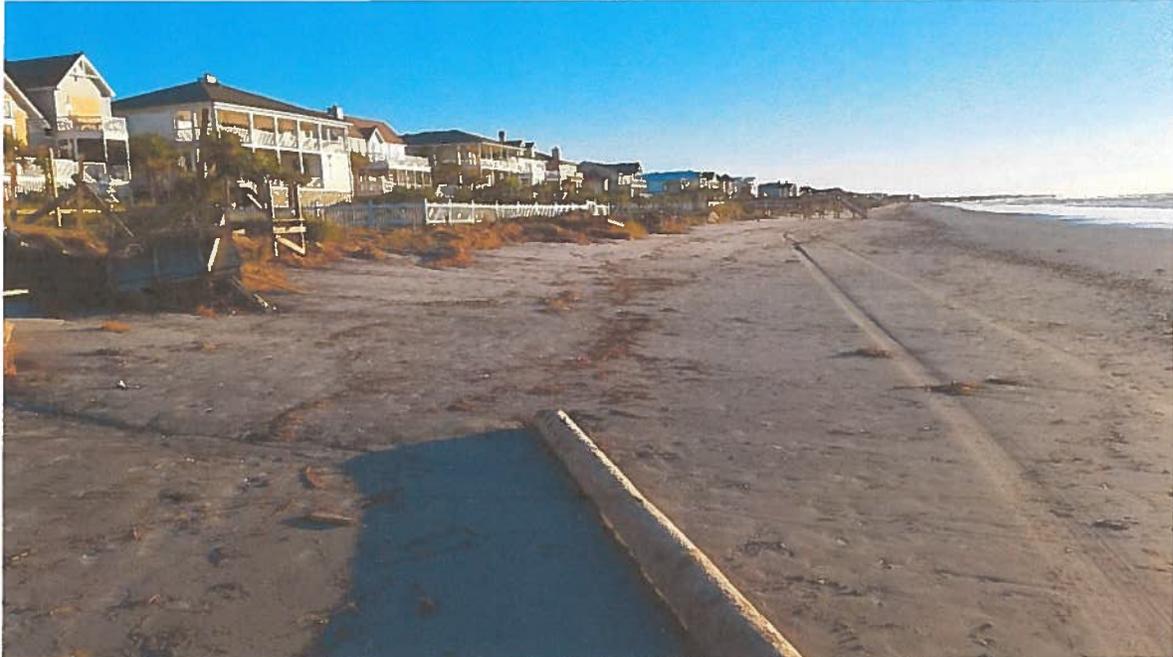
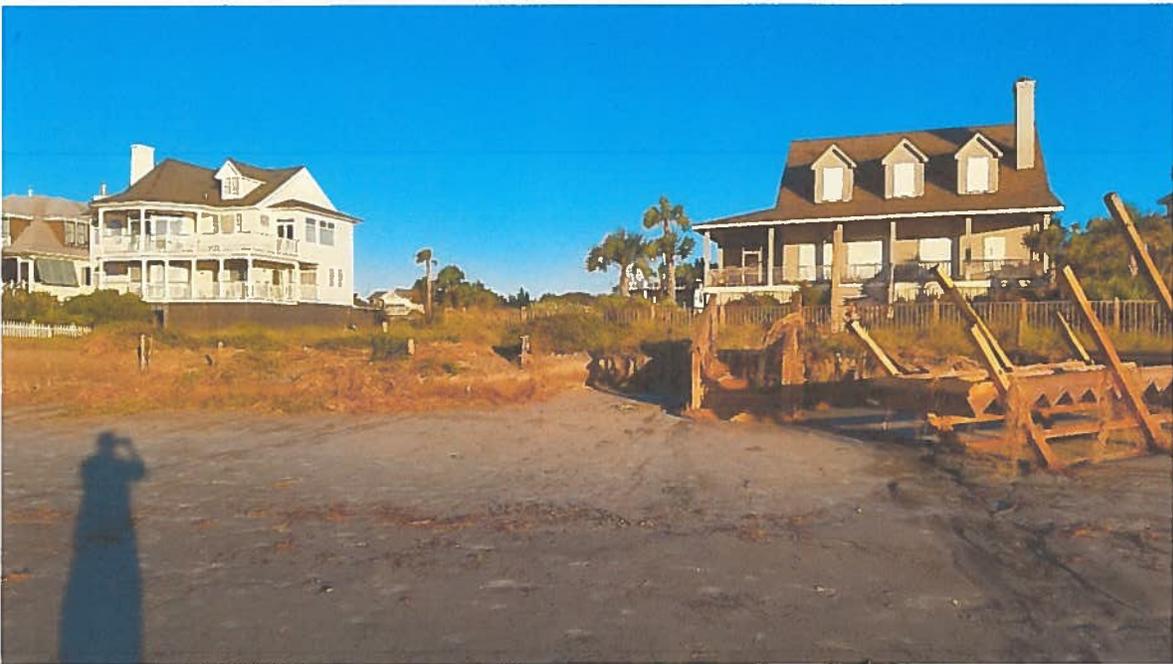
Photos from the area between 2nd and 6th Avenues showing complete loss of the primary dune and low elevations fronting oceanfront

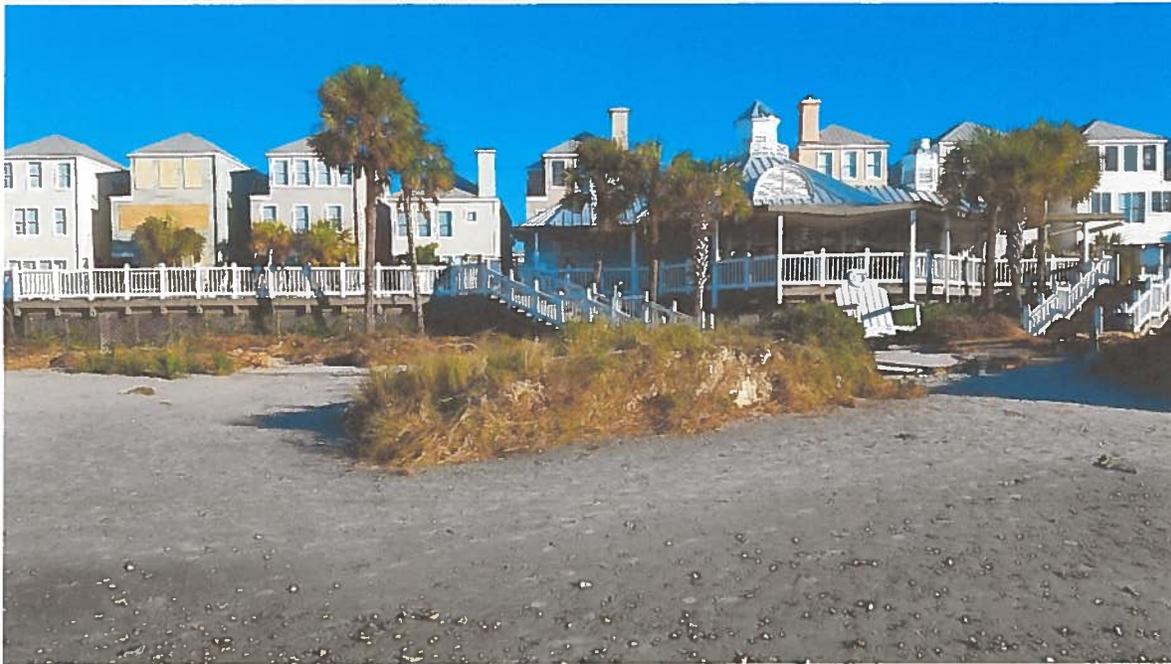
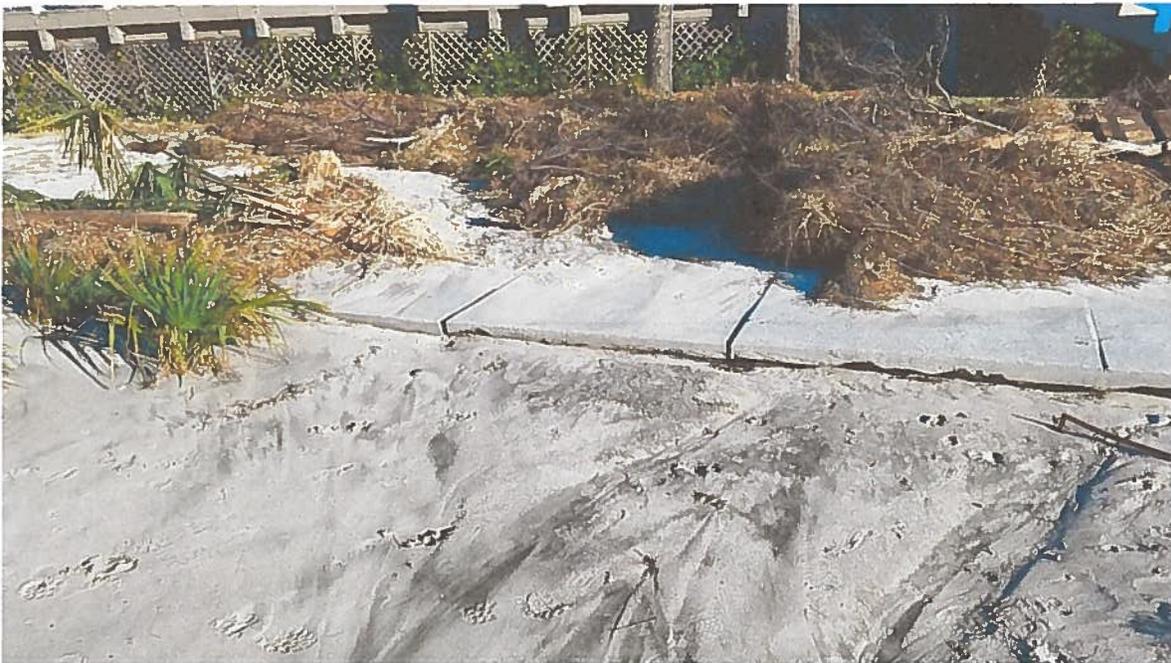
Near the Wild Dunes Grand Pavilion (Station 250+00) there was no dune and the high tide line reached sidewalks and decks.

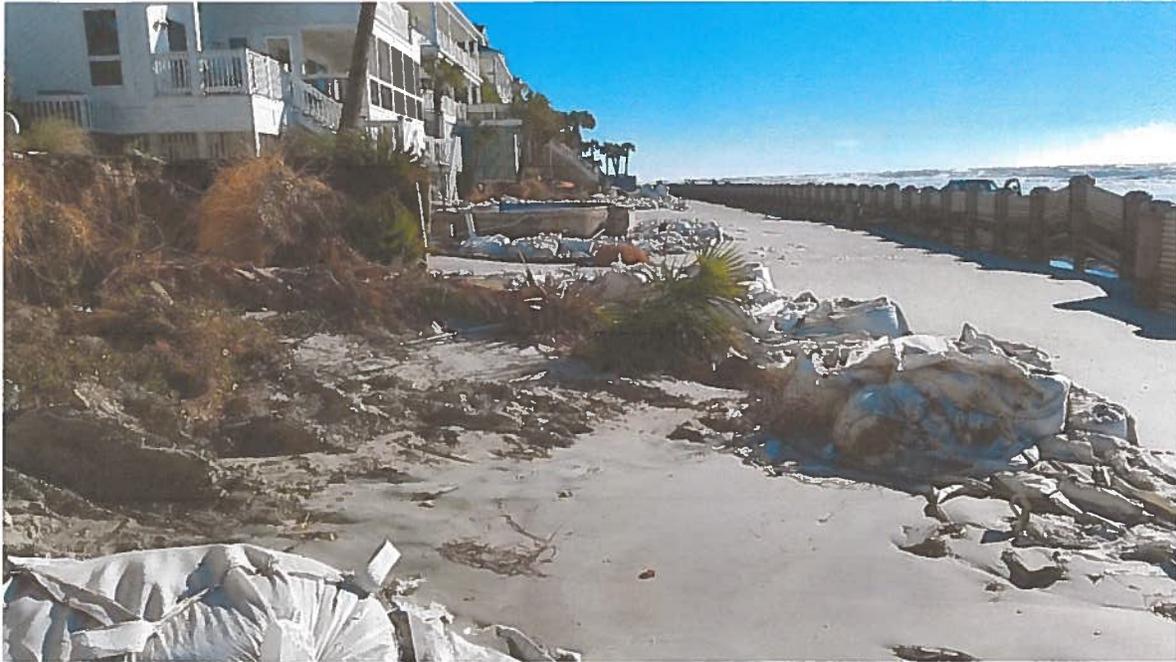
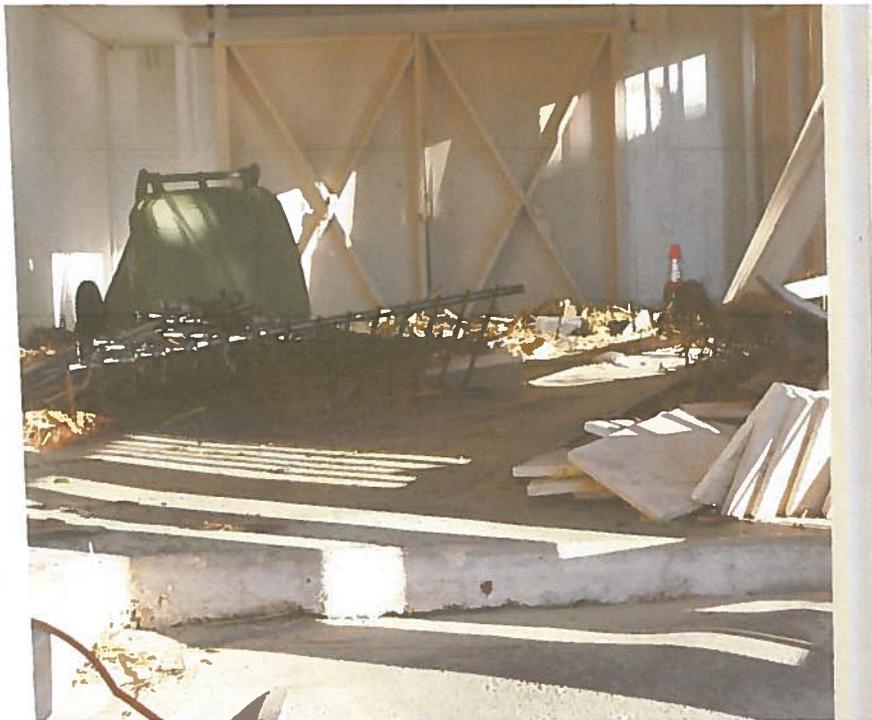
Along Beachwood East (~Station 260+00), the beach is critically eroded and sand washed into houses and the road.

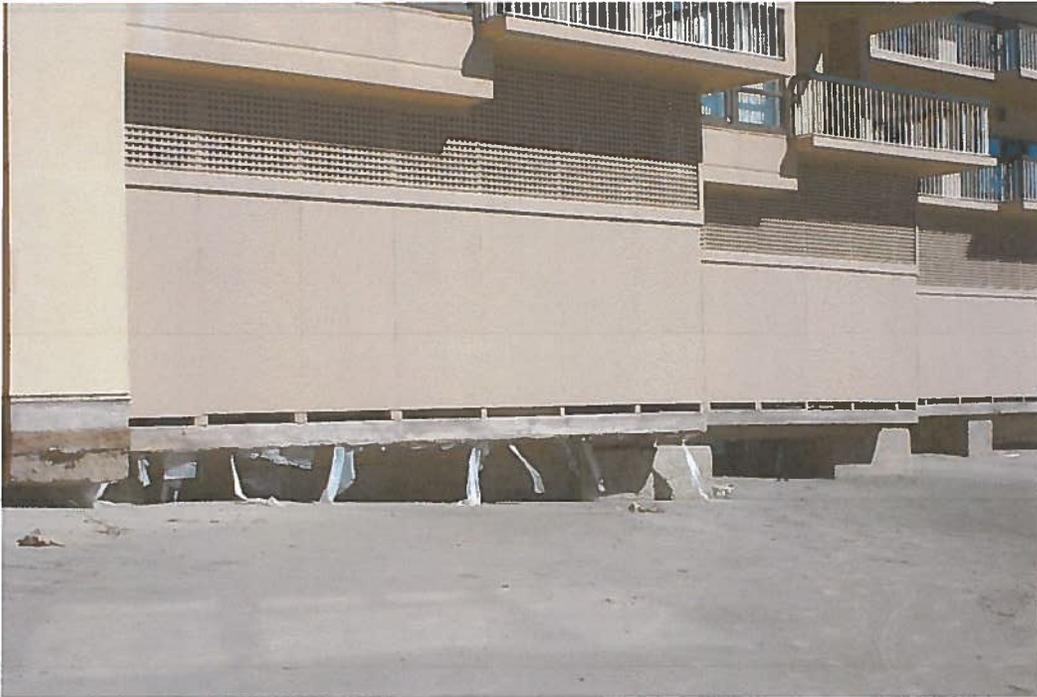
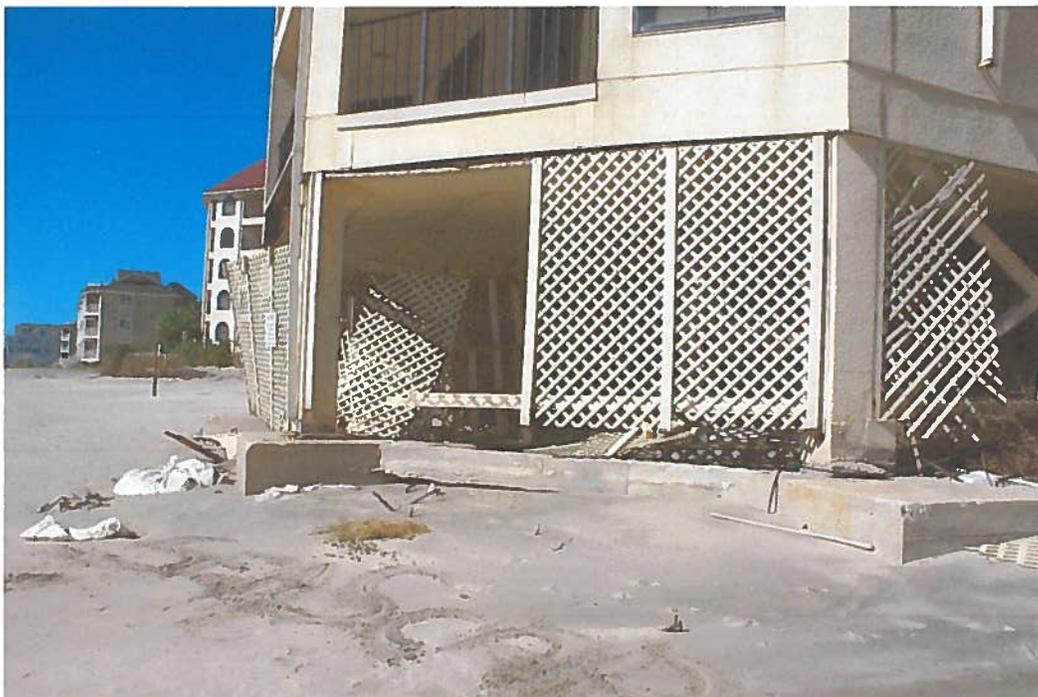
The high tide line reached the Seascape and Ocean Club buildings. No dune exists in these areas.
