Building Assessment *for*
MORGAN CREEK GRILL
80 41st Ave, Isle of Palms

City of Isle of Palms

April 11, 2019

SMH
architecture • planning • interiors

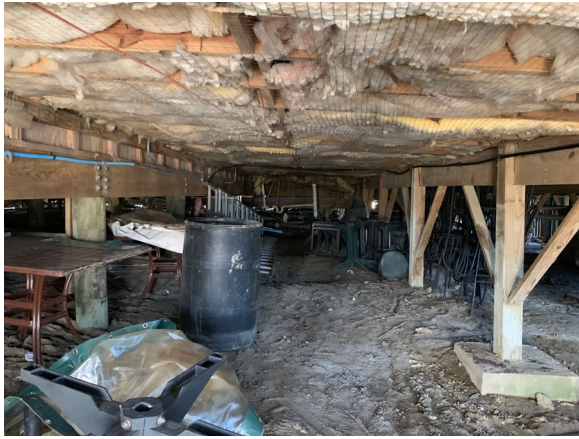
Enclosed porch, shallow foundation

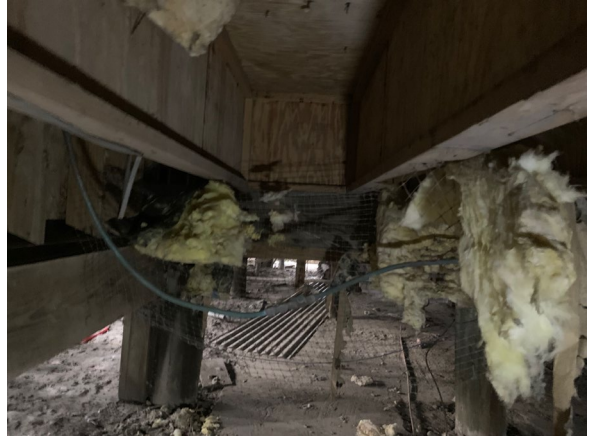
Pile foundation. Insulation falling down

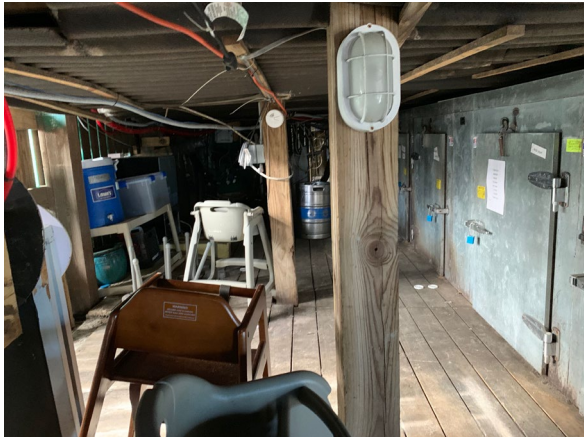
Beer coolers in crawl space / flood plain

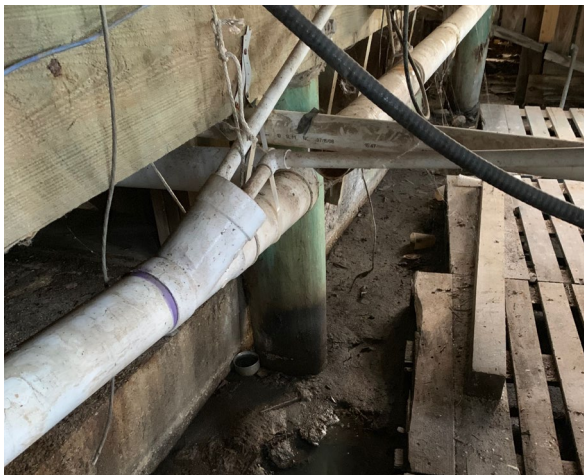
Open sanitary drains

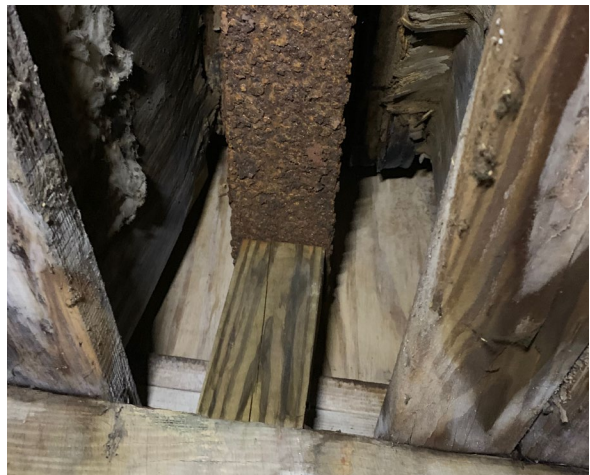
Shoring attempt with no connectivity

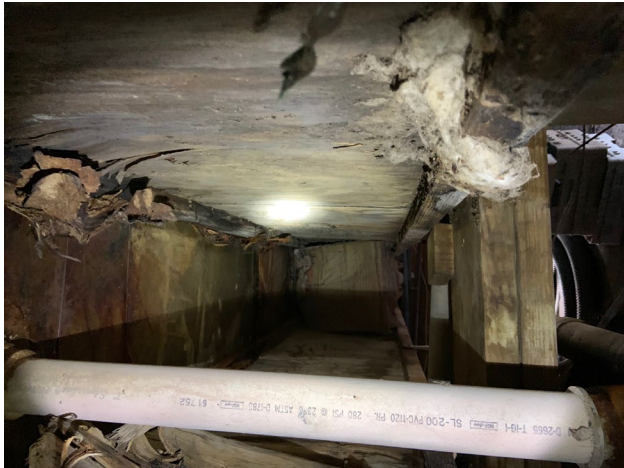
- There is serious degradation of the structural floor system supporting the walk-in refrigerator and freezer in the Kitchen. Condensation has “rotted out” the wood floor joists and the plywood subfloor. There are areas where the floor joists and the subfloor have completely rotted away to the point that the underside of the metal floor (or possibly the concrete slab floor) of the refrigerator / freezer are exposed in the crawl space. A “repair” has been attempted that is comprised of steel beams shored up to the underside of the wood subfloor (or cooler floor) and seated upon 6 x 6 blocks, which bear upon a stud wall constructed on top of an existing slab under the building. None of these components are actually attached to the other through any mechanical means. We feel this situation presents a dangerous condition and needs the direct attention of the Building Official.

Plywood totally deteriorated. Underside of cooler.

Any repair will require the removal of the cooler / freezer, the partial demolition of flooring system in the immediate area, the reconstruction of such flooring system to current engineering standards, and the reinstallation of the cooler / freezer. The reintroduction of the cooler / freezer should take into account the condensation issue and be designed to avoid the problem in the future.

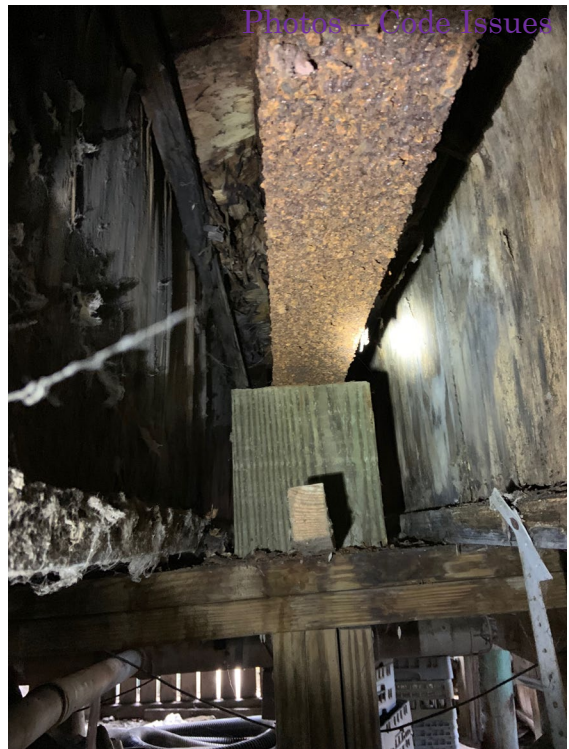
Steel beam blocked up, no connectivity

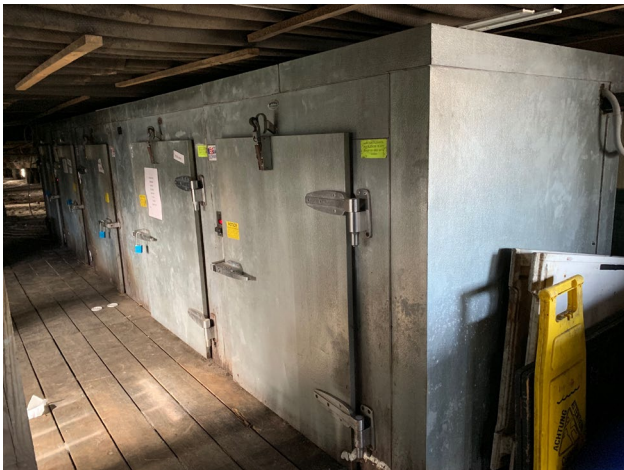
- There are a number of code violations in the crawl space relative to flood plain requirements. Most significantly, there are “permanently” installed beer coolers. It is noted that these pieces of equipment also have less than the minimum 7-foot clear headroom required by the code. Additionally, there are several extension cords and power strips in the crawl space.

Beer coolers in crawl space / flood plain

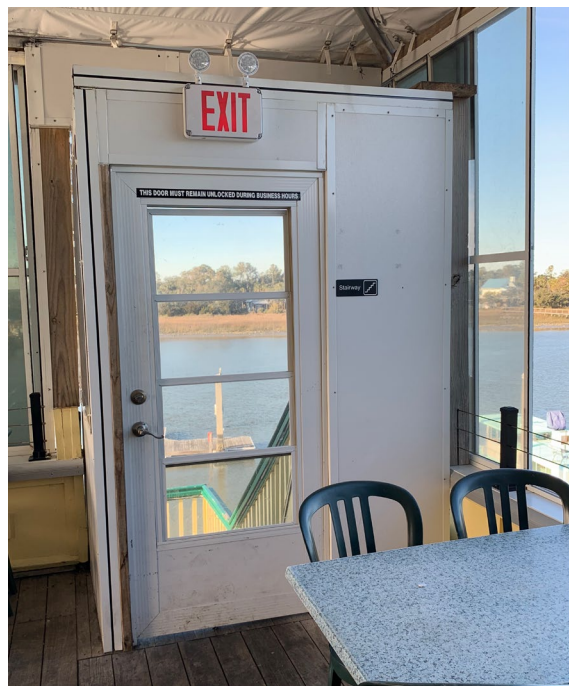
- None of the egress doors have panic hardware as required by 1010.1.10, however, there is one egress door from the infilled porch on the first floor that due to settlement or swelling is very difficult to push open. We feel that this should be corrected / repaired.

Exit door, no panic hardware

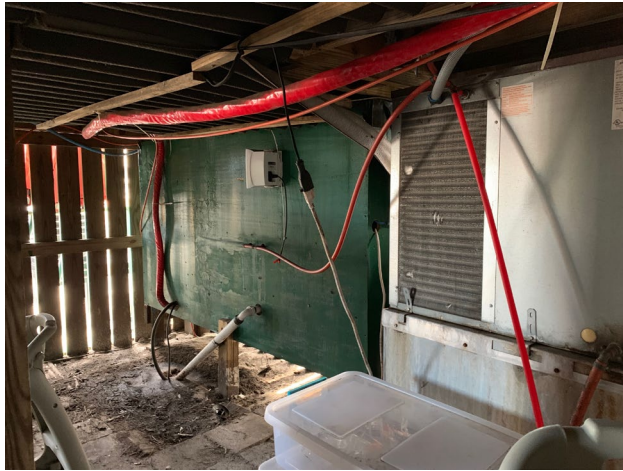
Equipment in crawl space, extension cords

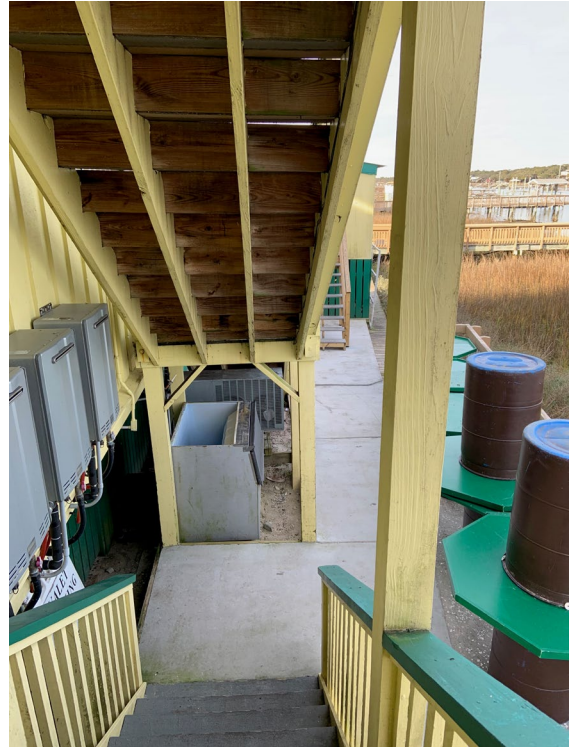
Egress, railing discontinuous
Lack of egress lighting

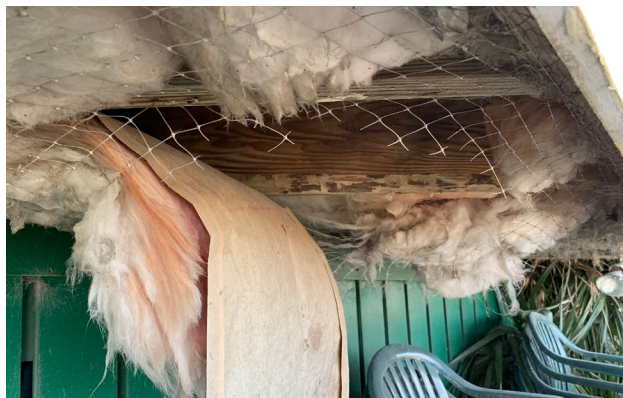
Insulation falling down or missing in floor

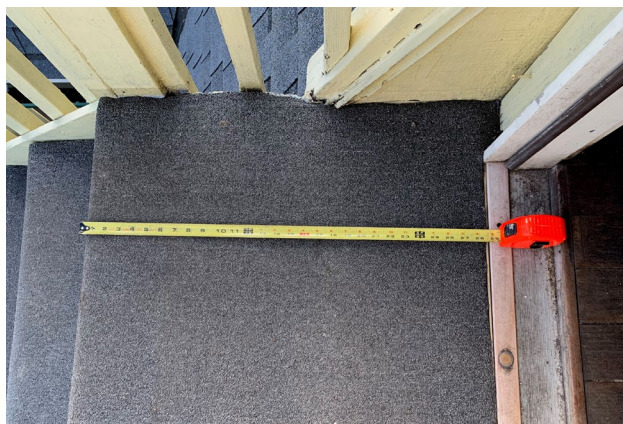
Insufficient landing depth at top of stair

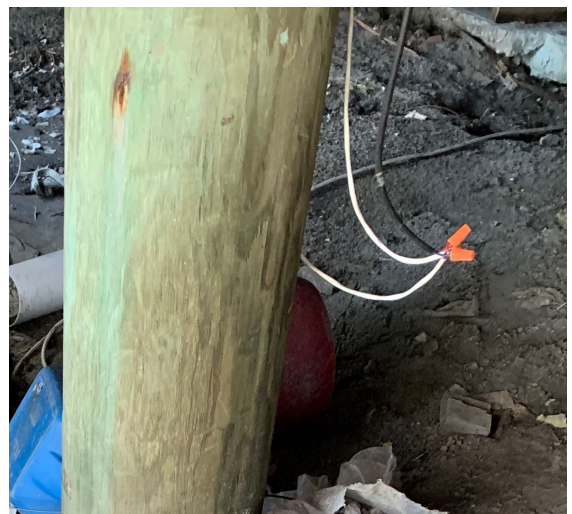
Open electrical connections

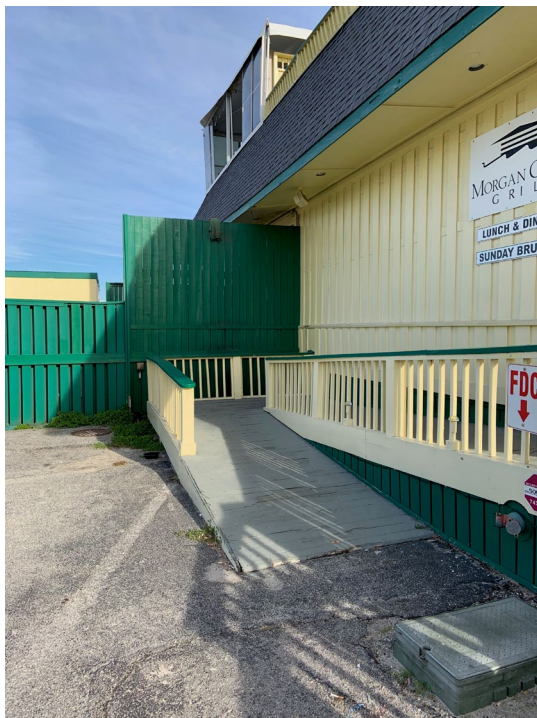
Start of ramp to first floor. Note electrical box in the way of the landing and the railing ending before the bottom of the ramp.

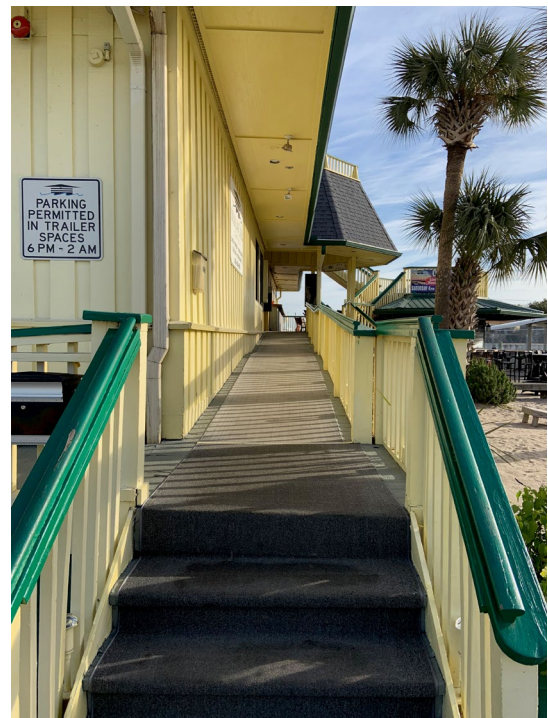
Ramp essentially serves its intended purpose but is not code compliant in a number of areas.

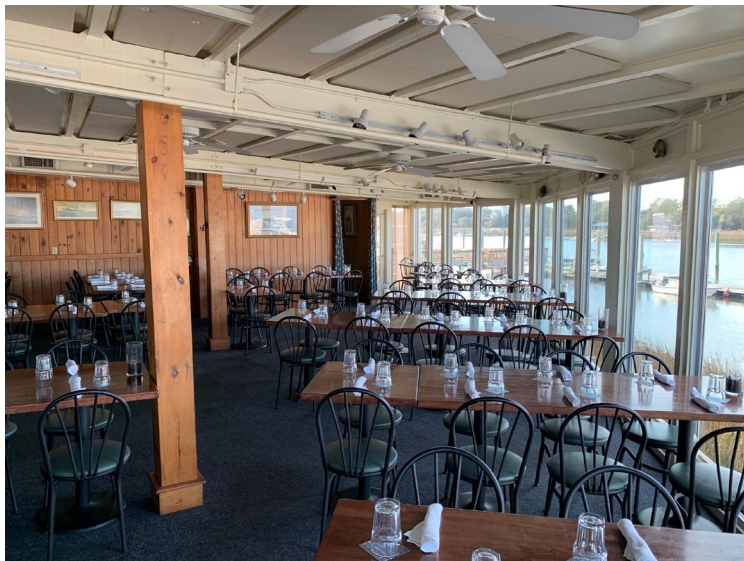
Infill porch slopes approximately 6 inches, creating a significant cross-slope in the room.

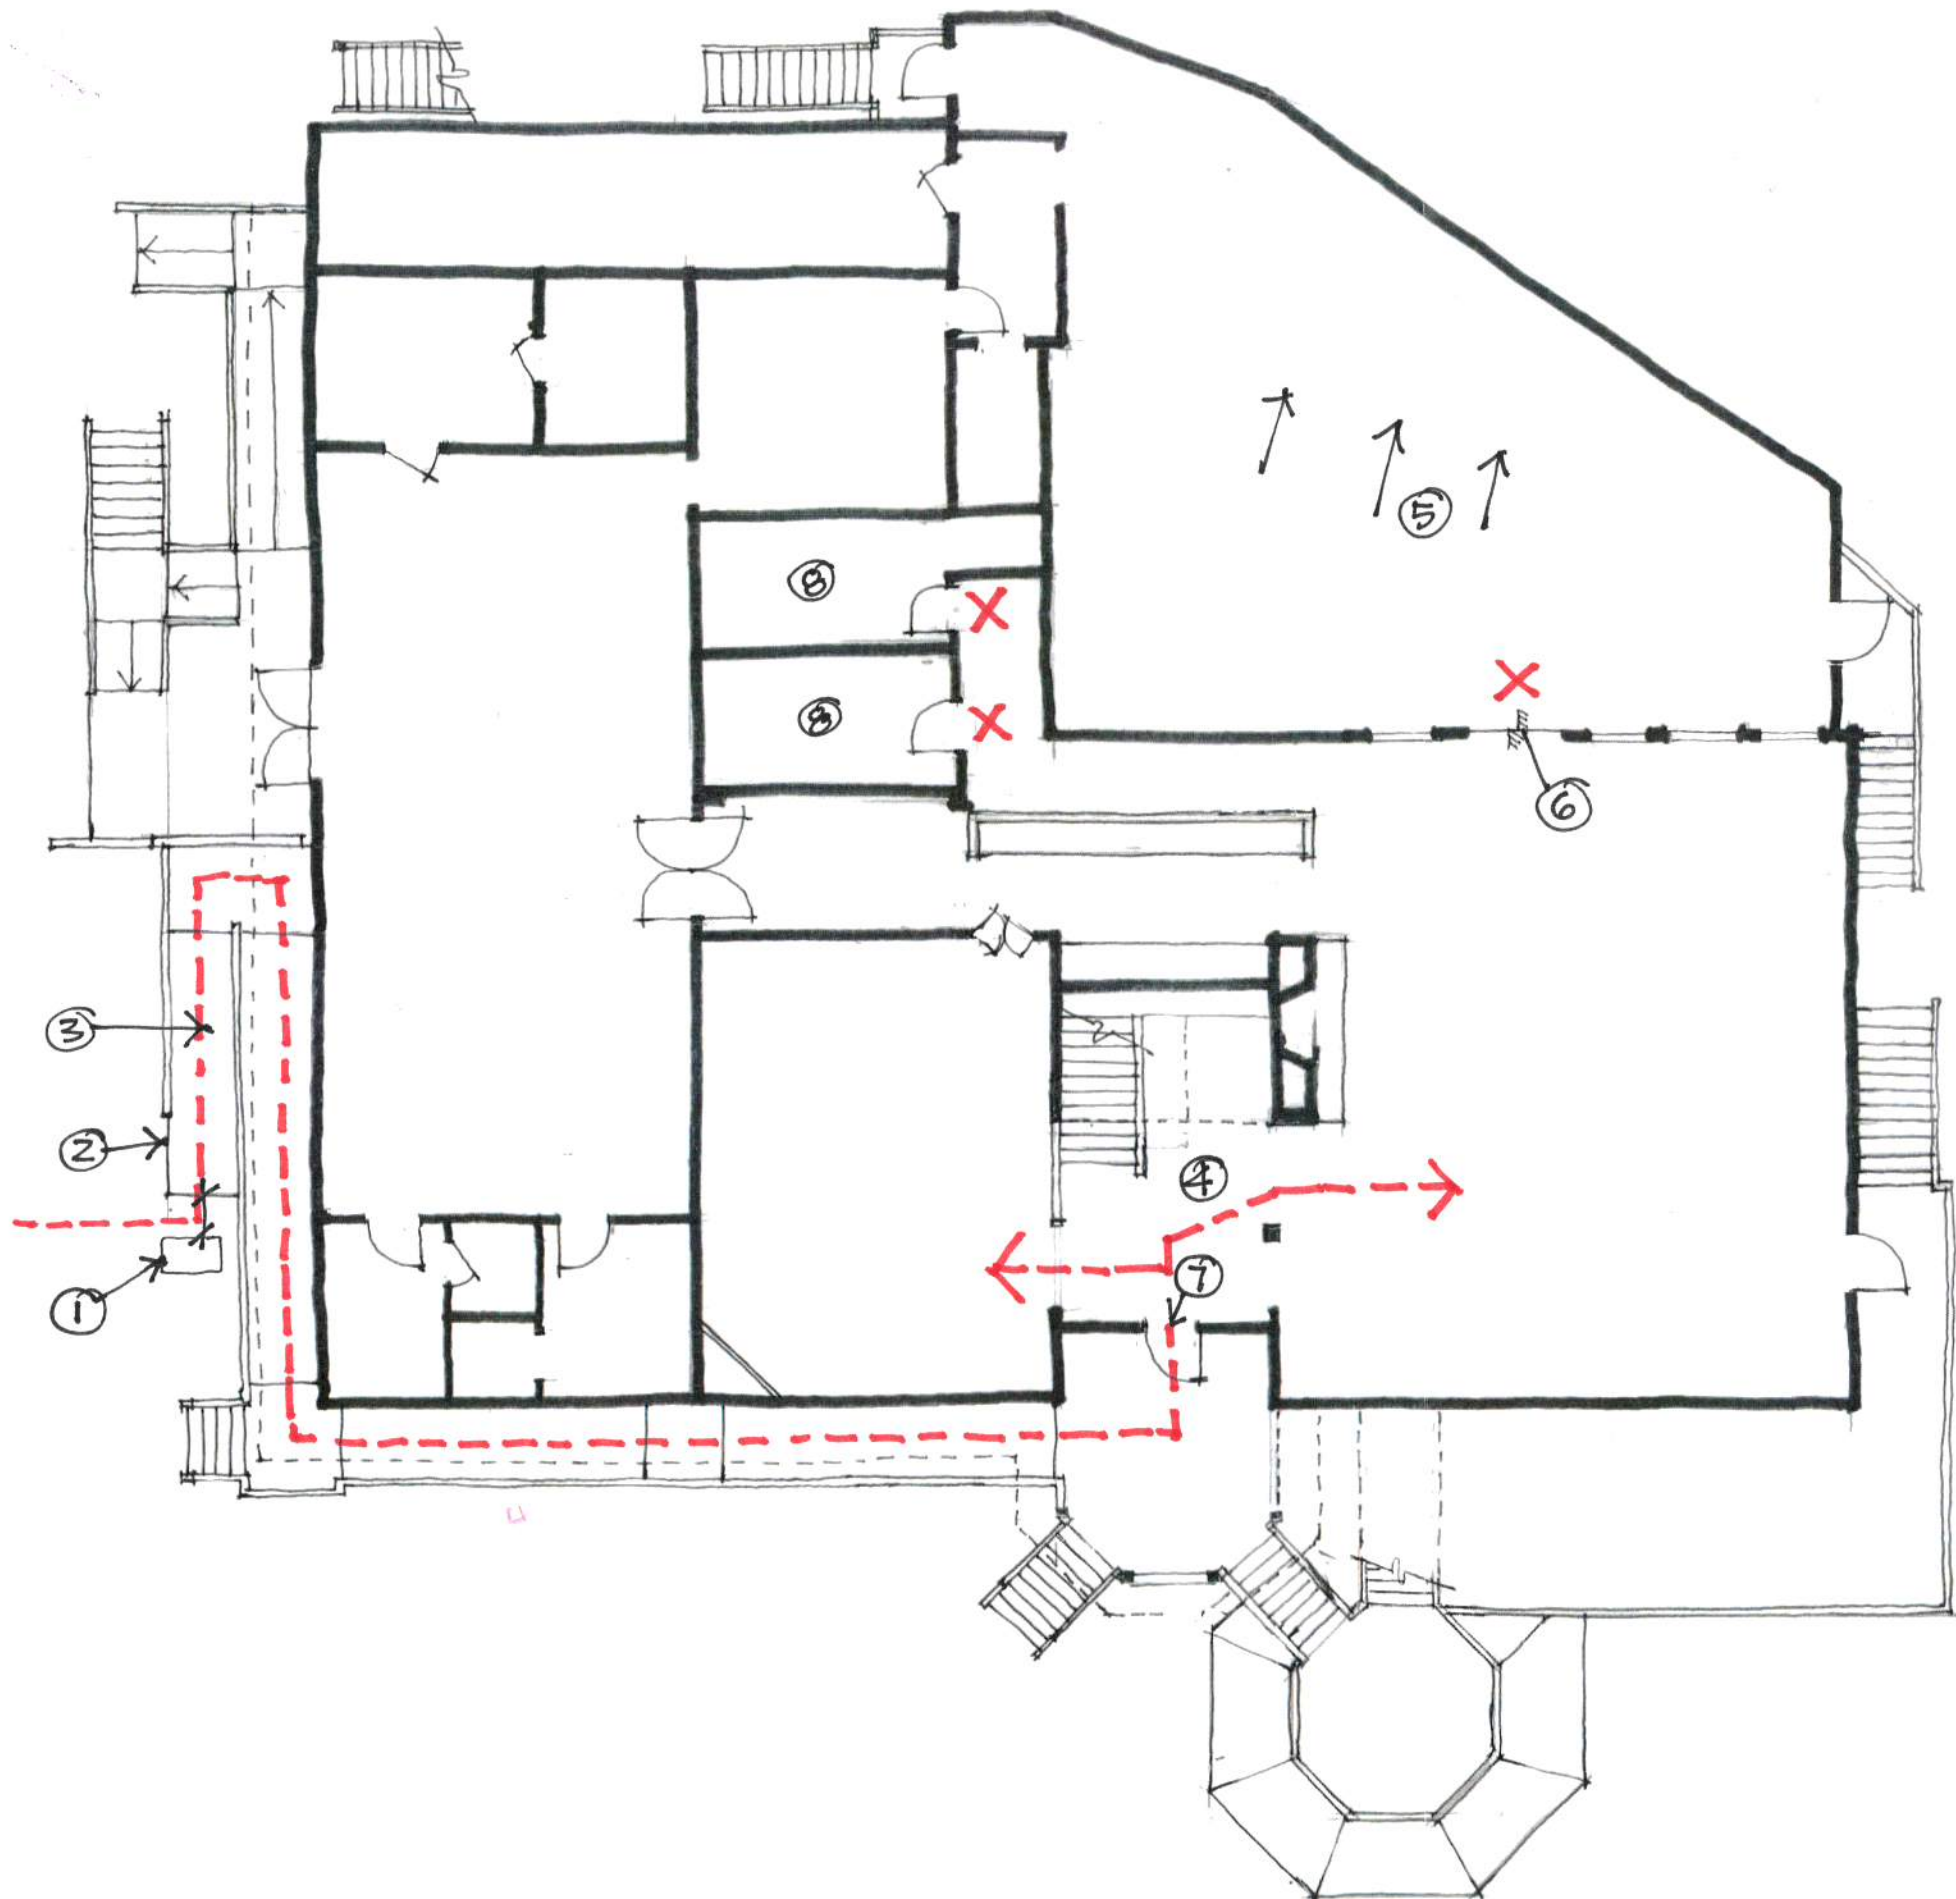
FIRST FLOOR

- 1 ELECTRIC BOX LIMITS ACCESS TO THE RAMP.
- 2 HANDRAIL IS NOT CONTINUOUS.
- 3 RAMP EXCEEDS 1:12 SLOPE (SLIGHTLY).
- 4 NO ELEVATOR ACCESS TO THE SECOND FLOOR.
- 5 FLOOR SLOPE IS GREATER THAN 1/4" PER FOOT, i.e. THIS SECTION OF RESTAURANT IS NOT ACCESSIBLE.
- 6 THRESHOLD EXCEEDS 1/2".
- 7 ONLY ONE MEANS OF ACCESSIBLE EGRESS. TWO REQUIRED.
- 8 TOILET IS NOT ACCESSIBLE.

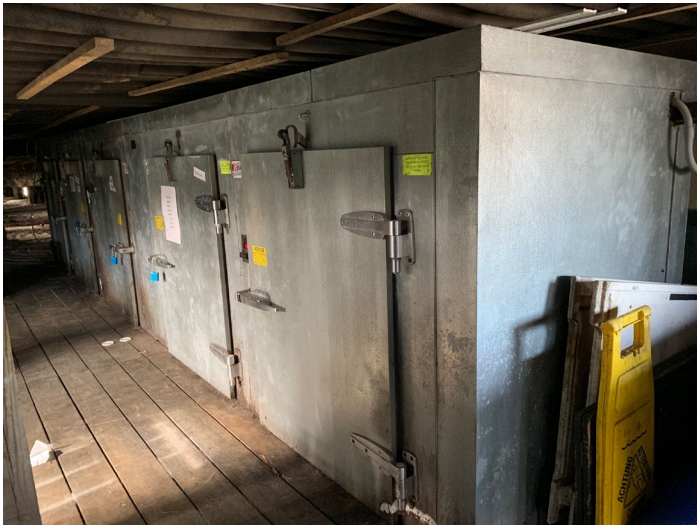
Draft beer coolers – seemingly permanent installation

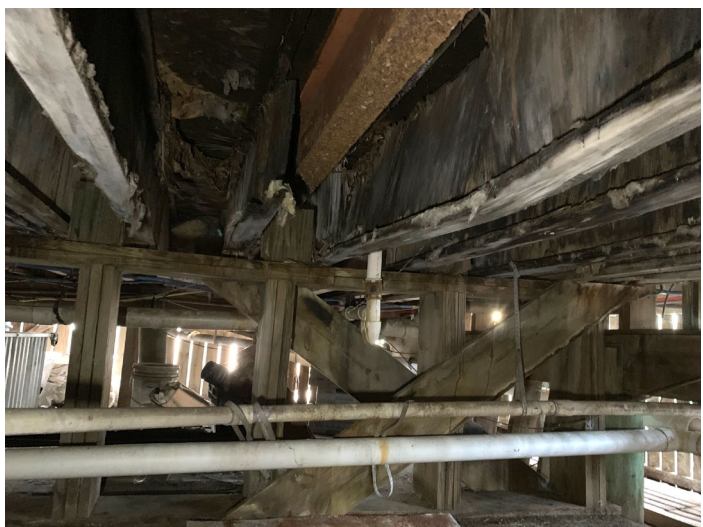
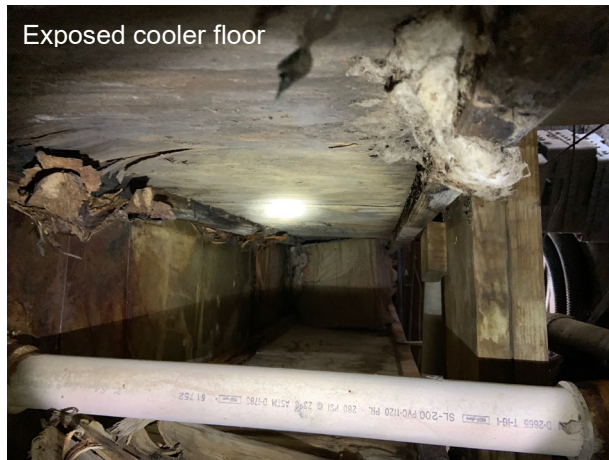
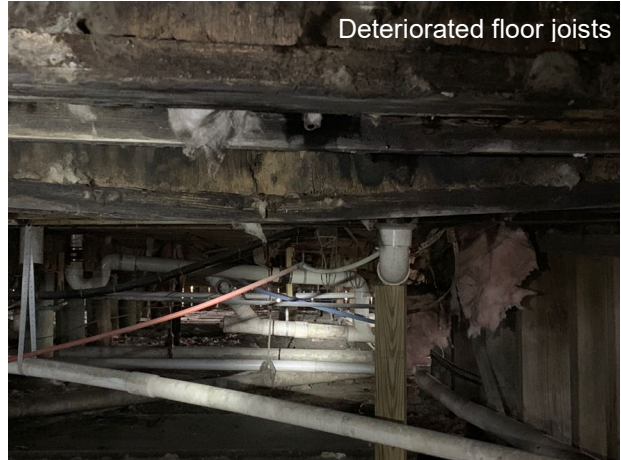
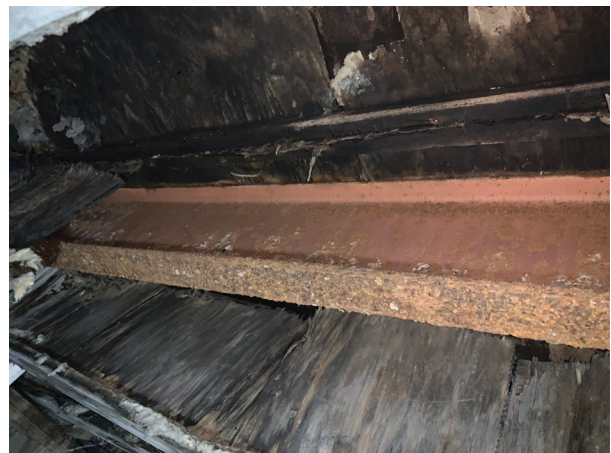
Photos – Structure of floor at walk-in cooler / freezer

This situation requires the immediate attention of the City of Isle of Palms (as Owner), the Tenant, and the Building Official. Condensation at the underside of the cooler / freezer has resulted in the complete deterioration of the plywood subfloor and a number of the wood floor joists. In some instances the plywood and the wood joists are completely gone. A “repair” was undertaken at some point that installed steel beams at the underside of the plywood subfloor. That repair is insufficient and tenuous. It consists of steel beams shored up by 4 x 4 wood blocking, bearing on a wood wall, which bears on an existing slab that preexisted under the restaurant. None of these components are attached or tied to the other in any meaningful way.

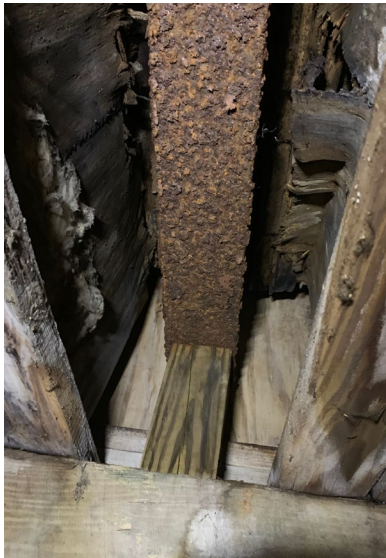
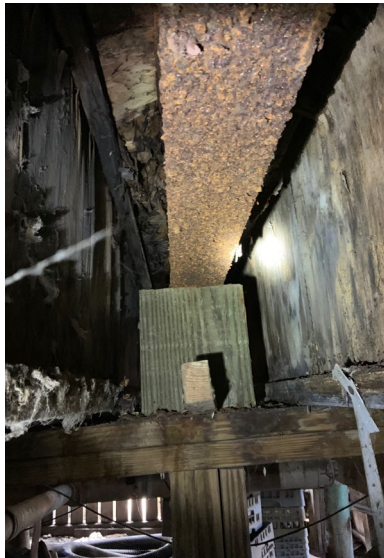
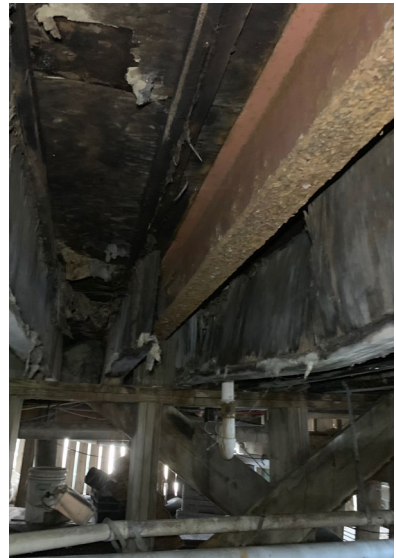
Observations: Structure of enclosed porch

The assessment team speculate that there are a number of potential issues with the enclosed porch. Whereas the existing restaurant building should have been designed for uniformly distributed live loads of 100 psf, and it is on a timber pile foundation, the Code requires any porch or deck to be designed to the same live load as the primary occupancy. It appears the now enclosed porch is on a foundation consisting of treated 6 x 6 or 8 x 8 posts on a shallow concrete foundation.

The perimeter of this porch was once a cantilevered structure, that has been “shored up” on the outside building line with 4 x 4 posts bolted to other 4 x 4 posts, that are simply in the ground, much like fence posts.

It is also noted that the enclosed porch – because it was once a porch – slopes away from finish floor. It is not clear that the Flood Elevation Certificate took that finish floor elevation into account, and by regulation, the lowest finish floor elevation determines the flood elevation for the entire structure.

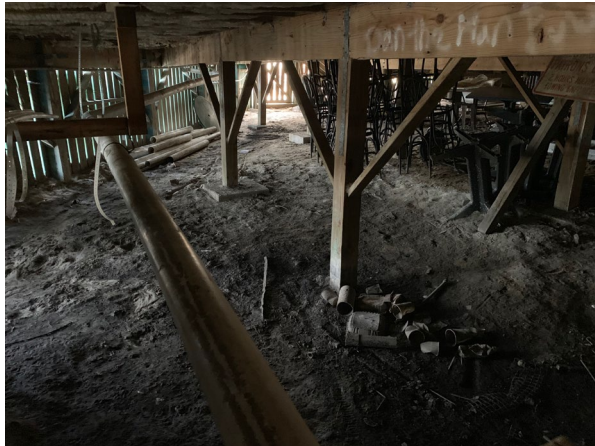
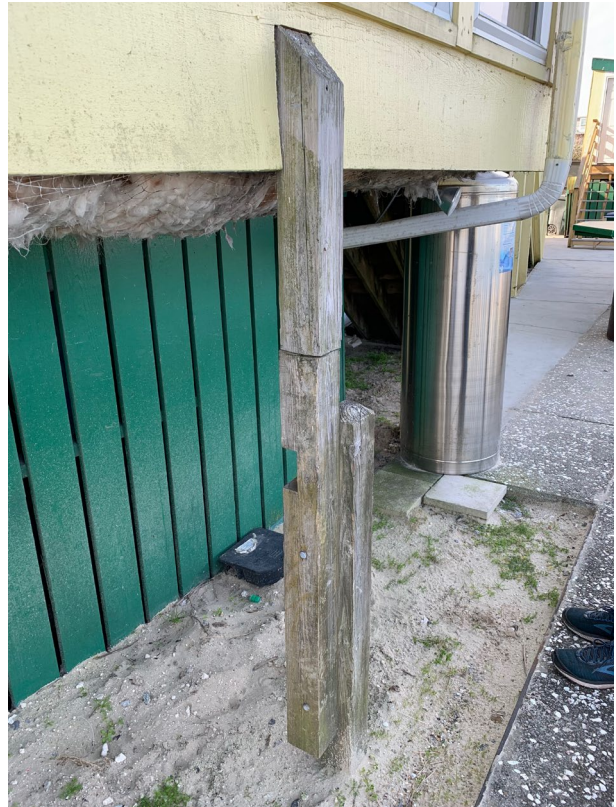
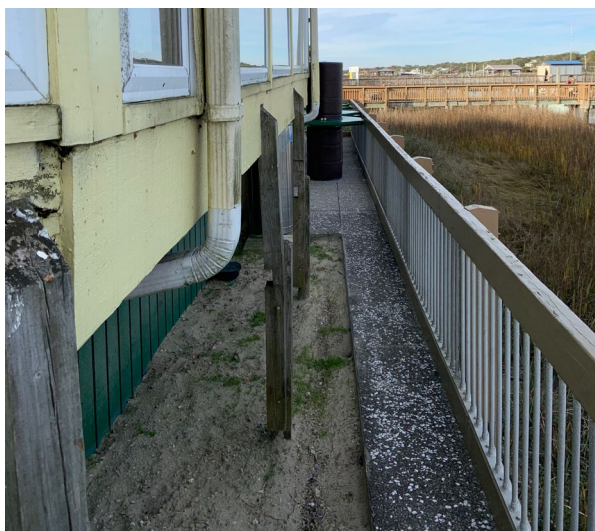
Observations: Structure of “add-on” rooms off kitchen

In much the same way that the enclosed porch has a different foundation system than the primary original building, the assessment team speculates that that foundation system for the 8-foot wide office / storage addition off the rear of the kitchen is similarly a shallow foundation.

This issue would only be reasonable to address if combined with a more comprehensive renovation. We did not observe any differential settlement at this location at this time.

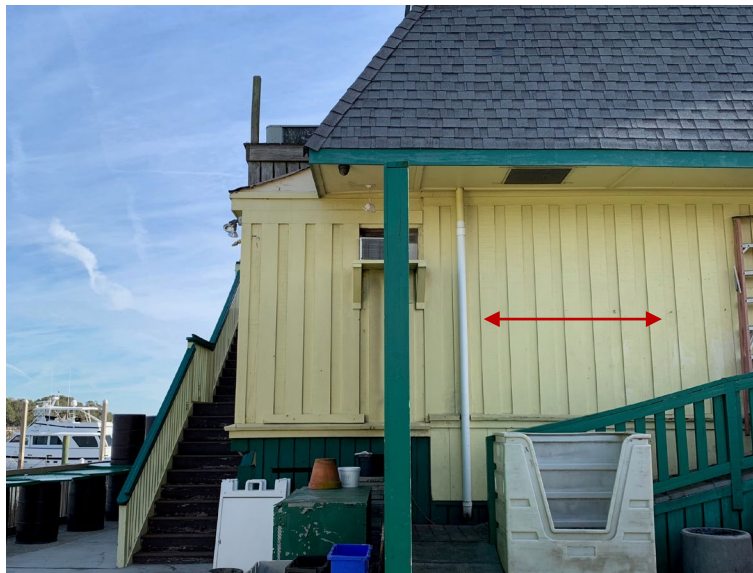
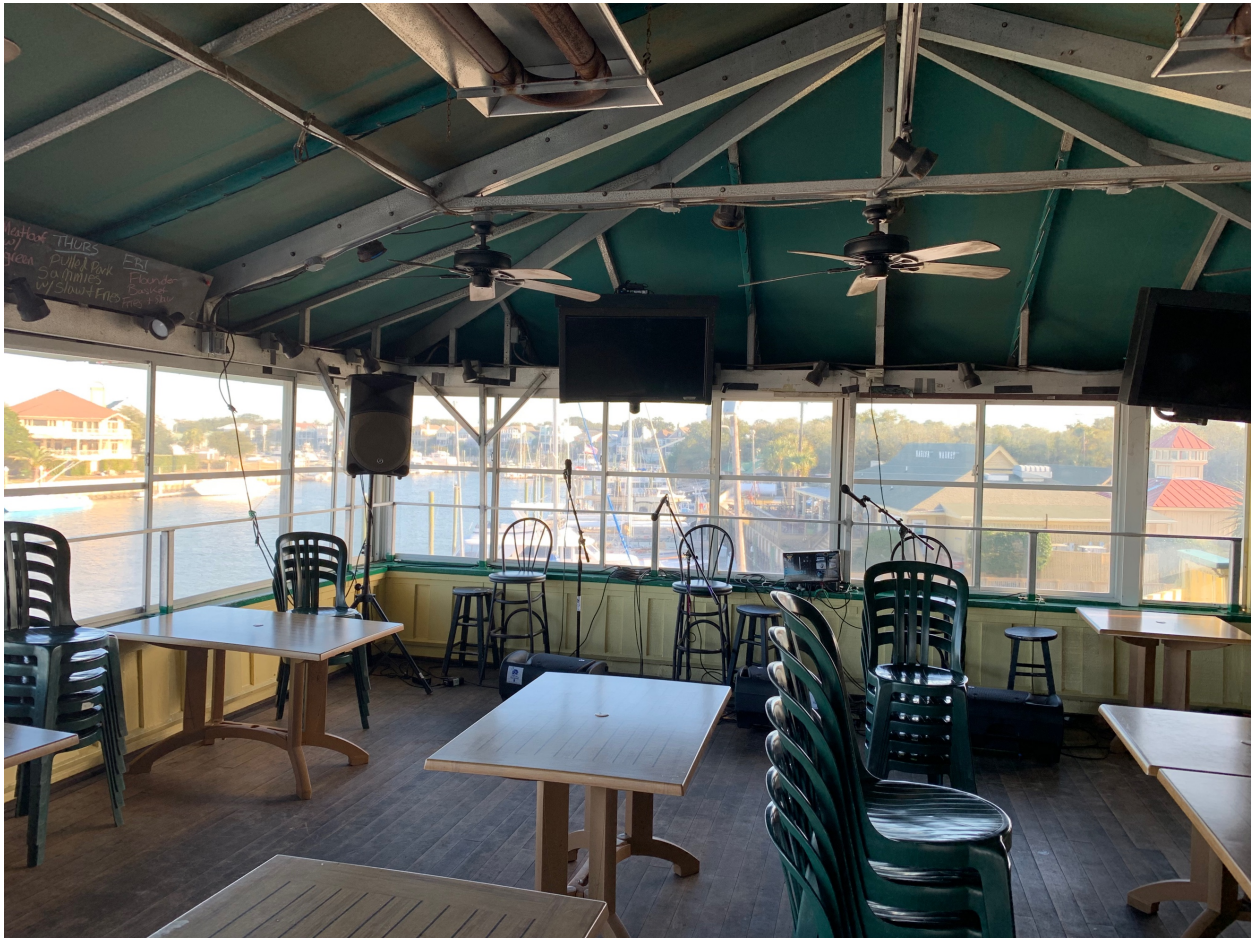
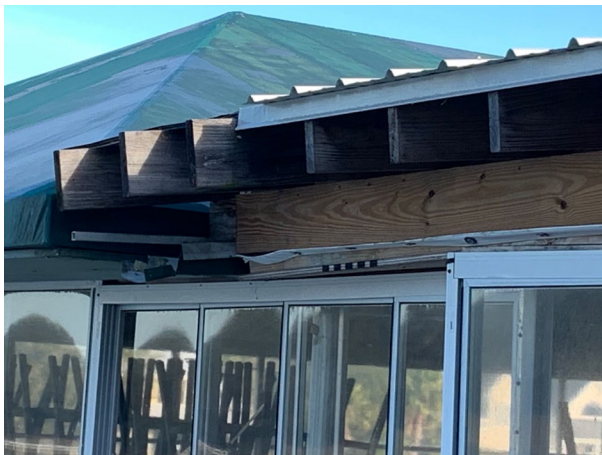
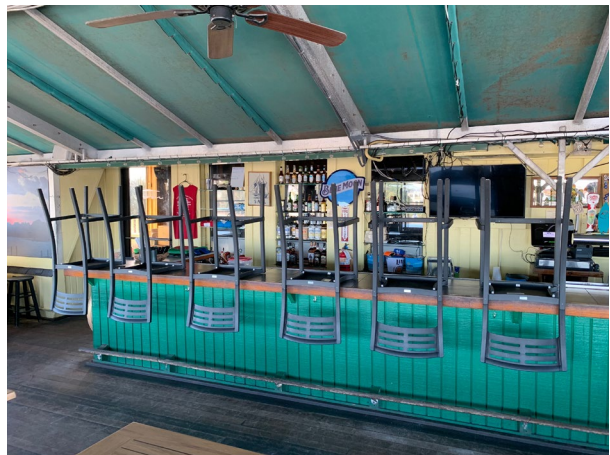
Observations: Temporary structures i.e. tents on second floor

Temporary structures, such as tents, are addressed in Section 3103 if the International Building Code (IBC). A tent may be erected for a period of less than 180 days, or otherwise must meet all provisions of the Code.

There are two on the second floor of the subject property; a “green tent” and a “white tent”. The green tent is more or less an enclosed space, with non-impact glazing on the perimeter. The white tent is more or less an open structure, with some areas of glazing or wind screens. Both have been erected for longer than 180 days, and do not meet all aspects of the Code. Structurally these tents have suspect connectivity that is likely dangerous in a high wind scenario. There is similarly a wood roof structure connecting the two tents that raises structural concerns. If these tent structures are to remain on the second floor we recommend review by a qualified structural engineer and subsequent corrective action.

Because the white tent is open, there should be guardrails at 42” above finish floor that prevent the passage of a 4” sphere and meet the structural requirements of 1607.8 in the IBC. The railing / fall protection under the white tent is inadequate and could pose a danger to the public.
