FISH CAMP * RAW BAR
(ACTUAL NAME TBD)

IOP City Council
February 23, 2021

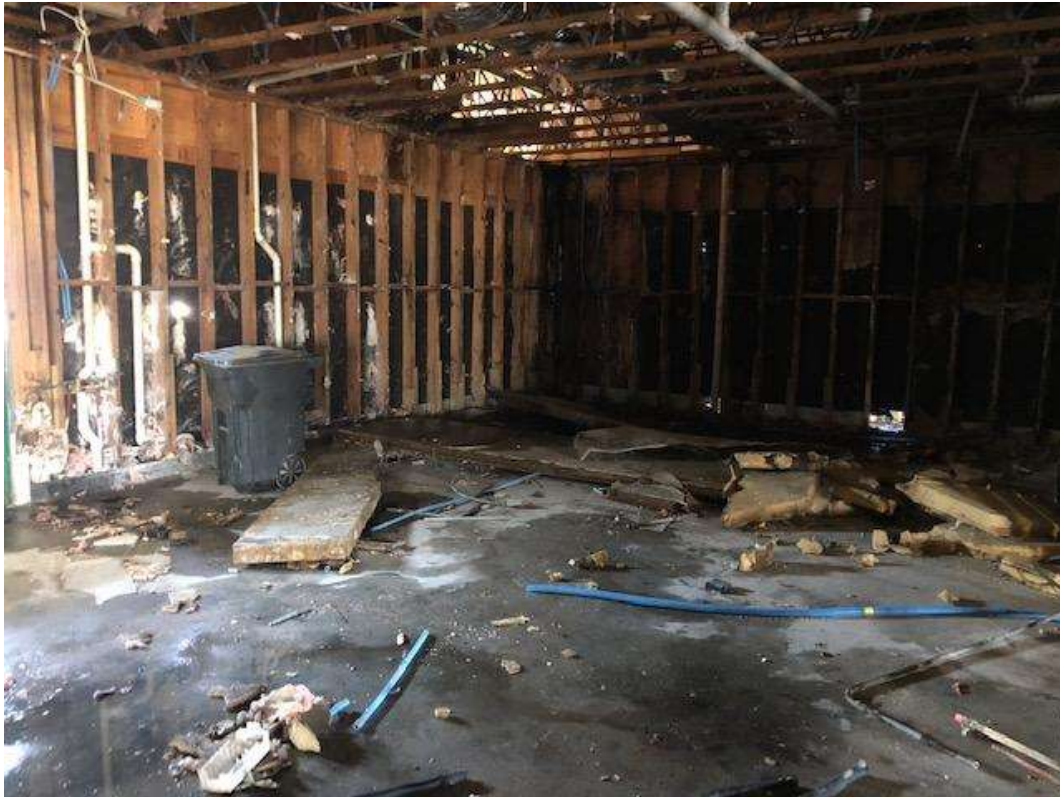
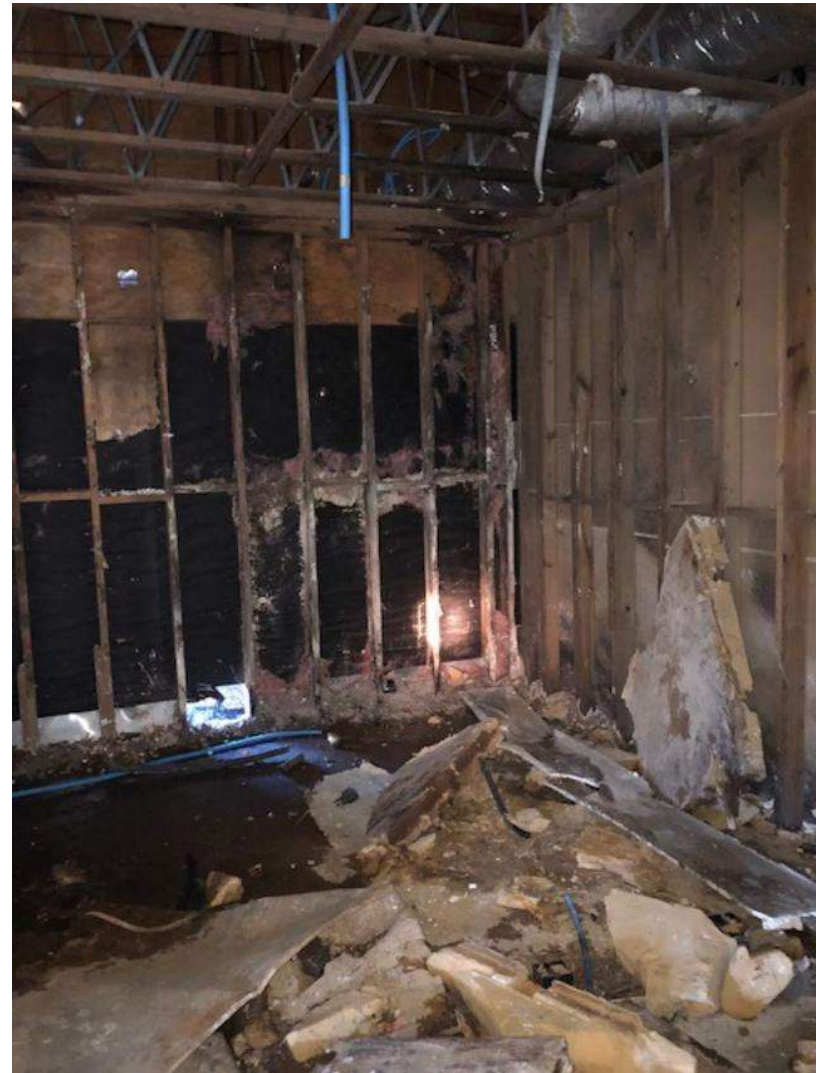
Pictures of Kitchen

Extensive water damage, wood rot, termite issues, and failing joists/support beams. Large portions of the kitchen roof/ceilings/walls/floors all compromised and unable to be salvaged.

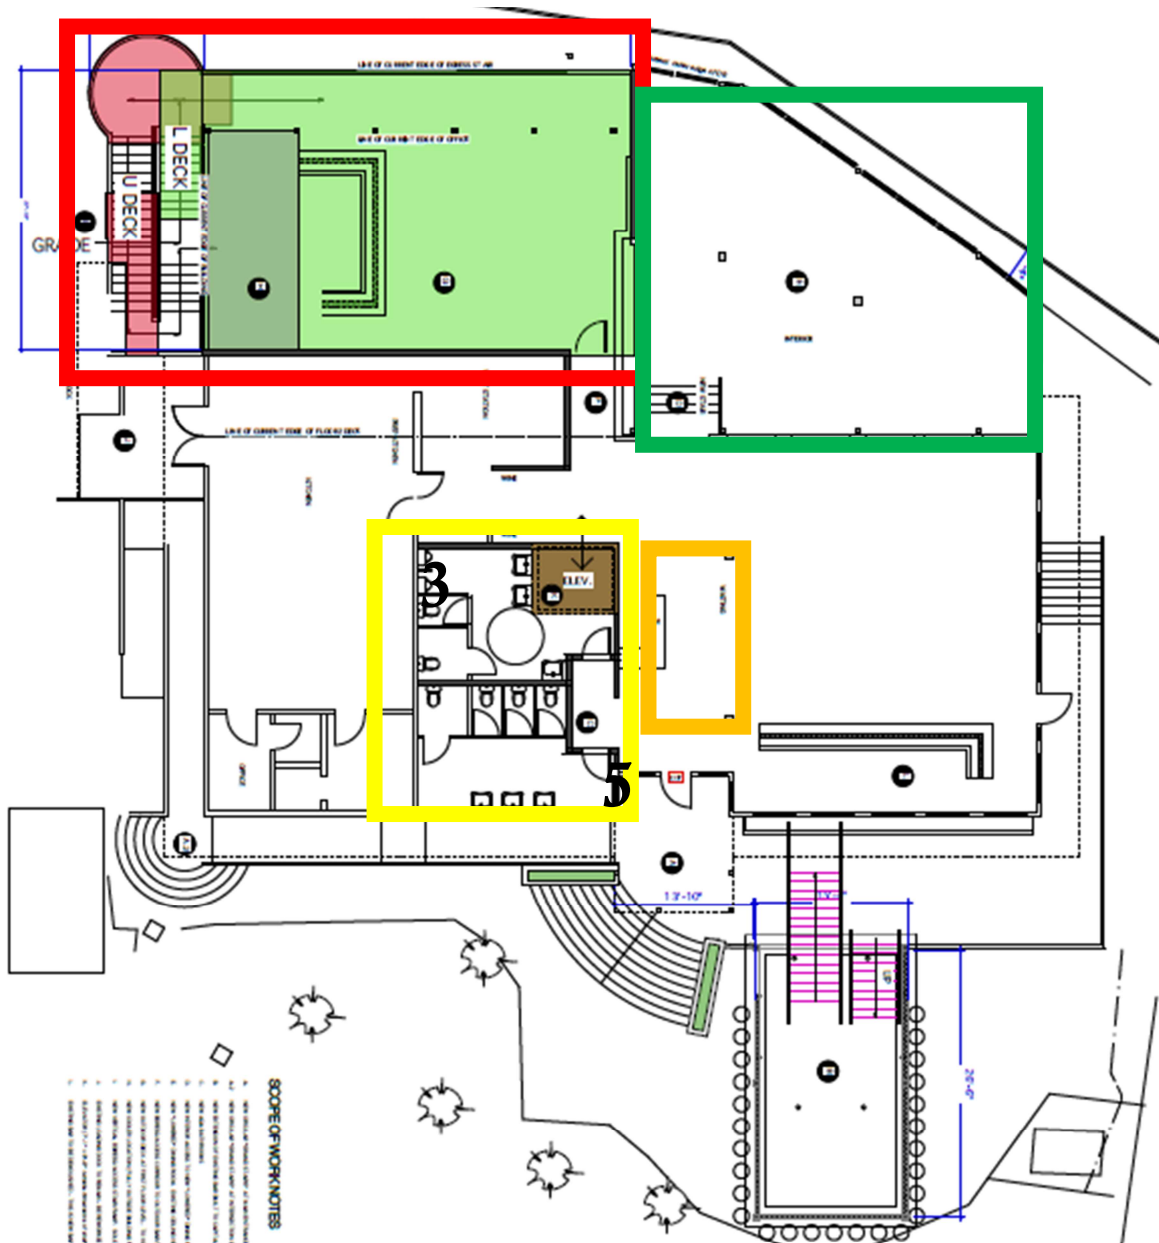
1st Floor Design

Red area is the unstable portion of the building that was larger than expected so it will be demolished and replaced with outdoor seating

Improvements that are not visible include an entirely new electrical system throughout the building, new plumbing, closed cell insulation underneath the building, new HVAC and ductwork, updated kitchen hoods, replacing 20+% of the framing of entire building

Green area will drop the floor of the inside dining room to allow for better views facing the sunset and level the floor

Yellow area new ADA compliant bathrooms, closer to the front door and a new elevator

Orange area will remove the existing interior stairs/fireplace/hostess stand to allow for improved foot traffic and views of the Intracoastal Waterway

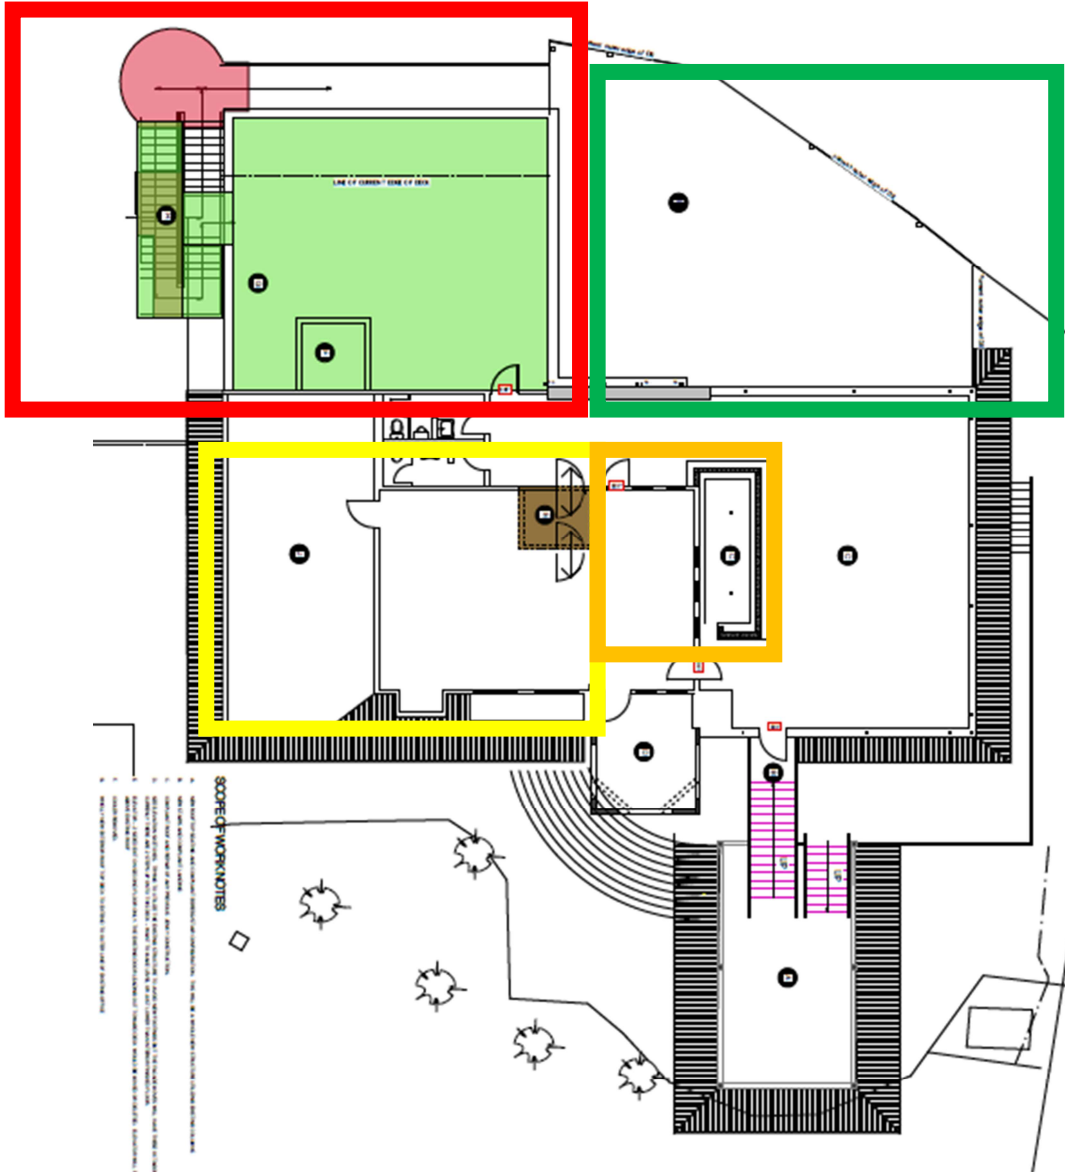
2nd Floor Design

Green area replacing the existing metal roof that has significant leaks

Yellow area will be the new elevator and updated kitchen area. Replacing the existing flat roof that has significant leaks

Red area new outdoor second floor porch with excellent sunset views

Orange area will now be the storage area and office that was removed from the 1st floor kitchen area inside and new 2nd floor bar
