### **Special City Council Meeting**

Consideration of a recommendation from the Real Property Committee for approval of a Change Order from Martin & Son Contracting for the Marina Bulkhead Rehabilitation Project in the amount of \$31,980

RE: Isle of Palms Marina Bulkhead Change Order #1 Recommendation

### Isle of Palms Marina Bulkhead Repair Change Order #1

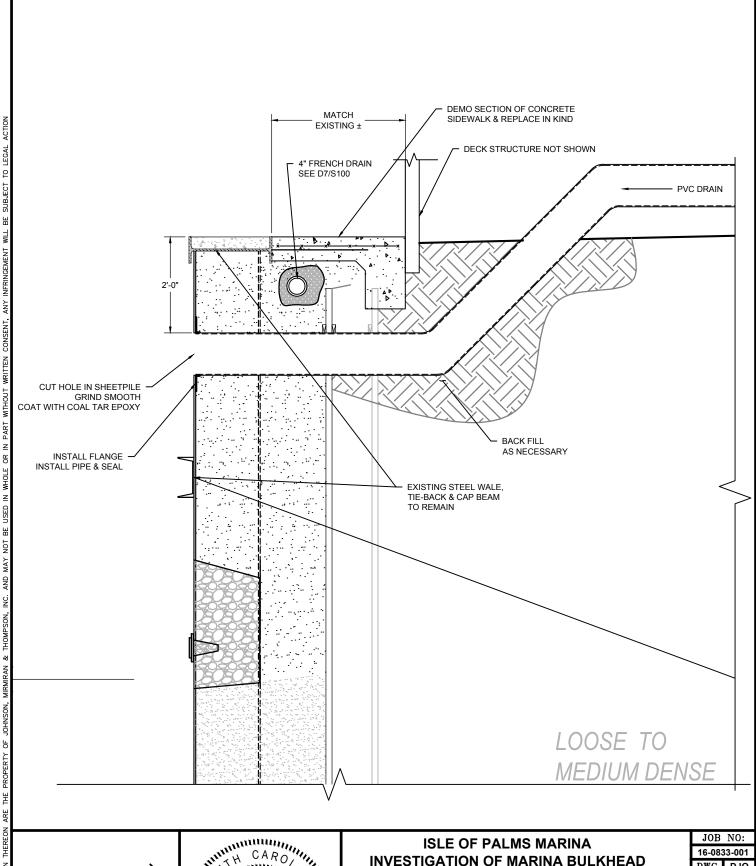
SK-C2

- 3. Pipe Penetration Thru Wall
  - a. Cut wall, Clean, Smooth and Repaint. Install Flange, run additional pipe to wall penetration
  - b. Time Requested -2 Days

OCTOBER 14, 2016 SKETCH REF. DRAWING NUMBER: N/A DRAWING: BULKHEAD REPAIR CHANGE ORDER - GUTTER PIPE PENETRATION

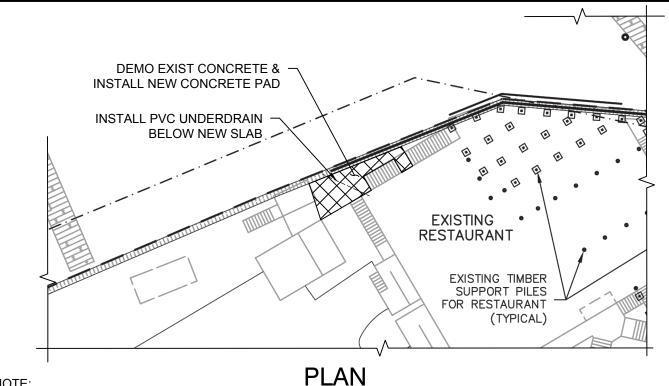
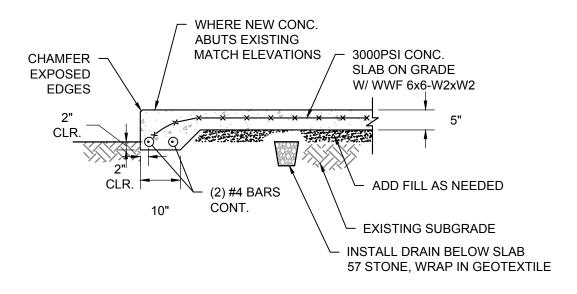
SK-C3

The last item which is not recommended is the new service slab at the restaurant. While JMT believes this work would be beneficial to the restaurant, it is the opinion of JMT that the cost of this work is excessive. And it may be in the City's interest in finding a separate contractor to perform this task.

- 4. Demolish & Replace Sunken Concrete Slab on North West Corner of Restaurant
  - a. Remove Existing Wooden Walkway 4'x12'
    - i. Concrete 4'x12' Area-Pour And Finish With Shell-

- b. Demo Cracked And Sunken Concrete Area- 10'x4' Area & 20'x20' Area
  - i. Replace With New Concrete-10'x4' Area & 20'x20' Area-Pour and Finish With Shell-Install Drainage Channel

OCTOBER 14, 2016 SKETCH REF. DRAWING NUMBER: DRAWING: BULKHEAD REPAIR CHANGE ORDER - NEW SERVICE SLAB @ RESTAURANT

NOTE: SLOPE CONCRETE SURFACE TO DRAIN AWAY FROM RESTAURANT

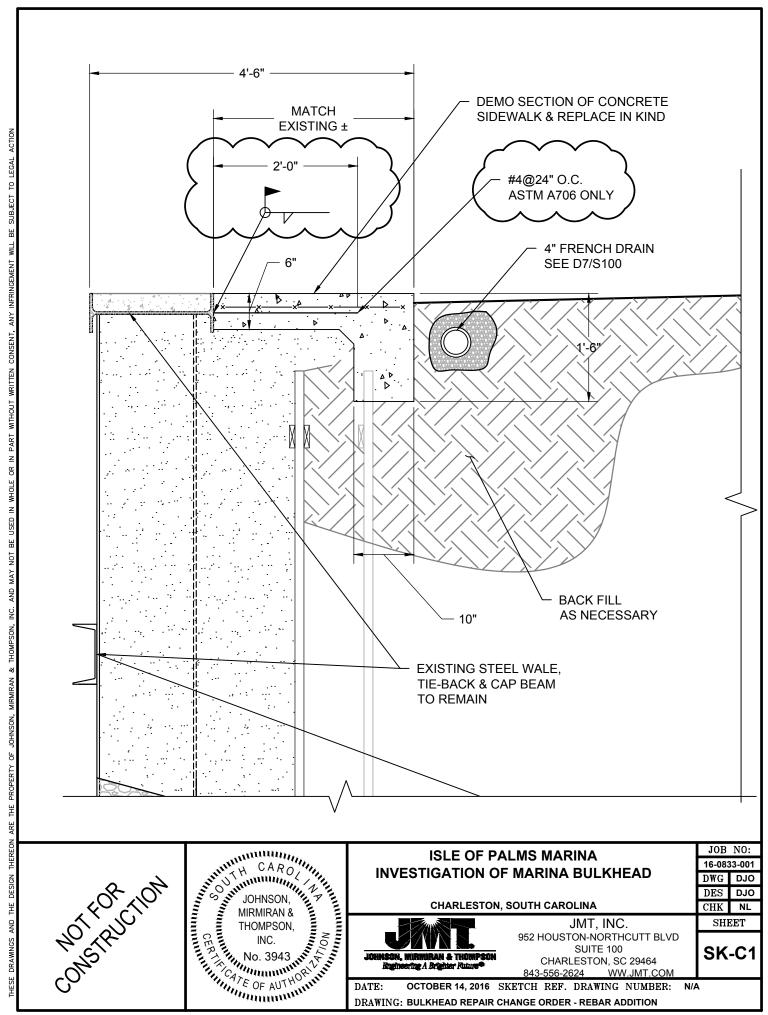
The additional thickness of concrete and rubble removal was considerably more than was anticipated. The investigation into the wall verified the sidewalk was thicker in that area, measured at 9-3/4", but the extent of additional concrete was not realized until complete demolition began, and it was discovered the concrete was nearly 18" thick in that area. When old concrete is pushed into an excavation typical construction method involve crushing or breaking the concrete up into pieces smaller than a fist. Martin and Son uncovered large chunks measured in feet that had to be broken up and removed to access the drain. The original plans available showed the concrete sidewalk as being reinforced with welded wire fabric (WWF-steel wire mesh). Upon demolition it was discovered some areas had steel rebar welded to the inboard flange of the steel cap beam of the wall. Other areas did have WWF. The areas with rebar performed significantly better than the areas with WWF.

- 3. Rebar Welded to I-Beam:
  - a. Remove Broken & Damaged Rebar- Weld Rebar to I Beam Every 24"-400' #4 Rebar
  - b. 3 Days- \$5,400.00
- 4. Repair Beam At Fuel Station 1 Area
  - a. Cut Plates and Furnish- 4 x 40- Weld Plates to Repair Seam in Beams-
  - b. 1/2 Day \$760.00

DRAWING: BULKHEAD REPAIR CHANGE ORDER - REBAR ADDITION

This performance improvement is the basis for JMT's opinion that IOP take this opportunity to rebuild the slab with rebar throughout in place of the WWF. With the removal of the sidewalk it was also discovered that there were joints in the steel cap beam that needed to be joined by welding to prevent movement that may have caused concrete cracking in the sidewalk.
