**2008 BEACH RESTORATION PROJECT
ISLE OF PALMS SOUTH CAROLINA**

**Monitoring Report No 1
December 2009**

YEAR 1 MONITORING REPORT

Coastal Science & Engineering (CSE)
PO Box 8056 Columbia SC 29202-8056

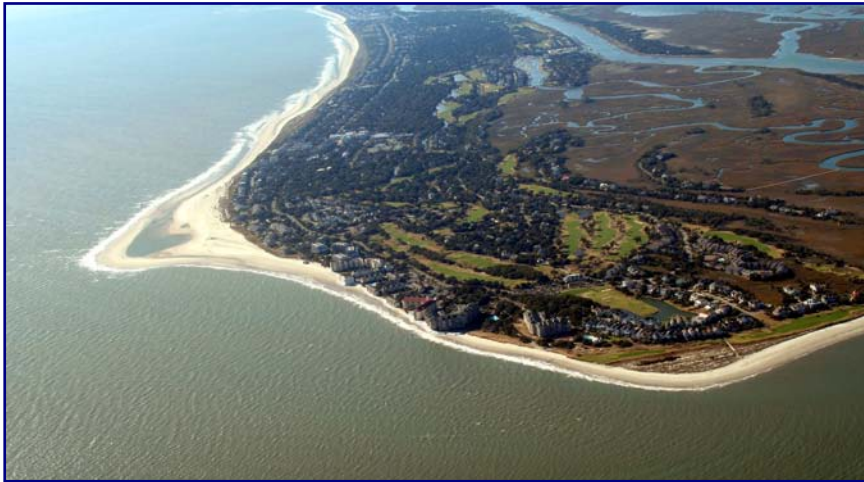
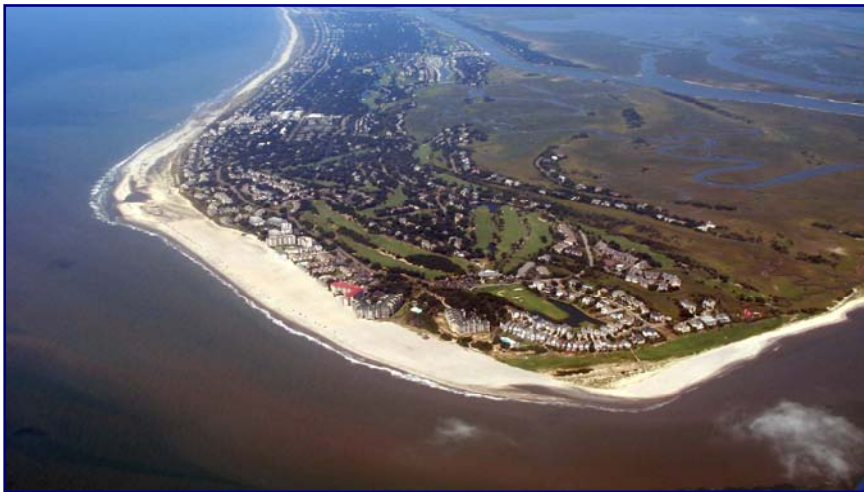
COVER PHOTO – Oblique aerial images of the northeastern end of the Isle of Palms (looking southwest).

[UPPER] Before the project (5 December 2007). **[LOWER]** After the project (26 June 2008).

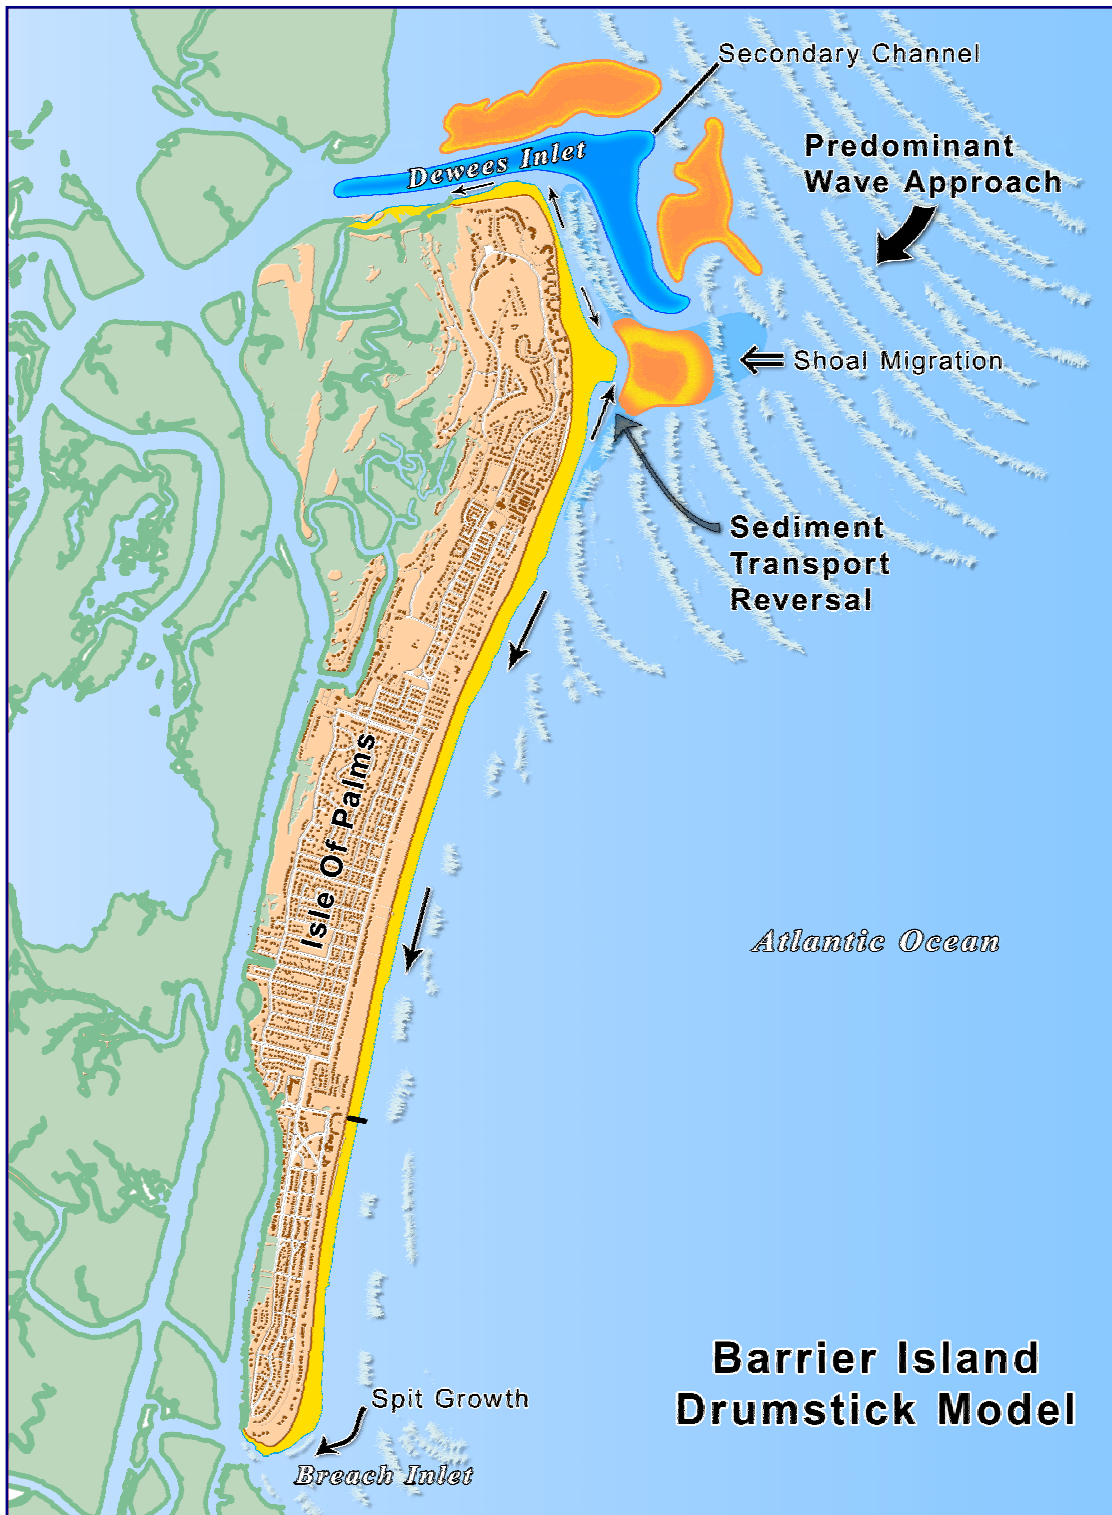
FIGURE 1.2. Isle of Palms is a typical “drumstick” barrier island (after Hayes 1979), where the upcoast end is wider due to sediment accumulation through shoal-bypass events, and the downcoast end usually forms a growing recurve spit. Other examples of drumstick barrier islands along South Carolina are Bull Island, Kiawah Island, and Fripp Island. Zones of sediment transport reversal generally occur in the lee of delta shoals which are situated offshore. Upon shoal attachment to the beach, transport directions in the vicinity of the shoal switch, spreading sand away from the attachment point (cf — Fig 1.4).

Another feature typical of the central South Carolina barrier islands is the “drumstick” shape produced by the interaction of waves and tides, and formation of prominent ebb-tidal deltas at the inlets. Seaward shoals of each delta produce wave refraction and variable longshore transport rates. This leads to a wider upcoast (northern) end and a relatively thin downcoast end (Breach Inlet end, Fig. 1.2). The wider end of the island is influenced by shoal bypassing, a process whereby sand is periodically released from the inlet delta and moved onshore through wave action. This process occurs at somewhat regular intervals (average interval between events from 1941 to 1997 is 6.6 years, Gaudio 1998) and contributes to the overall health of the island. However, it also can cause focused erosion in areas adjacent to the shoal attachment zone (Kana et al 1985). Longshore sediment transport is also modified by inlet shoals, contributing to accumulation of sand and growth of the island near the southern terminus of the ebb tidal delta. This produces a characteristic bulge in the shoreline some distance downcoast from Dewees Inlet (marked “A” in Fig 1.1).

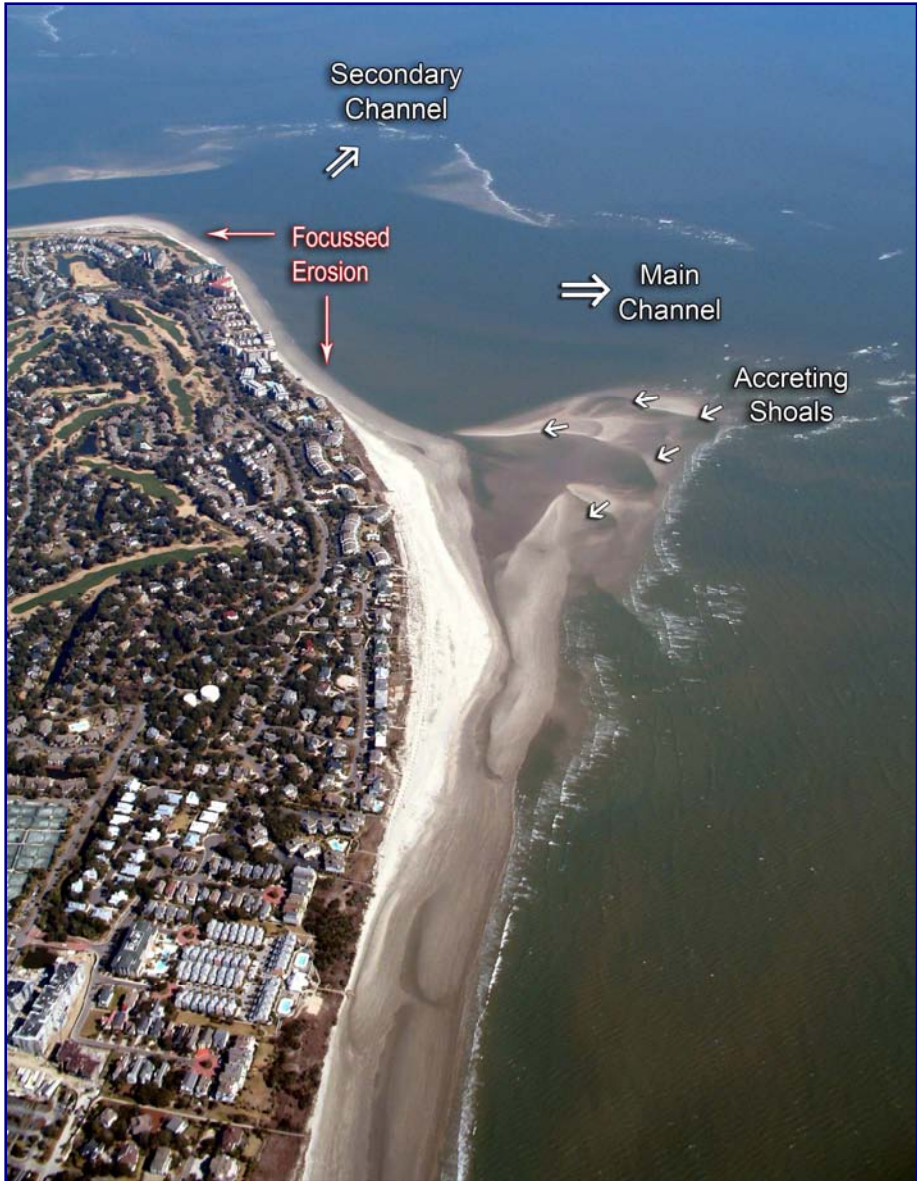
FIGURE 1.5.

The shoal-bypassing event which led to the 2008 project appears to have begun around 2003. By 2004, some areas (eg – Port O’Call) experienced 150 ft of beach recession in one year (ATM 2006). In February 2007, exposed bars extended nearly one-half mile offshore around Beach Club Villas and the WDCA beach house (Fig 1.5). The southern part of the attaching shoal was already in Stage 3 with some sand moving south to nourish other parts of IOP; the northern side remained in Stage 2. As Figure 1.5 shows, all properties north of Beach Club Villas had lost their dry-sand beach by then. To protect buildings, property owners placed ~5 gallon-sized sand bags along the scarped dune. These bags quickly were destroyed or washed away, and large (1 cy) sand bags were placed in front of buildings for protection. Erosion continued into 2008, eventually claiming half of the signature 18th hole of the Wild Dunes Links Course and leaving no dry beach (even at low tide) in front of several properties.

Prior to nourishment in June 2008, most of the *North Wild Dunes* reach was severely eroded with profile volumes seaward of development well below an ideal condition. Sandbags were piled against buildings, and little or no dry beach was present (see Fig 1.5). The condition was beginning to improve just before the nourishment as the shoal attaching at the western end of the reach was in Stage 3 of the bypass cycle. Sand was moving from the shoal toward Dewees Inlet, but not quickly enough to restore the beach along most properties north of the Wild Dunes Property Owners Beach House.

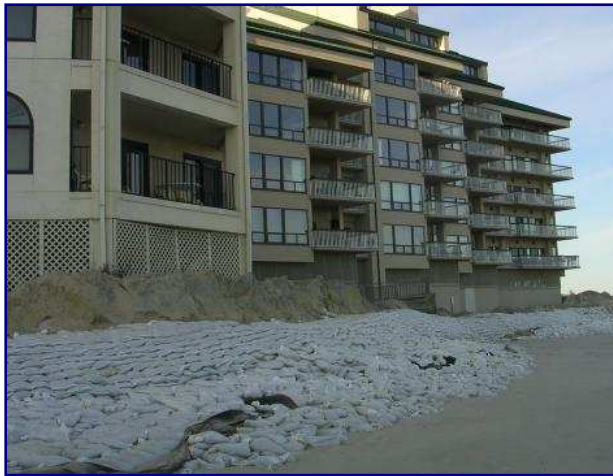
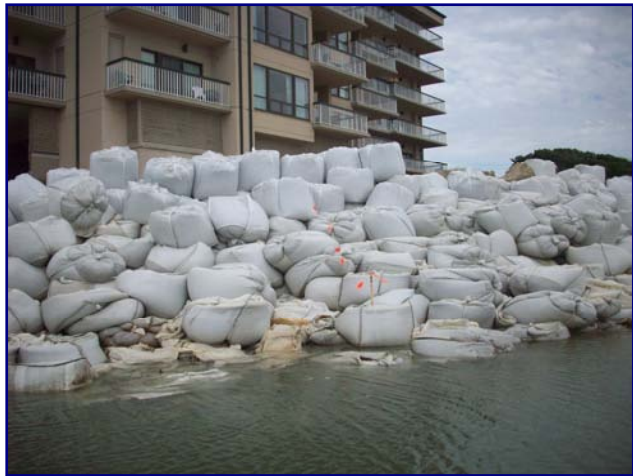
Prior to the 2008 project, little to no beach was present at low tide near the Ocean Club condominiums.

Left image courtesy of Coastal Carolina University Beach Erosion Research and Monitoring Program.

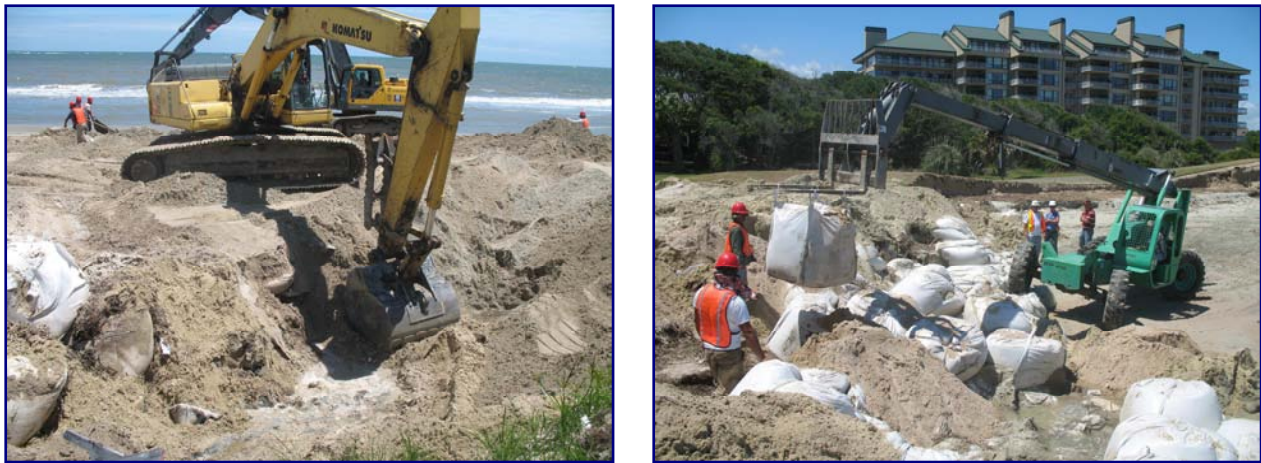
FIGURE 1.7. Contractor, Dirt Cheap Inc, removing sandbags prior to nourishment. In the left image, a track hoe digs to remove buried small and large bags. In the right image, a long-reach forklift removes accessible bags. Material was dumped from the bags and inspected for compatibility. Unacceptable material was removed from the beach by truck. [Photos by S. Traynum]

An important aspect of the project was the removal of sandbags which had been placed in front of buildings. Bid documents estimated ~13,125 large (~1 cy) sandbags and ~5,400 cy of small sandbags existed in front of, between, and underneath buildings in Reach B. Dirt Cheap began removing accessible sandbags prior to dredging, starting at the southwestern limit of the sandbags and moving toward Dewees Inlet. They used a combination of excavators, a bobcat, and a long-reach forklift to lift or dig the sandbags; then cut the bags to remove the sand (Fig. 1.7). On-site personnel would visually determine whether the sediment within the bags was beach quality. Unacceptable material was removed from the beach by truck. Sandbag removal took 16 working days to complete between 19 May and 5 June 2008. A total of 9,401 large bags were removed.

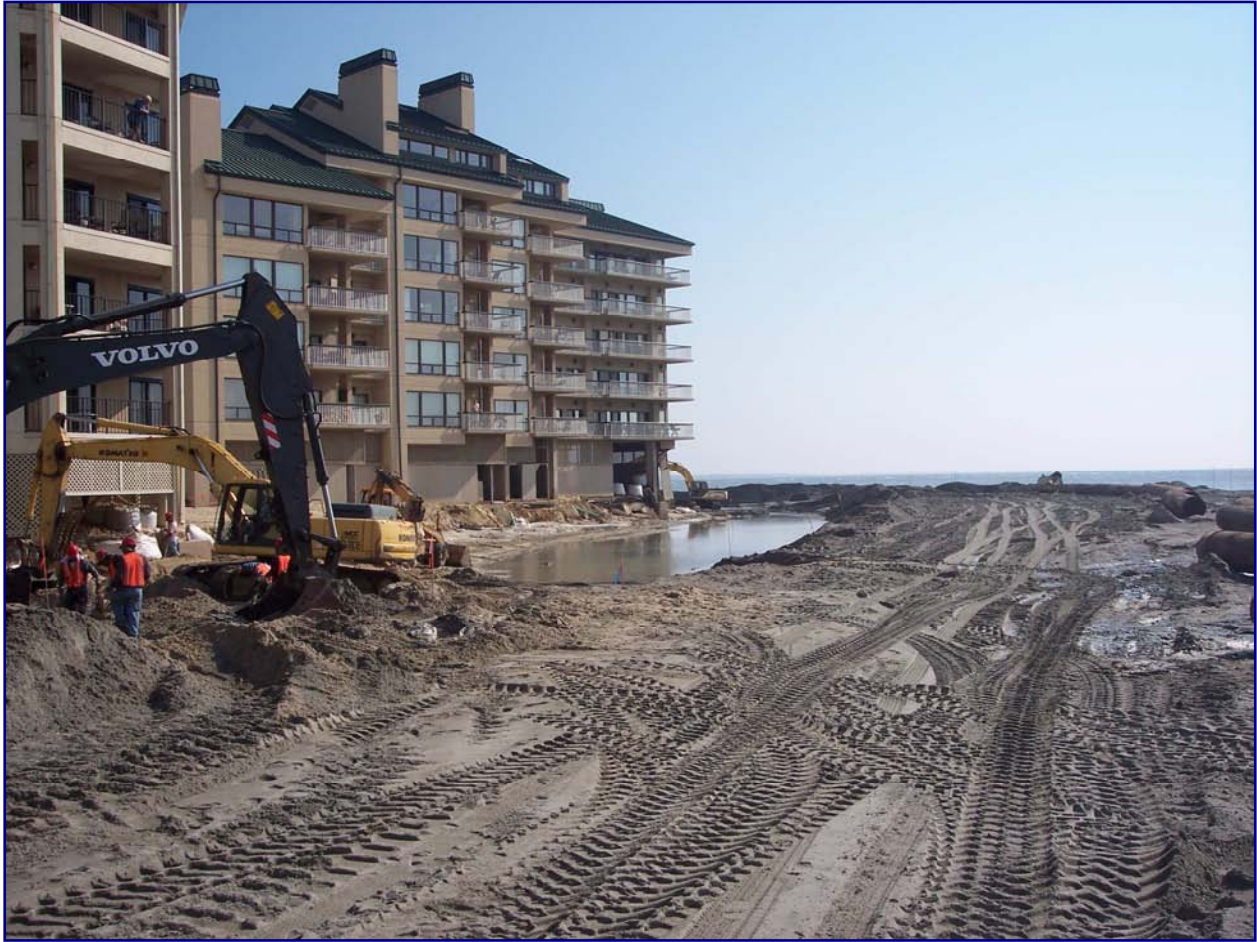
FIGURE 1.8. A temporary berm was built by Weeks Marine to protect buildings and the work area while Dirt Cheap Inc. removed remaining sandbags. Once all bags were removed, the area was re-pumped to fill in the remaining berm. [Photo by S. Traynum]

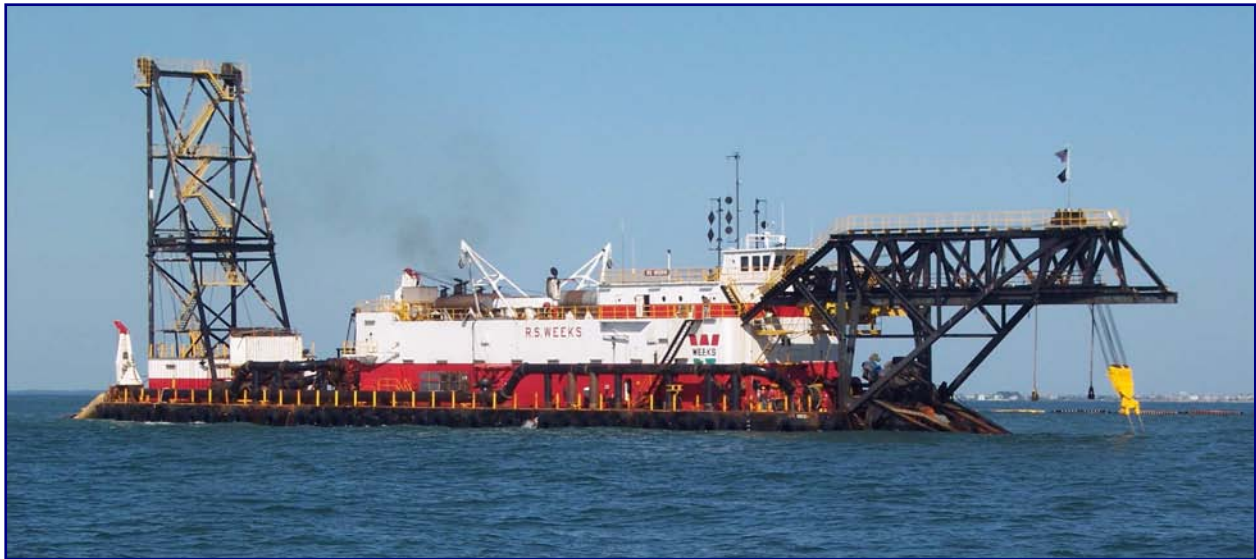
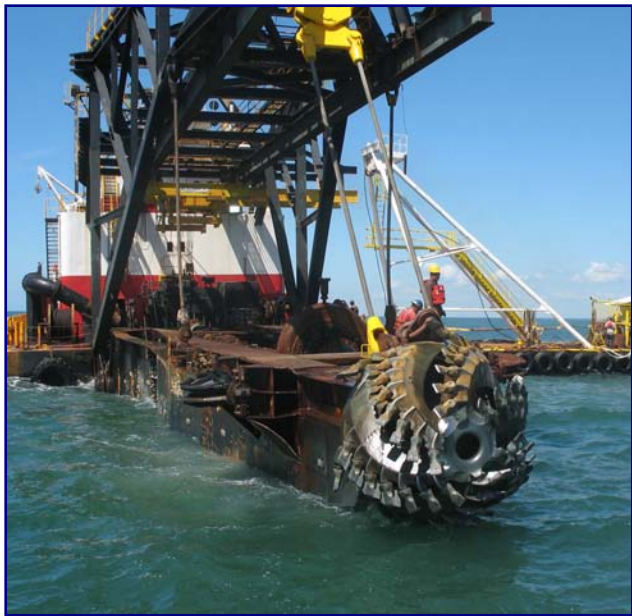
FIGURE 1.9.

The cutterhead-suction dredge (*RS Weeks*) arrived in the borrow area on 24 May 2008 (Fig 1.9). The dredge used a 30-inch pipe and up to 12,000 horsepower to pump the slurry to the beach. Three borrow areas situated between 2 and 3 miles offshore of the Isle of Palms were used for the project (see Fig 1.6). At the guidance of state regulatory and resource agencies, the borrow areas were placed around bathymetric ridges to minimize creation of deep holes. The selected borrow areas were identified as deposits having sediment which both matched the native beach and provided a stable fill. Project permit conditions restricted the depth of cut to 7 ft below existing grade. Detailed geotechnical data for the borrow areas is given in CSE (2008b).

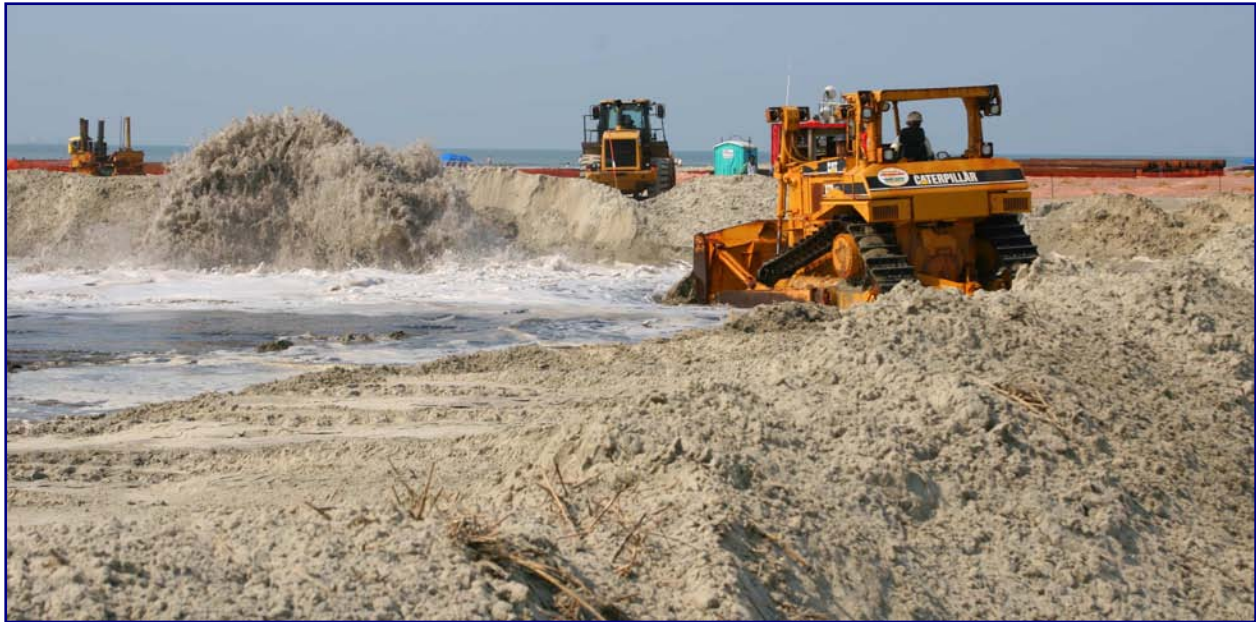
FIGURE 1.10.

Tilling the beach after completion of the project. Tilling reduces the compaction of the sand. The entire project area was tilled to a depth of 36 inches.

Nourishment activities continued 24 hours per day, with the only down time due to mechanical repairs to the dredge or stoppage to relocate pipe. On the beach, bulldozers shaped the fill to the design template. Temporary dikes were used to channel the slurry and control the fill placement (Fig 1.10, upper). Pumping began in Reach B, along the most severely eroded area of Wild Dunes. Once Reach B was complete, Reach C along Dewees Inlet was filled, followed by Reach A between 53rd Avenue and Beach Club Villas. Borrow area A was used to fill the majority of Reach B. Borrow area C was used to fill the northern end of Reach B and all of Reach C. Borrow area B was the sediment source for Reach A. The design berm was set at an elevation of +6 ft NAVD, with the beach face sloping at 1 on 20 (1 on 12 in Reach C due to the naturally steeper shoreline along inlets). A storm berm (set at +8 ft NAVD) was incorporated in the design along the most severely eroded areas of Wild Dunes.

Final pumping was 25 June 2008 near 53rd Avenue. Weeks Marine was issued substantial completion and began demobilizing equipment. The beach was tilled to a depth of 36 inches overnight on 30 June (Fig 1.10, lower). Pre- and post-nourishment surveys were performed by Weeks Marine and CSE to verify each section was filled to design. The final volume added to the beach calculated from Weeks Marine's surveys was 933,895 cy, which was ~10 percent greater than the design volume of 847,400 cy. The overage of 86,495 cy was not a pay quantity as stated in the contract; therefore, the City was only required to pay for the contract volume of 847,400.

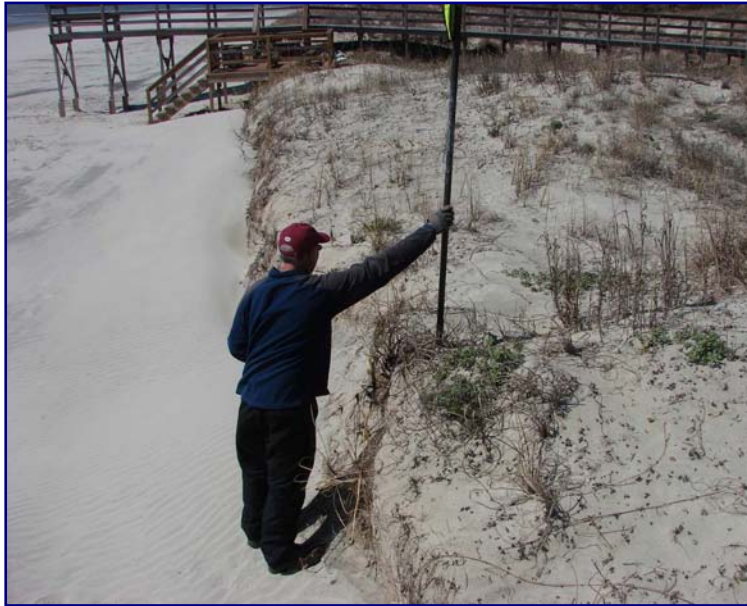
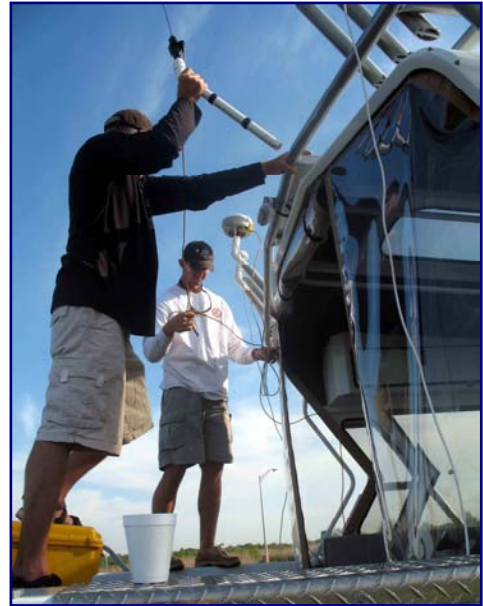
FIGURE 2.2. CSE beach monitoring methods include land-based data collection using Trimble™ RTK GPS from the backshore to low-tide wading depth and over-water work using RTK GPS linked to a precision echosounder aboard CSE's shallow draft boat (RV Congaree River).

Topographic data were collected via RTK-GPS (Trimble™ R8 GNSS), which provides position and elevation measurements at sub-centimeter accuracy. Beach profiles were obtained by collecting data at low tide along the dunes, berm, and active beach to low-tide wading depth. Over-water work was then performed at high tide to overlap the land-based work (Fig 2.2). Over-water work was collected with RTK-GPS coupled with an Odom HydroTrak™ precision echo sounder mounted on CSE’s shallow-draft vessel, the *RV Congaree River*. Profiles were collected from the most landward accessible point in the dune system to a minimum of 1,500 ft from the baseline. Profiles in the project area extended up to 15,000 ft offshore to encompass the shoals associated with Dewees Inlet and to monitor changes in bathymetry in the vicinity of the nourishment borrow areas. Alongshore spacing of the profiles ranged from 200 ft to 1,000 ft with the more closely spaced profiles in the project area and along Breach Inlet. Comparative profiles from CSE’s monitoring efforts are shown in Appendix A. The complexity of areas impacted by inlets requires more detailed analysis (closer profile spacing) to fully incorporate volume changes associated with shoal-bypassing events and inlet migration. Bathymetric data were collected in the borrow areas at 100 ft spacing for comparison to pre- and post-dredging DTMs.

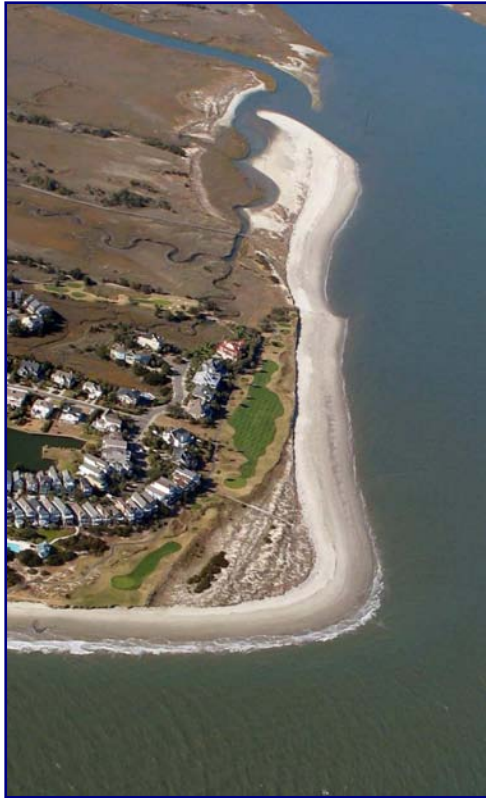
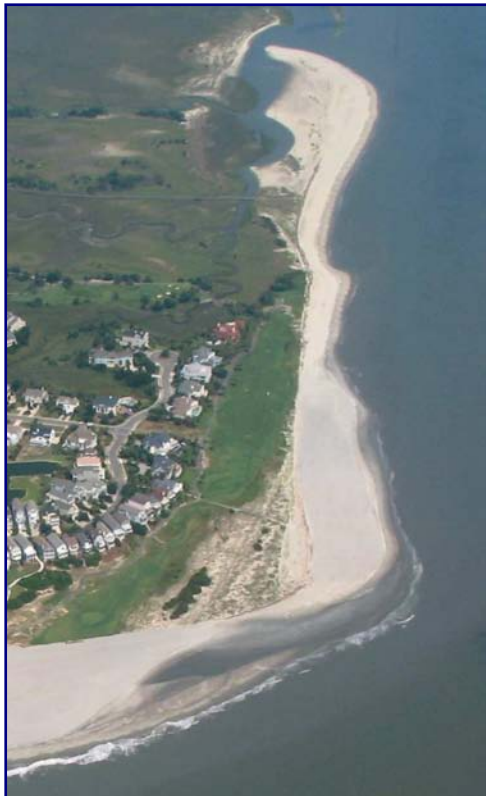
FIGURE 3.2

Dewees Inlet (Fig 3.2, previous page) generally receives less wave energy than the rest of the Isle of Palms, due to the sheltering effects of the ebb-tidal delta associated with the inlet. Shorelines along stable inlets usually show less dynamic volume changes than ocean-facing beaches; however, over time, they can experience severe erosion due to several factors. One factor thought to contribute to localized erosion along the *Dewees Inlet* shoreline is wave focusing through breaks in the inlet delta (Kana and Dinnel 1980). Breaks between the outer shoals allow larger waves or destabilizing diffracted waves to reach the shoreline and cause localized erosion. A low profile groin was built in 1981 near the 17th tee of the Wild Dunes Links Course to trap sand moving into *Dewees Inlet* and slow erosion (Kana et al 1985). The monitoring reach extends from the turn in the shoreline near the 18th tee to the end of Cedar Creek Spit.

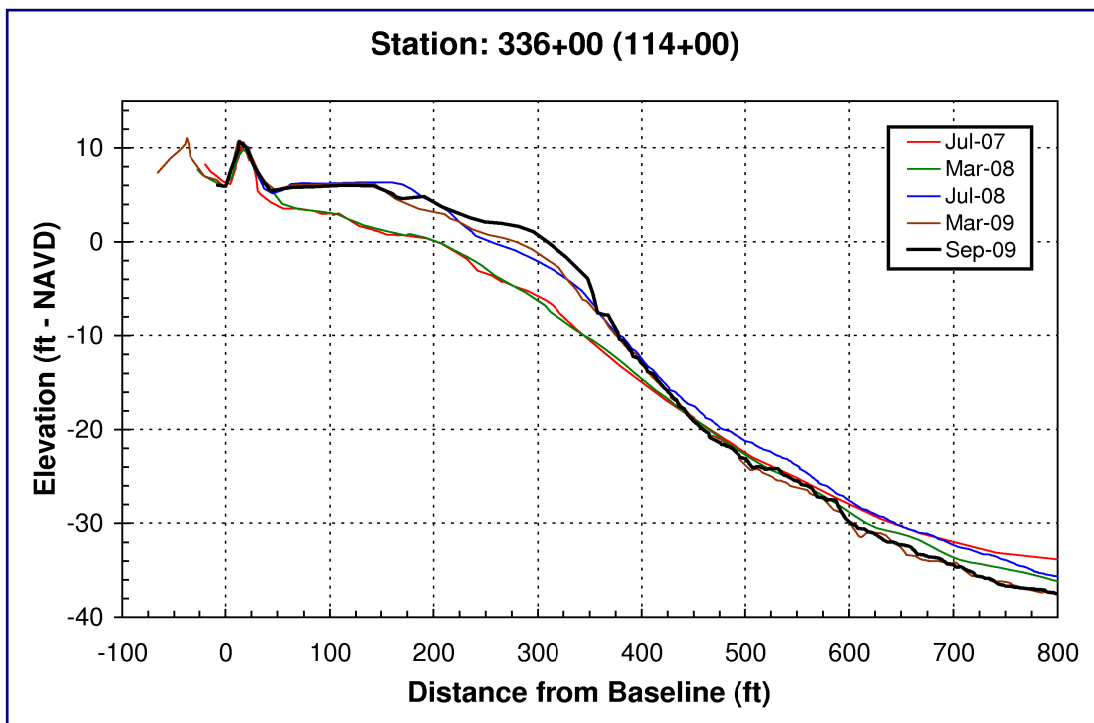
FIGURE 3.5. Profiles from station 336+00 (near the 17th green) in the Dewees Inlet project area. This profile currently contains 7.3 cy/ft more sand than immediately after the project. The new sand migrated from the oceanfront in the opposite direction to the normal play of golfers along the 18th fairway.

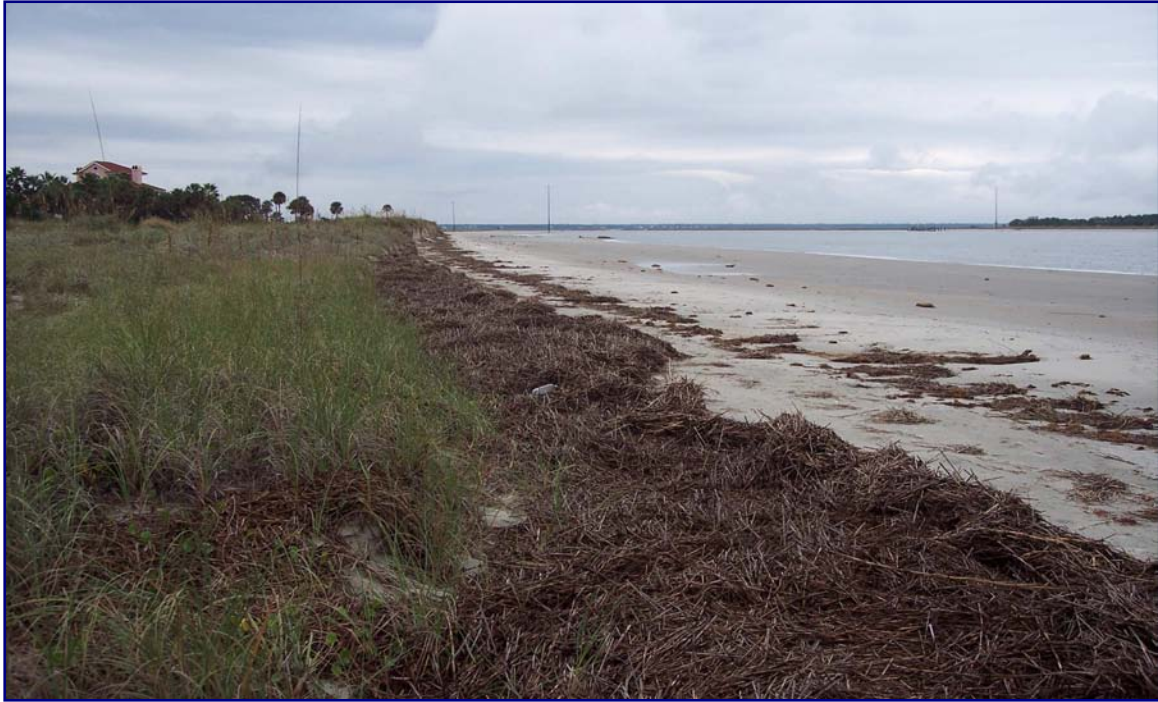
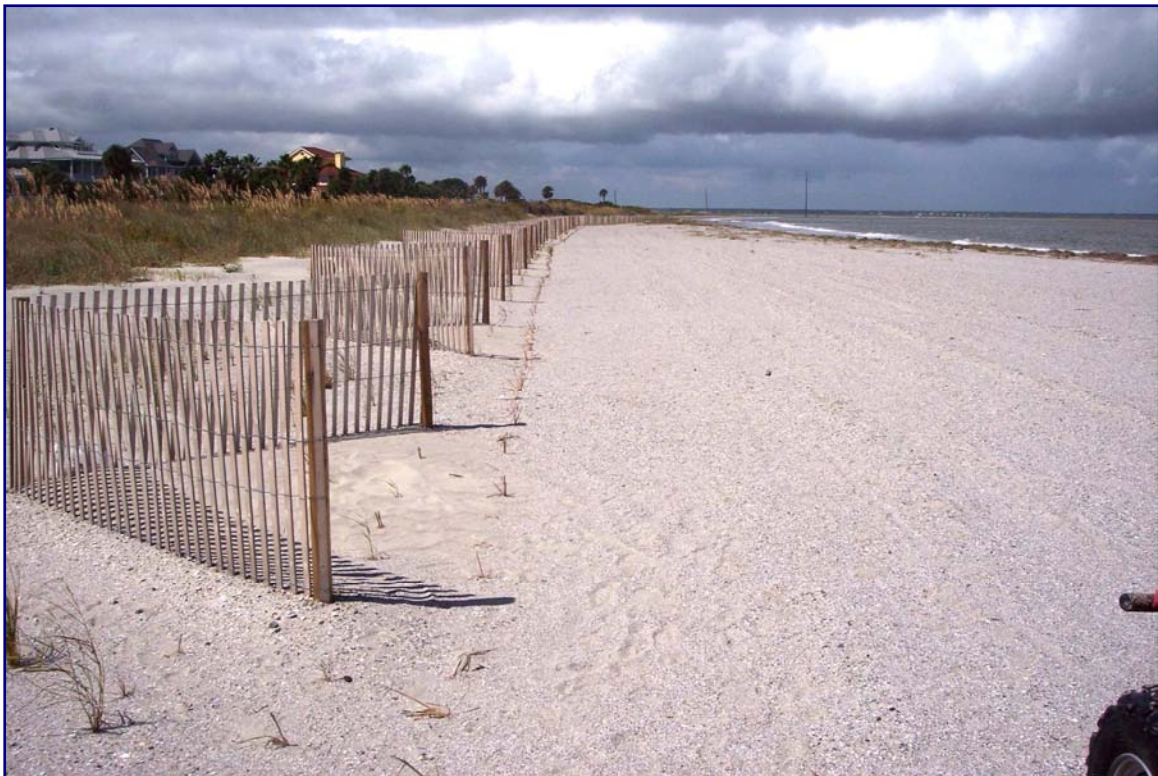
FIGURE 3.6. View looking northwest in the *Dewees Inlet* reach in the vicinity of the 17th green of the Wild Dunes Links Course in October 2007 (upper) and September 2009 (lower).

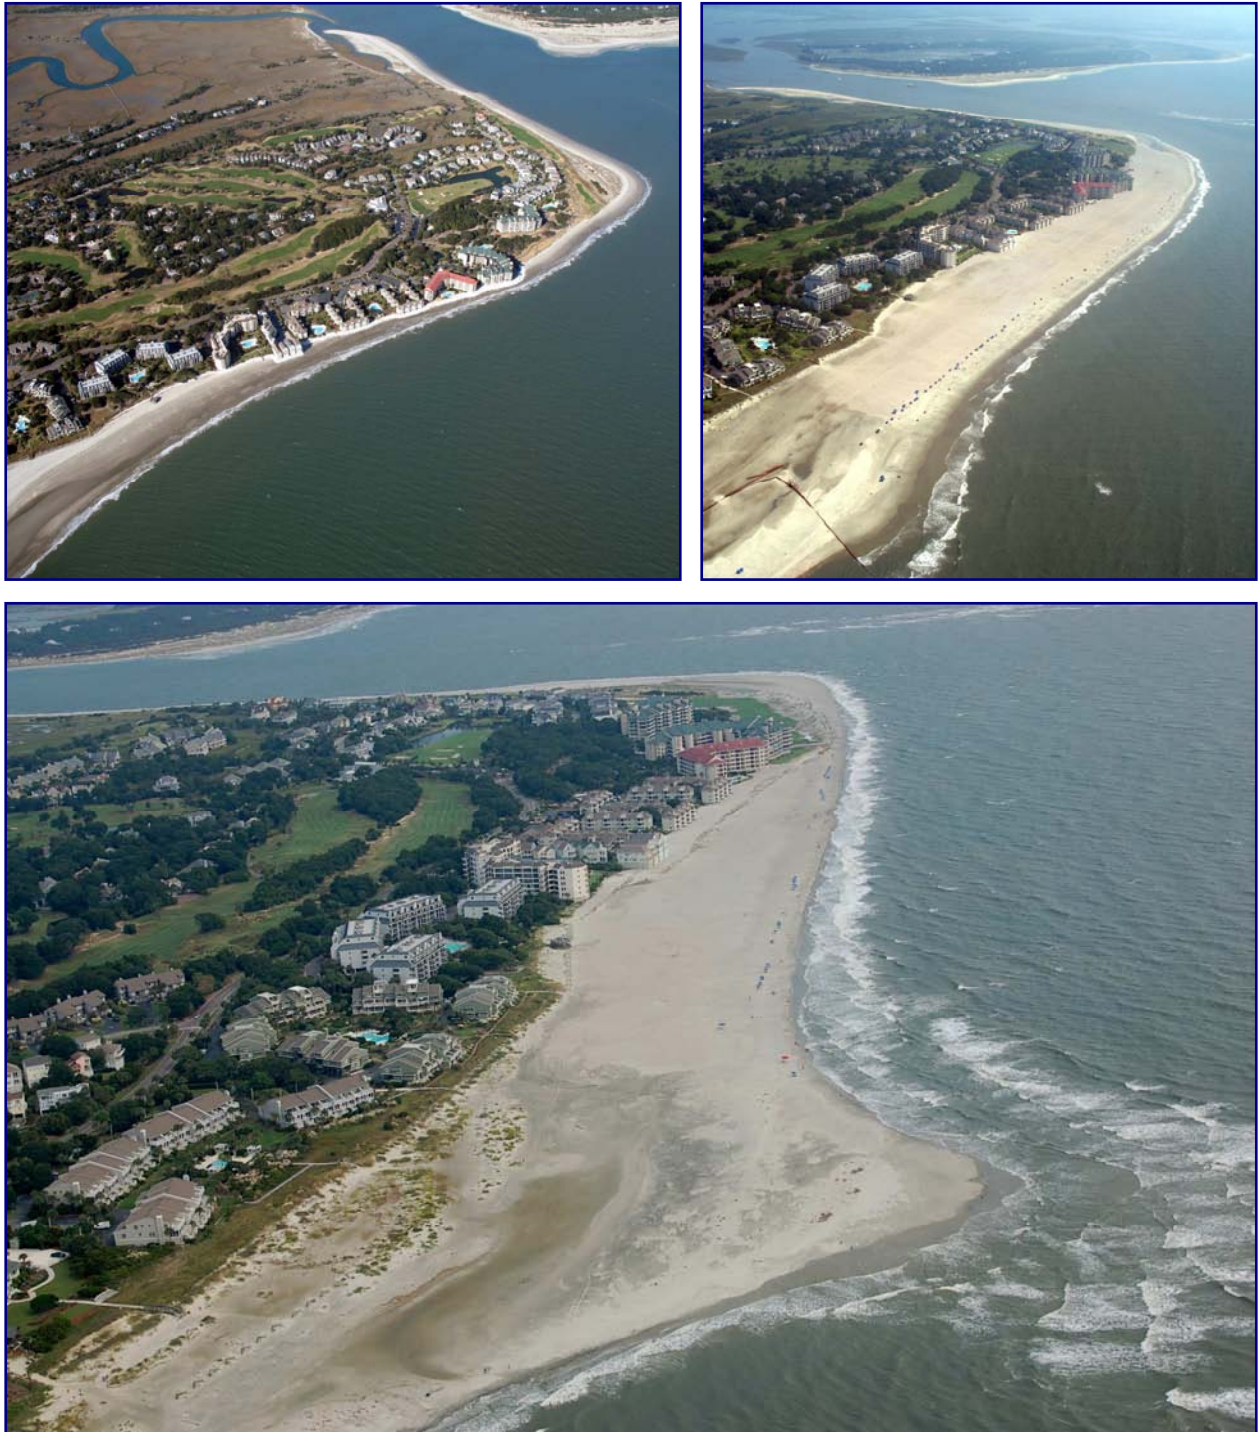
FIGURE 3.8. The *North Wild Dunes* reach in December 2007 (upper left), June 2008 near the end of the project (upper right), and September 2009 (lower). [Upper images by TW Kana; lower image by C Jones]

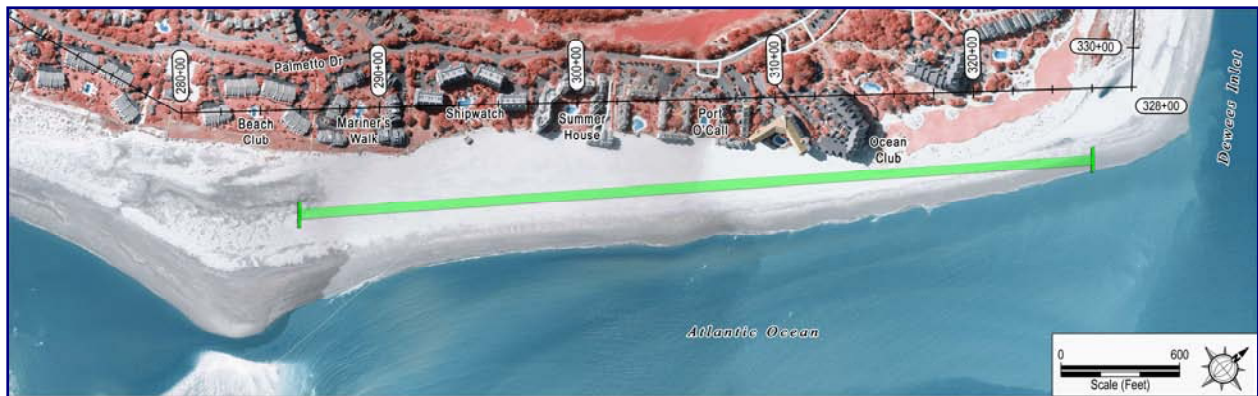
FIGURE 3.9. The *North Wild Dunes* reach spans from the Wild Dunes Property Owners Beach House (station 280+00) to the 18th fairway of the Wild Dunes Links Course (station 328+00). The approximate limits of nourishment Reach B are identified by the green bar. March 2009 aerial image by Independent Mapping Consultants Inc.

The *North Wild Dunes* reach (Fig 3.8, previous page) extends from the Wild Dunes Property Owners Beach House northeast ~4,900 ft to the 18th fairway, where the beach turns into Dewees Inlet (stations 280+00 to 328+00, Fig 3.9). This area has been highly impacted by shoal-bypassing events since the island's development. Depending on the location and timing of bypass events, the shoreline can change hundreds of feet over a period of several months (Kana et al 1985, Gaudio 1998). As was the case in 2007-2008, the shoreline may encroach on development in this reach when shoal-bypass events are prolonged. Previous studies have suggested that the background, long-term erosion for the northeastern end of IOP is between 15,000 cy/yr and 30,000 cy/yr, even though the estimated average volume of sand added by each shoal-bypass event is ~500,000 cy (CSE 2007a). This means that, while large fluctuations in the shoreline and severe local erosion may occur, the long-term erosion rate for the area is relatively low. Sand simply migrates from one area of the beach to another and is either transported back to Dewees Inlet or downcoast to IOP, eventually being replaced by offshore sand through another shoal-bypassing event.

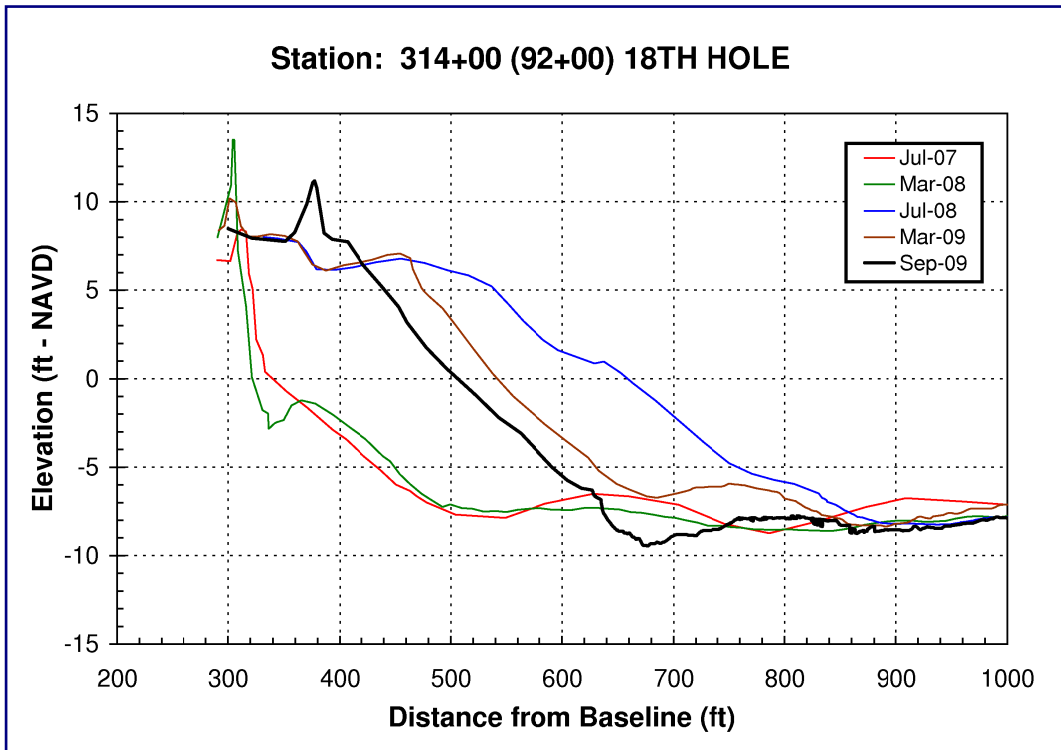
FIGURE 3.11. Profiles from stations in the *North Wild Dunes* reach. Station 296+00 has remained stable since July 2008, while station 314+00 has experienced significant erosion. CSE expects sand from the ongoing shoal-bypass event (now in Stage 3) to migrate into eroded areas in the next year, reducing the erosion rate and potentially rebuilding some of the area between Port O'Call and Ocean Club.

At the attachment location, sand volumes on the beach have increased over 150 cy/ft since July 2008 and currently show unit volumes equal to or greater than those in the nourished areas. Sediment transport away from this shoal (indicated by increasing profile volumes) has reached ~1,000 ft north to station 296 (Shipwatch Villas), leaving stations 280 to 296 much healthier than pre-project conditions (Fig 3.10). North of station 296, the trend has been rapid erosion since July 2008 with maximum losses (50-70 cy/ft) occurring between stations 306 and 322 (Port O’Call to Ocean Club, Fig 3.11).

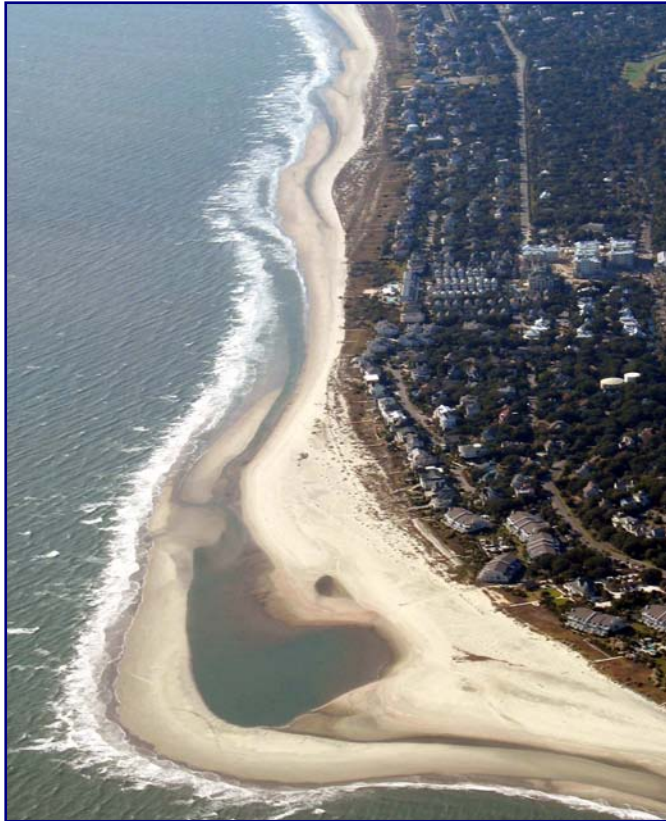
FIGURE 3.13.

[UPPER LEFT]
The *South Wild Dunes*
reach in December 2007.

The *South Wild Dunes* reach (Fig 3.13, previous page) spans ~6,000 ft between 53rd Avenue and the Wild Dunes Property Owners Beach House (Fig 3.14, stations 222+00 thru 280+00) and encompasses project Reach A. Like the *North Wild Dunes* reach, this area is greatly influenced by shoal-bypass events, especially at the northern end of the reach where the majority of shoals attach to the beach. Prior to the 2008 nourishment, an erosional arc had formed in the area of the Wild Dunes Grand Pavilion (Fig 3.15, station ~248+00). Erosional arcs are typical in areas adjacent to shoal attachment sites because of wave refraction and sediment transport reversals, which drive sand from these areas into the lee of the shoal during Stages 1 and 2 of the shoal-bypass cycle. Immediately prior to nourishment, the “2006” shoal had completely attached (Stage 3) at the northern end of the reach, and sand was beginning to spread into the eroded areas.

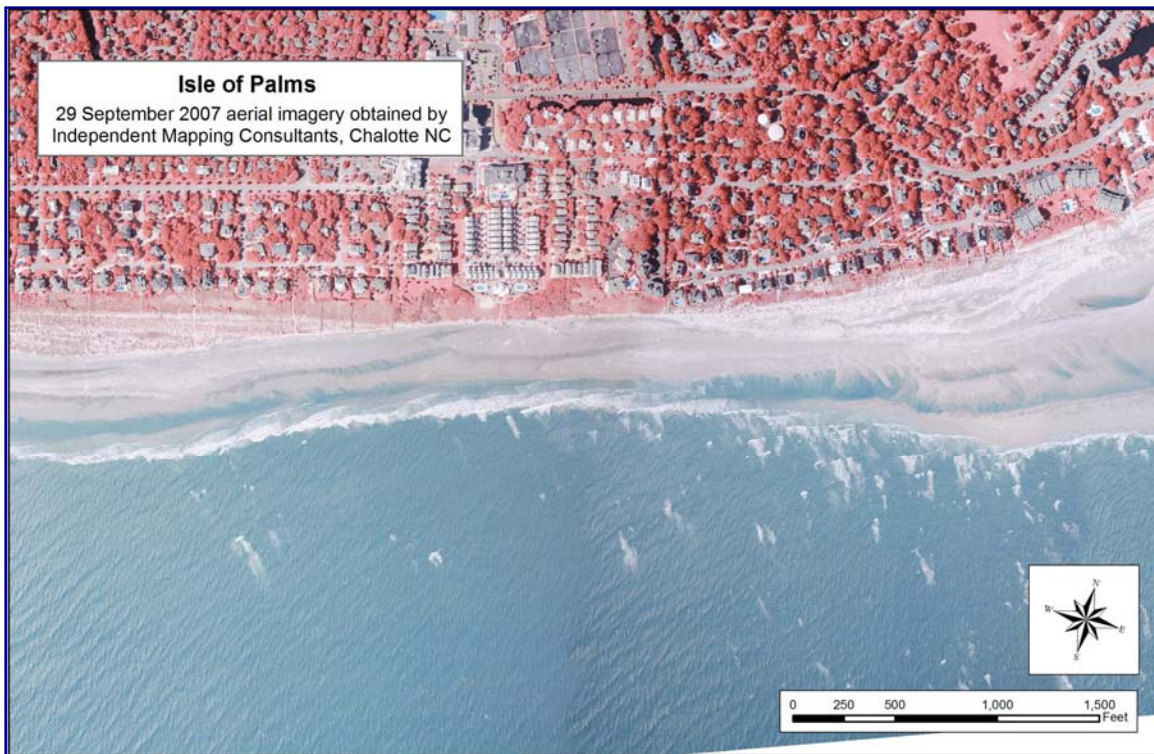
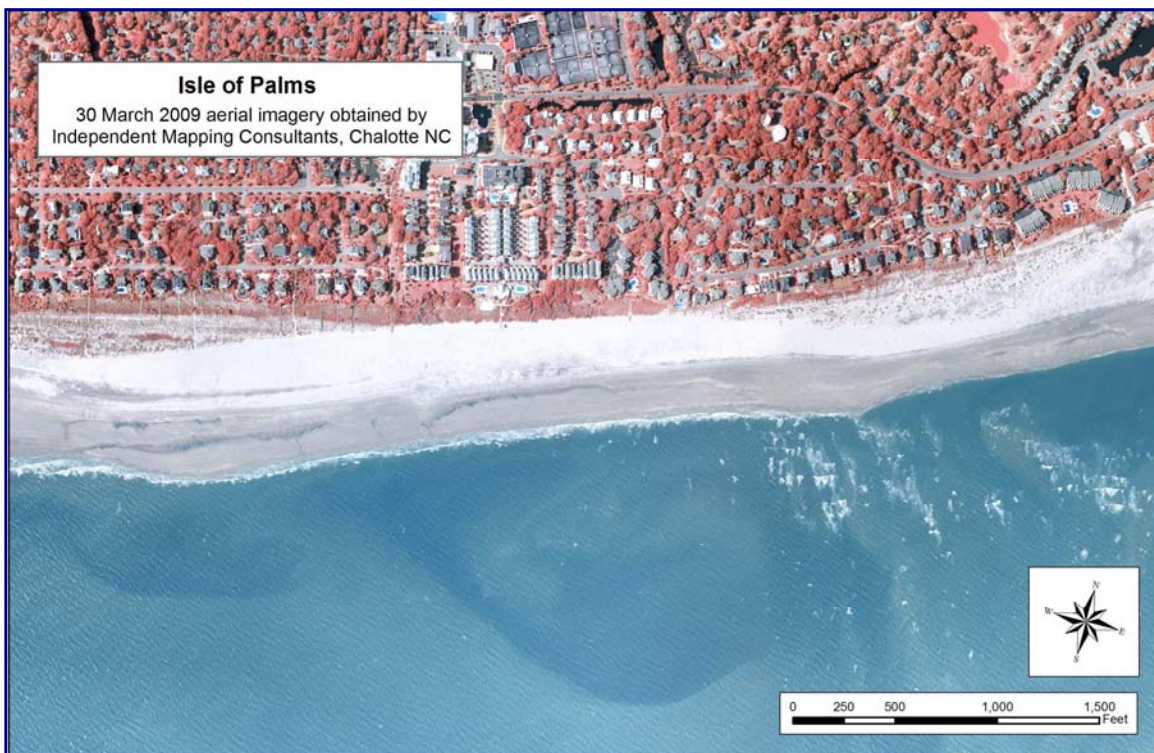
FIGURE 3.15. The *South Wild Dunes* reach in September 2007 (upper) and March 2009 (lower). Note the erosional arc in the 2007 image adjacent to the Wild Dunes Grand Pavilion (center of image). Wave refraction around shoals causes sand to erode from areas adjacent to the attachment site (right edge of image), producing the erosional arcs. Following nourishment in 2008, another shoal attachment event caused erosion along portions of the project area. The project was designed to provide sufficient sand to withstand erosion associated with small-scale bypass events in the next decade. The uncertainty about project performance centers mainly on the scales of change associated with large-scale shoal-bypassing events.

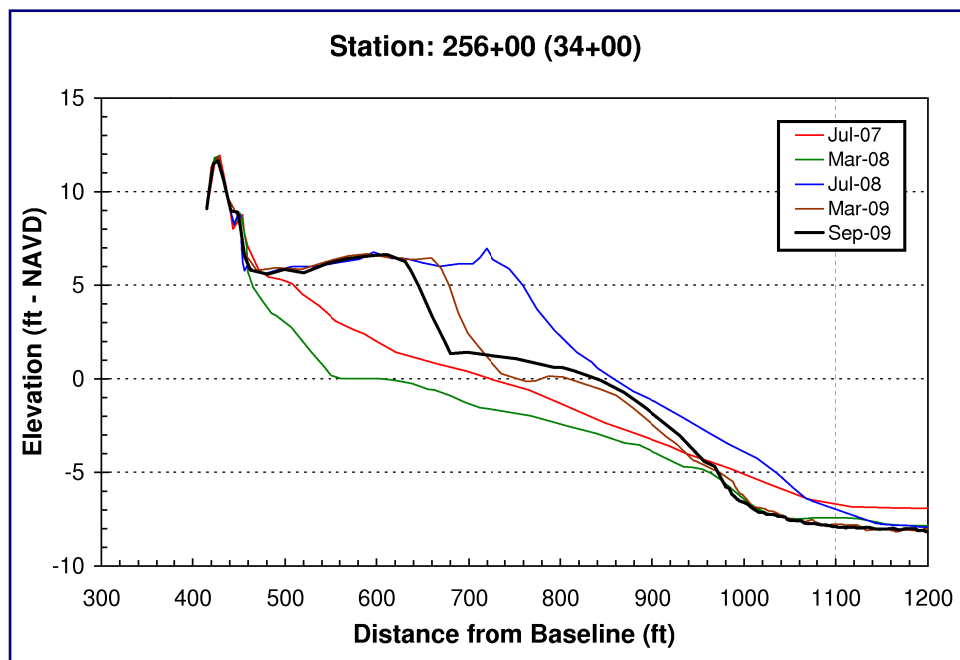
FIGURE 3.17. Profiles from station 256+00 in the *South Wild Dunes* reach. This area initially eroded rapidly while the current shoal-bypass event was in Stage 2. Now that the shoal is attached (Stage 3), the erosion trend should slow or reverse to accretion.
