**2008 BEACH RESTORATION PROJECT
ISLE OF PALMS SOUTH CAROLINA**

**Monitoring Report No 1
December 2009**

YEAR 1 MONITORING REPORT

Coastal Science & Engineering (CSE)
PO Box 8056 Columbia SC 29202-8056

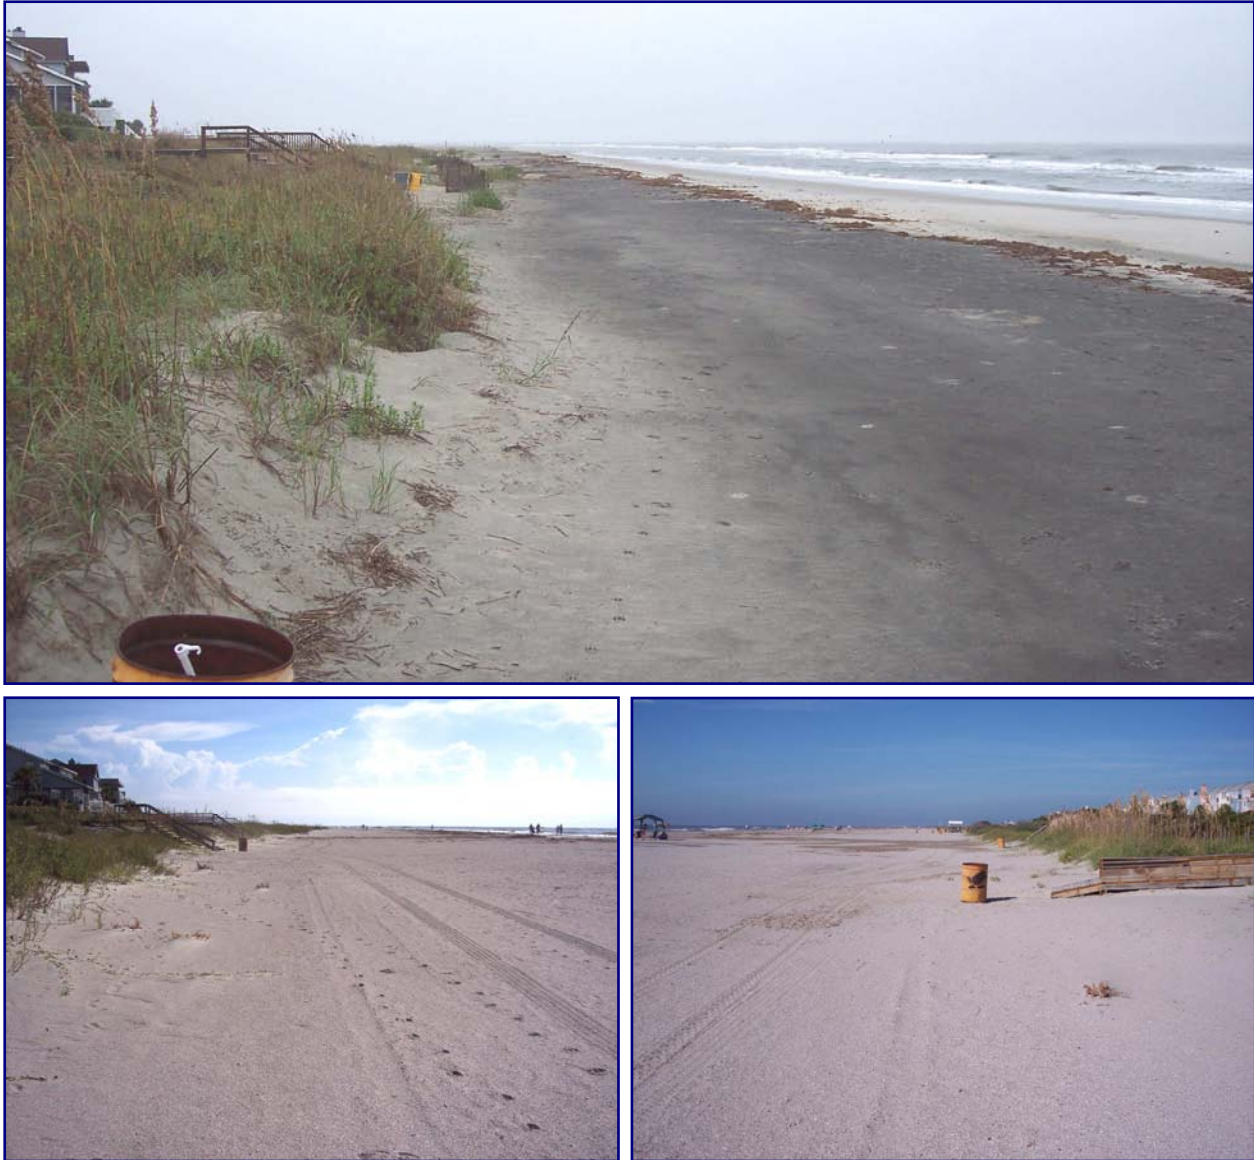
FIGURE 3.18. View northeast from station 254+00 (adjacent to Seagrove Villas) prior to the project in October 2007 (upper) and views northeast (lower left) and southwest (lower right) in September 2009. An erosional arc associated with the 2006 shoal-bypass event had formed in this area prior to the project (see Fig 3.15).

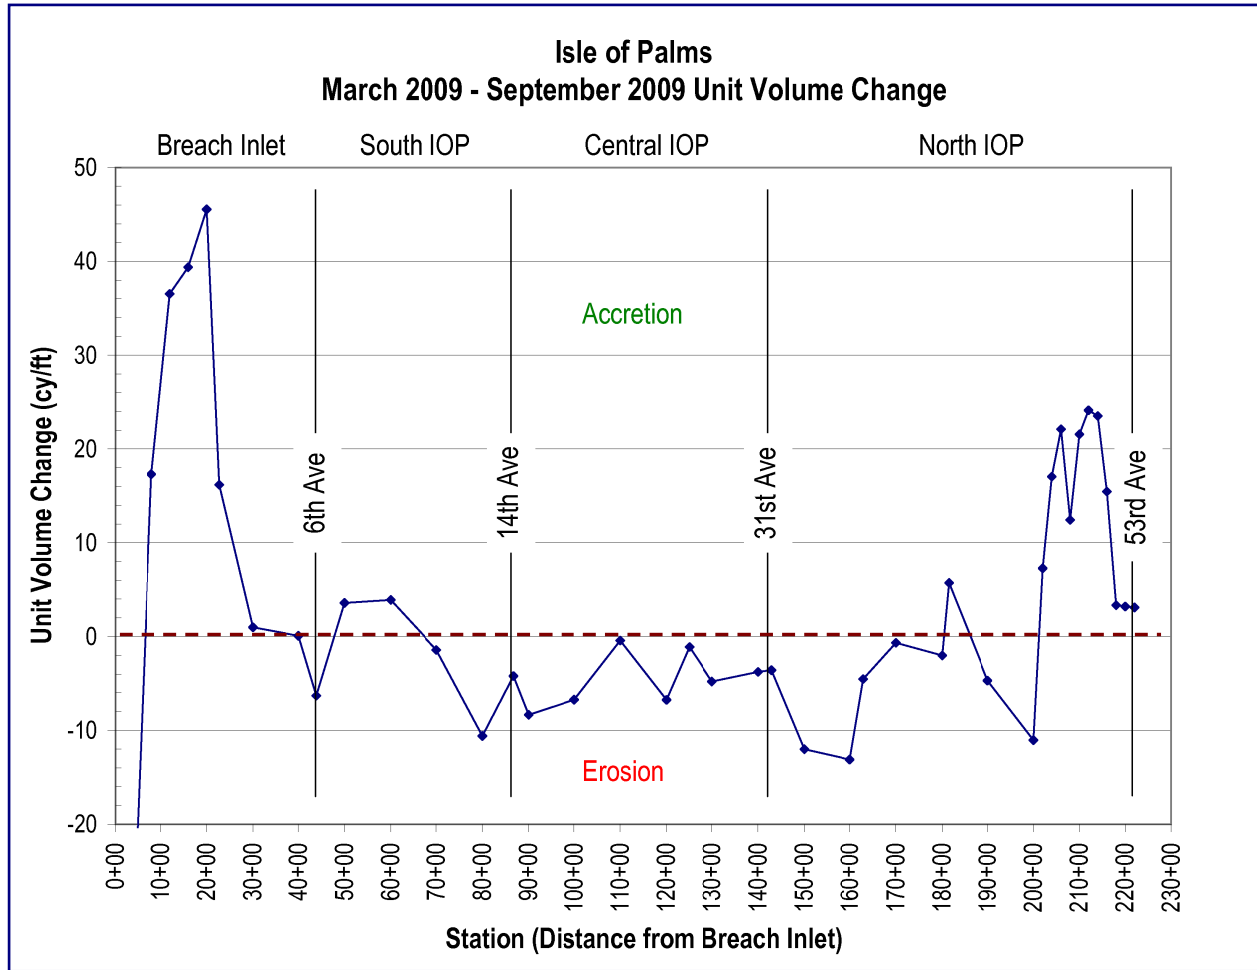
FIGURE 3.20. Profile unit-width volume change (cy/ft) between March and September 2009 for the *Isle of Palms* and *Breach Inlet* reaches. CSE established and surveyed profiles spaced 1,000 ft apart in the *Isle of Palms* reaches and reoccupied monuments surveyed annually by SCDHEC-OCRM. Historically, these reaches have been accretional; however, between March and September 2009, most stations outside of the influence of the inlet or project were erosional. Change is relative to the March 2009 condition.

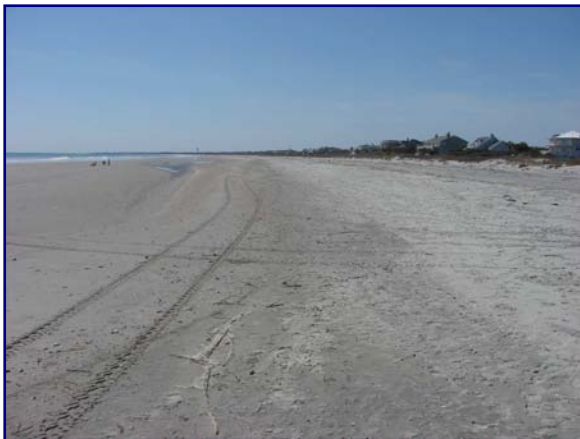
FIGURE 3.23.

CSE conducted the September 2009 survey during an extreme high tide. Photos (Fig 3.23) suggest that little dry beach is present; however, under normal tide conditions, there is a dry beach 20-30 ft wide at most stations in the reach. Wider berms are present near the project area where sand is moving into the reach from upcoast. Historical accretion in all of this reach (combined with sufficient setbacks for development) has led to a substantial dune system between most structures and the beach. As long as there is slow, steady accretion, the foredune will continue to build wider and higher, offering more storm protection to property behind the dunes. In future monitoring reports, CSE will provide estimates of the level of protection afforded by the dune system by determining the volume of sand above potential storm-surge levels.

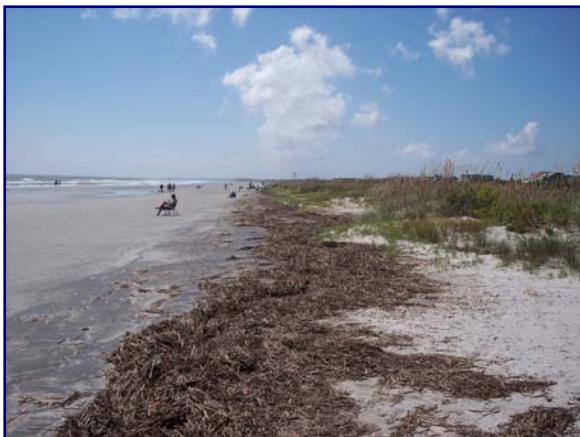
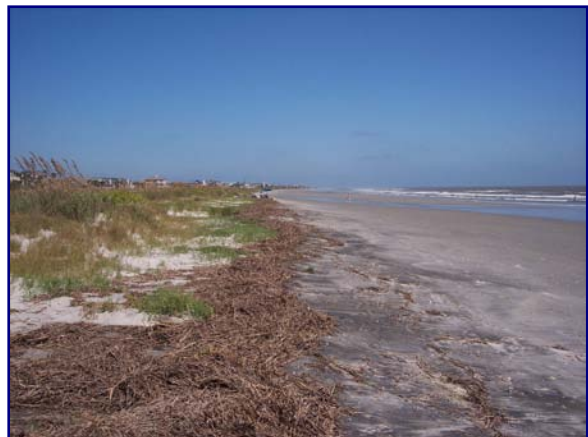
Views from station 170+00 (~38th Avenue) in September 2009. Extreme spring tides cause the beach to look eroded; however, this station remained stable between March and September 2009.

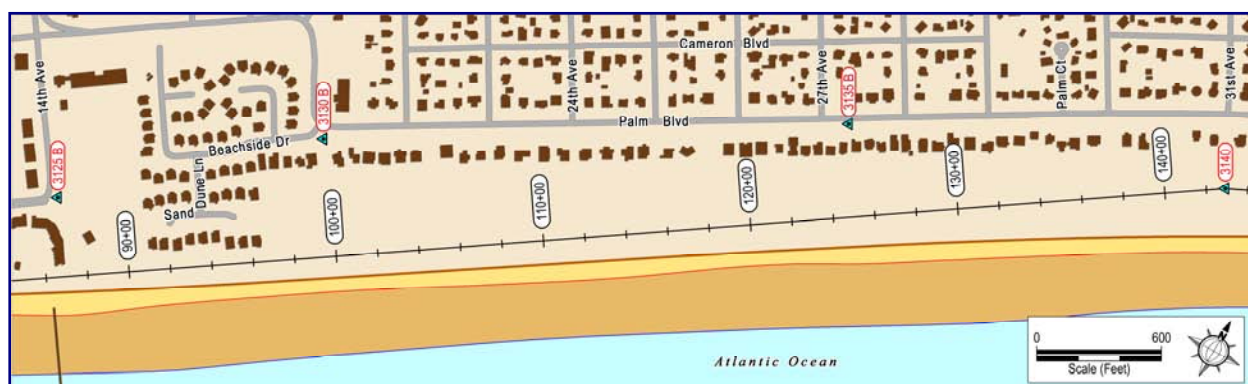
FIGURE 3.24. The *IOP Central* reach spans from stations OCRM 3125 (pier) to OCRM 3140 (31st Avenue).

The *IOP Central* reach spans the oceanfront between the pier and 31st Avenue (OCRM monuments 3125 – 3140, Fig 3.24). As previously mentioned, the long-term trend in this area is stable to accretional. Profiles from OCRM station 3135 (near 27th Avenue) show the beach in this area has gained ~40 ft in width at the +5 ft NAVD contour (Fig 3.25) over the past ten years. A similar trend is evident at OCRM station 3125 (14th Avenue) with dune growth and beach widening over the past ten years.

Opposite from the historical trend, the *IOP Central* reach was the most erosional of the IOP reaches between March and September 2009. As a whole, the reach lost ~25,600 cy (4.6 cy/ft). Profile volume change ranged from -0.43 cy/ft to -8.35 cy/ft for the stations in this reach. Erosion in this area (as well as in all the IOP reaches) is likely due to the recent shoal attachment events at the north-eastern end of the island. The process interrupts the natural, longshore-sediment transport pattern, which generally moves sand from northeast to southwest. CSE expects downcoast areas to slowly transition from erosional to accretional over the next few years as sand spreads from the present shoal-bypass zone. Figure 3.26 shows the beach condition in September 2009.

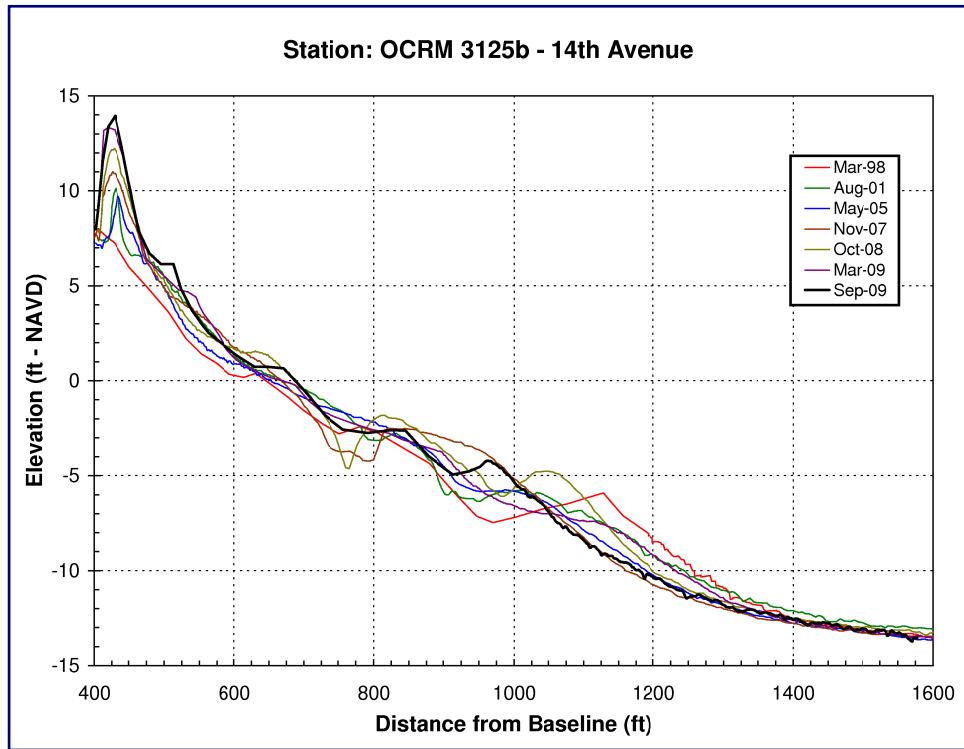
FIGURE 3.25. Profiles from OCRM station 3125 (upper) and OCRM station 3135 (lower), showing long-term accretion despite erosion in 2009. Protective dunes reach to +15 ft NAVD in this area and have been building since 1998. [Profiles prior to March 2009 courtesy SCDHEC-OCRM.]

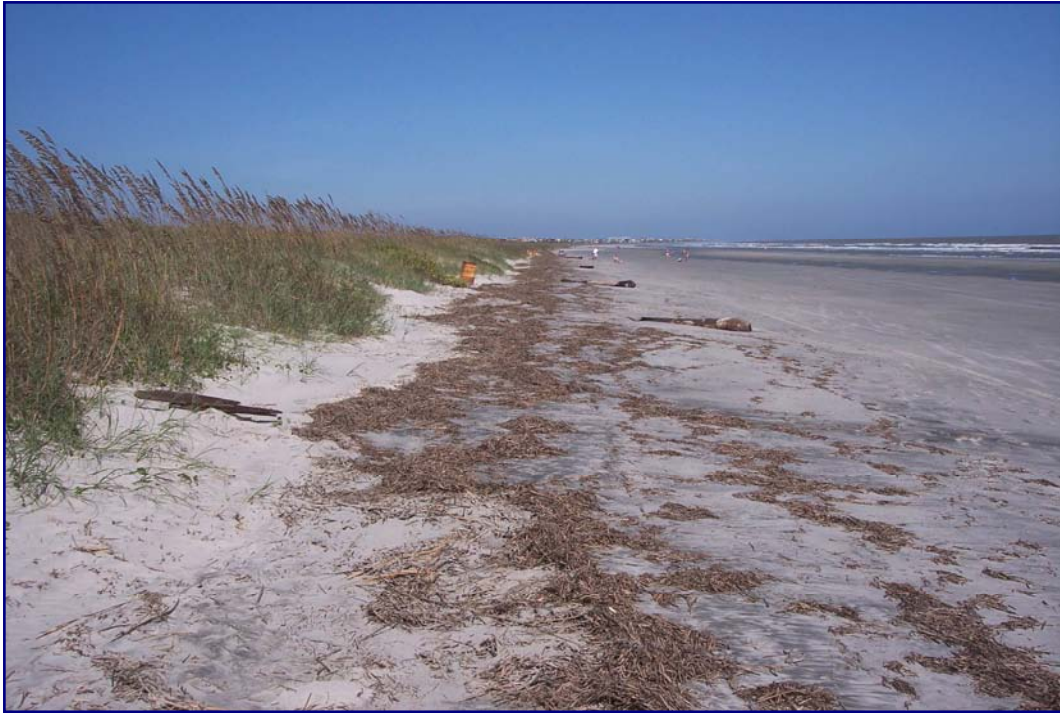
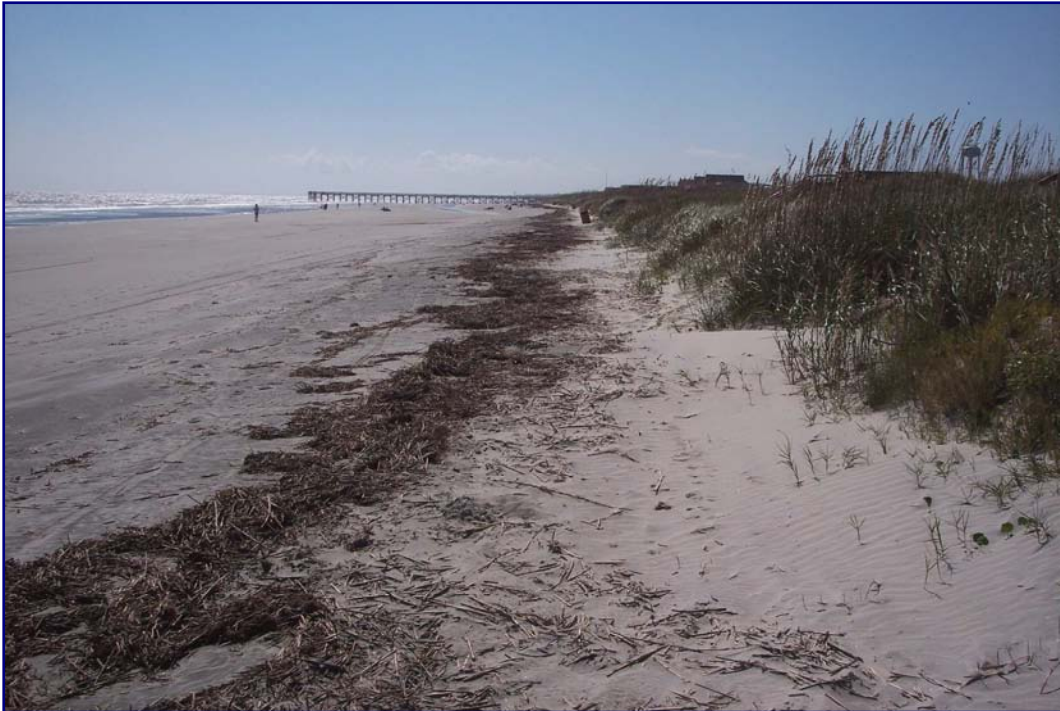
FIGURE 3.26. Views northeast (upper) and southwest (lower) of station 110+00 in the *IOP Central* reach (vicinity of 24th Ave). No scarping is present in the dunes, even under spring tide conditions, indicating a healthy supply of sand in the area.

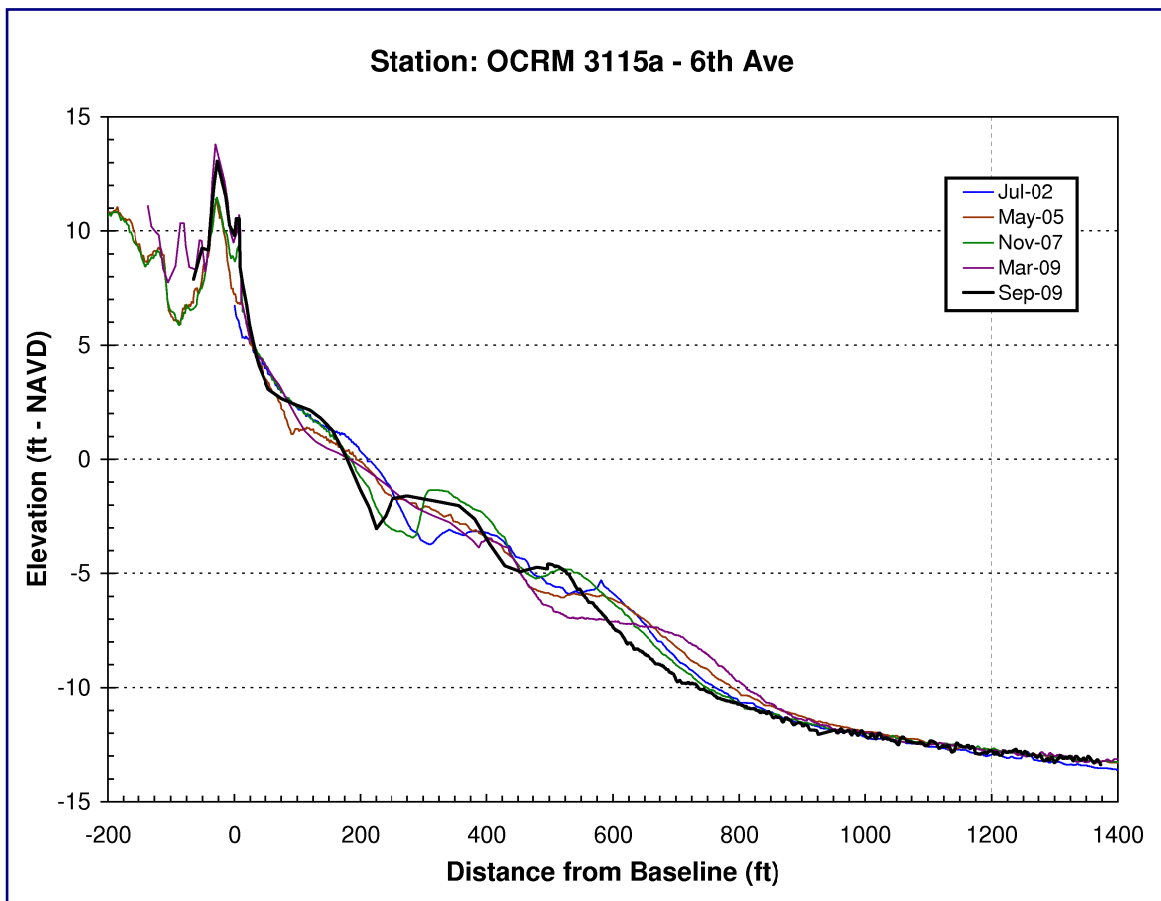
FIGURE 3.28. Profiles from OCRM station 3115 (6th Avenue) in the IOP South reach.

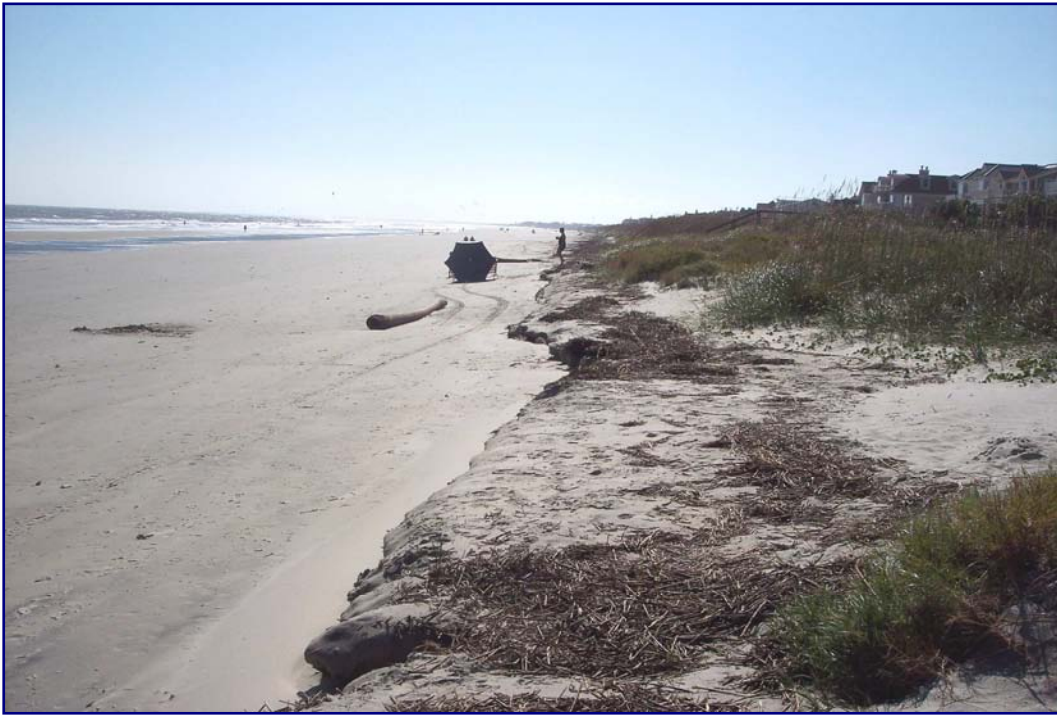
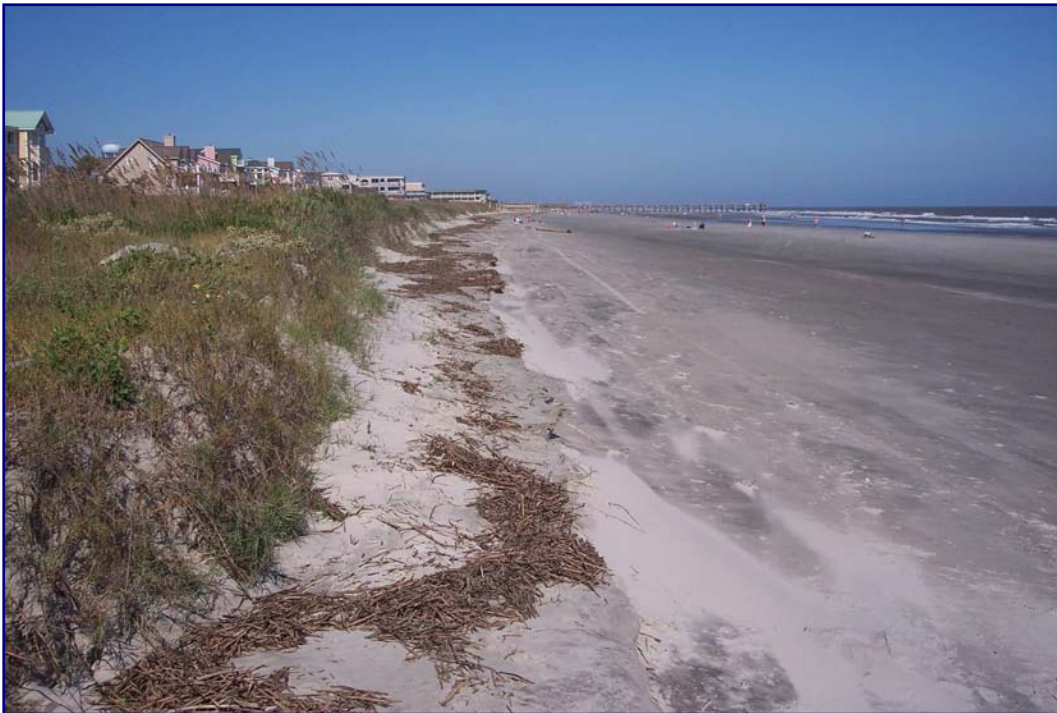
FIGURE 3.29. Photos from station 60+00 (8th Ave) in September 2009. Note a small scarp visible seaward of the vegetation line. The scarp is likely the result of high spring tides around the time of the photo. CSE expects this area to rebuild under normal wave and tide conditions.

The *IOP South* reach spans 4,280 ft between 6th Avenue and the pier (OCRM monuments 3115 – 3125, Fig 3.27). The two southernmost stations (7th and 8th Avenues) gained an average of 3.74 cy/ft, while the other stations in this area eroded an average of 6.12 cy/ft between March and September 2009. Total volume loss was 6,870 cy (1.6 cy/ft) over the reach. OCRM station 3115 (6th Avenue) has been fairly stable since 2002 (Fig 3.28) as evident in the growth of the dunes. As of September 2009, station 3115 contained ~1.5 cy/ft more sand than the July 2002 condition; however, the March 2009 condition showed 8.2 cy/ft more sand than the 2002 condition. A small scarp was present in September 2009 near station 60+00 (8th Avenue). It was ~6 inches high and was likely caused by the high spring tide around the time of CSE's data collection (Fig 3.29).

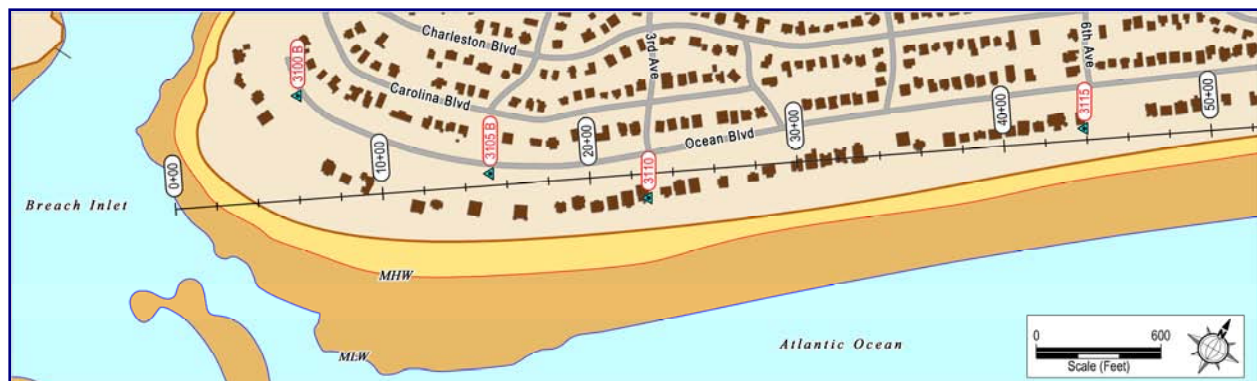
FIGURE 3.31. The *Breach Inlet* reach spans ~4,200 ft from Breach Inlet to OCRM station 3115 (6th Avenue).

The *Breach Inlet* reach, between Breach Inlet and 6th Avenue (Fig 3.31), is classified as an unstabilized inlet erosion zone due to the dynamic nature of the shoals associated with the inlet delta. While labeled as unstable, the long-term trend for this reach is accretional with an estimated growth of ~8.9 ft/yr (linear beach width). The historical accretion trend in this reach is due to a plentiful sand supply from upcoast and sand trapping by the Breach Inlet ebb-tidal delta. Sand supply originates from shoal-bypass events at Dewees Inlet and longshore sand transport from north to south over the length of the Isle of Palms. Excess sand is deposited along the southern spit of the island (the *Breach Inlet* reach) and in the Breach Inlet ebb-tidal delta. Shoals of Breach Inlet form a protuberance in the shoreline, which backs sand up along the oceanfront much like a terminal groin traps sand. Changes in this area are related to bars from the inlet delta migrating onto the beach or marginal flood channels moving landward or seaward. Such natural processes lead to rapid changes in the beach volume compared to the central IOP reaches.

Between March and September 2009, the two stations closest to Breach Inlet (0+00 and 4+00) were highly erosional, while the remaining stations in the reach showed accretion. Stations 8+00 through OCRM 3110 (3rd Ave) each gained over 15 cy/ft, including gains over 35 cy/ft for stations 12+00 through 20+00. Stations 30+00 and 40+00 were more stable, only gaining 1.0 and 0.1 cy/ft (respectively). It is difficult to determine the source of sand causing the accretion, but profiles suggest that some of the sand gained is a result of the onshore migration of a bar on the updrift side of the inlet.

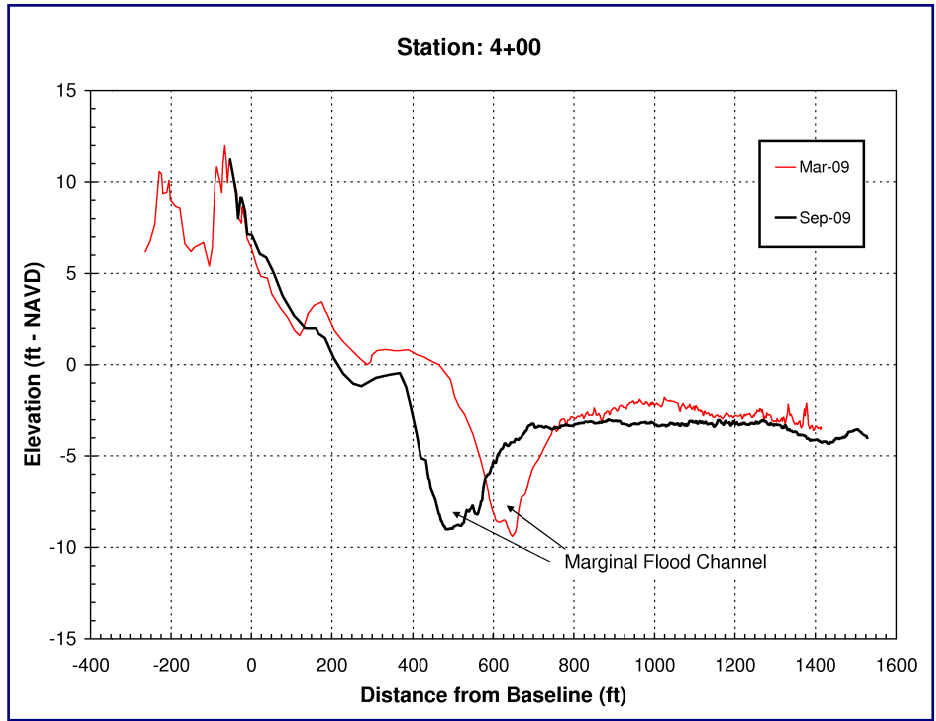
FIGURE 3.21. March and September 2009 profiles from station 4+00 near Breach Inlet. While the upper beach built out between March and September, the lower beach lost a significant volume of sand as the marginal flood channel of Breach Inlet migrated closer to the shore.

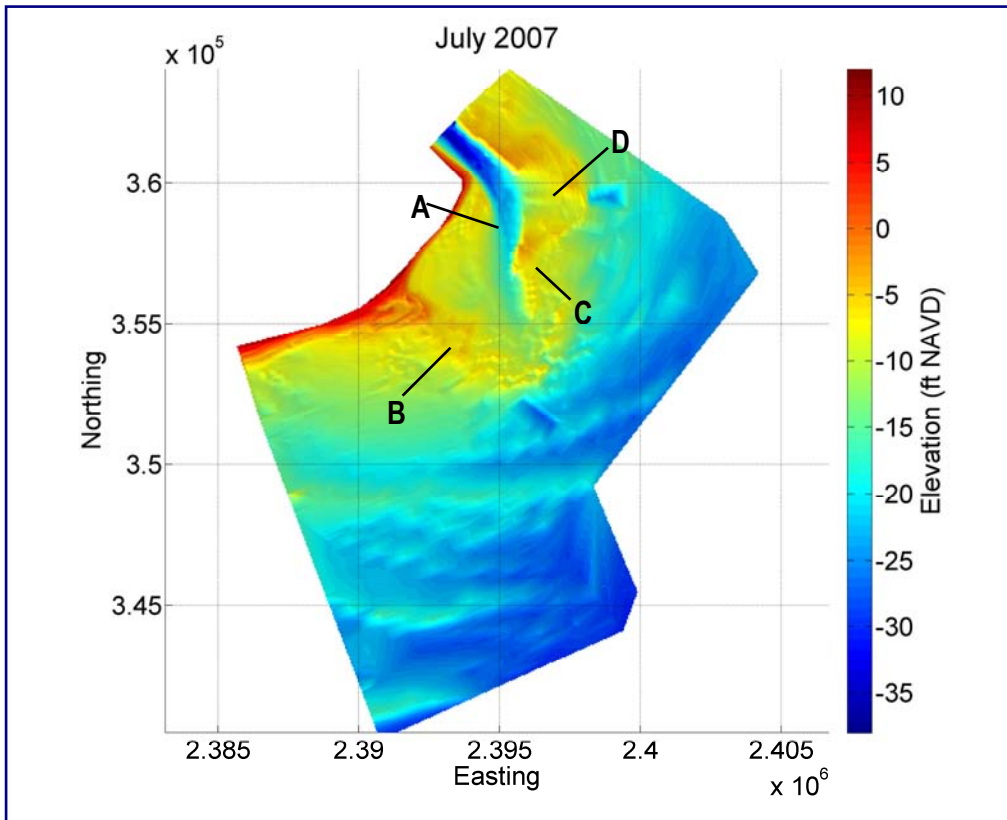
FIGURE 3.35. DTMs from July 2007 (upper) and July 2008 (lower) showing changes in the shoals of the Dewees Inlet ebb-tidal delta. Labels are described in the text.

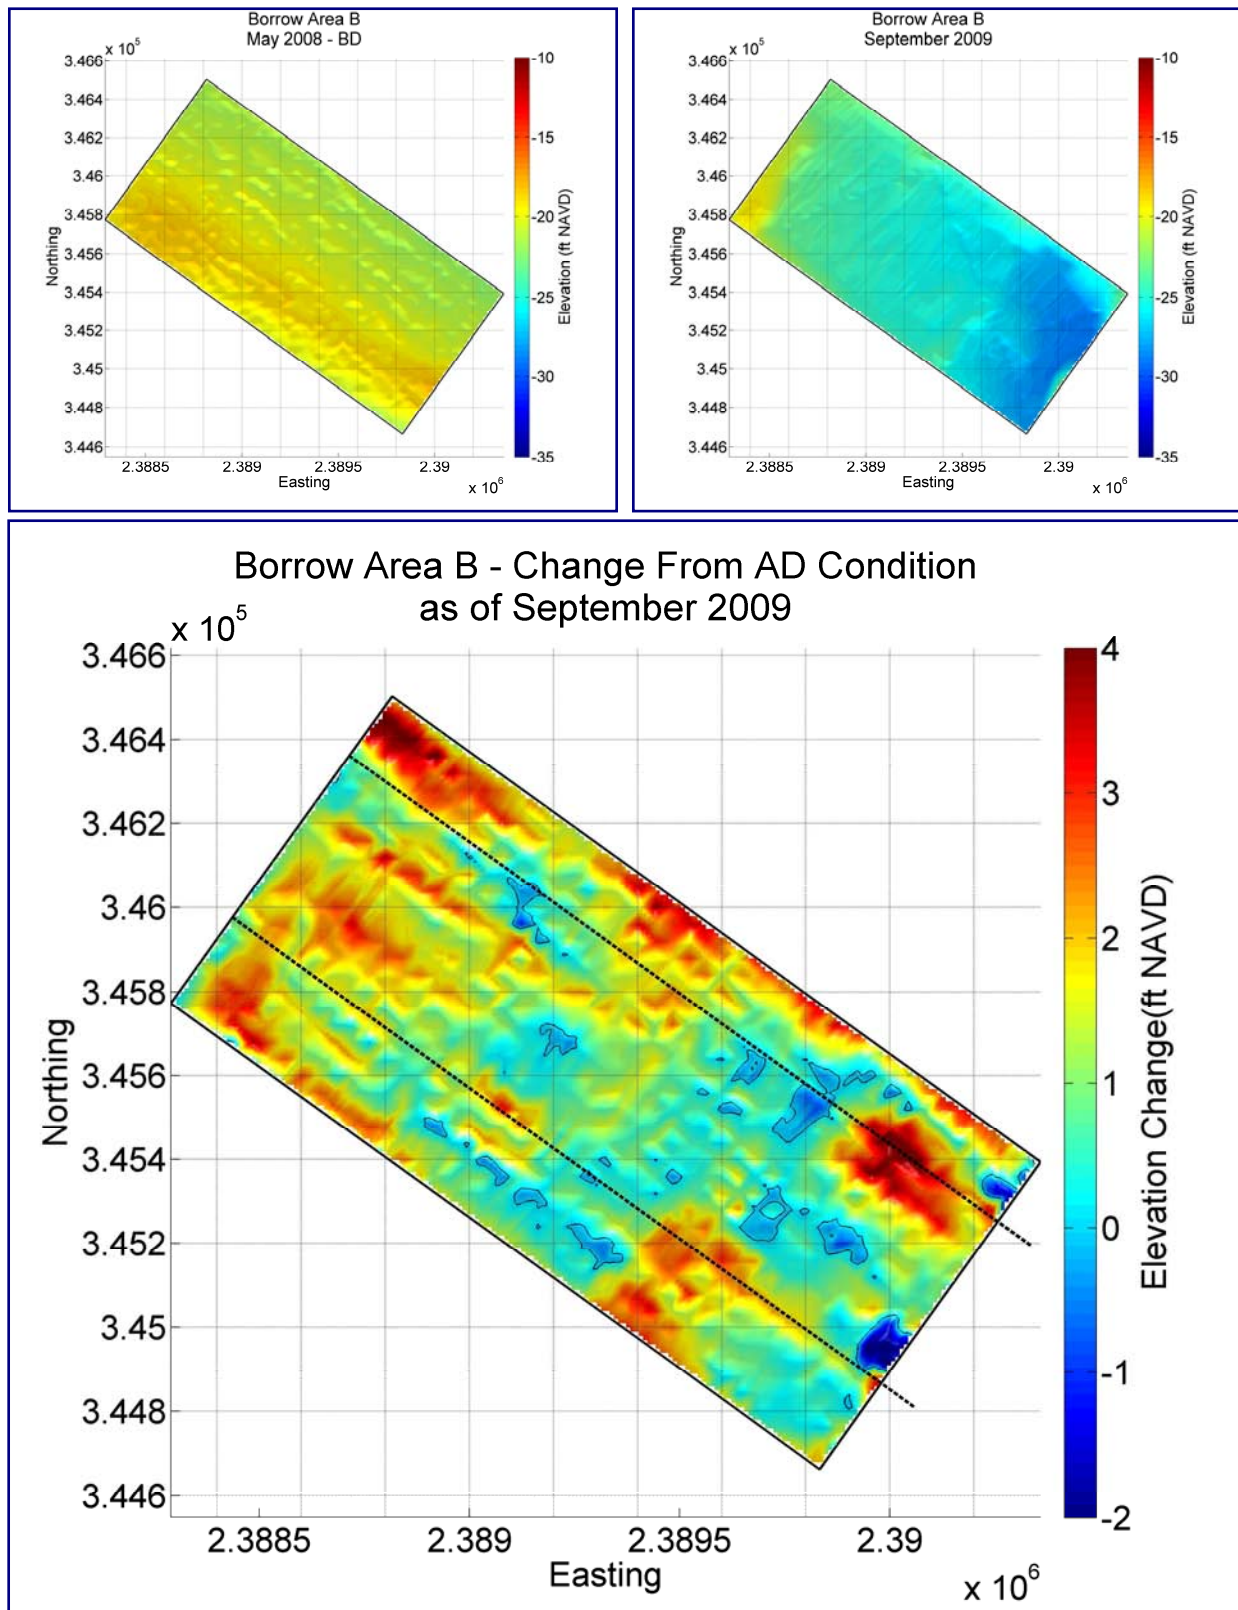
FIGURE 3.41. DTM models of borrow area B before nourishment (upper left), in September 2009 (upper right), and the elevation change between the post-dredge and September 2009 conditions showing infilling/erosion following the project (lower). Generally, areas left higher (where the dredge ladder was raised to avoid muddy sediments) eroded and shifted to deeper sections. Boundary areas also gained elevation as material from undredged areas sloughed into the dredged areas. [Dashed lines are the locations of sections in Figure 3.43. BD = before dredging. AD = after dredging.]

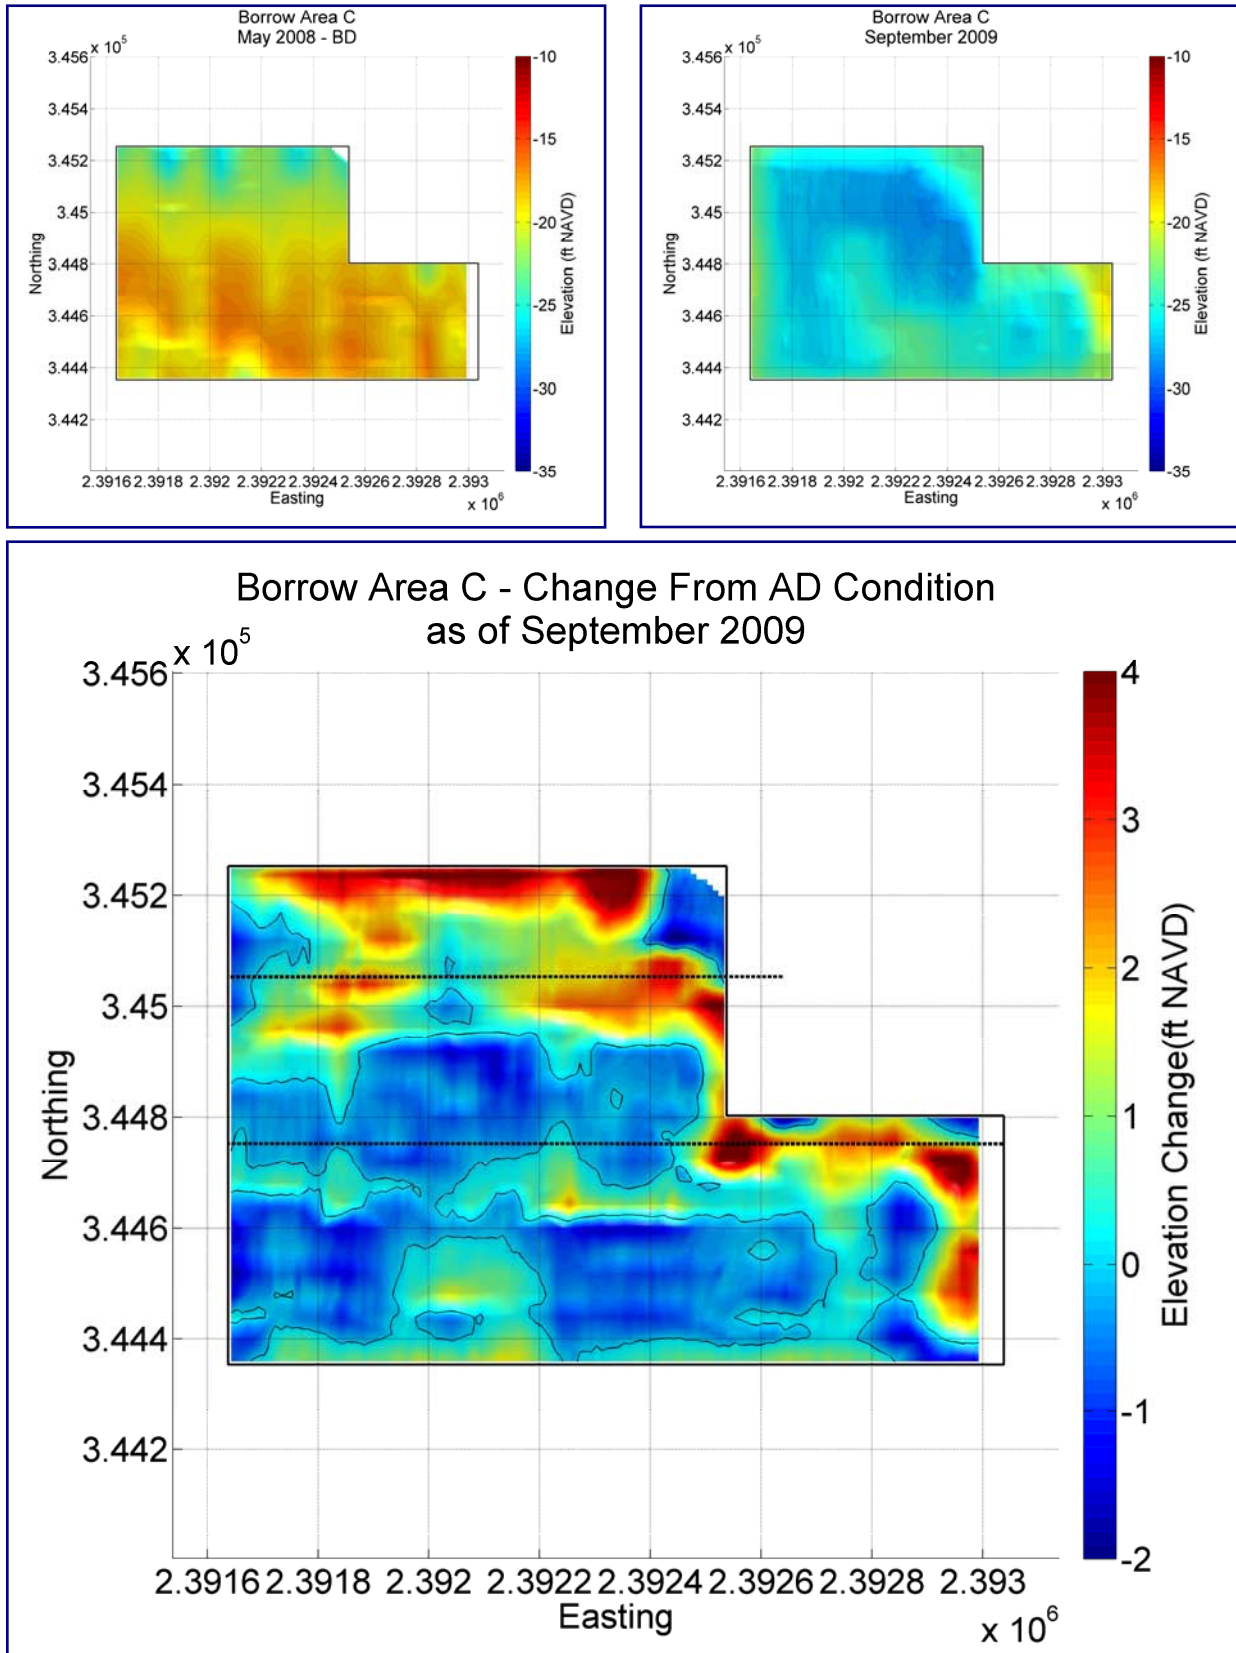
FIGURE 3.42. DTM models of borrow area C before nourishment (upper left), in September 2009 (upper right), and the elevation change between the post-dredge and September 2009 conditions showing infilling/erosion following the project (lower). Generally, areas left higher (where the dredge ladder was raised to avoid muddy sediments) eroded and shifted to deeper sections. Boundary areas also gained elevation as material from undredged areas sloughed into the dredged areas. [Dashed lines are the locations of sections in Figure 3.43. BD = before dredging. AD = after dredging.]

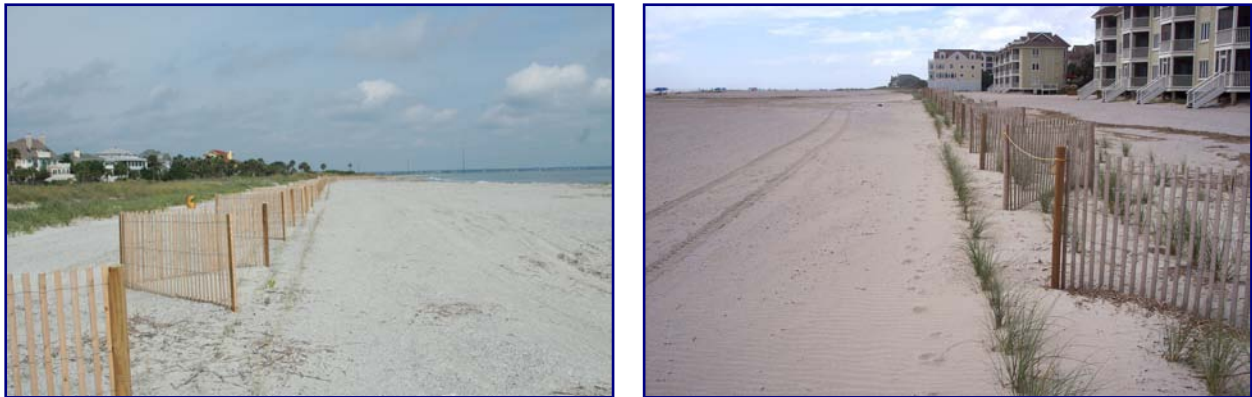
FIGURE 3.46. [LEFT] Sand fencing in the *Deweese Inlet* reach in May 2008, shortly after installation. [RIGHT] Sand fencing and vegetation in the *North Wild Dunes* reach (near *Seascape Villas*) in September 2009, ~4 months after installation. Note v-shaped configuration of sand fencing, opened toward the sea, with 10 ft gaps between sections—following design guidance by SCDHEC-OCRM.

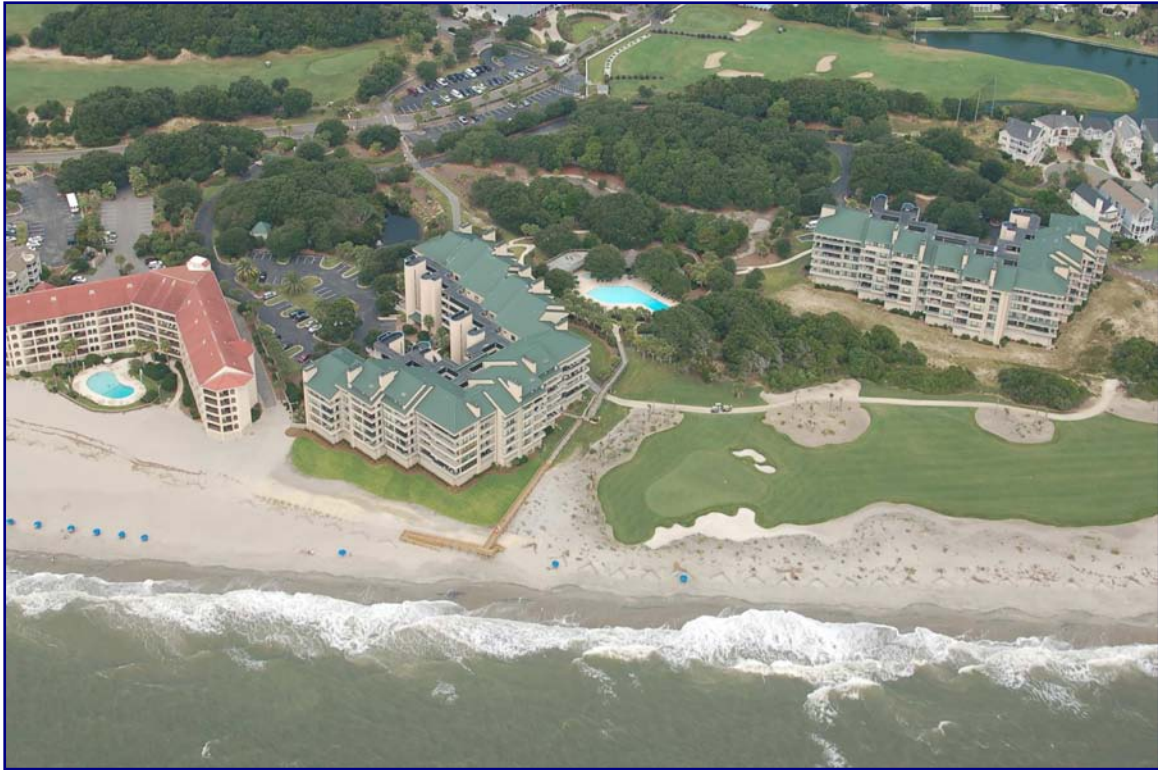
FIGURE 4.1. Walkover placed seaward of Ocean Club and reclamation of the 18th hole of the Wild Dunes Links Course following nourishment. [Photo by C Jones, 10 September 2009]
