**2018 Isle of Palms Restoration Project
Year 6 Monitoring Report**

2024
MONITORING REPORT

Prepared for
City of Isle of Palms
Isle of Palms, South Carolina

2018 Isle of Palms Restoration Project
Year 6 (2024) Monitoring Report
Annual Beach and Inshore Surveys

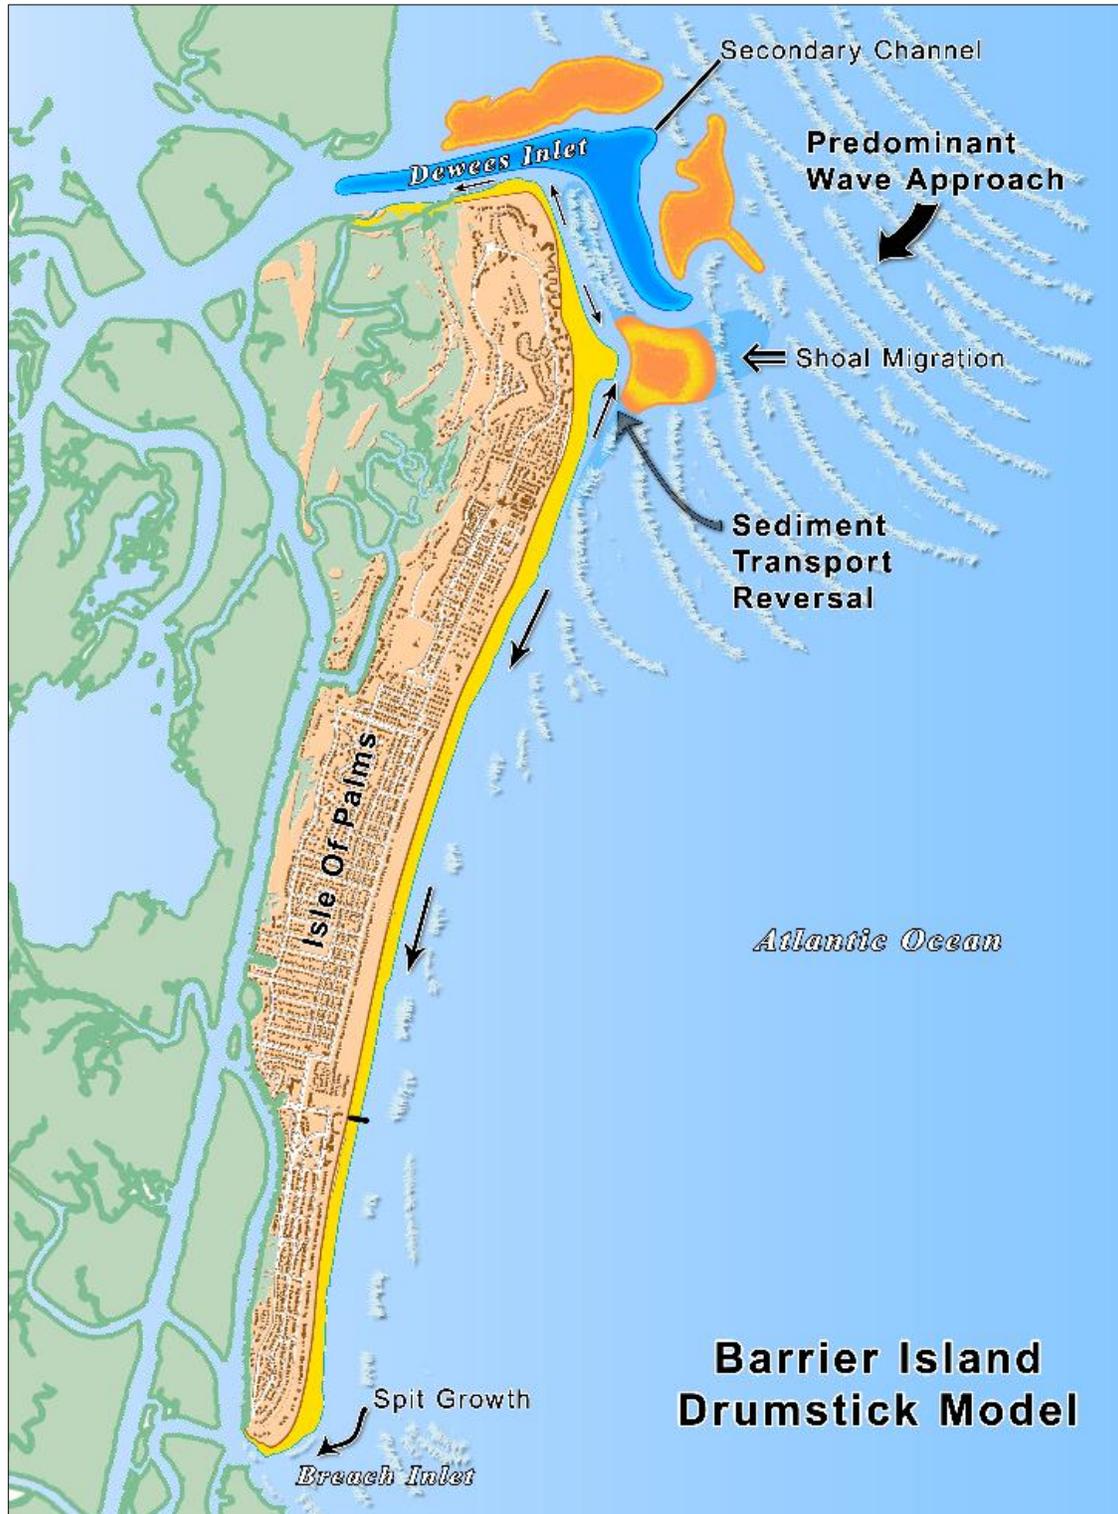
FIGURE 2.1. Schematic of the Isle of Palms showing the wider northeast end characteristic of a 'drumstick' barrier island.

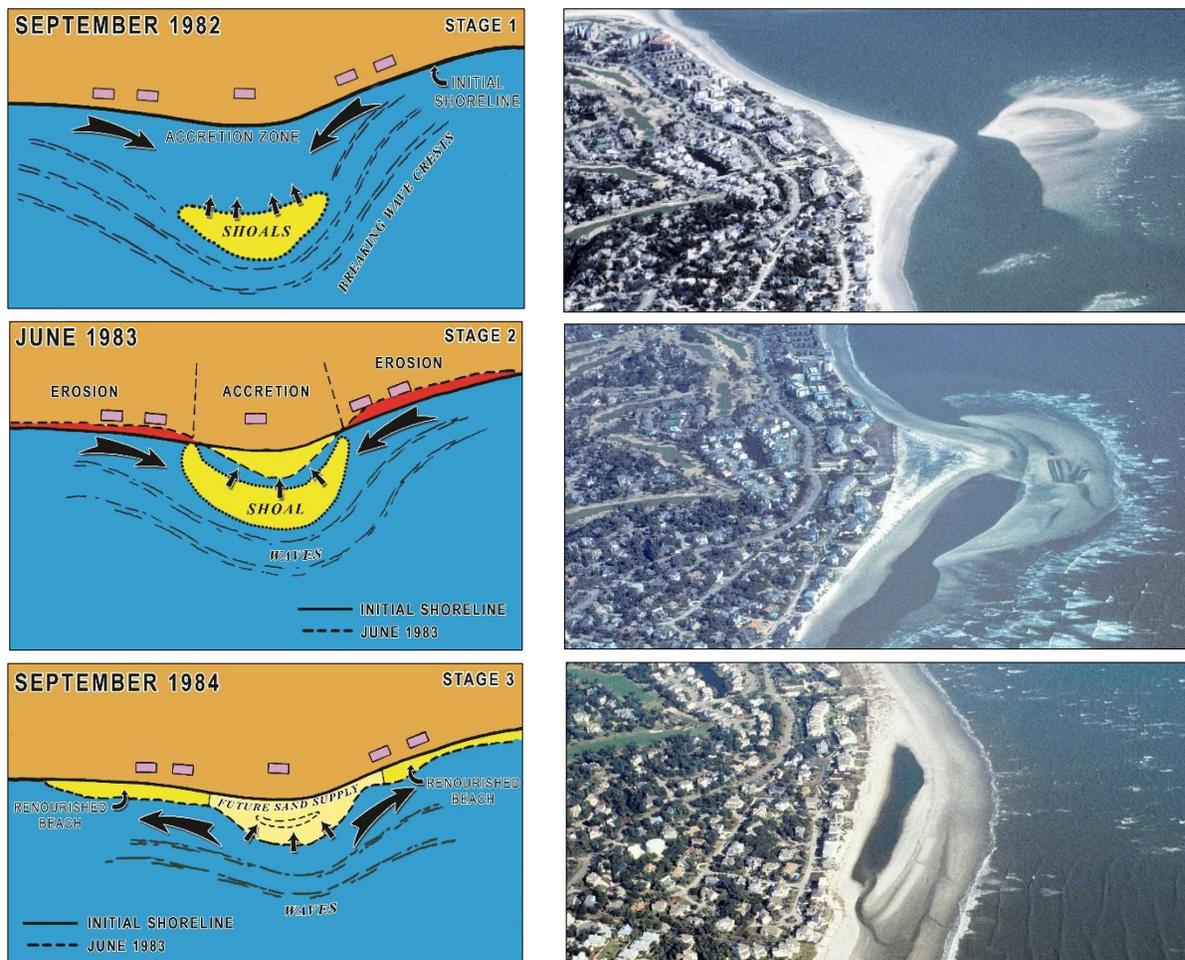
FIGURE 2.3. [LEFT] Schematic of the shoal-bypass cycle originally modeled from a bypass event at Isle of Palms. [RIGHT] A shoal-bypass event at northeastern Isle of Palms corresponding to the schematic. The upper photo shows a shoal in Stage 1 (1996). The middle image illustrates Stage 2 (1997). The bottom photo shows Stage 3 (1998).

Following the large-scale event mentioned previously, the eastern end of the island continued to experience shoal-bypass events, though all were substantially smaller in magnitude than the 1940s–1960s event. These events generally attached along the central Wild Dunes area and are more characteristic of shoal-bypass events characterized by Kana (2002), with distinct stages of 1) emergence, 2) migration and attachment, and 3) spreading (Fig 2.3). These events have been responsible for focused erosion along various portions of the Wild Dunes area, including two events in the 1980s, another in the late 1990s, and a large event in the mid-2000s that led to the 2008 beach nourishment project.

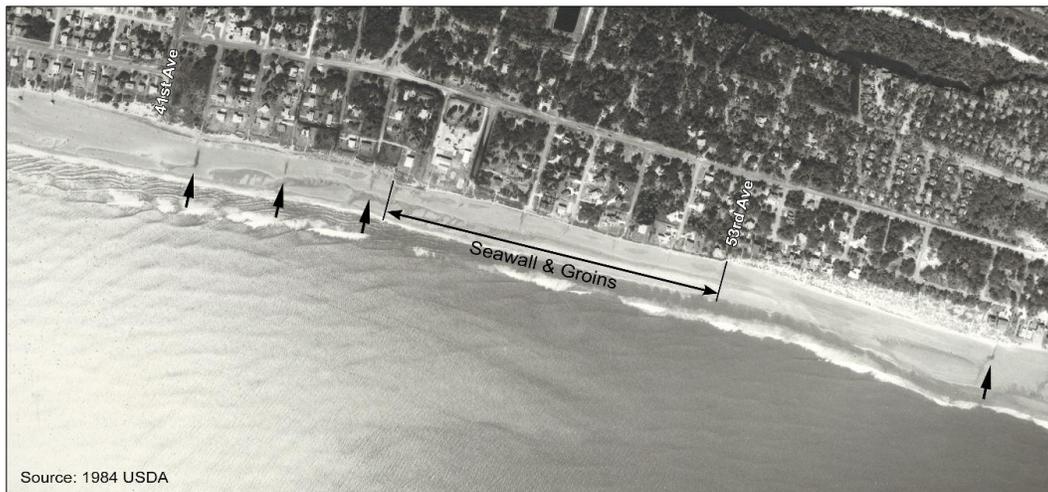
FIGURE 2.4. A seawall and groins were in place in 1984 between 46th Ave to 53rd Ave. Today, due to rapid accretion, these groins and seawalls have been buried.

The addition of sand from shoal bypassing at the east end of the island has contributed to relatively steady accretion along the central and western ends, resulting in a wide setback for most properties west of 58th Avenue. In the 1970s, properties along 46th Ave to 53rd Ave installed a seawall and several groins by 1984, as shown in Figure 2.4. Since 1984, the beach has accreted rapidly, and all groins and seawalls have been buried.

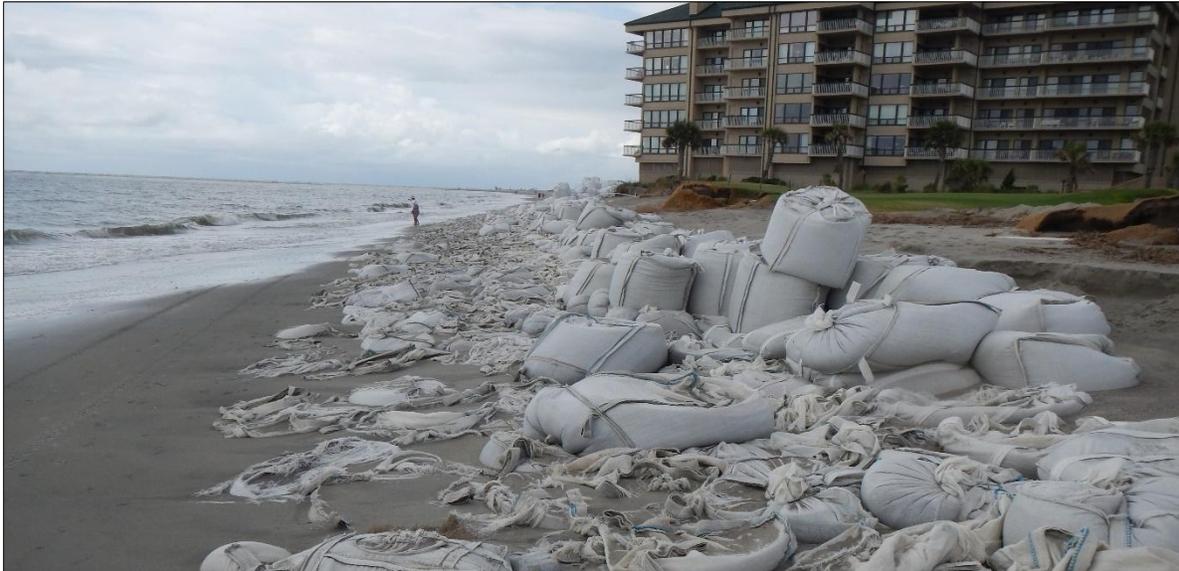
FIGURE 2.5. To prevent additional erosion, sandbags were installed along several structures from Shipwatch to Ocean Club from 2004 to 2007.

From 1984 to 2007, sand scraping from accretional areas was the only mitigation attempted to combat shoal-induced erosion. CSE and its predecessors documented scraping efforts circa 1983, 1987, and 1998 (Figure 2.3) that attempted to move sand from accreting areas to erosional arcs. From 2004–2007, sandbags were installed to protect several structures from Shipwatch to Ocean Club and prevent additional shoreline retreat (Figure 2.5).

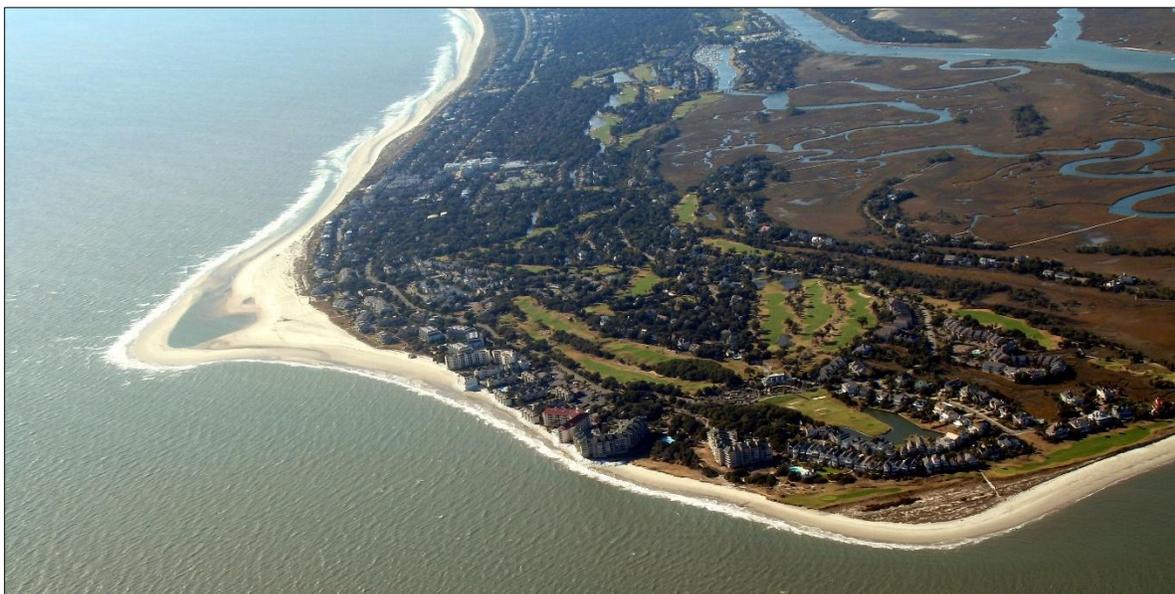
FIGURE 2.6. Isle of Palms in 2007 prior to beach nourishment.

Erosion reached such a severe condition in 2007 that there was little-to-no beach along portions of the east end of the island, even at low tide (Figure 2.6). The Wild Dunes Community Association contracted with CSE to evaluate the causes of erosion and prepare a feasibility study outlining alternatives for restoration (CSE 2007). CSE recommended nourishing the beach using sand from an offshore borrow area and began the steps to obtain a permit for the work. The City of Isle of Palms then took ownership of the project and served as the permit applicant. Permits were obtained (P/N 2007-02631-2IG), and the City contracted with Weeks Marine for a project involving the nourishment of 847,000 cy of sand over 10,200 lf (linear feet) of beach. The project extended from 200 ft north of 53rd Avenue to the 17th green of the Links Course.

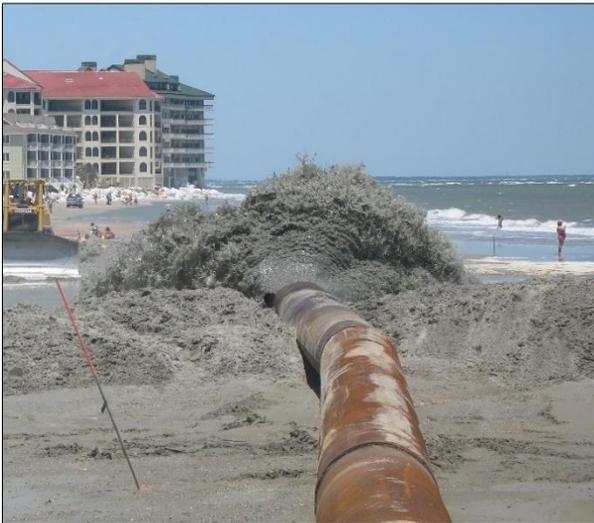
FIGURE 2.7. [ABOVE] 2008 beach nourishment project (completed on 15 July 2008).

The 2008 project was completed between 15 May and 15 July 2008 (Figure 2.7). As part of the project, Weeks Marine removed all sandbags from the project area, which totaled ~9,400 bags. Homeowners removed an additional 4,680 bags from under buildings. Averaging ~25,000 cy of sand per day, the dredge *RS Weeks* pumped sand from three borrow areas 2–3 miles from the beach. The nourishment was placed in three reaches and included ~270,000 cy between 53rd Ave and Dune Crest Ln (Reach A), 552,400 cy from Mariners Walk to the 18th fairway (Reach B), and 25,000 cy from the 18th tee to the 17th fairway (Reach C). Figure 2.8 shows the layout of the 2008 project. Figure 2.9 shows a post-project aerial photo (2008) that compares to the project area before renourishment (2007).

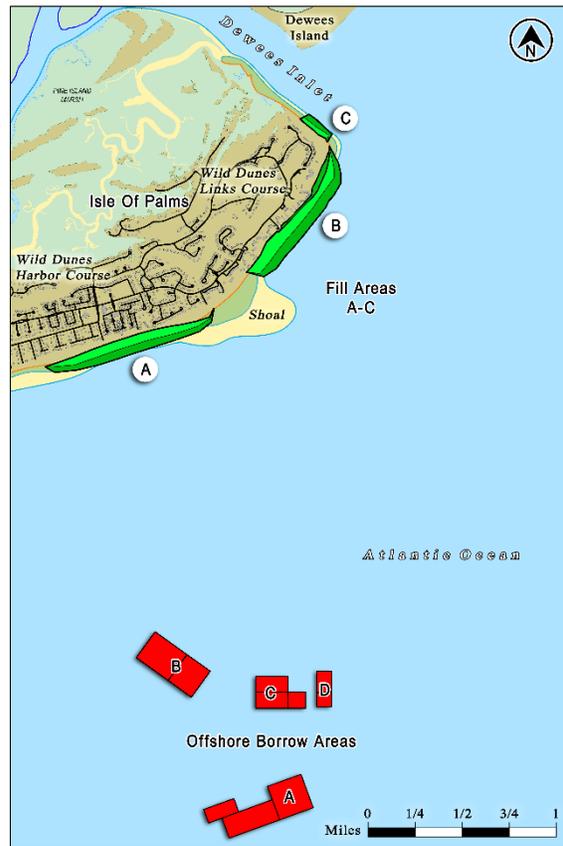
FIGURE 2.8. [RIGHT] 2008 nourishment project map.

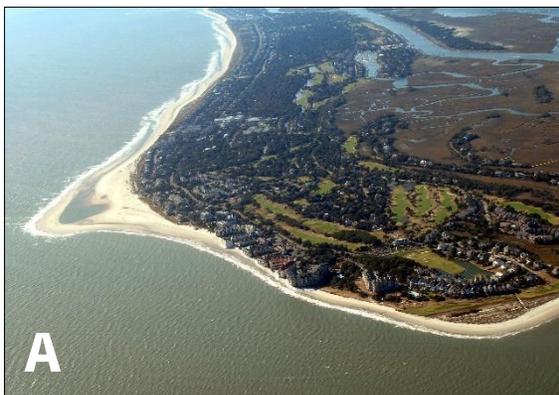
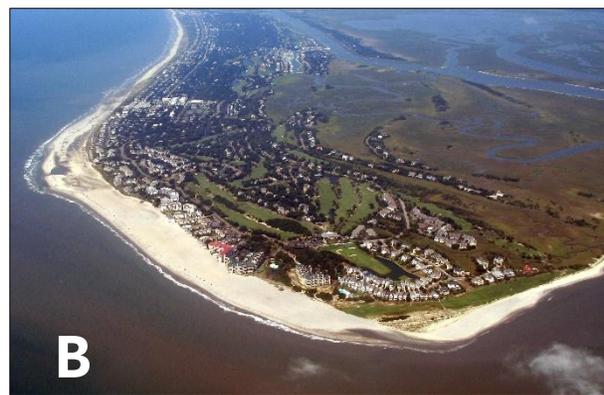
FIGURE 2.9. [LEFT] Isle of Palms in 2007 prior to nourishment. **[RIGHT]** The project area in 2008 following nourishment.

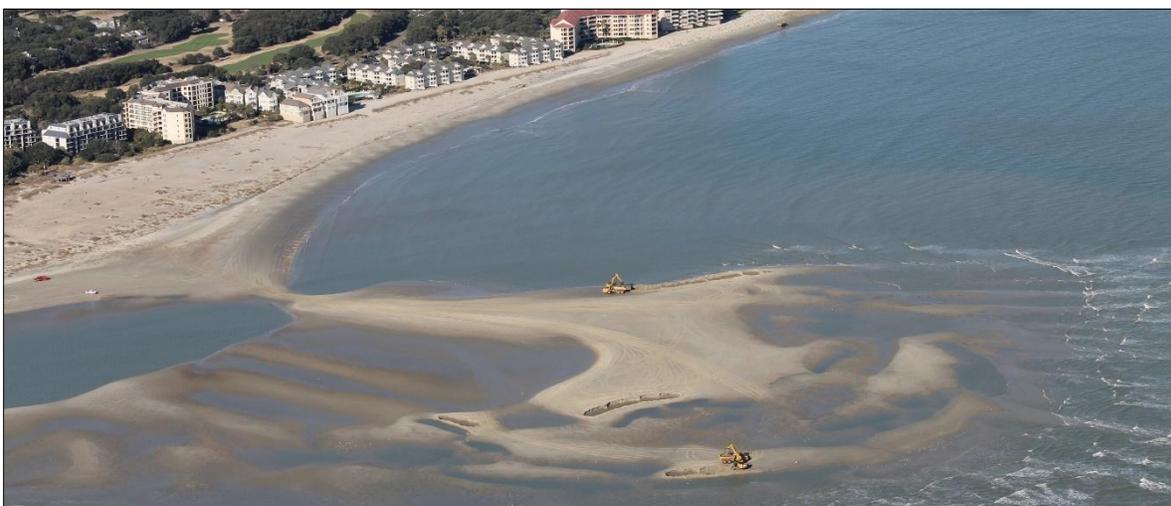
FIGURE 2.10. January 2015 aerial image of the 2014–2015 shoal management project showing equipment transferring sand from an attaching shoal to the eroded beach.

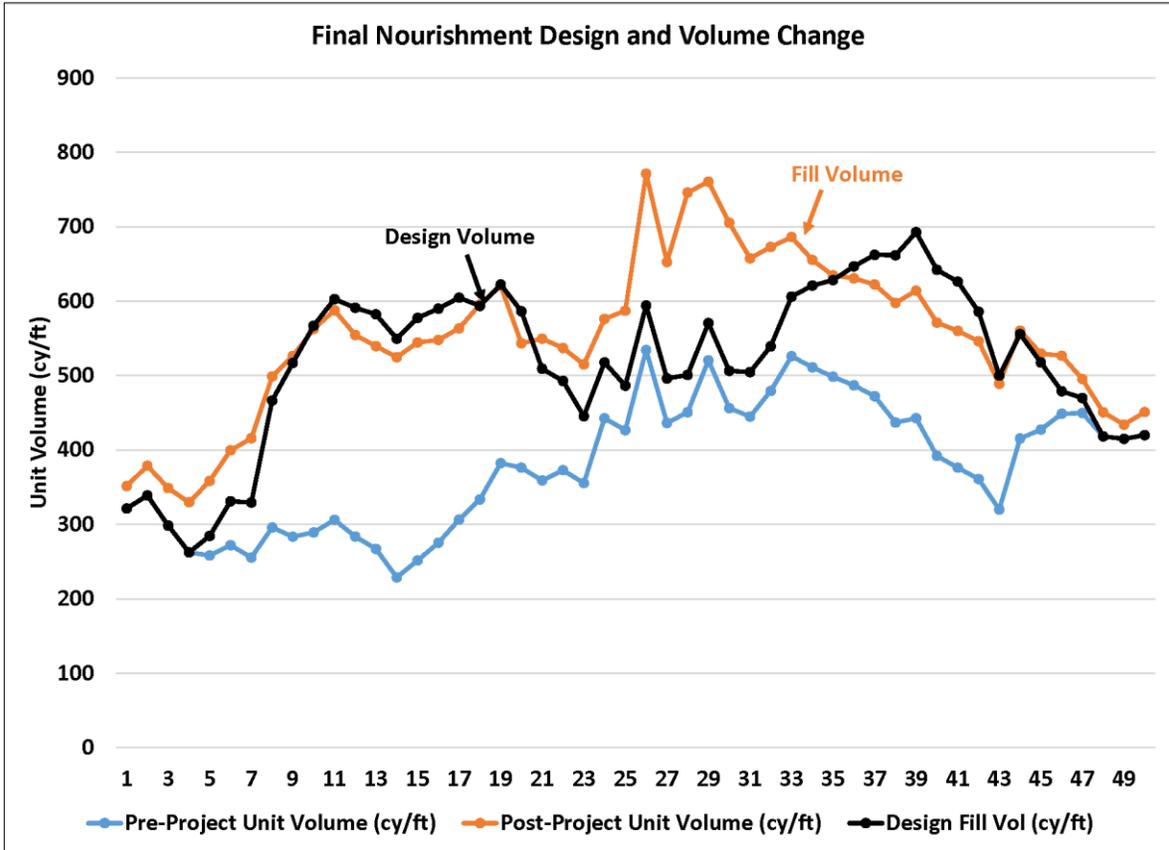
FIGURE 2.11. A graphic representation of the 2018 final fill template (shown in TABLE 2.2).

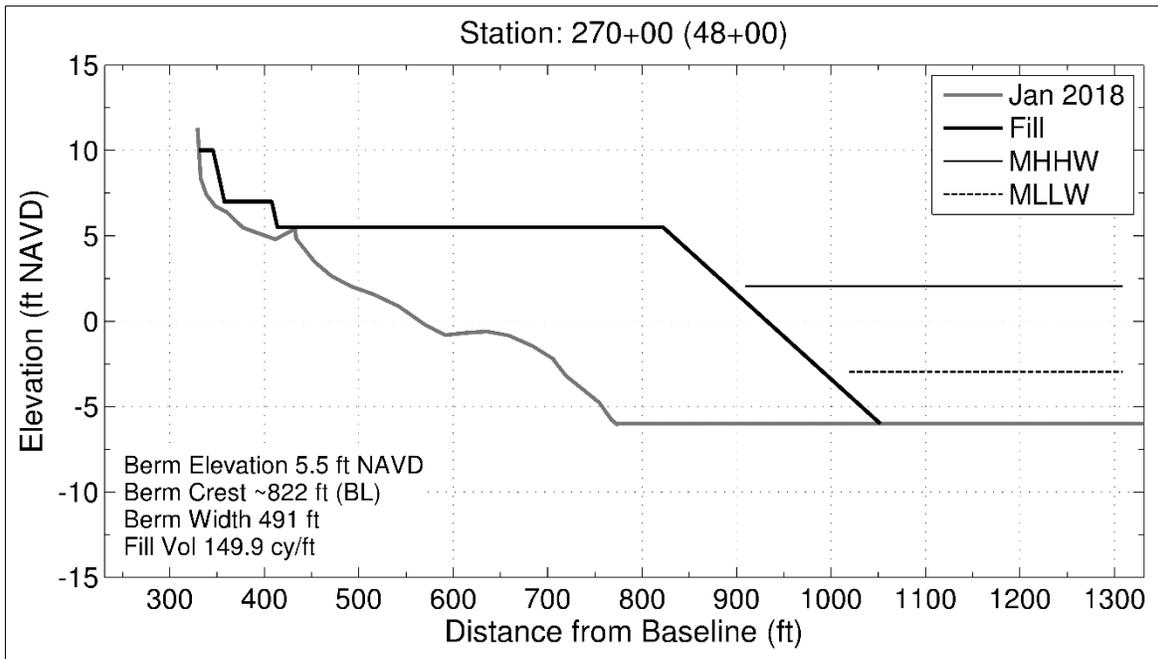
FIGURE 2.12. The 2018 design fill profile incorporated a dune, storm berm, wide fill berm, and sloping section.

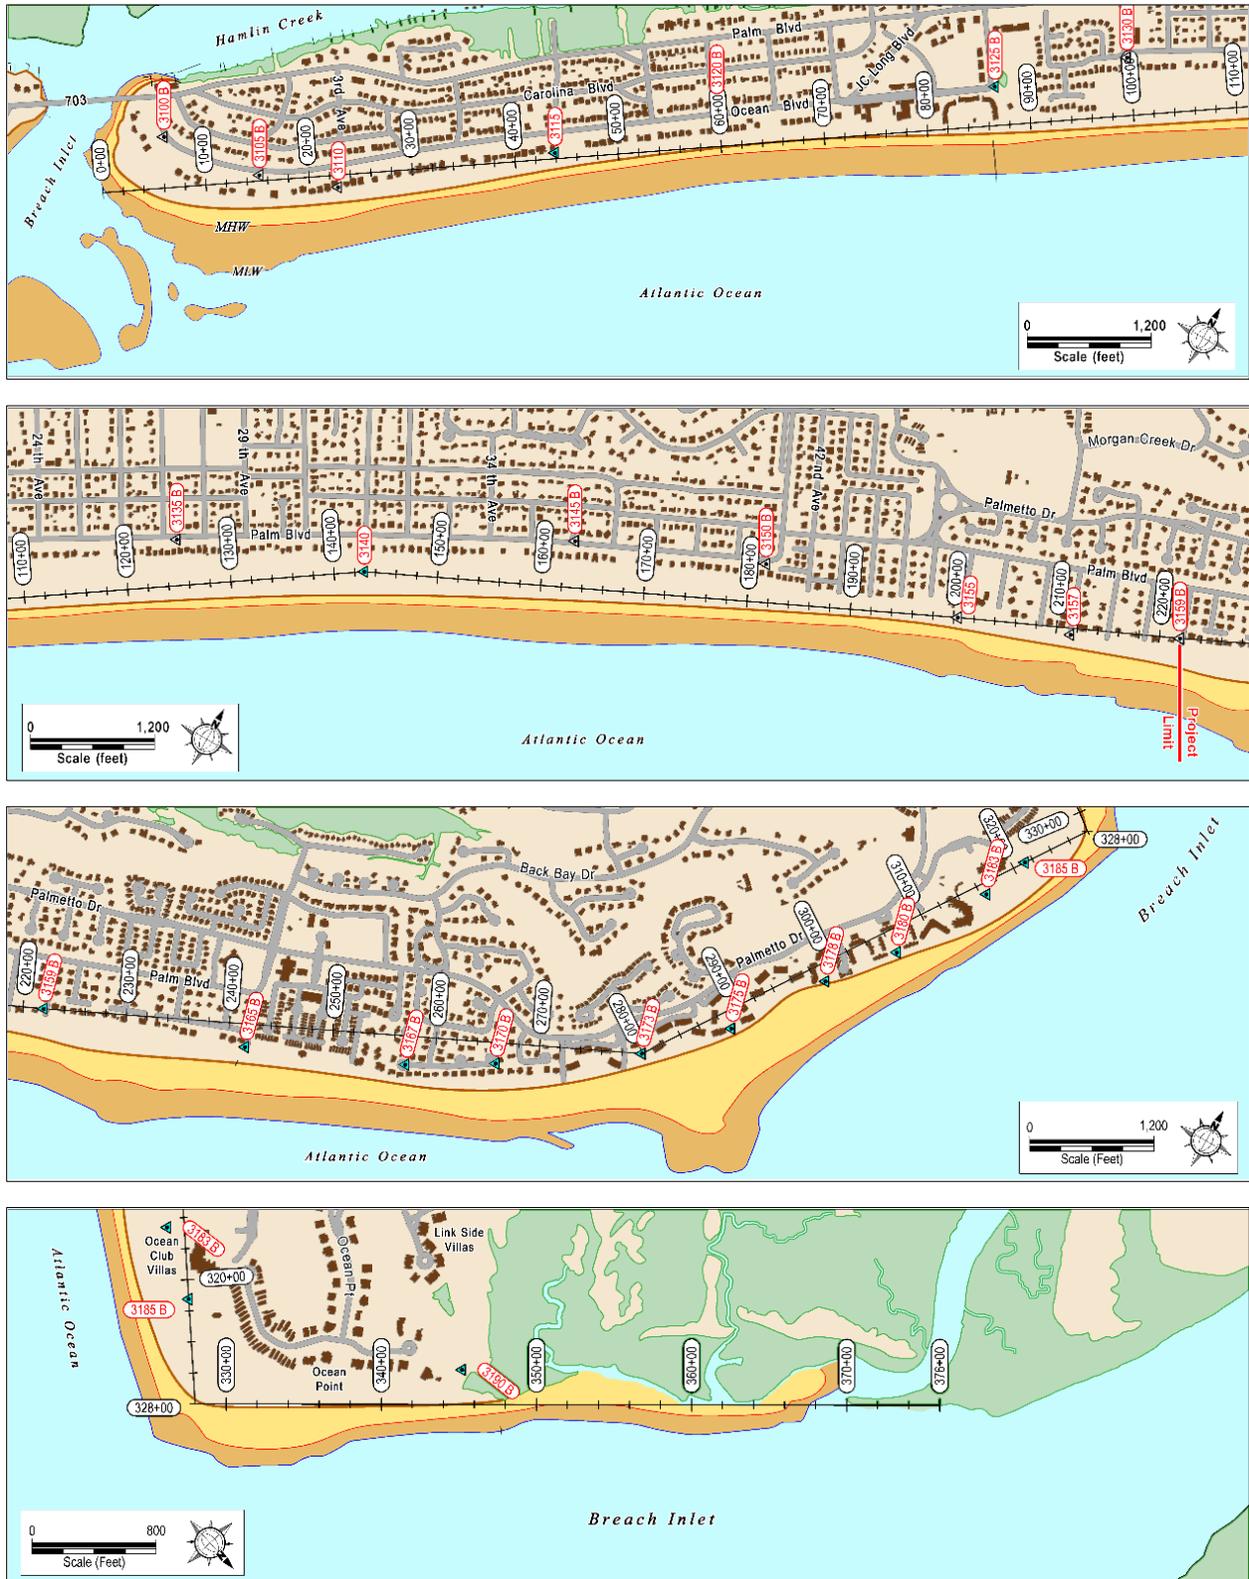
FIGURE 3.1. Baseline map of Isle of Palms showing the reference line used to establish monitoring profiles. Stationing increases to the north from Breach Inlet.

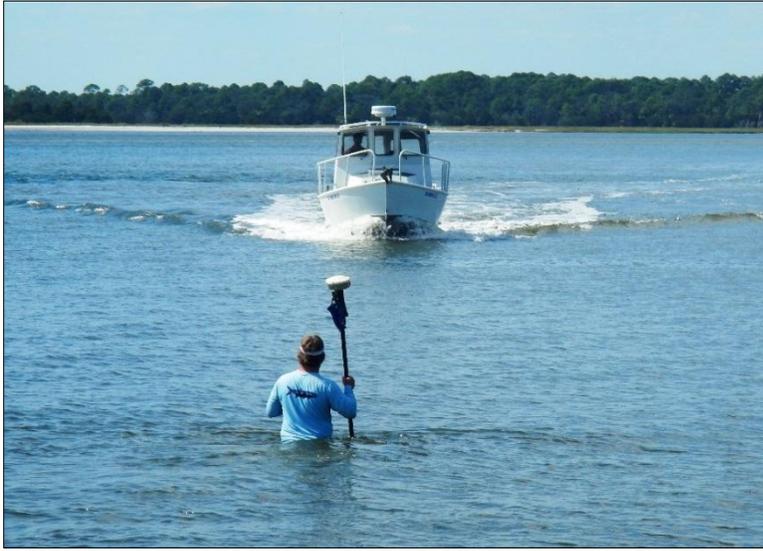
FIGURE 3.2.

Surveying beach profiles involves collection of land-based data at low-tide and hydrographic data collection overlapping the land-based work.

Topographic data were collected via RTK-GPS (Trimble™ R10 GNSS), which provides position and elevation measurements at centimeter accuracy. Beach profiles were obtained by collecting data at low tide along the dunes, berm, and active beach to low-tide wading depth. Overwater work was then performed at high tide to overlap the land-based work (Fig 3.2) and was collected with RTK-GPS coupled with an Odom CV100™ precision echosounder mounted on CSE’s survey vessel, the *RV Southern Echo*.

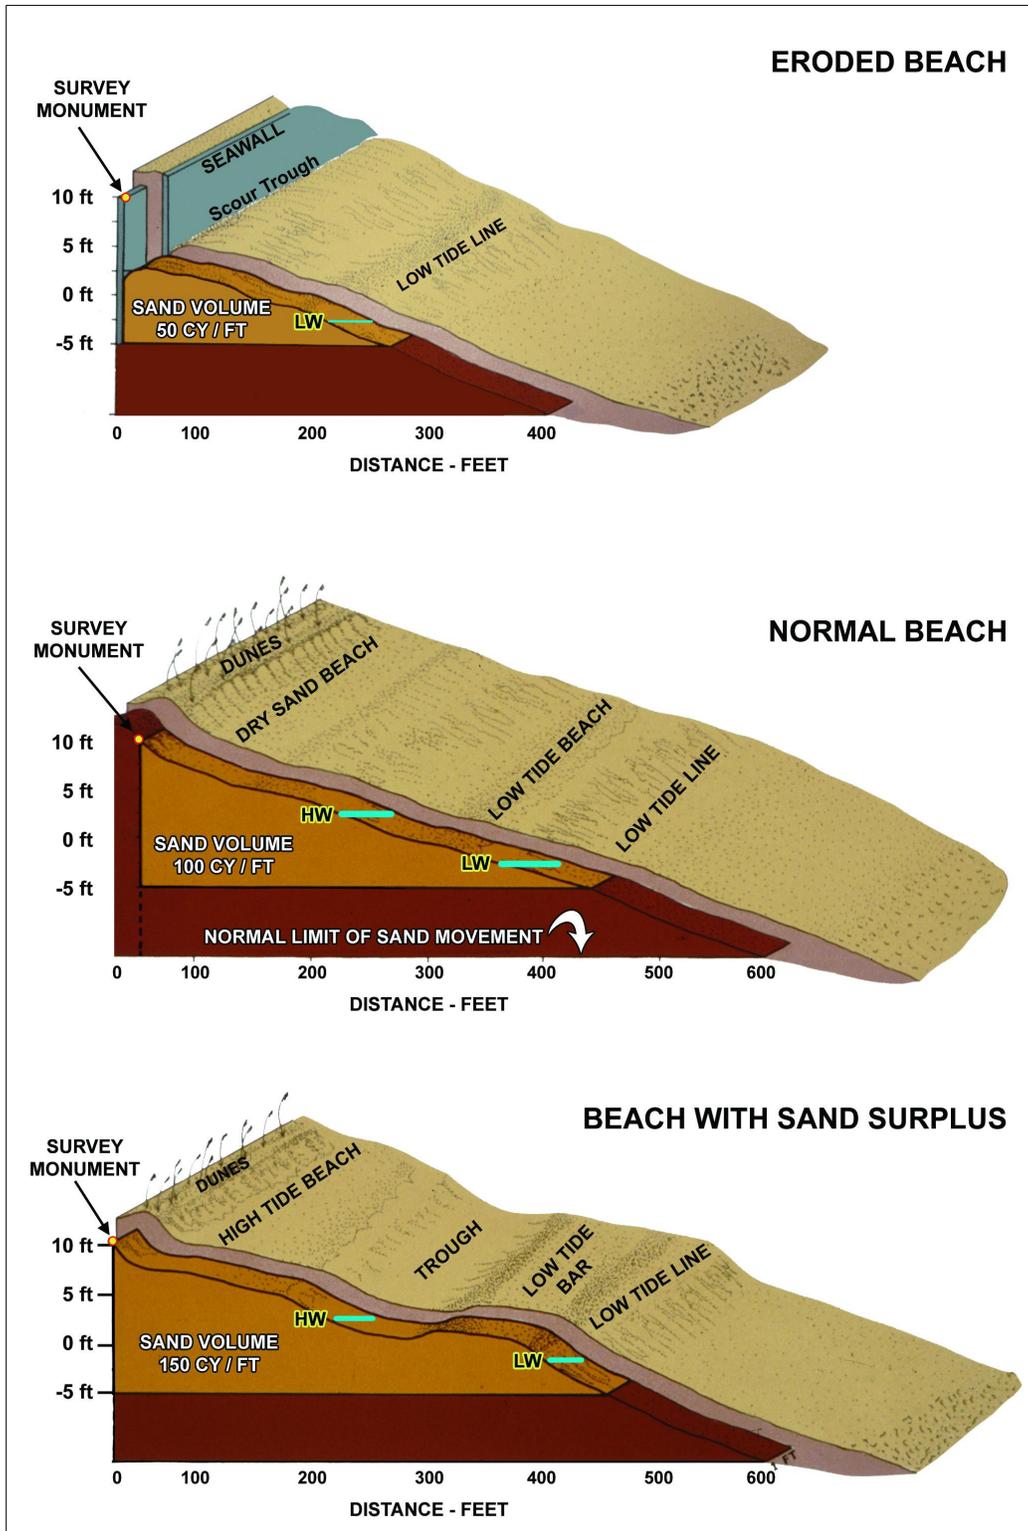
FIGURE 3.4. Illustration of the profile volume concept.

To determine changes in beach volume along Isle of Palms, beach profile data were entered into CSE's in-house custom software, Beach Profile Analysis System (BPAS), which converts 2D profile data in x-z (distance-elevation) format to 3D volumes. The software provides a quantitative and objective way of determining ideal minimum beach profiles and how the sand volume per unit length of shoreline compares with the desired condition. It also provides an accurate method of comparing historical profiles—as the volume method measures sand volumes in the active beach zone rather than extrapolating volumes based on single-contour shoreline position (ie – from aerial photography). Unit-volume calculations can distinguish the quantity of sediment in the dunes, on the dry beach, in the intertidal zone to wading depth, and in the remaining area offshore to the approximate limit of profile change (closure depth).

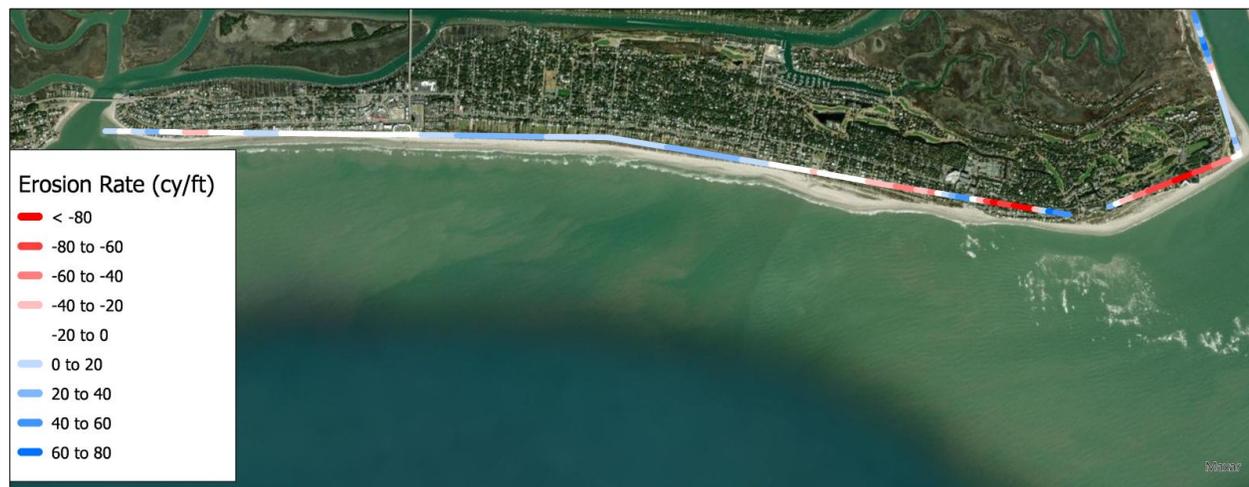
FIGURE 4.1. Line map showing variations in erosion and accretion patterns over Isle of Palms from August 2023 to September 2024. The shoal attachment zone along the eastern third of the island was the most dynamic over the last year. The central portion of the island exhibited a slightly positive beach volume change, while the Breach Inlet portion of the island lost sand at a more moderate pace than has been observed since 2021.

The Isle of Palms lost ~43,200 cy of beach sand from August 2023 to September 2024. Erosion was the most severe along Wild Dunes and Reach 2 (Fig 4.1). Within Wild Dunes, there were variations in volume change due to the onshore migration of a shoal from the Dewees Island system. Accretion downcoast of the project area (south of 53rd Ave) continued as in prior years. Across the entire island, the beach contains ~456,700 cy more sand than the 2017 pre-nourishment condition and ~211,000 cy more sand than in 2009 (Figure 4.3).

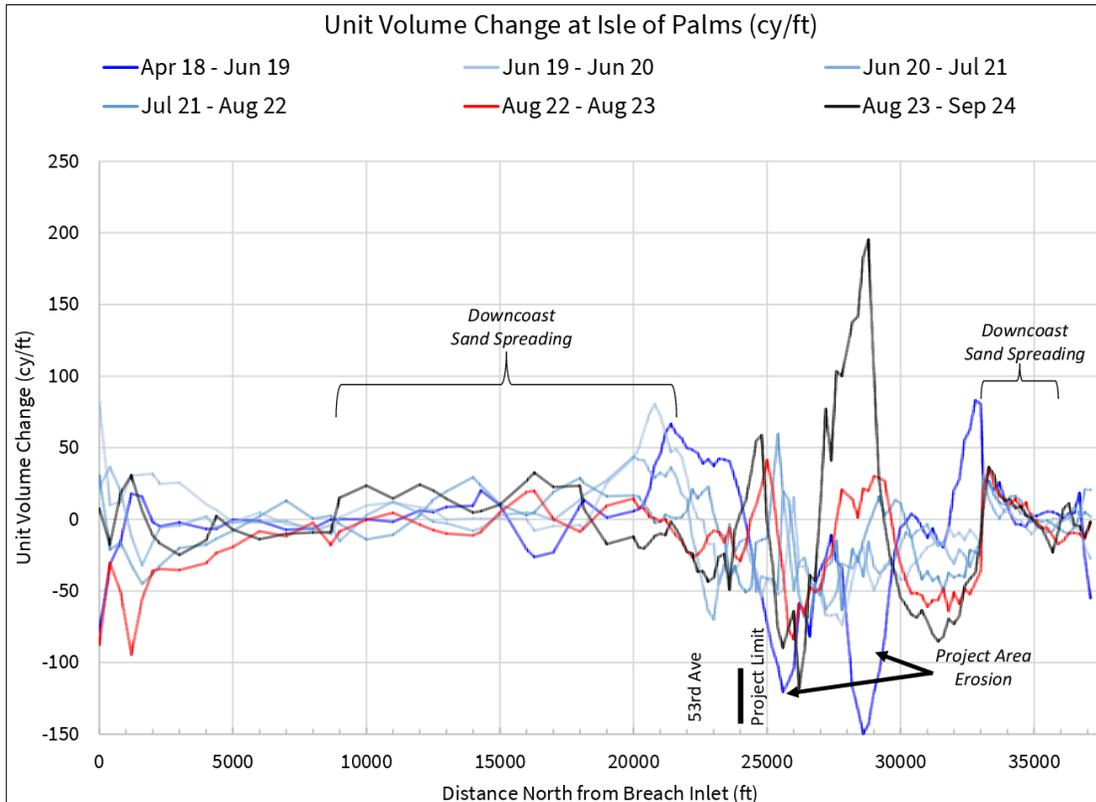
FIGURE 4.2. Beach unit volume change between each monitoring event at Isle of Palms. The X axis represents distance from Breach Inlet. This graph highlights the erosion occurring in the project area and accumulation of spreading sand adjacent to the project area.

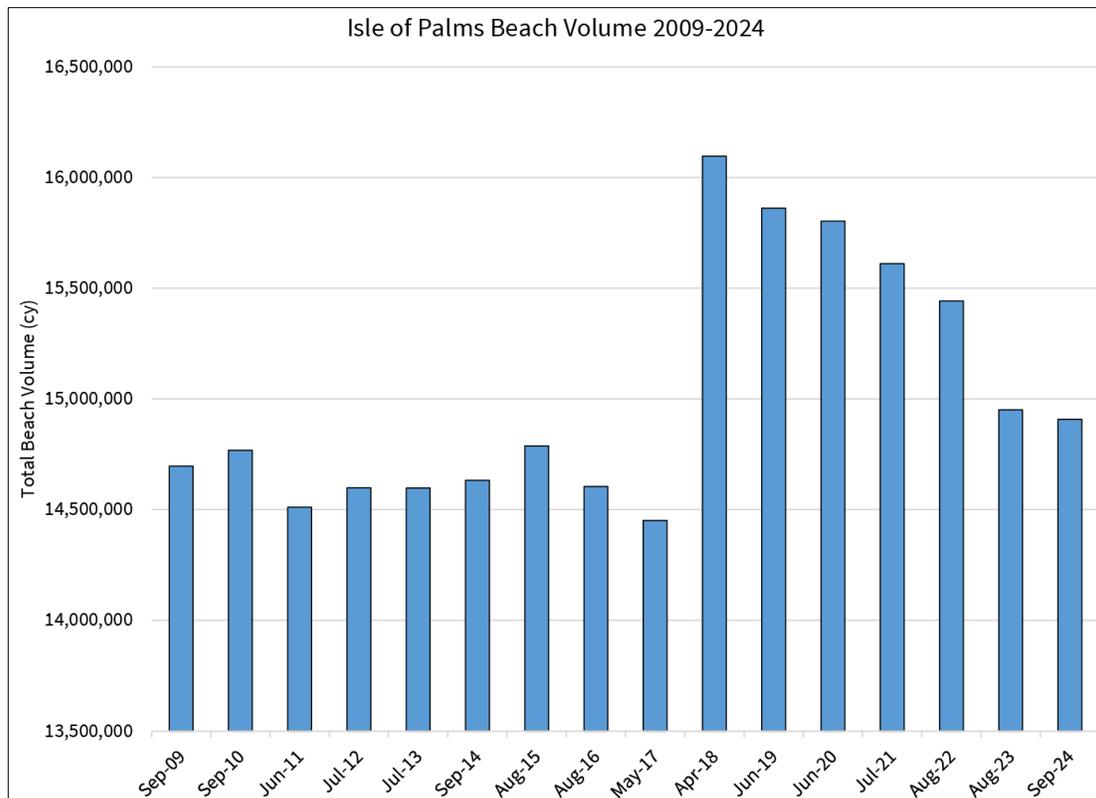
FIGURE 4.3. Total beach volume at Isle of Palms from 2009 to 2024. Effects of the 2018 project are seen in the rapid increase in the April 2018 island-wide beach volume.

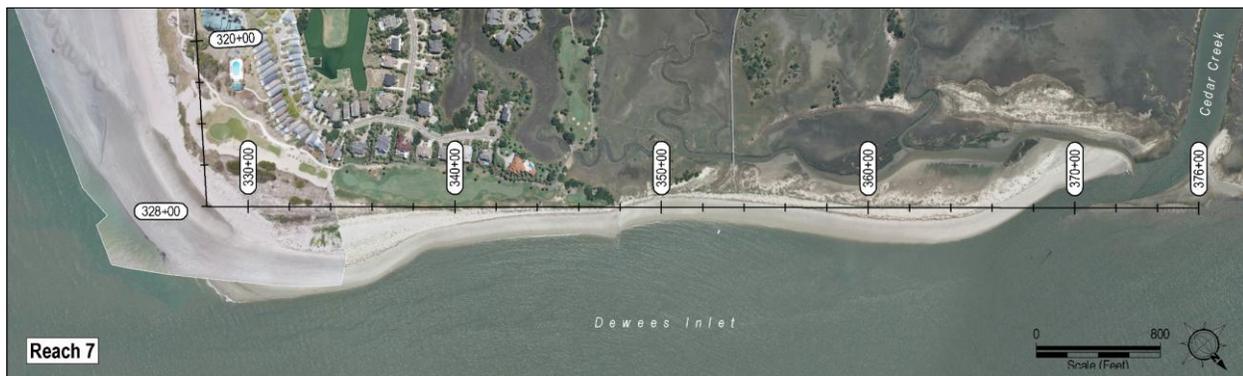
FIGURE 4.4. Baseline stationing along Reach 7 encompassing the length of beach between lines 330 and 370.

Reach 7 encompasses the beach between lines 330 and 370 that span the shoreline fronting the Dewees Inlet channel (Figure 4.4). The inlet shoals shelter this portion of beach from the largest open-water waves, so the profile generally features a narrow, dry sand berm and a steep beach face. The steep beach face reduces the total profile volume needed for a stable profile compared to oceanfront areas. The seaward end of the reach was included in the 2008 nourishment project and has traditionally exhibited relative stability in beach volumes.

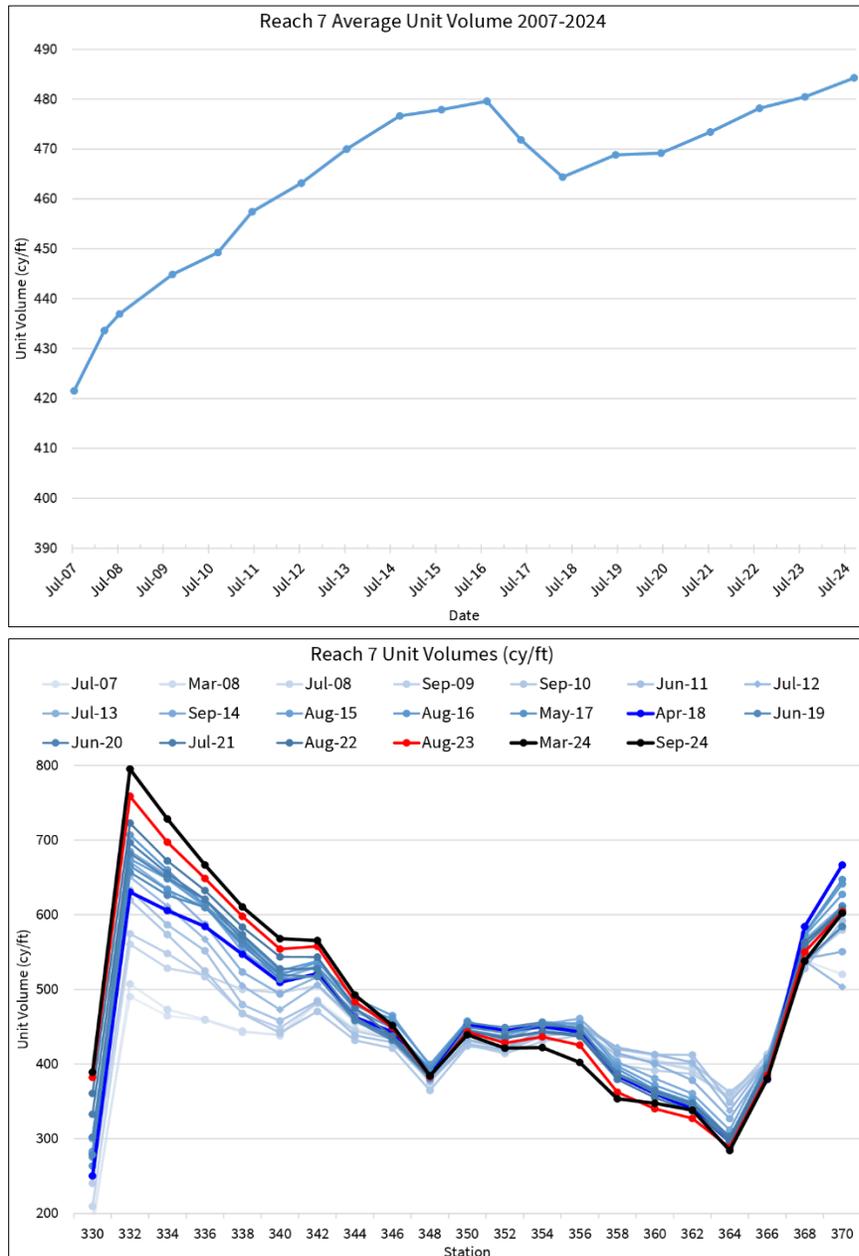
FIGURE 4.5. [UPPER] Average beach volume in Reach 7 since 2007. [LOWER] Profile unit volumes for each monitoring line in Reach 7.

Since 2018, there has been an erosional ‘wave’ moving north and west (inland) along Reach 7. The highest losses along individual profiles have shifted from Station 340 between 2018 and 2019 north and west to Station 360 between 2023 and 2024. Fortunately, these profiles are located along an undeveloped portion of the beach well within Dewees Inlet, such that any minor to moderate chronic erosion – like that observed in the last ~6 years – does not represent a significant threat to life or property.

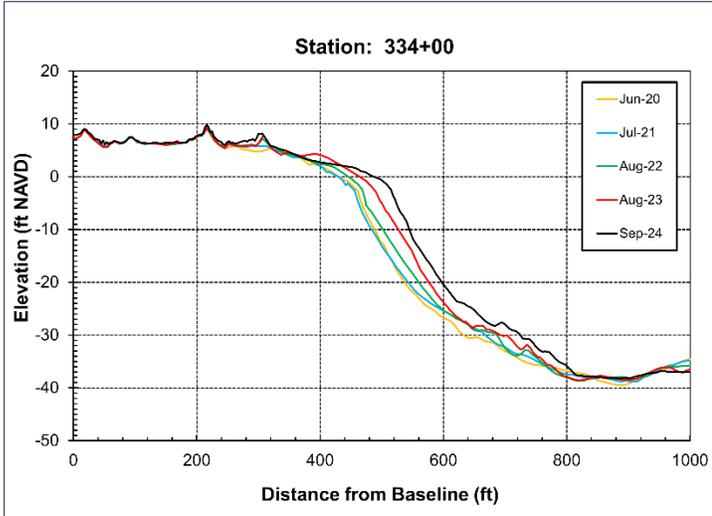
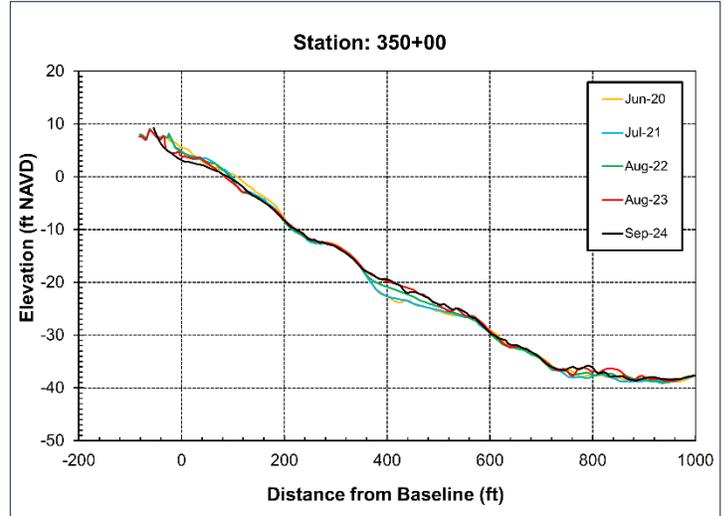
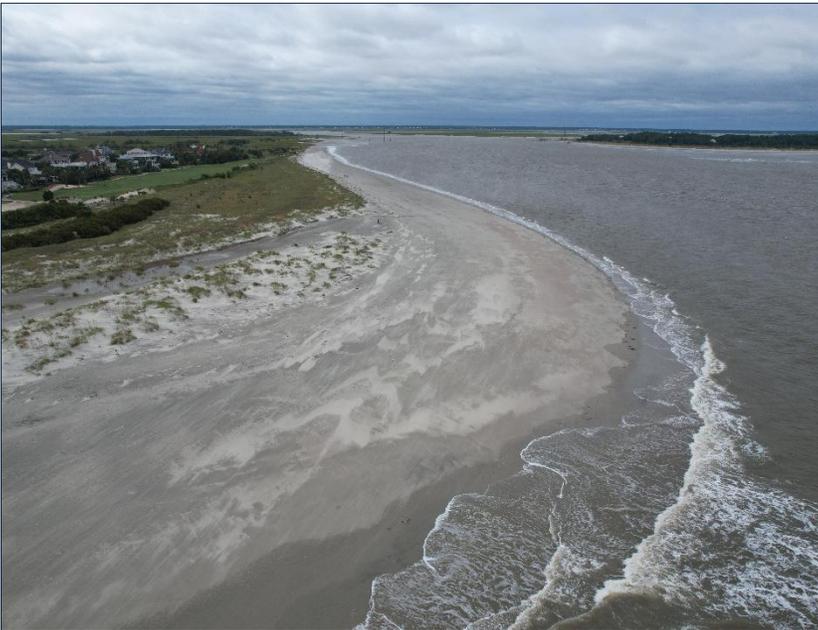
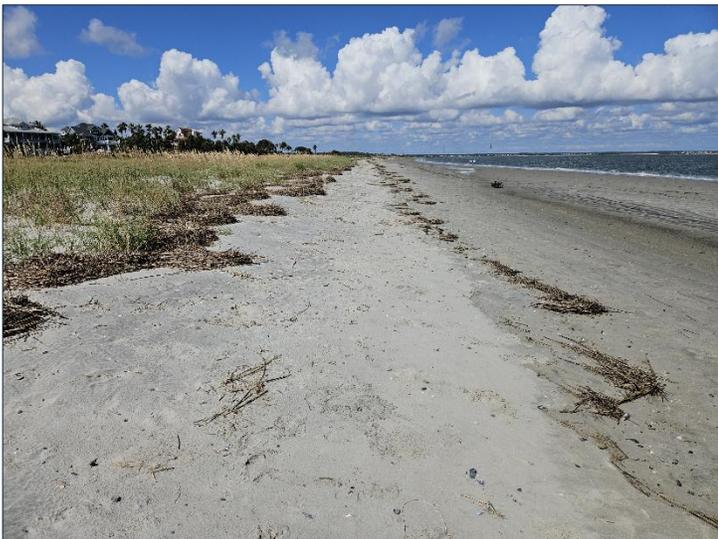
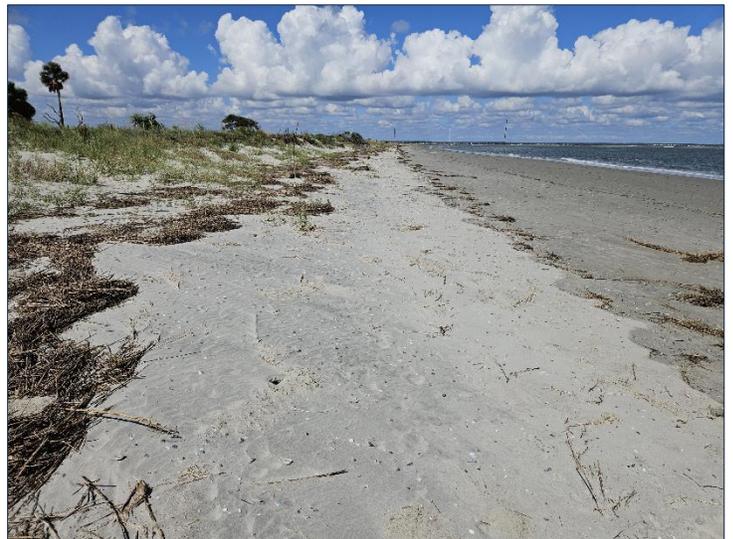
FIGURE 4.6.

Accretion at the seaward end of the reach has led to an increase of over 260 ft of berm width since 2008, including over 150 ft of seaward advance in the high water line since 2018 at Station 334. All stations seaward of the 17th tee (groin) show at least 10 cy/ft more sand than the most eroded condition since 2008 (Fig 4.5). Ground photos from the reach show that the berm is transitioning into a healthy dune field, with no visible escarpments and reduced areas of dry sand as vegetation cover increases. Photos from further inland also show a healthy dry-sand beach with vegetation-covered dunes well landward of the typical high tide line (Fig 4.6).

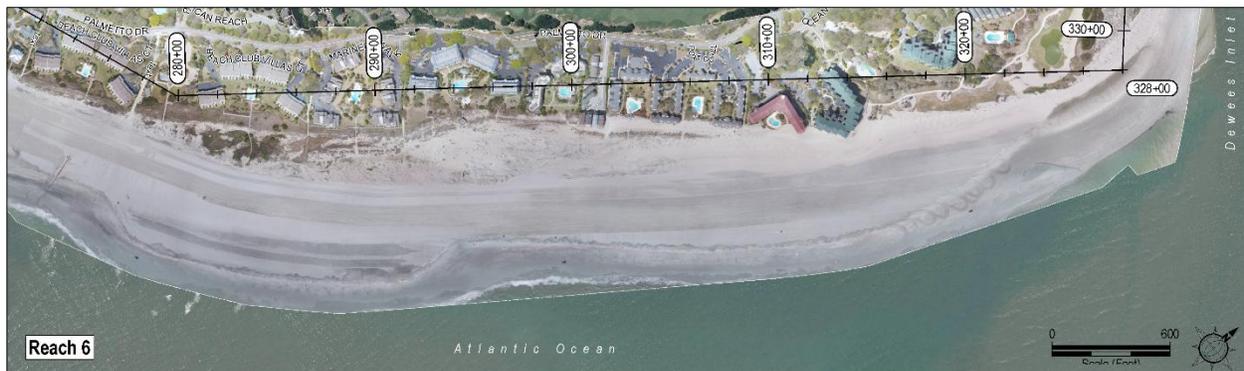
FIGURE 4.7. Baseline stationing along Reach 6 encompassing ~4,900 lf of beach between Wild Dunes Property Owners Beach House and the 18th hole of the Links Course.

Reach 6 encompasses ~4,900 linear feet of beach between the Wild Dunes Property Owners Beach House (Station 280) and the 18th hole of the Links Course (Station 328+00) (Figure 4.7). This area is along the ‘corner’ of the shoreline between Dewees Inlet and the open ocean and is where shoals attach as part of cyclical bypass events from the inlet. Depending on the location and magnitude of the bypass, the shoreline can move hundreds of feet landward or seaward over the course of just a few months (Kana et al 1985, Gaudio 1998).
