**2018 Isle of Palms Restoration Project
Year 6 Monitoring Report**

2024
MONITORING REPORT

Prepared for
City of Isle of Palms
Isle of Palms, South Carolina

2018 Isle of Palms Restoration Project
Year 6 (2024) Monitoring Report
Annual Beach and Inshore Surveys

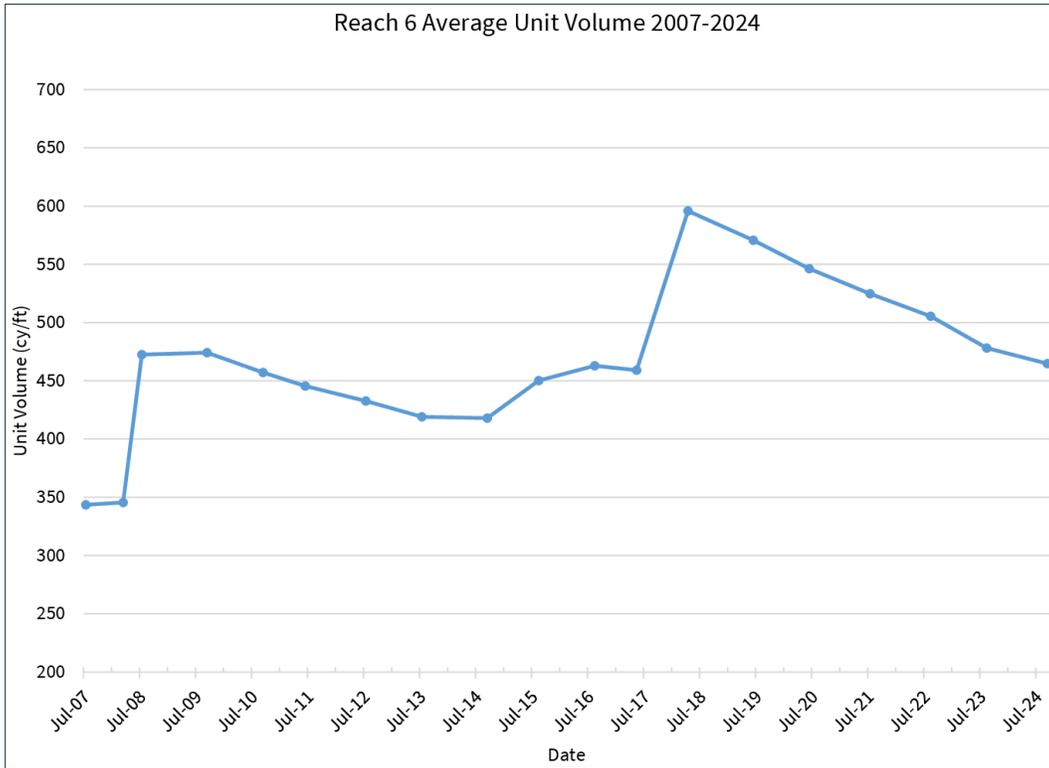
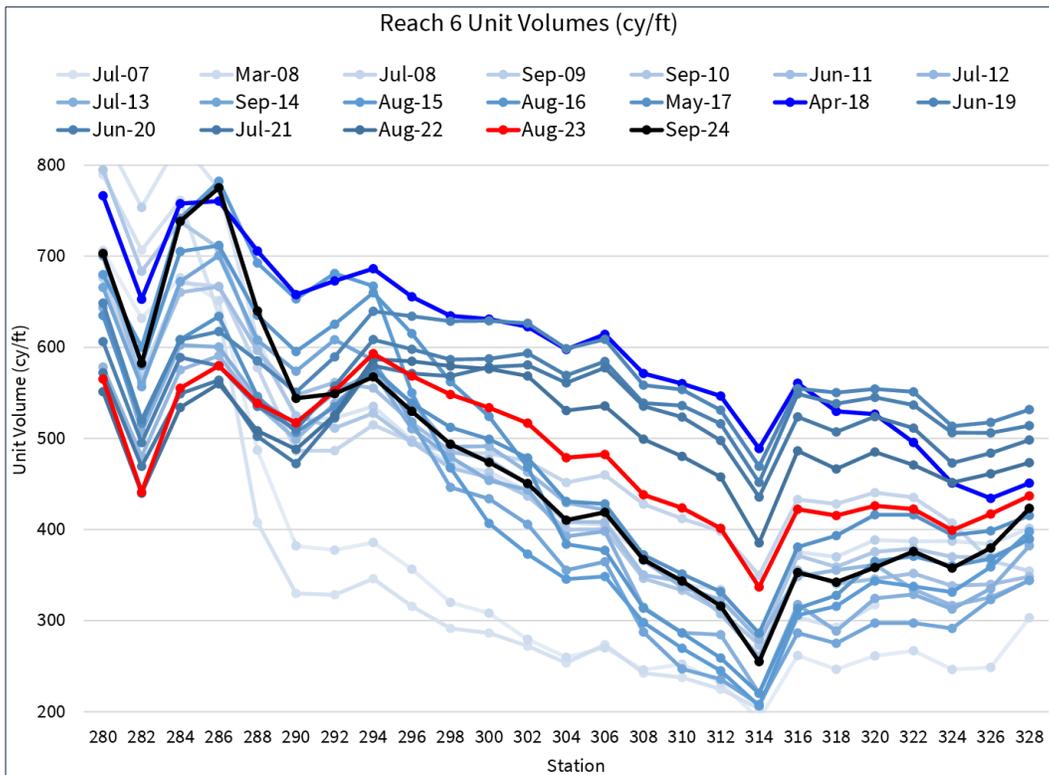
FIGURE 4.8. [UPPER] Average beach volume in Reach 6 since 2007. [LOWER] Profile unit volumes for each monitoring line in Reach 6.

Reach 6 lost 65,150 cy (13.3 cy/ft) of sand from August 2023 to September 2024. This is the lowest loss recorded since May 2017, before the 2018 project. Since completing the 2018 project, Reach 6 has lost ~642,000 cy (131.0 cy/ft). This represents more than 95% of the nourishment volume added in 2018; however, several profiles along the western end of the reach have documented significant volume increases over the post-project period. Stations 280–292 show an average gain of 78.6 cy/ft compared to the pre-project condition, whereas Stations 294–328 show an average loss of 22.5 cy/ft of sand compared to pre-nourishment conditions.

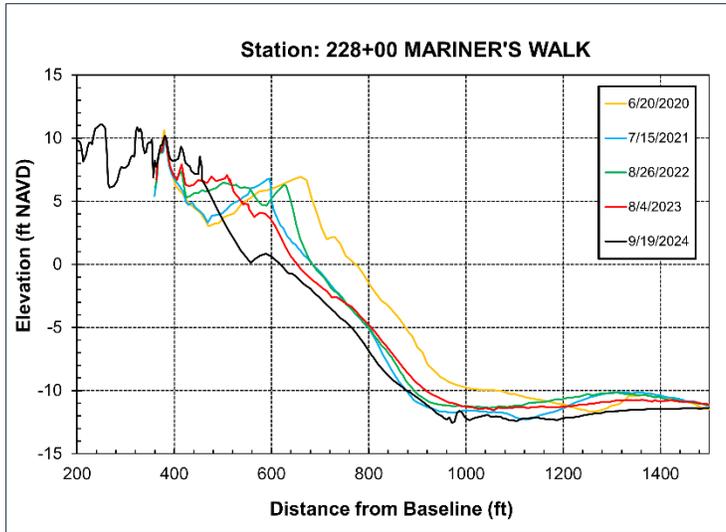
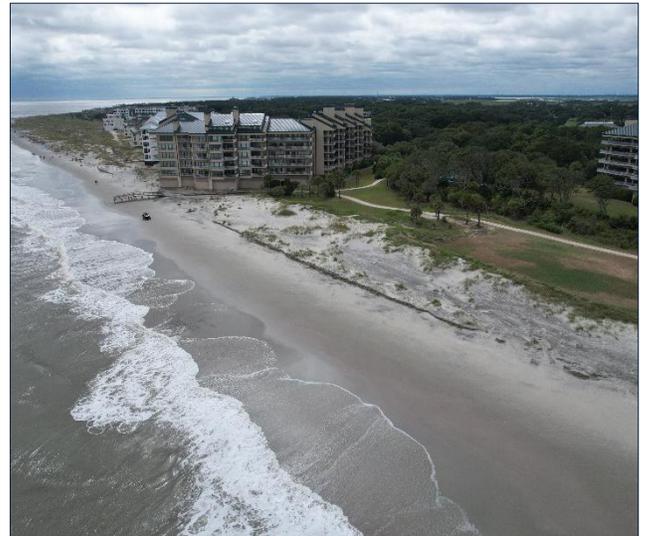
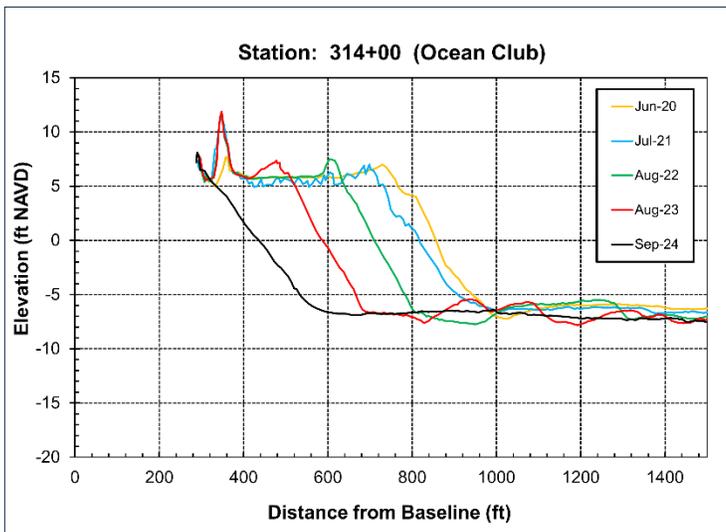
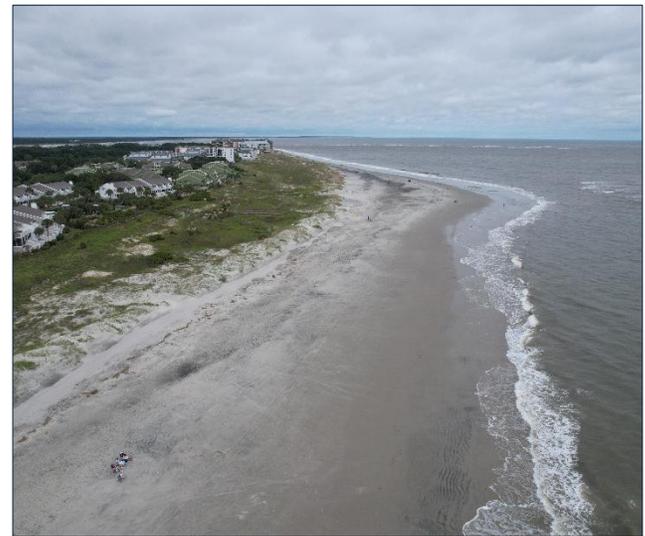
FIGURE 4.9. [LEFT] Reach 6 profiles. The rapid erosion in this area is suspected to be a continuation of the higher erosion trend observed prior to the 2018 project. **[RIGHT]** Aerial photos collected in September 2024.

Aerial and ground photos of the reach taken in September 2024 document the recent variability in beach and dune volumes (Figs 4.9 and 4.10). Whereas the western portion of the reach contains relatively healthy and continuous vegetation along the upper dry-sand beach and dunes, cover along the eastern portions of the reach is sparse to nonexistent. Around the Ocean Club, there is little-to-no dry-sand beach protecting structures.

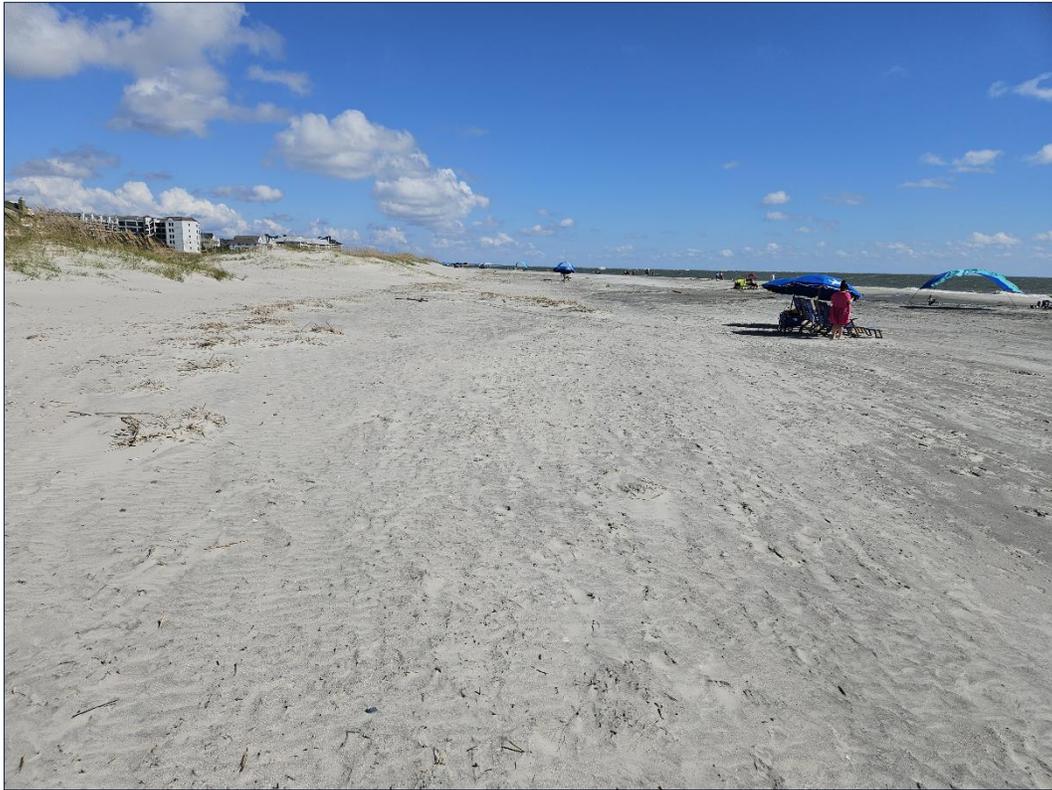
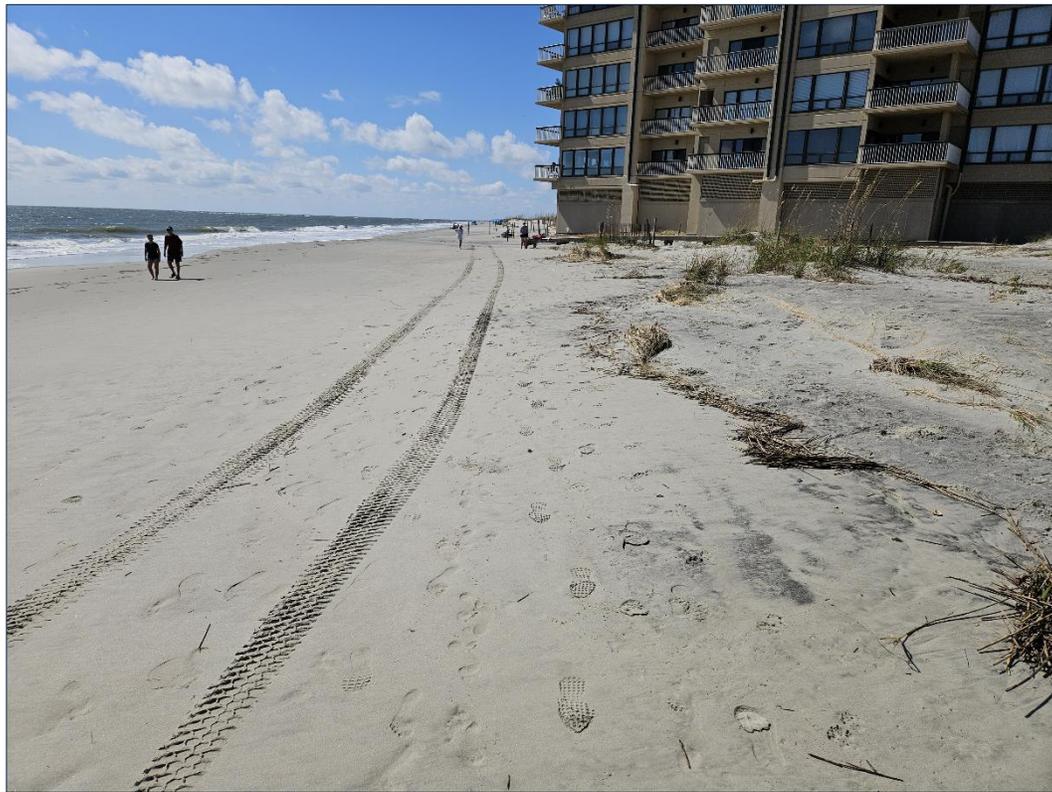
FIGURE 4.10. Ground photos from Station 284 [UPPER] and Station 316 [LOWER] in September 2024.

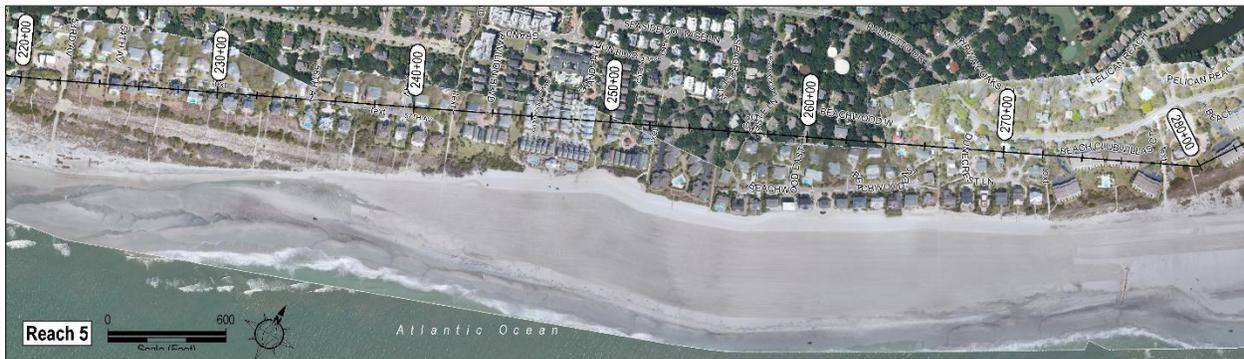
FIGURE 4.11. Baseline stationing along Reach 5 which spans ~5,800 lf of beach between 53rd Avenue and Wild Dunes Property Owners Beach House.

Reach 5 includes ~5,800 lf of beach between 53rd Avenue and the Wild Dunes Property Owners Beach House (Stations 222–280 – Figure 4.11). The central and eastern portions of Reach 5 are strongly influenced by shoal-bypass events, much like Reach 6. An important difference between Reaches 5 and 6, however, is that because the shoals tend to attach along Reach 6, Reach 5 tends to experience the waves of erosion and accretion during and after shoal bypass events: while Reach 6 has experienced accretion as well as erosion over the years, Reach 5 tends to exhibit more erosion over the long term.

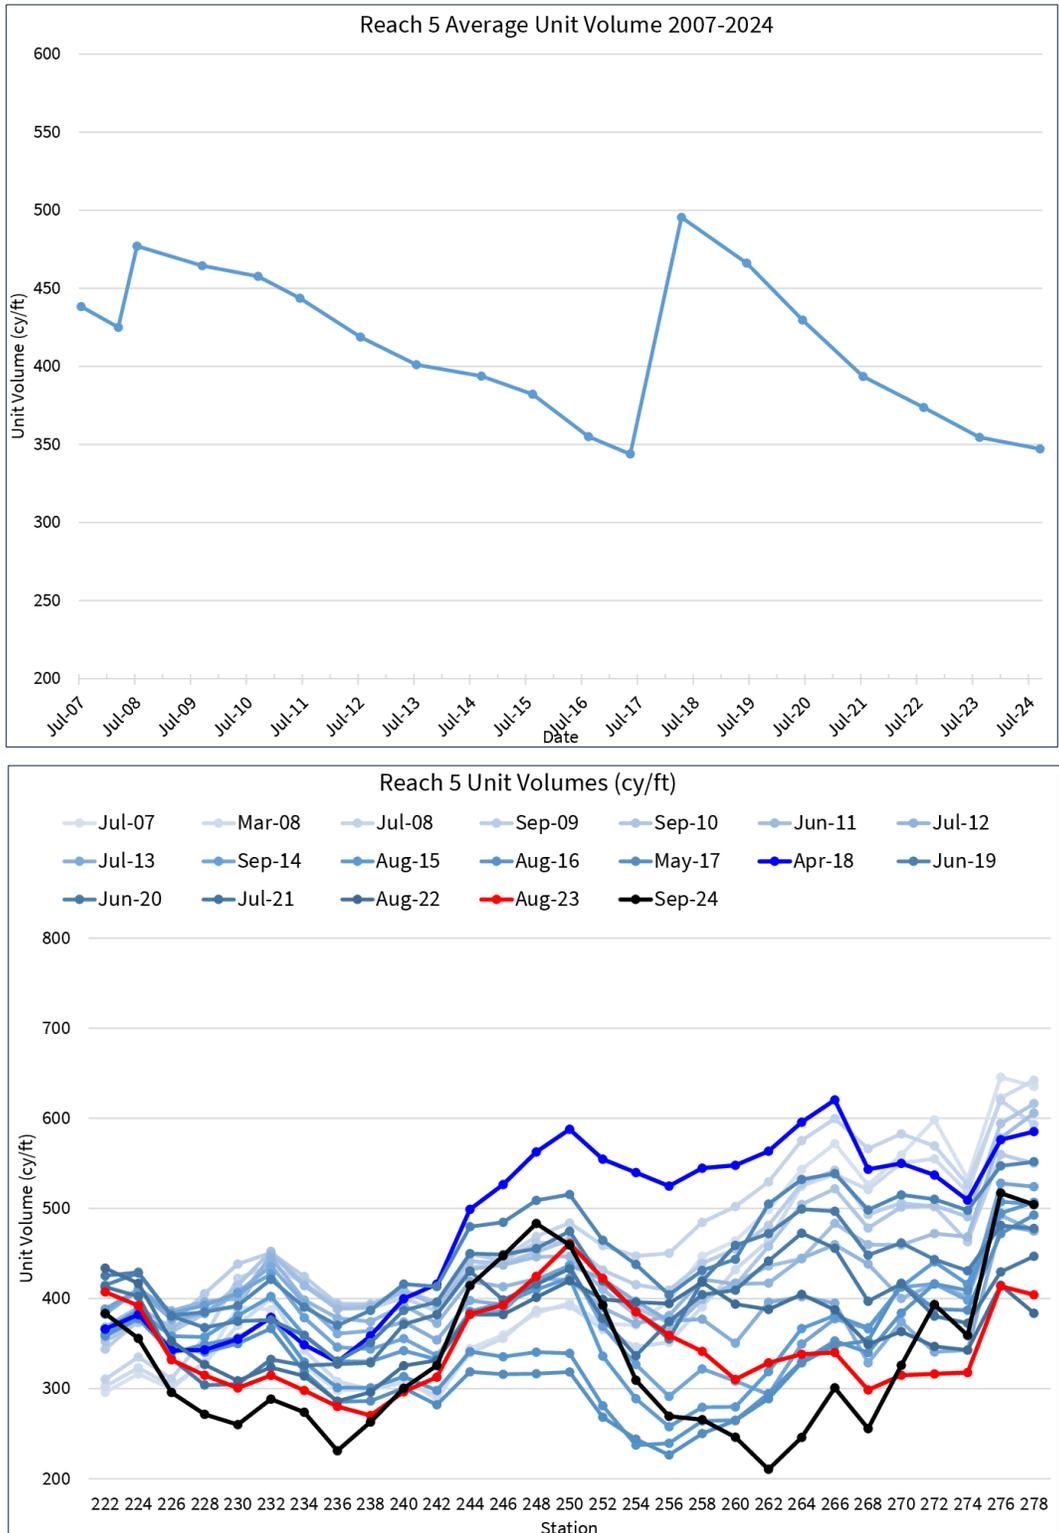
FIGURE 4.12. [UPPER] Average beach volume in Reach 5 since 2007. [LOWER] Profile unit volumes for each monitoring line in Reach 5.

Losses measured since the 2018 project have been particularly high along Beachwood East, especially across approximately 1,000 ft of shoreline. Such changes in beach conditions along isolated areas are known as ‘hot spots’ and can be driven by variations in nearshore bathymetry (Kraus and Galgano 2001). As shoals move ashore on the east end of Reach 5 and at the Wild Dunes Grand Pavilion, the gap along Beachwood allows higher waves to pass through. This leads to concentrated wave energy along relatively short lengths of beach. Based on anecdotal observations of the ongoing shoal bypass event along Reaches 5 and 6, it is probable that such a change in wave energy along the Reach has driven the recent dramatic erosion along Beachwood East.

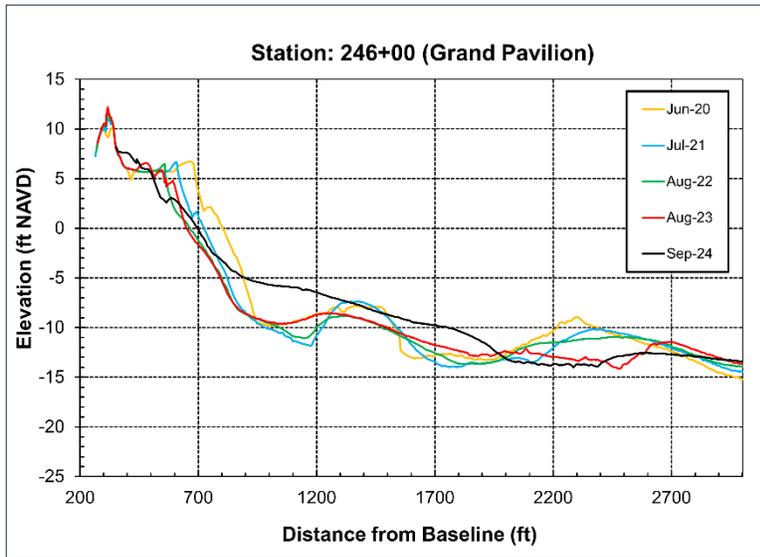
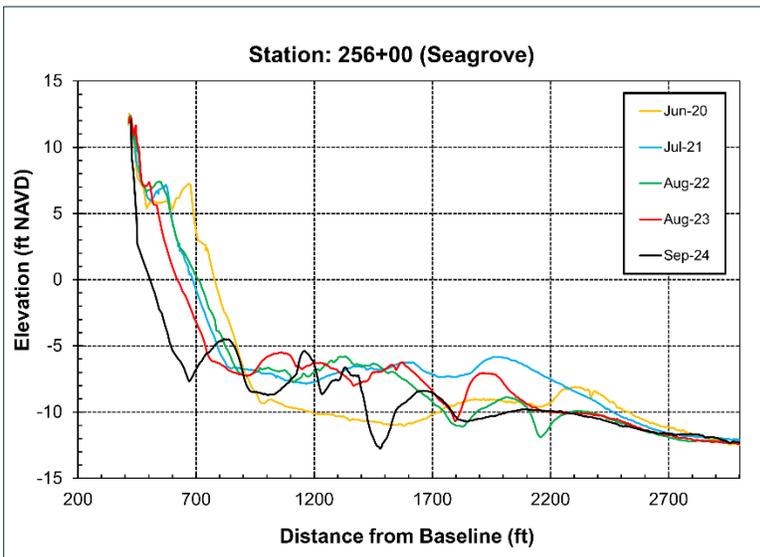
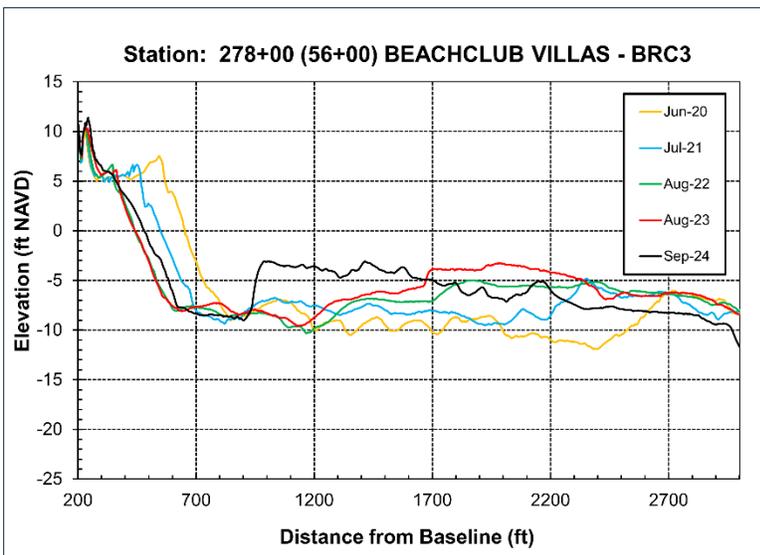
FIGURE 4.13. Reach 5 profiles.

While the magnitude of the erosion is high, beach conditions along much of the Wild Dunes area remain similar to or better than before the 2018 project. Erosion has occurred along the central portion of Wild Dunes, and much of the shoreline along Reaches 5 and 6 retains at least 100 ft more beach width than the 2017 condition (Fig 4.15). Notable exceptions to this trend are near the 59th Avenue access, Beachwood East, and Ocean Club. As the ongoing shoal bypass event continues and sand begins spreading laterally, some of the recent losses along these areas should begin to reverse, and some accretion – albeit temporary – is anticipated.

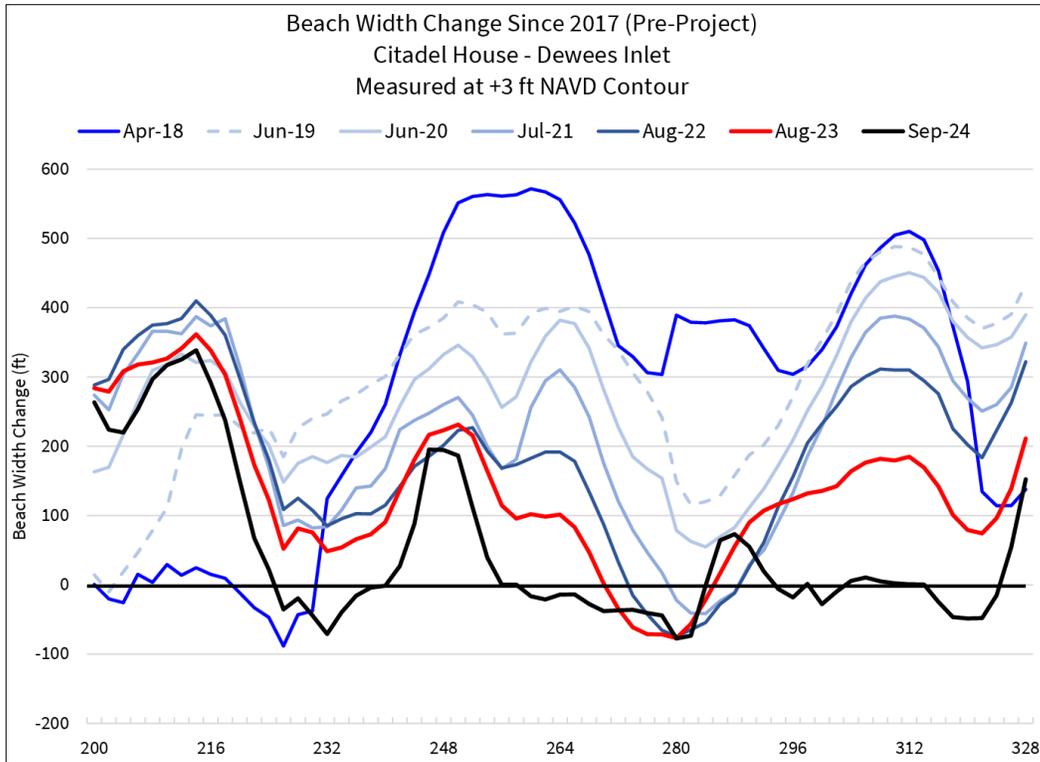
FIGURE 4.15a. Beach width changes along the area spanning the Citadel House to the 18th hole of the Links Course. Note the greater losses around Stations 230 (55th Ave) and 270–280 (Beachwood). Also, note the extensive accretion present south of the 2018 project area (left side of the image from Stations 200–230).

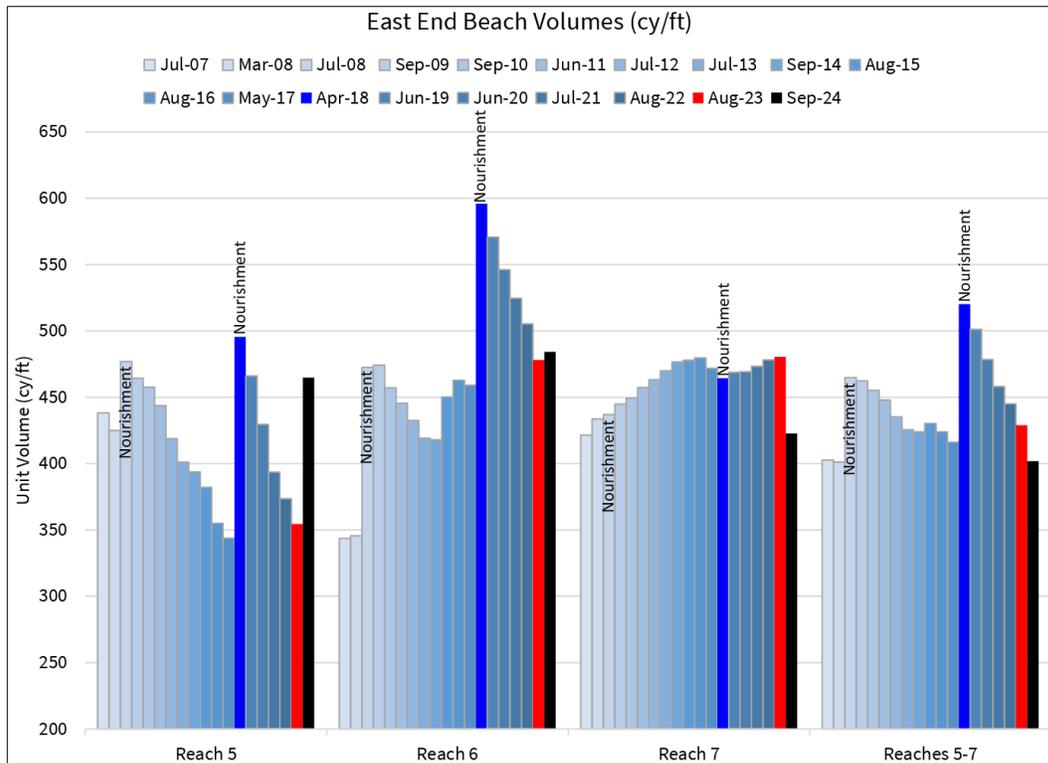
FIGURE 4.15b. The beach volume history of the eastern end of the island since 2007, with dates following nourishment indicated.

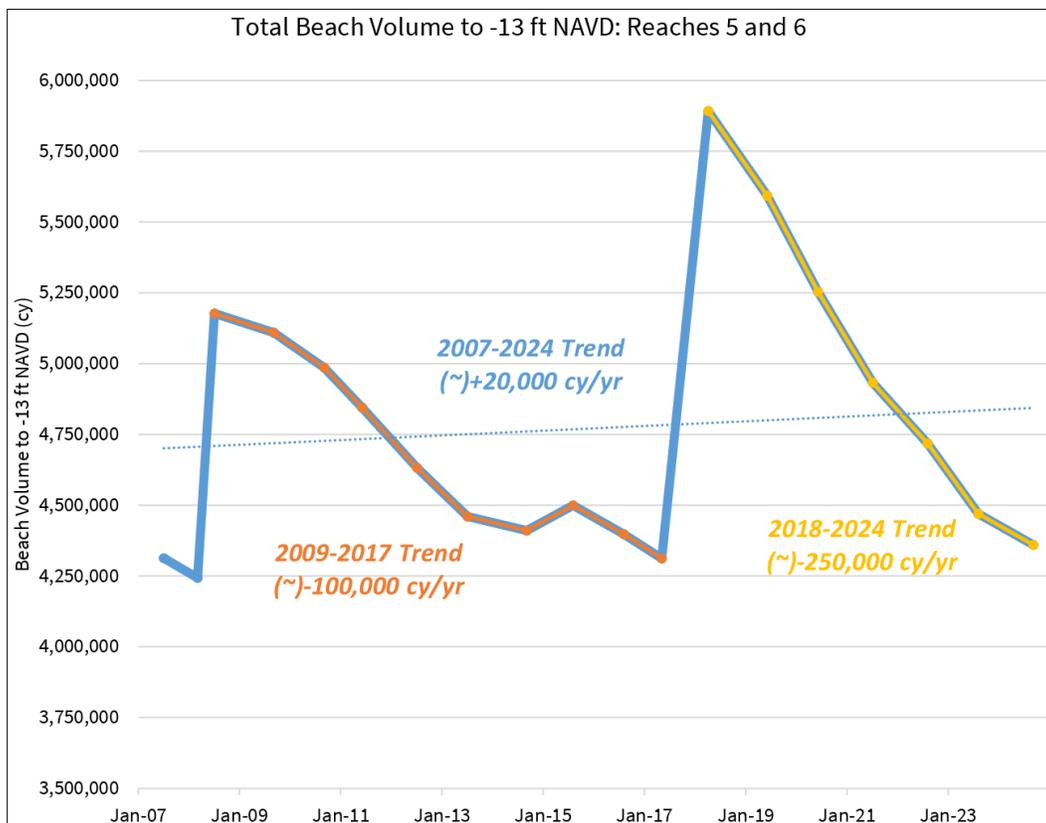
FIGURE 4.16. Total beach volume history of the eastern end of the island since 2007. The graph illustrates the overall erosional trend along reaches 5 and 6 between nourishment projects.

Annualized erosion rates from 2018 through 2024 are 150% higher than those observed in the preceding decade (see Fig 4.16). It is likely this increased erosion is due to the relatively high number of impactful storms (both tropical and non-tropical) the Charleston area has experienced since 2016, as well as increased water levels due to ongoing sea level rise. CSE has observed similar increases in year-to-year erosion rates along several beaches across South Carolina and is closely tracking these changes as they affect the projected lifetimes of nourishment projects and related funding cycles in local communities.

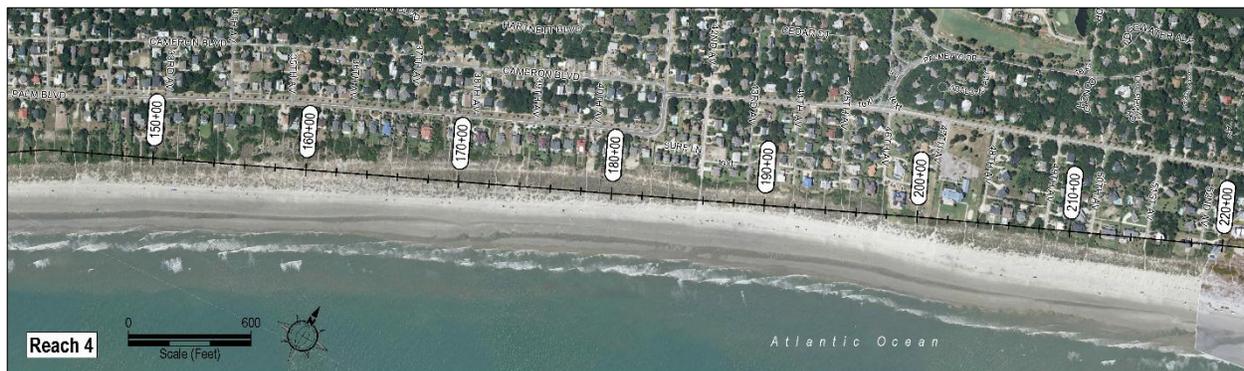
FIGURE 4.17. Baseline stationing along Reach 4 spanning the length of beach between 31st Ave and 53rd Ave.

Reach 4 includes the length of beach between 31st and 53rd Avenues (Stations OCRM 3140 to CSE 222+00 – Fig 4.17 and Fig 4.18). This reach is ~7,910 ft long and immediately downdrift of the 2008 and 2018 project area. It is also outside Dewees Inlet's direct influence and maintains a more typical and consistent beach profile shape. By being positioned downdrift of the nourishment area, it receives nourishment sand spreading from the placement area as well as spreading shoal sand. The reach has gained sand every year since 2009 except for 2016, the year after Hurricane *Matthew* impacted the Isle of Palms.

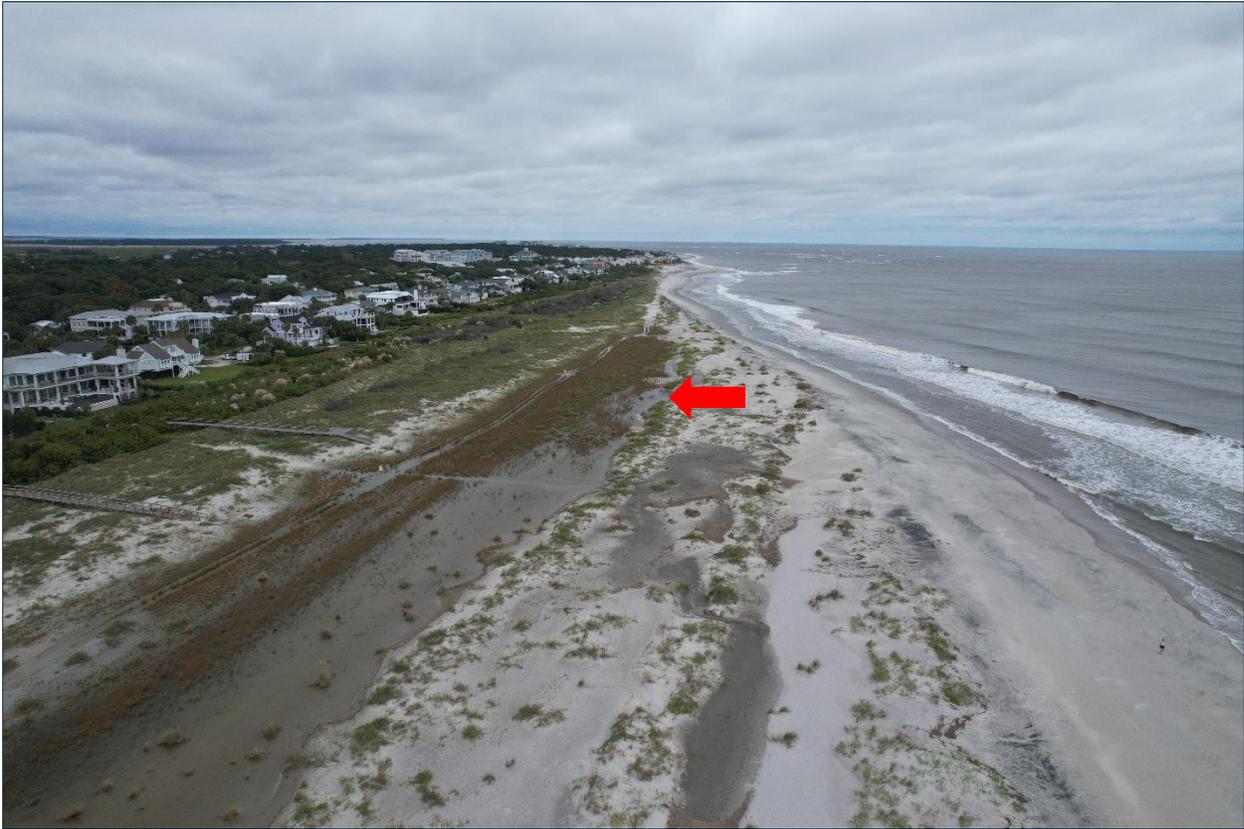
FIGURE 4.18. September 2024 aerial photo of Reach 4 (53rd Avenue is at the middle of the image). By being positioned downdrift of the nourishment area, Reach 4 receives nourishment sand spreading from the placement area as well as spreading shoal sand. This reach has gained sand every year since 2009 except 2016. As the vegetated dunes expand, sheltered locations (such as low-lying areas behind protective dune ridges) will gradually transform into a shrub habitat with larger areas of wax myrtle replacing dune grasses. The 2008 dune line is shown by the red arrow.

The reach receives sand eroded from the island's east end, particularly reaches 5 and 6, with that sand originating from shoal bypass events or nourishment. A significant influx of sand has been observed along the reach since the 2018 project, with an accretional wave propagating south. The leading edge of the spreading sand is visible as a span of high accretion relative to adjacent areas. Over time, the magnitude of the accretion wave decreases as sand spreads at uneven rates. The peak in accretion along individual profiles reached ~70 to 80 cy/ft between Stations 214 and 208 (in 2019 and 2020, respectively), but has subsided to ~20 to 30 cy/ft between Stations 180 and 150 (in 2023 and 2024, respectively). Accretion has led to the creation of a new dune ridge and wide dry-sand beach along the reach (Fig 4.19).

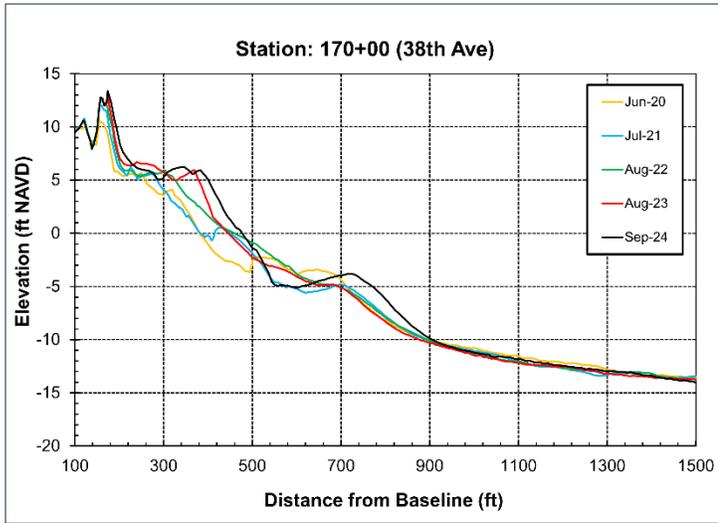
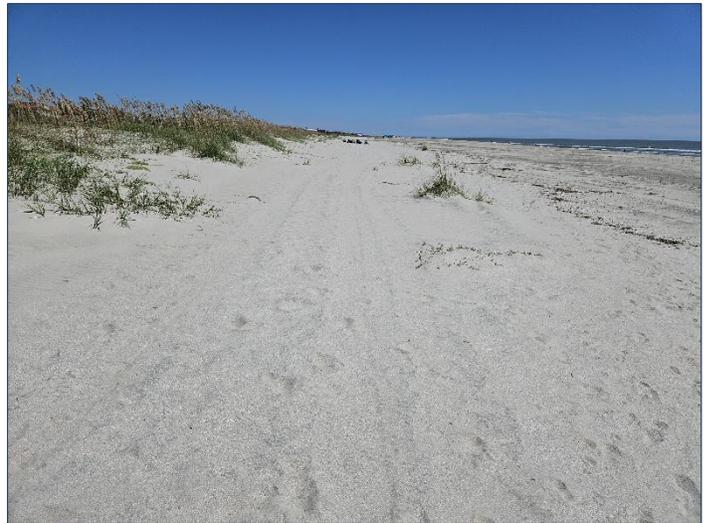
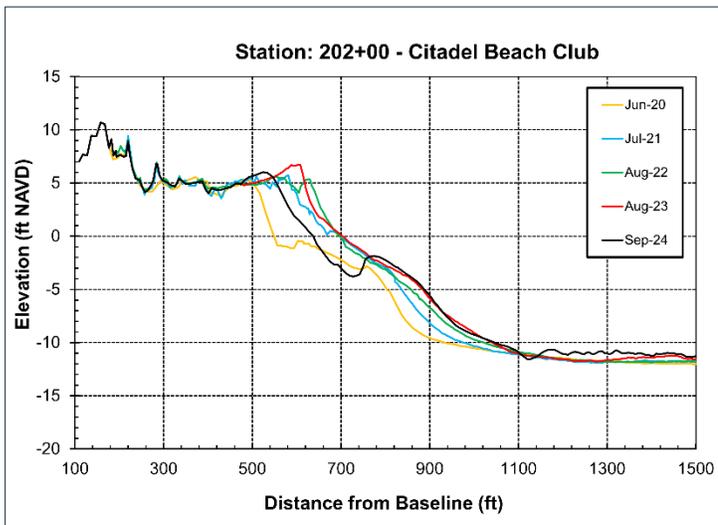
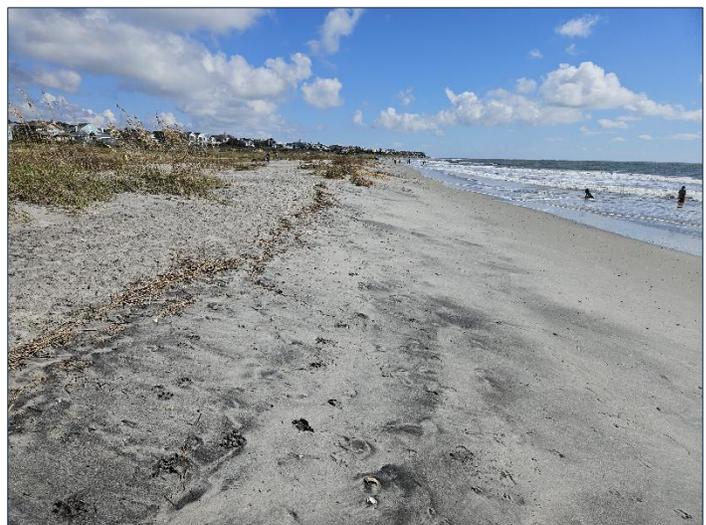
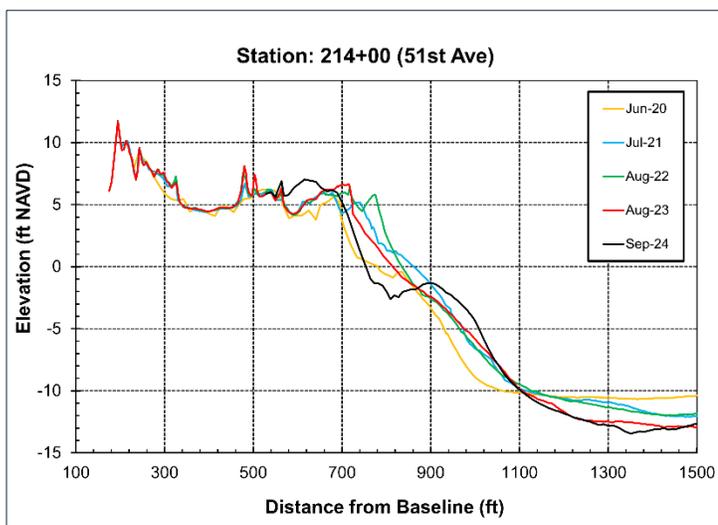
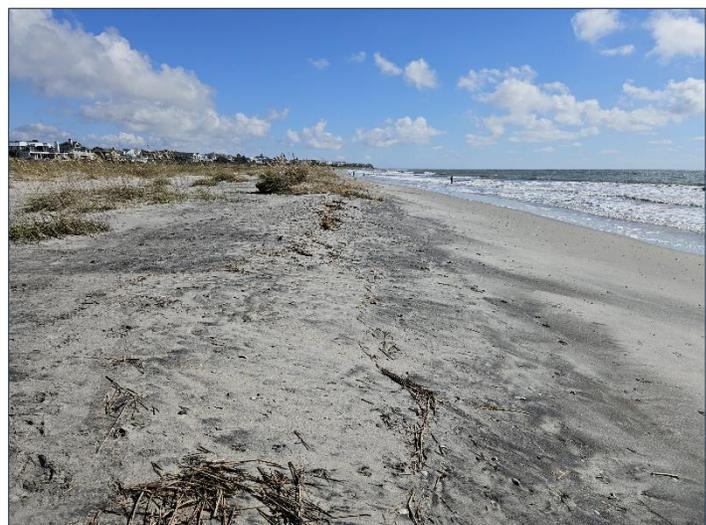
FIGURE 4.19. [LEFT] Profiles along Reach 4 show accretion has led to gains of over 300 ft of dry sand width and formation of new dune ridges. [RIGHT] Ground photos from Station 170 [UPPER], Station 202 [MIDDLE], and Station 214 [LOWER] in September 2024.

Reach 4 has gained 945,200 cy (+119.5 cy/ft) since 2009 and 554,400 cy (+70.1 cy/ft) since 2017. Individual profiles show the dune width has increased by at least 50 ft along the reach, and the dry-sand beach by at least another 50 ft. Along the northern end of the reach, the beach is over 250 ft wider than the 2009 condition, with unit volume gains of over 155 cy/ft. This level of accretion is of similar magnitude to many large beach nourishment projects conducted along coastal communities in South Carolina and is equivalent to a \$10–15 million nourishment investment. The dune has grown ~3–5 ft in elevation and offers substantially more storm protection than the 2009 condition.

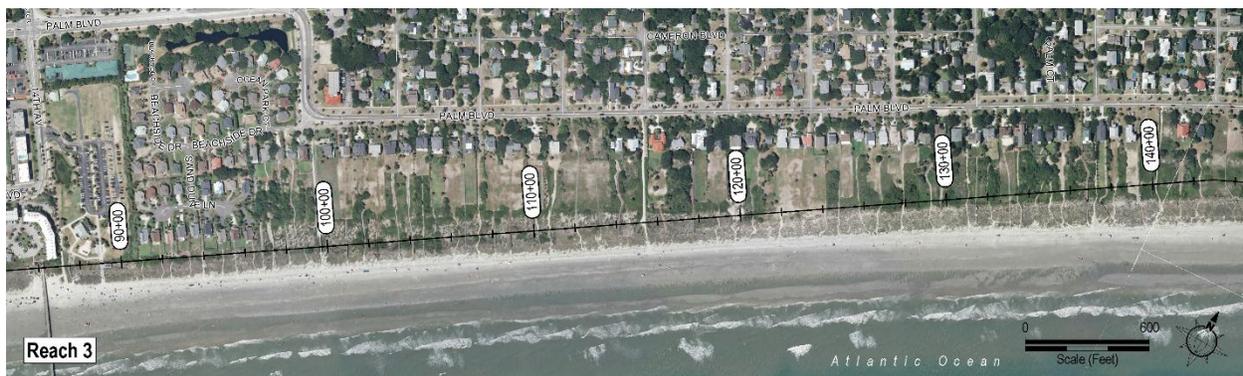
FIGURE 4.20. Baseline stationing along Reach 3 spanning the length of beach from the Sea Cabins Pier to 31st Ave.

Reach 3 extends from the Sea Cabins Pier to 31st Avenue (OCRM monuments 3125 to 3140 – Fig 4.20 and Fig 4.21). Like Reach 4, the long-term trend in this area is stable to accretional. Dwellings in the reach are well set back from the beach, generally between 400 ft and 500 ft, except at the western end where Sand Dune Lane and the county park are set back ~150 ft. The reach has shown periods of erosion and accretion since CSE began island-wide monitoring in 2009. This is typical for stable to moderately accretional beaches as variations in wave conditions from year to year and temporary changes in sediment supply lead to minor fluctuations in yearly volume change.

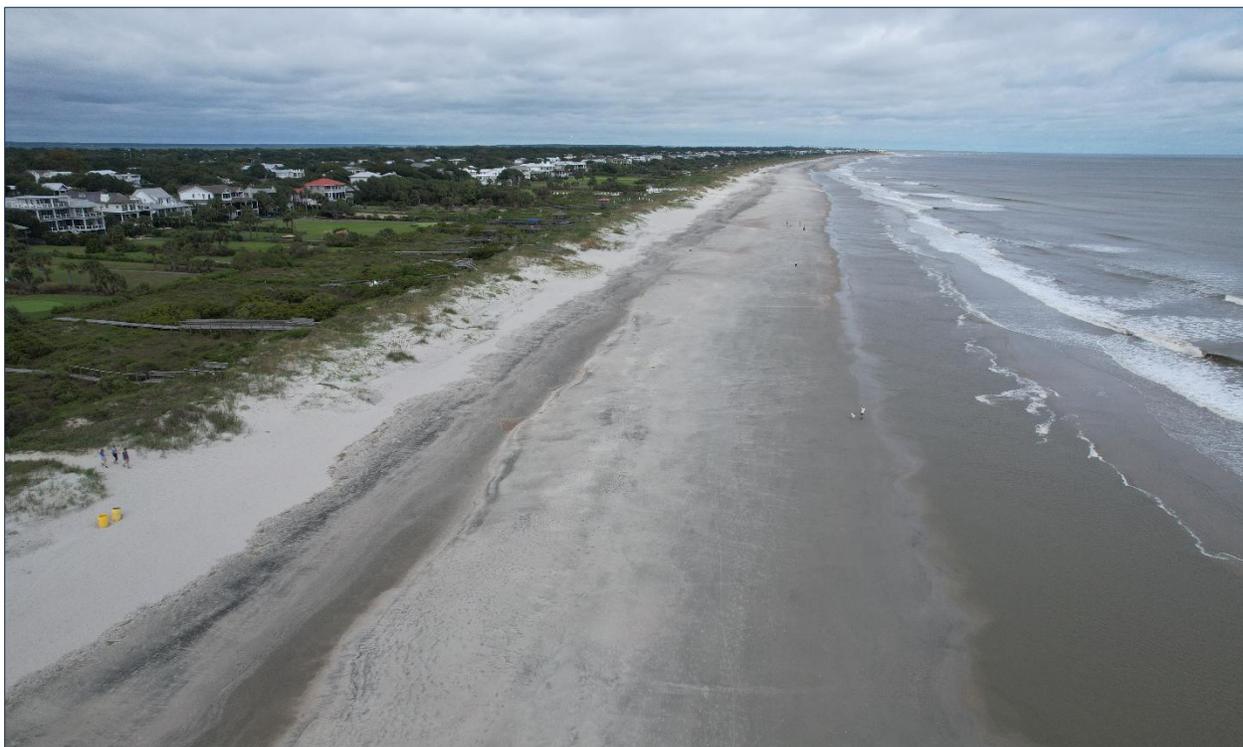
FIGURE 4.21. Aerial photo of Reach 3 in September 2024 (24th Ave in the foreground). The long-term trend for Reach 3 is stable to accretional. Dwellings in the reach are generally set back from the beach between 400 ft and 500 ft.

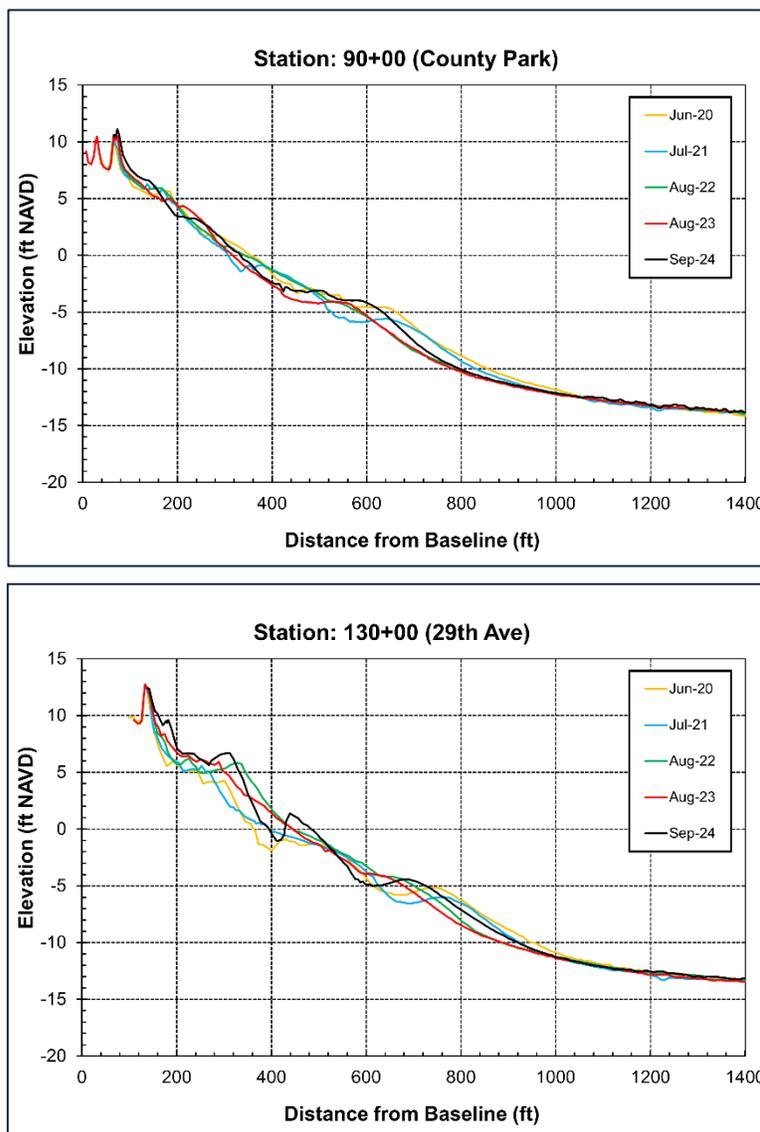
FIGURE 4.22. Example profiles from Reach 3. At Station 90+00, there was a net loss of volume due to movement of the underwater sandbar. The dry beach remained stable over the past year.

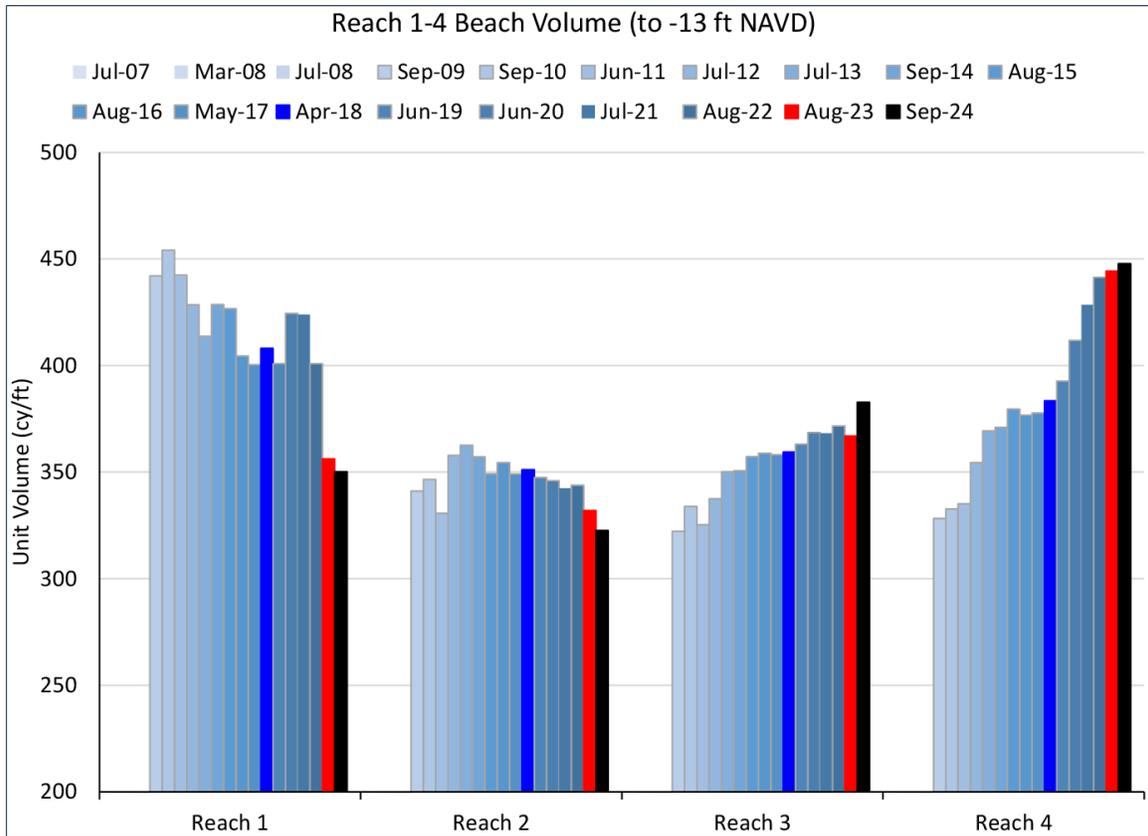
FIGURE 4.23. Reaches 3 and 4 have steadily gained sand since 2007, while Reaches 1 and 2 have experienced more erosion over the last 2–3 years relative to the long-term trends. This recent shift towards erosion in Reaches 1 and 2 is related to the dynamics of Breach Inlet and is addressed later in the report.

Year-to-year changes in unit volumes along Reach 2 (Figure 4.23) highlight general trends of accretion and erosion over the past decade. Volume increases and/or relative stability tended to dominate from 2007 through the August 2016 survey. From August 2016 through April 2018, changes varied between relatively minor accretion and erosion. However, from 2018 through 2024, erosion has set in and has gradually increased such that the losses observed from August 2022 to August 2023 and August 2023 through September 2024 have both (individually) represented the greatest year-to-year erosion in over a decade. Between August 2023 and September 2024, the Reach lost 39,750 cy (–9.3 cy/yr).

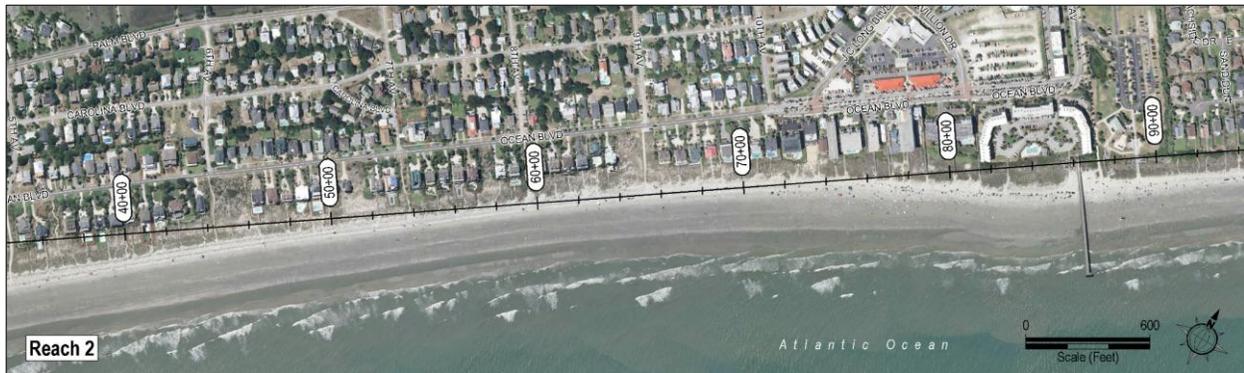
FIGURE 4.24. Baseline stationing along Reach 2 spanning between 6th Avenue and the Sea Cabins Pier.

Reach 2 spans 4,280 ft between 6th Avenue and the Sea Cabins Pier (OCRM monuments 3115–2125 – Fig 4.24 and Fig 4.25). It includes the oceanfront commercial area at the eastern end of the reach. Reach 2 shows an erosion/accretion pattern like Reach 3, with intermittent periods of accretion and erosion and a long-term trend towards accretion. Since monitoring began in 2009, Reach 2 has been the most stable reach, with lower magnitude volume changes than all other reaches.

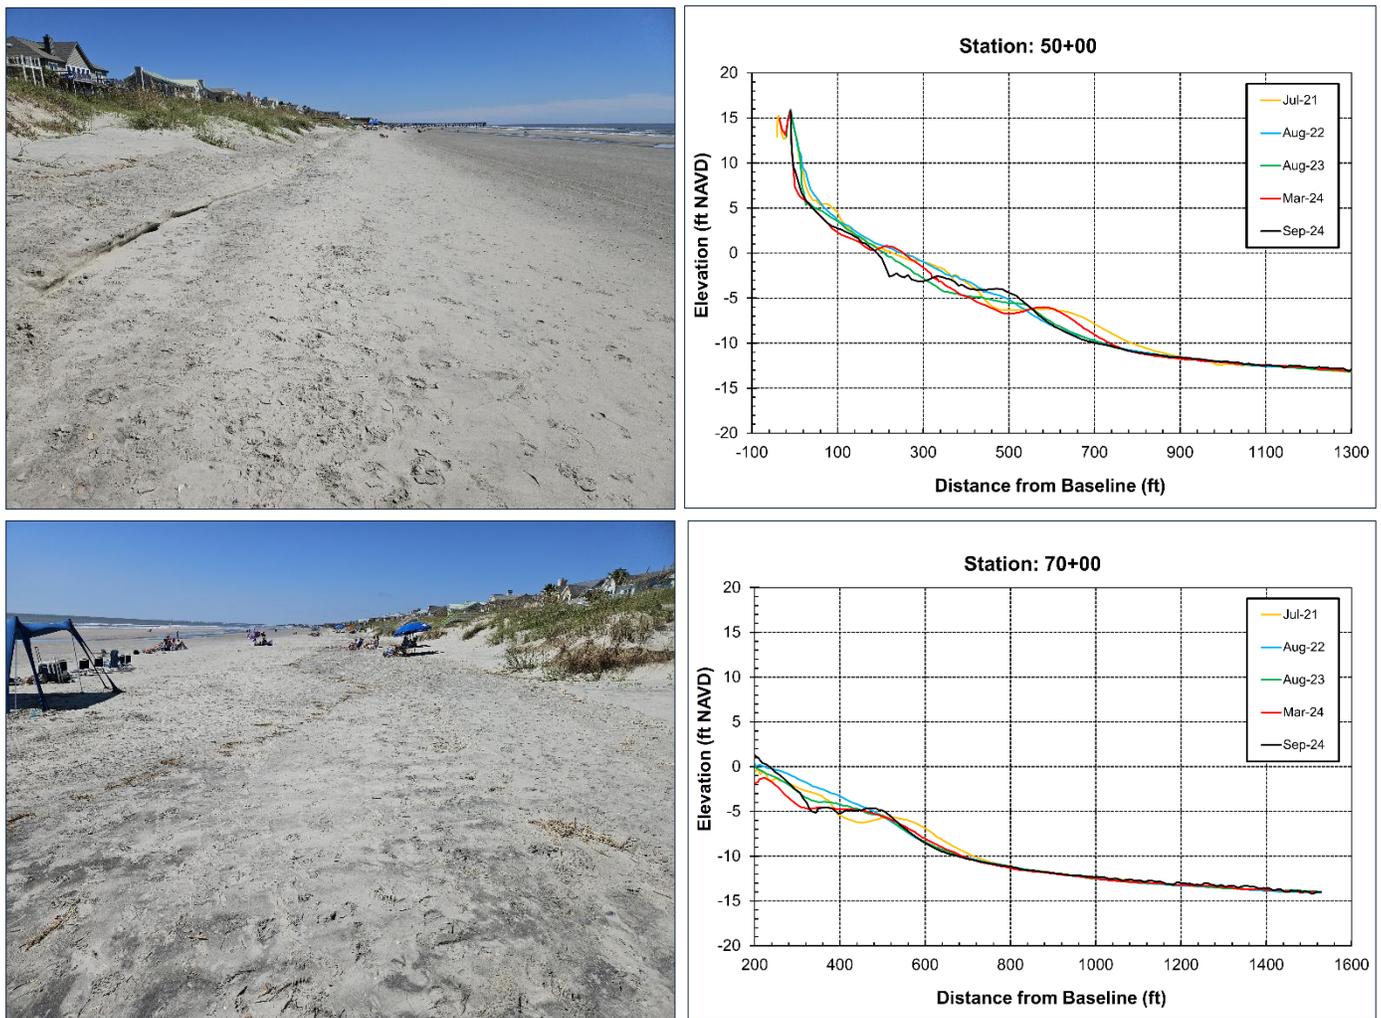
FIGURE 4.25. September 2024 photos of Reach 2. [UPPER LEFT] View north from Station 50. [LOWER LEFT] View west from Station 70. The photos show a healthy beach with dry sand seaward of the dune. Profiles show that the dune remains more landward than the 2012 condition; however, it has been fairly stable since 2017.

Photos and profiles show the healthier condition of the eastern end of the reach (south of the pier) compared to the western end (Fig 4.25). The dune created in 2017 after Hurricane *Irma*, which was constructed by scraping sand from the intertidal beach to accelerate recovery, initially provided some protection. However, despite its initial stability, the dune has now completely eroded. While the northern portion of the reach still exhibits stability, no trace of the *Irma* dune remains as of September 2024.
