**2018 Isle of Palms Restoration Project
Year 6 Monitoring Report**

2024
MONITORING REPORT

Prepared for
City of Isle of Palms
Isle of Palms, South Carolina

2018 Isle of Palms Restoration Project
Year 6 (2024) Monitoring Report
Annual Beach and Inshore Surveys

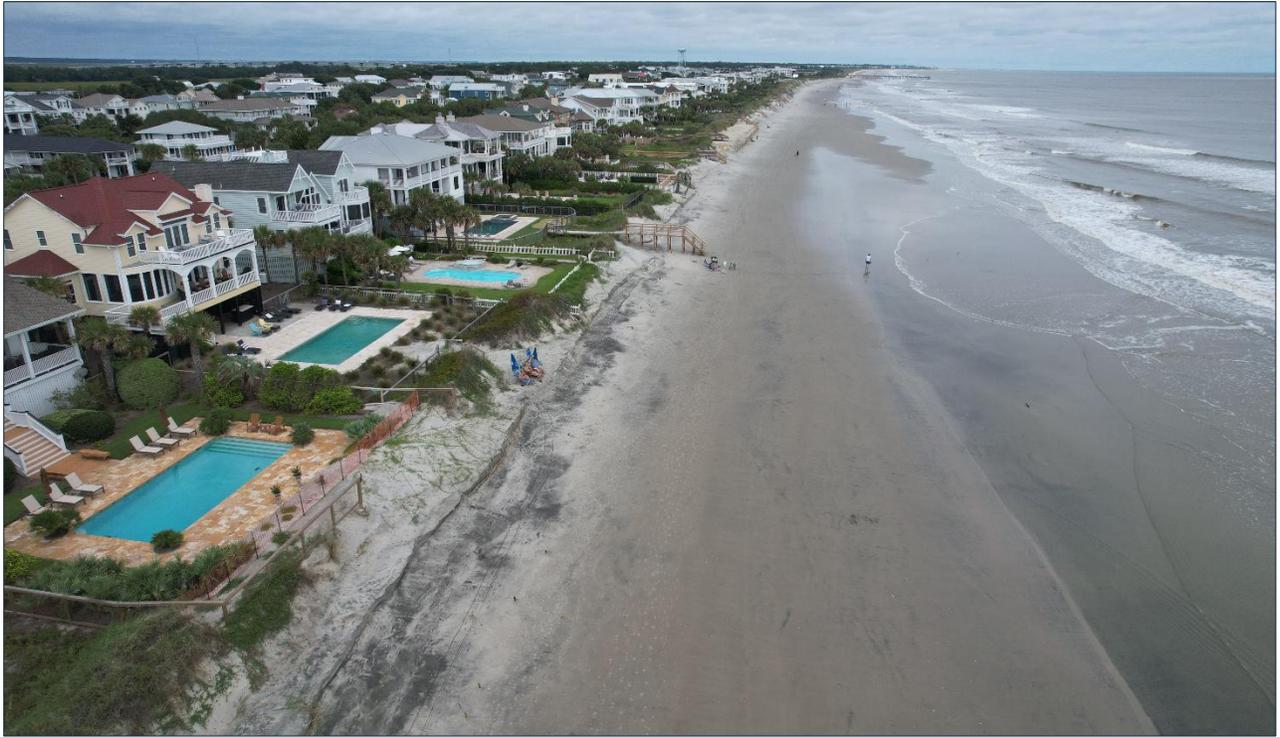
FIGURE 4.26. Aerial view of Reach 2 in September 2024. Since monitoring began in 2009, Reach 2 has been the most stable reach, typically showing lower magnitudes of volume change compared to the other reaches along Isle of Palms. The arc in the shoreline west of the pier indicates that the pier may act to trap sand, which may impact Reach 2 in certain wave conditions.

Aerial photos (Fig 4.26) of the reach show a crescent-shaped beach extending south of the pier. The shoreline morphology and the variable erosion patterns observed in this area should be closely monitored, as building setbacks are generally less than along Reaches 3–4. Should an erosional period persist, or a major storm impact the area, structures along Front Beach or the southern end of the Isle of Palms could become threatened. At a minimum, additional erosion along the south end of the reach will reduce the dry beach width, limiting recreational area. From 2011 to 2022, the reach was essentially stable, gaining a total of only 11,460 cy. The last two years experienced an unprecedented acceleration in erosion, resulting in a volume loss of approximately 90,740 cy. This represents a substantial increase from historical erosion rates. The Reach is showing a two-year average annual erosion rate of ~45,000 cy/yr. This equates to 360,000 cy over an 8-year period if erosion continues at this pace. This magnitude of loss would require mitigation via nourishment. Given the observed increase in erosion rates, CSE recommends that this area be included in future permit applications for nourishment.

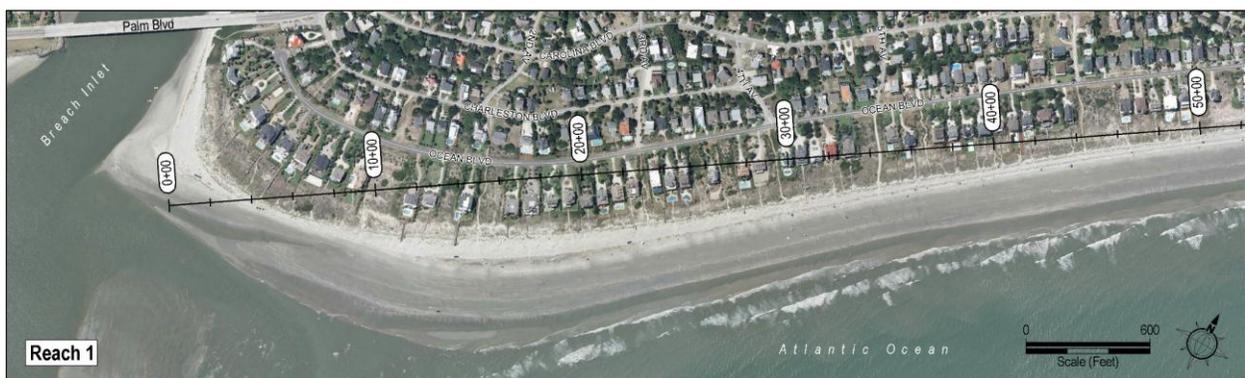
FIGURE 4.27. Baseline stationing along Reach 1 which encompasses the beach between Breach Inlet and 6th Avenue.

Reach 1 encompasses the beach between Breach Inlet and 6th Avenue (Fig 4.27) and is classified as an unstabilized inlet erosion zone due to the dynamic nature of the shoals associated with the inlet delta. The long-term trend in the reach is accretion, evidenced by a new row of houses built seaward from the original ‘beachfront’ row in the 1980s. Sand supply originates from shoal-bypass events at Dewees Inlet and longshore sand transport from north to south over the length of the Isle of Palms. Excess sand is deposited along the southern spit of the island and in the Breach Inlet ebb-tidal delta. The shoals of Breach Inlet form a prominence in the shoreline, which backs sand up along the oceanfront much like a terminal groin traps sand. Changes in this area are related to bars from the inlet delta migrating onto the beach or marginal flood channels moving landward or seaward. Such natural processes lead to rapid changes in the beach volume compared to the central Isle of Palms reaches.

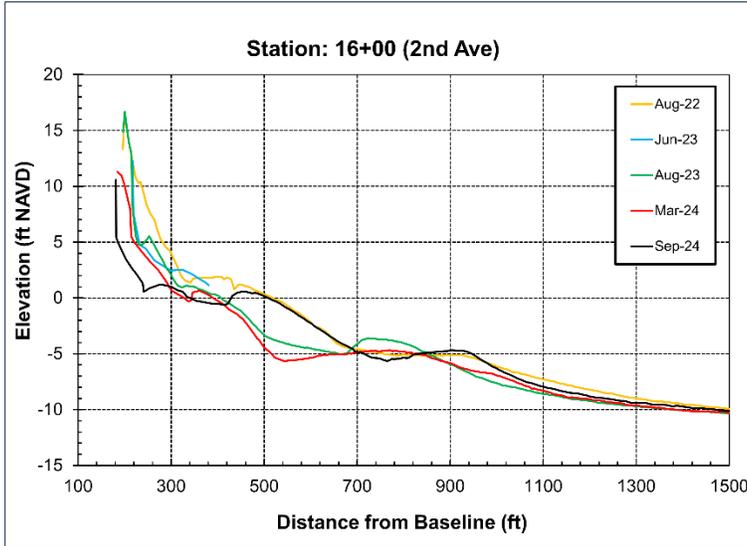
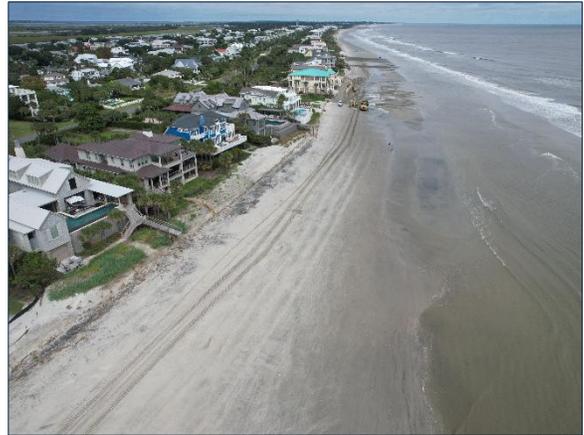
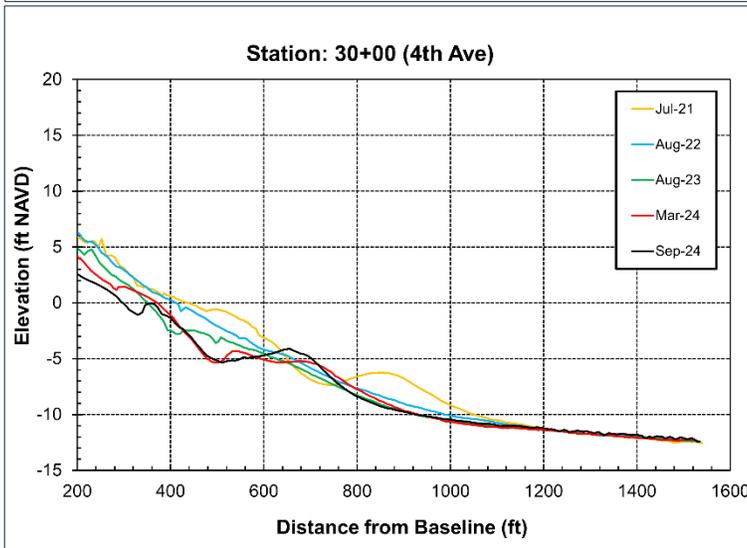
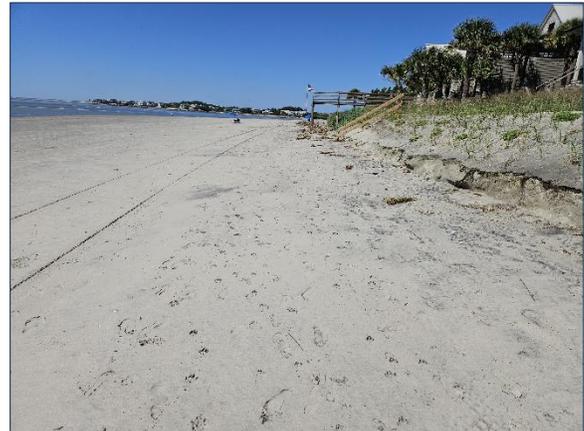
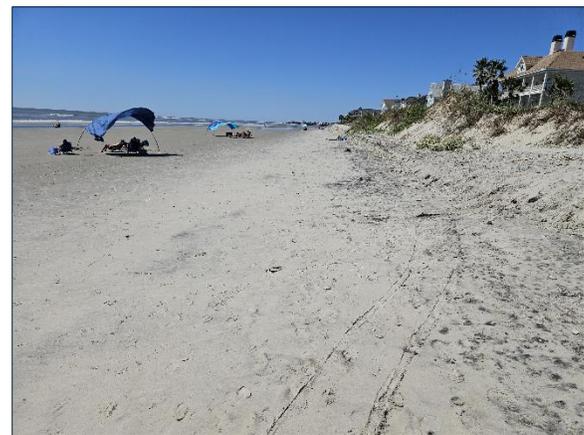
FIGURE 4.28. [LEFT] Profile plots for Reach 1 showing significant loss of the dune area over the past two years. [TOP RIGHT] September 2024 aerial photo of Reach 1. [MIDDLE RIGHT] Ground photo of Station 12 looking south. [BOTTOM RIGHT] Ground photo of Station 30 looking south.

The beach condition has continued to fluctuate over the past year, with some recovery of the dry-sand beach. However, sandbags remain in place along the 100–300 blocks, indicating ongoing erosion concerns. As of September 2024, erosional waves were still impacting the reach, and ridge-and-runnel systems were visibly influencing the dry-sand beach conditions. While some sections have seen improvements, persistent erosion remains a challenge across the area. Photos of the 2024 condition are shown in Figure 4.28.

Waterway and will place a planned 500,000 cy of sand along Reaches 1 and 2. The City is planning on supplementing this project by shifting material placed by the USACE into the dune areas eroded over the past two years. Once complete, the project will have added more sand than has been lost in the reaches since monitoring began in 2009. CSE recommends the City also consider including Reach 1 in future large-scale renourishment projects.

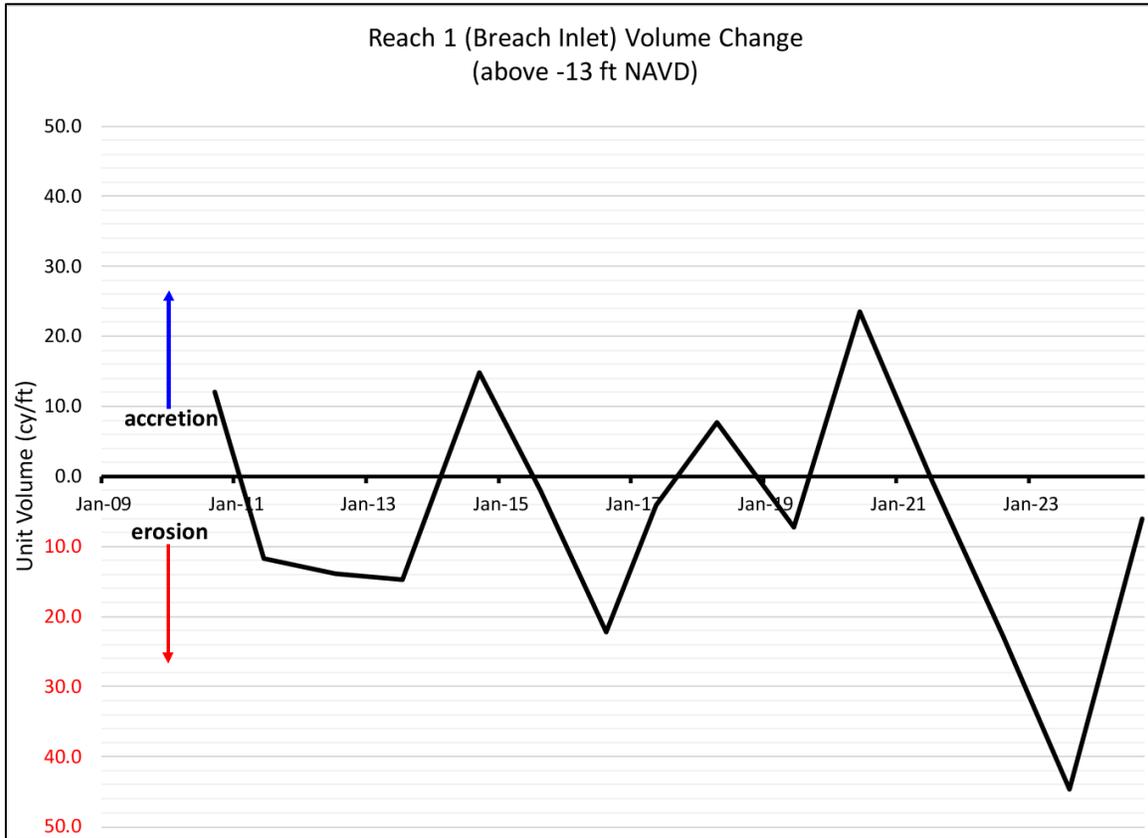
FIGURE 4.29. Volume changes along Reach 1 are highly cyclical and alternate between periods of moderate erosion and accretion. This is a common dynamic equilibrium around relatively small inlets like Breach Inlet, which tend to experience shoal bypass events at a greater frequency – but generally lower magnitude – than the larger inlet systems like Dewees Inlet at the east end. As the underwater bars and channels of Breach Inlet shift back and forth from the Isle of Palms to Sullivan’s side of the system, there are likewise changes in shoreface steepness, wave energy, and beach volumes on either side of the inlet. This is a natural feature of systems like Breach Inlet, and has been well documented in other mixed energy settings around the world (Beck and Wang 2019, Nienhuis and Ashton 2016, Gaudio and Kana 2001, FitzGerald 2000).

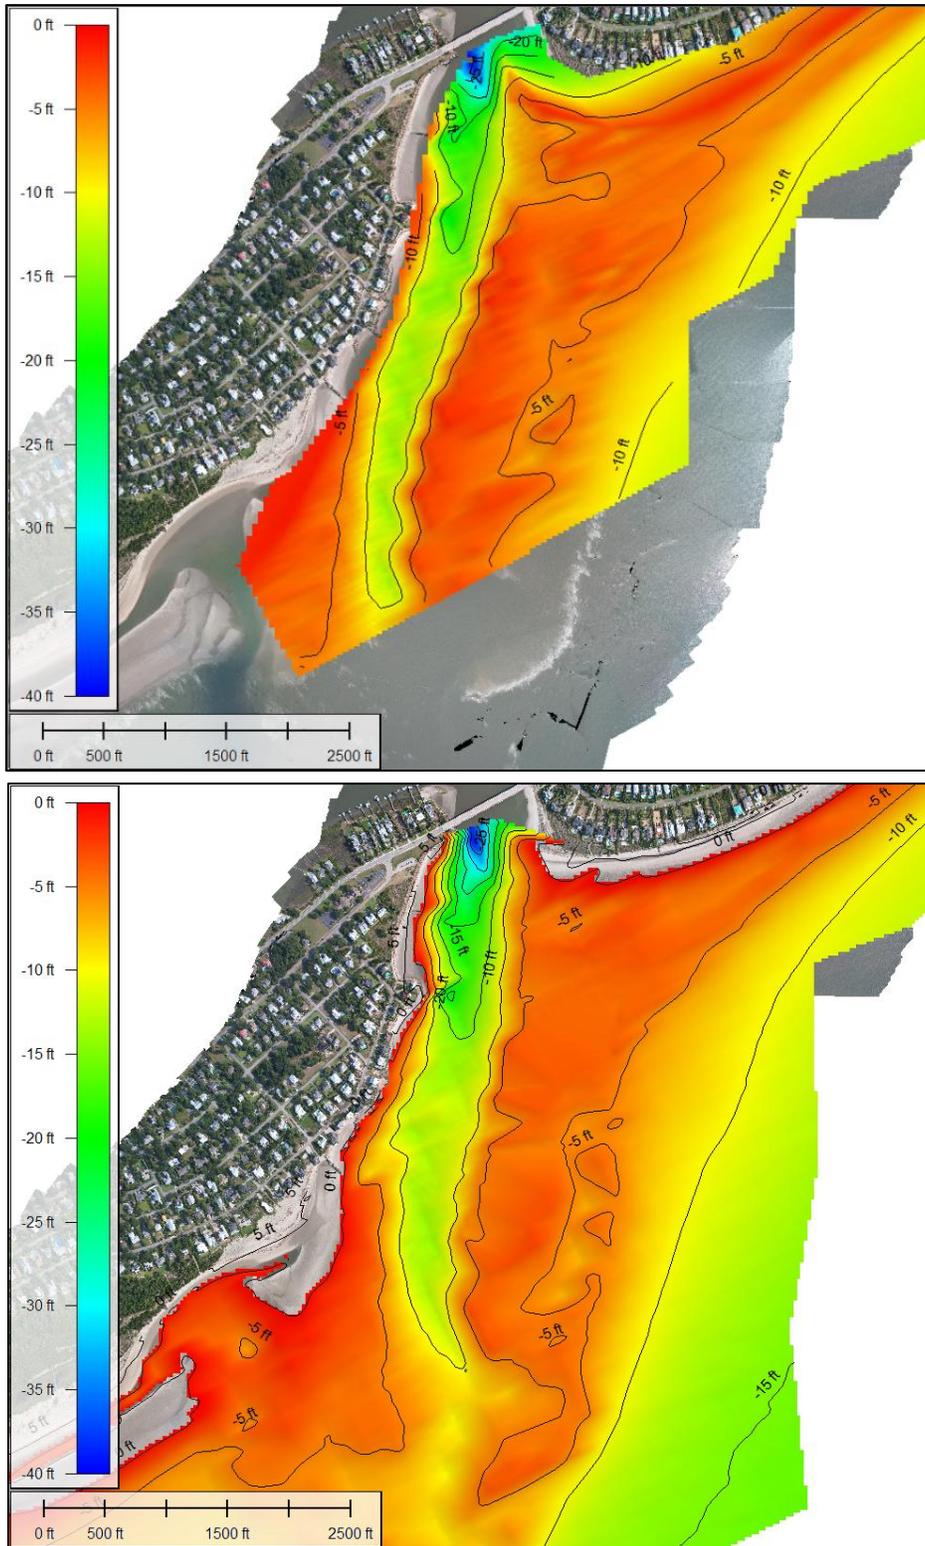
FIGURE 4.30. A pair of digital terrain models spanning the majority of Breach Inlet collected in 2023 (upper) and 2024 (lower). The most notable trend over the last year is the continued migration of the primary inlet channel (up against the Sullivan’s side of the inlet) towards Sullivan’s Island. The submerged spit running south and west from the Isle of Palms side of the channel remains a swash platform at elevations from -3 to -5 ft NAVD.

CSE obtained bathymetric data spanning most of the Breach Inlet channel and created a digital terrain model of the data (Figure 4.30). The model shows a well-defined primary channel bordering Sullivan’s Island, and a ~5,000-ft long submerged spit running south and west off the Isle of Palms shoreline. In recent years, particularly between 2020 and 2022, secondary channels developed running across the submerged spit. It is likely the development of these channels impacted beach volumes along the Isle of Palms side of Breach Inlet and played a role in the excessive erosion rates observed from 2021 through 2023. These observations indicate Breach Inlet experienced a shoal bypass event over that 2-year period (see FitzGerald et al 2000), which by 2024 had displaced the -5 ft contour off Sullivan’s Island and deflected the main channel seaward. No new secondary channels have developed since that bypass event, and erosion rates along the Isle of Palms side of Breach Inlet have returned closer to the long-term averages.

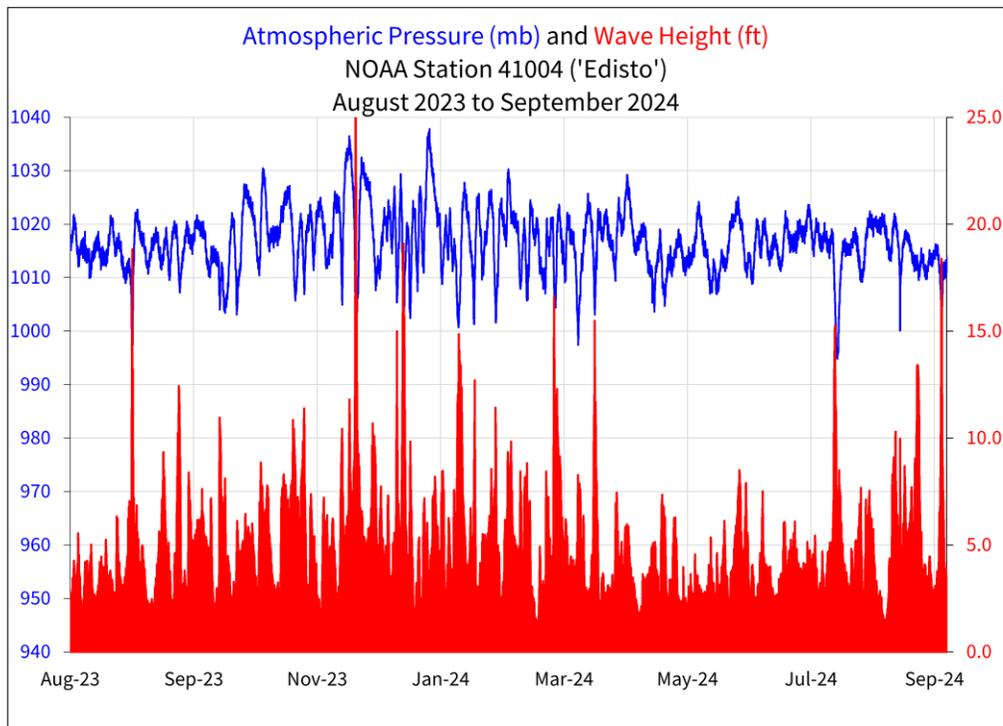
FIGURE 5.2. Atmospheric pressure and wave height at NDBC 41004 from August 2023 to September 2024. Wave heights exceeded 10 ft multiple times during the study period –and atmospheric pressure did go below 1000 mb during a few low-pressure systems occurring during the winter, spring, and summer months. These two parameters indicate conditions have been rough over the past year.

Wave data are recorded by the National Data Buoy Center (NDBC) Station 41004 (‘Edisto’), 41 nautical miles (nm) southeast of Charleston (SC) (NOAA 2025, http://www.ndbc.noaa.gov/station_page.php?station=41004). The average wave height at Station 41004 from August 2023 to September 2024 was ~4.4 ft, with an average dominant wave period of ~7.6 seconds. The maximum observed wave height was ~27.2 ft on 17 December 2023 during the passage of a nor’easter. The average wave direction was ~166° (approximately southeast).

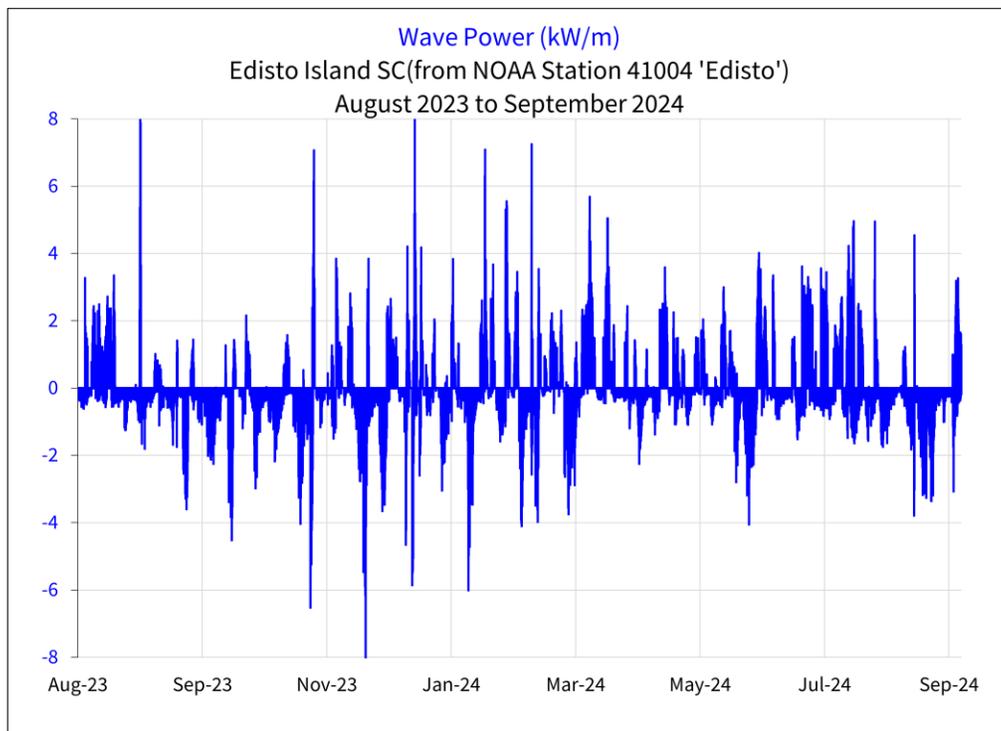
FIGURE 5.3. Wave power (in kW/m) and wave height (in m) for NDBC 41008 from August 2023 to September 2024. Wave power is a useful parameter for determining the relative magnitude and direction of wave energy in an alongshore direction along a beach. Positive values indicate waves move from south to north (ie – northerly transport), while negative values indicate a predominance of north-to-south (ie – southerly) transport.

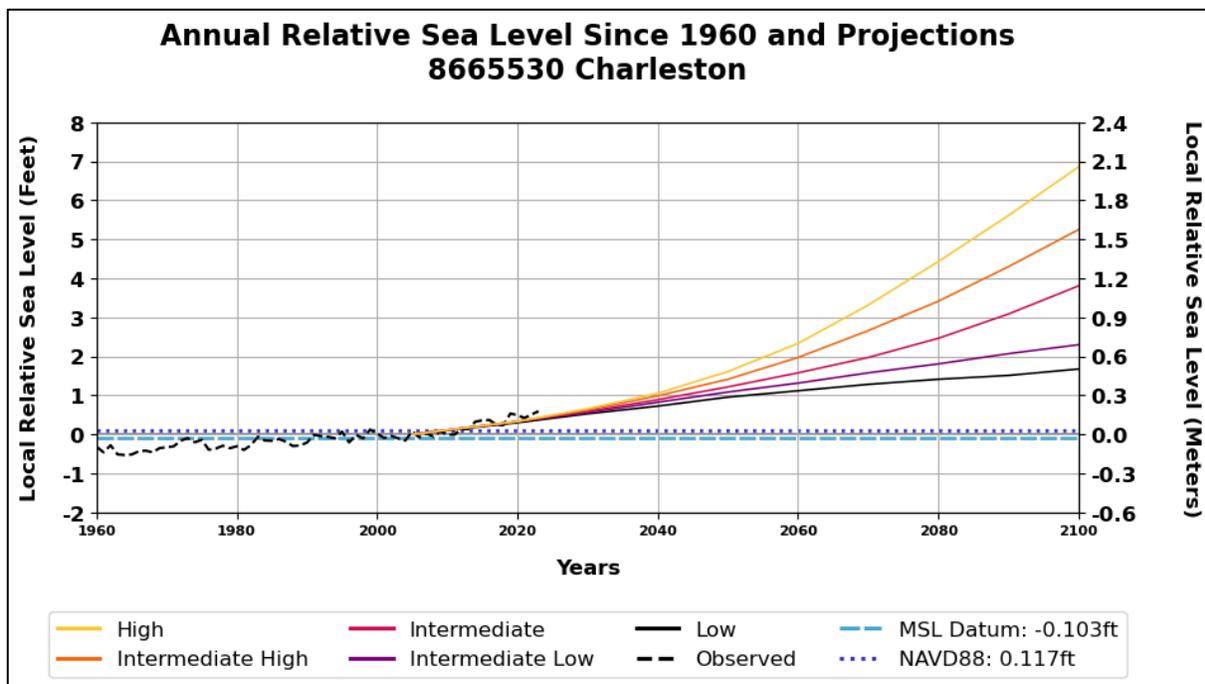
FIGURE 5.4. Projected MSL values under an ‘Intermediate’ emissions scenario average ~2 ft by 2060, and ~4 ft by 2100 at Charleston Harbor. These projections are global-scale predictions of future water levels (based largely on emissions) adapted to the Lowcountry by accounting for regional and localized changes in ocean circulation, vertical movement in the ground surface, and other factors.

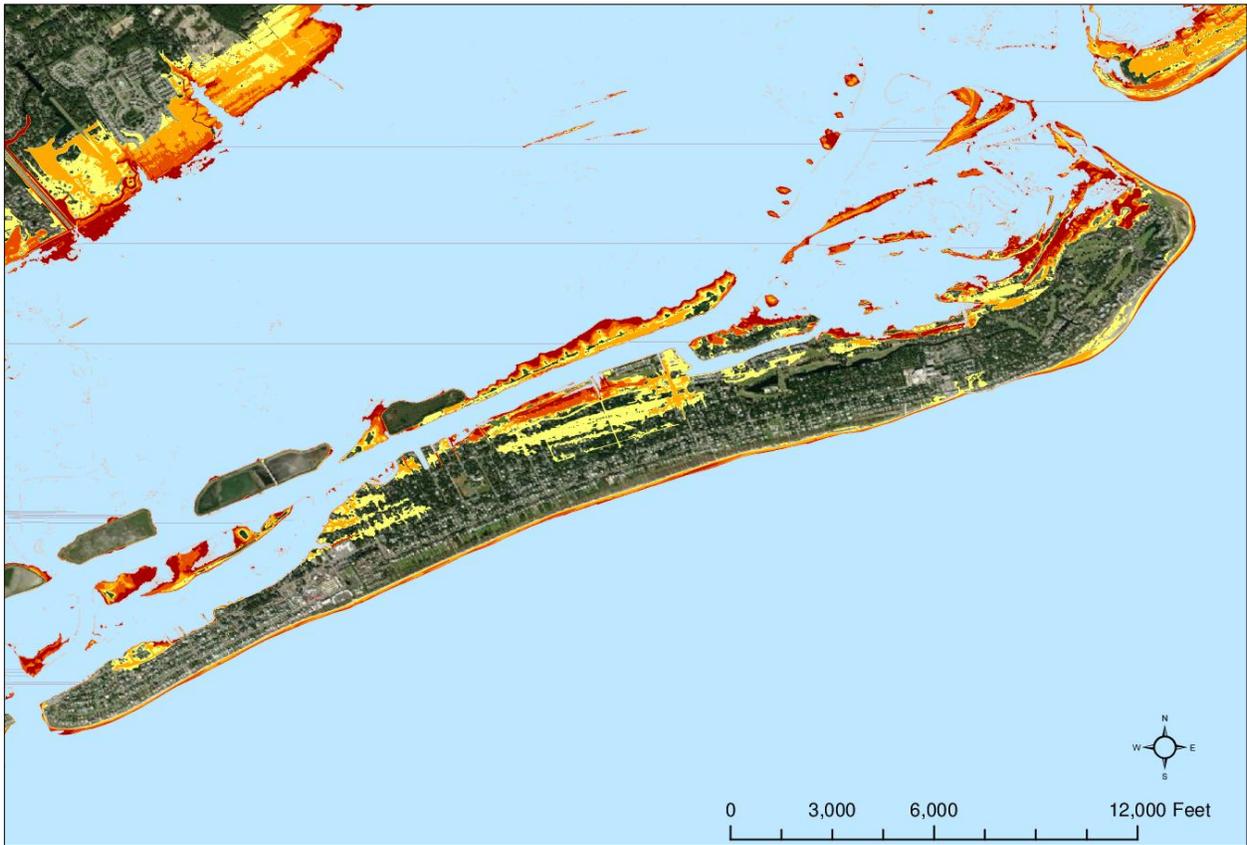
FIGURE 5.5a,b. Sea level inundation models around the Isle of Palms generated using data from NOAA (<https://coast.noaa.gov/digitalcoast/tools/slr.html>). Shades of yellow, orange, red, and maroon are used to signify SLR of 1, 2, 3, and 4 ft above present-day MHHW.
