**Beach Preservation Ad Hoc Committee
11:00 a.m., Tuesday, August 12, 2025
City Hall Council Chambers
1207 Palm Boulevard, Isle of Palms, SC 29451**

Erosion Assessment of the South End of Isle of Palms

Prepared By
COASTAL PROTECTION ENGINEERING, LLC

May 2025

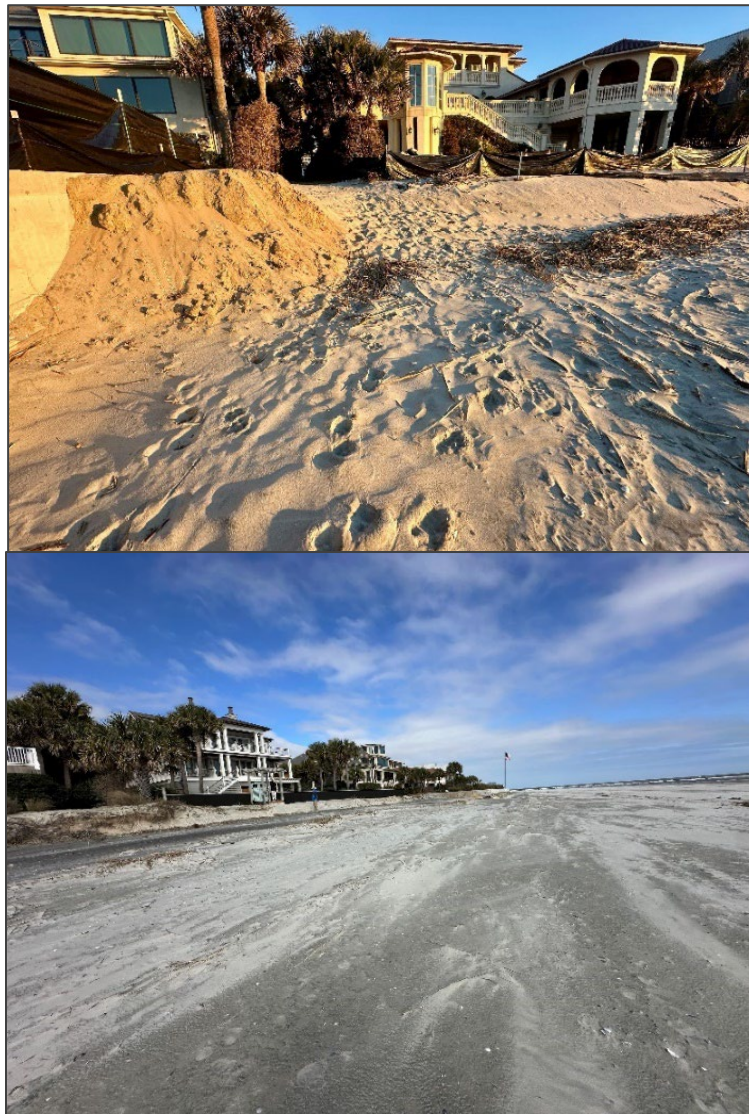
Figure 1. Photographs from recent site visit showing the high tide wrack line at the toe of the artificial dune (top photo) and a wide flat beach lacking a dune (bottom photo).

The combined effect of limited beach width, lack of dune protection, visible signs of threatened homes and infrastructure, dynamic bedforms, and offshore sediment placement highlights the vulnerability of this stretch of the Isle of Palms. Immediate action strategies will be needed to avoid continued land loss and storm damage.

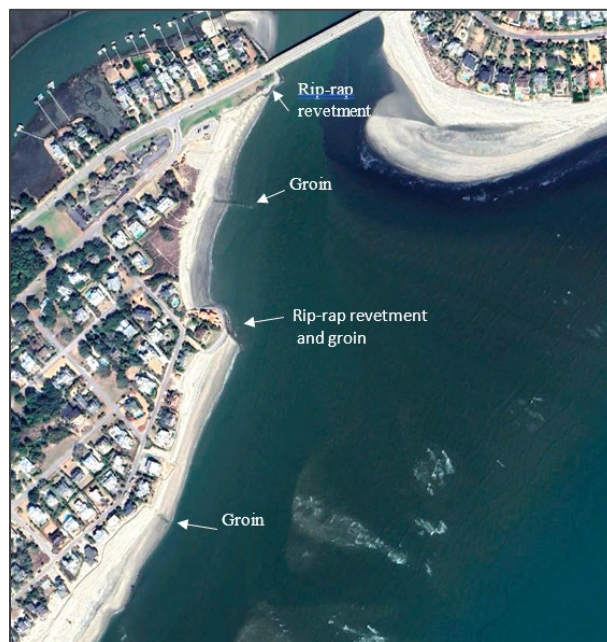
Figure 3. Recent (03/2025) aerial photo of Breach Inlet and the northwest end of Sullivan's Island. The structures identified in the image have served to stabilize the inlet's location and reduce erosion.

characterized by cyclic erosional and depositional patterns driven by inlet hydrodynamics and sediment transport processes. The southwestern end of Isle of Palms directly abuts Breach Inlet, which migrated steadily southward before stabilizing near its present-day location by the early 1900s. Since that time, the inlet has scoured into semi-consolidated mud layers, anchoring the main channel and preventing further large-scale migration. In addition, groins and riprap revetments placed along the downdrift shoreline of Sullivan's Island have helped stabilize the inlet's location and limit further erosion of the northern-facing shoreline of Sullivan's Island (see Figures 2 and 3).

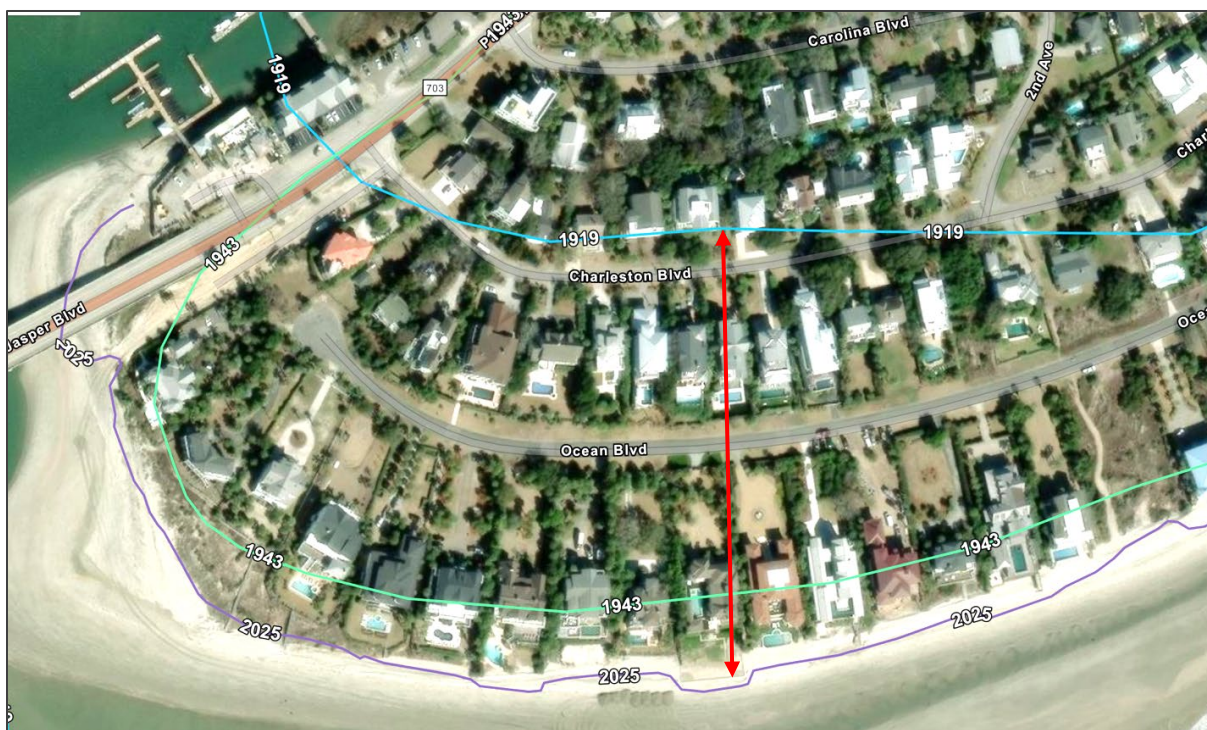
Figure 4. Aerial photo of the southwestern end of Isle of Palms showing the position of the highwater shoreline in 1919, 1943, & 2025. During this +100-yr period the ocean shoreline built seaward by almost 200 m (see red arrow).

Understanding historical shoreline changes along the southwestern end of Isle of Palms is critical for interpreting recent coastal changes in context. Figure 4 shows the position of the high-water shoreline in 1919, 1943, and 2025, illustrating a gradual southwestward migration of the island and substantial seaward progradation of the beach over the past century. The expansion of the beach and dune system during this period was primarily driven by sediment moving southward along the barrier island chain from Bull Island.

An inspection of historical shoreline changes (see Figure 4 above) shows that the presence of a strong ebb-spillover lobe in 2020 coincided with a period of relatively slower shoreline recession, compared to more recent years when the spillover lobe was absent.

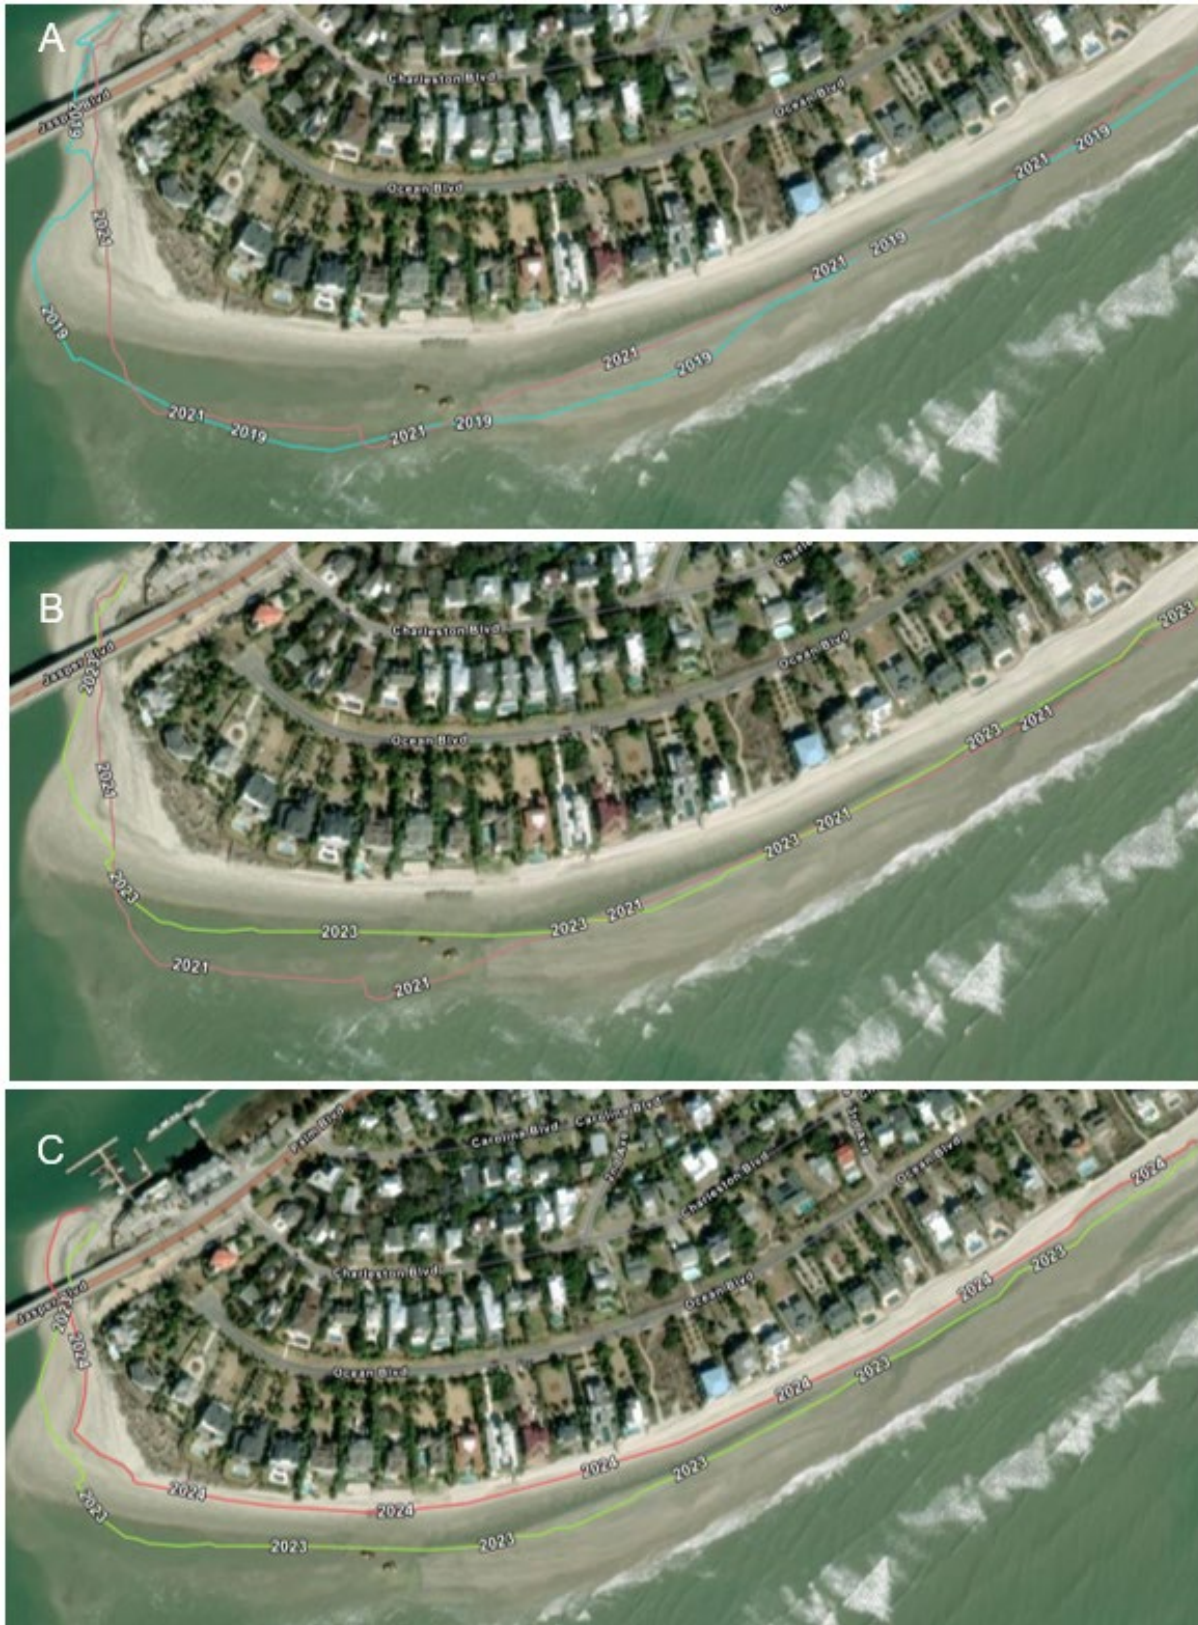
Figure 5. Shoreline changes near Breach Inlet. A. 2019 and 2021, B. 2021 and 2023, C. 2023 and 2024. Note the gradual retreat of the shoreline from 2019 to 2024.

A more recent history of the beach is presented in Figure 5, showing shoreline positions in 2019, 2021, 2023, and 2024. Although some local variability exists, the overall trend is a consistent pattern of beach erosion and shoreline retreat. Between 2019 and 2024, the high-water shoreline migrated landward by approximately 40 to over 70 meters.

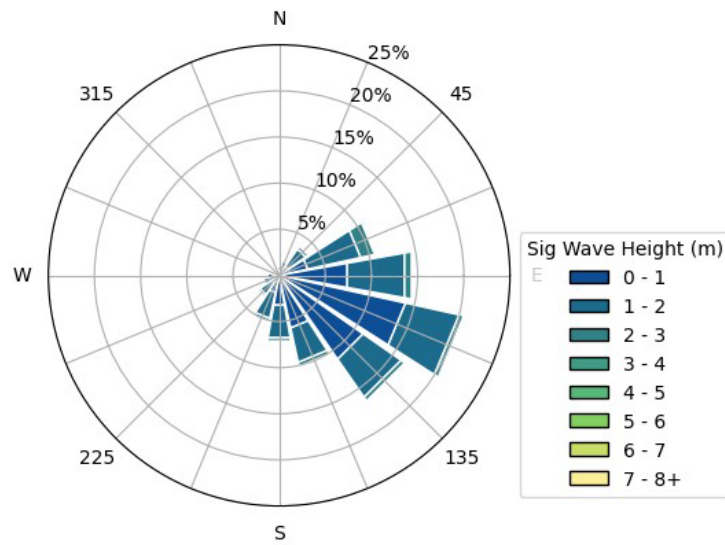
WIS Atlantic Hindcast: 63347
 1980-01-01T01:00:00Z - 2024-01-01T00:00:00Z
 Loc: -79.416702° / 32.583302° Depth: 21.0 [m]
 Total Obs: 385704

Figure 6. Wave rose offshore Isle of Palms displaying hourly hindcasted wave data from January 1st, 1980 to January 1st, 2024.

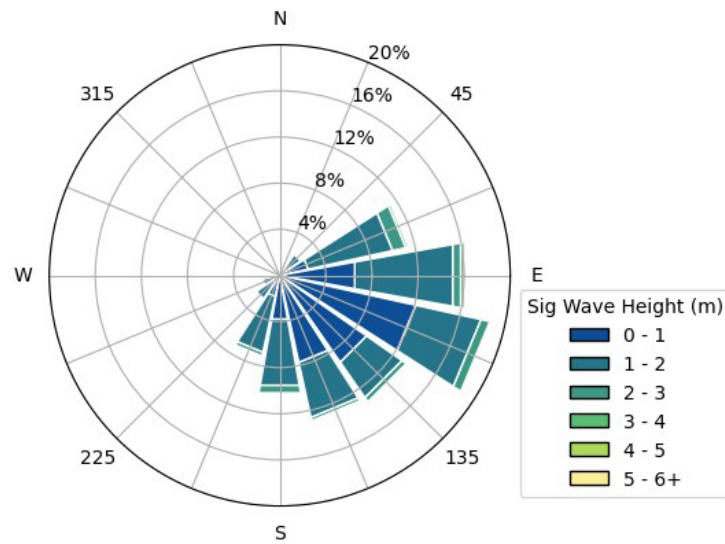
WIS Atlantic Hindcast: 63347
 2022-01-01T05:00:00Z - 2024-01-01T00:00:00Z
 Loc: -79.416702° / 32.583302° Depth: 21.0 [m]
 Total Obs: 17516

Figure 7. Wave rose offshore Isle of Palms displaying hourly hindcasted wave data from January 1st, 2022 to January 1st, 2024.

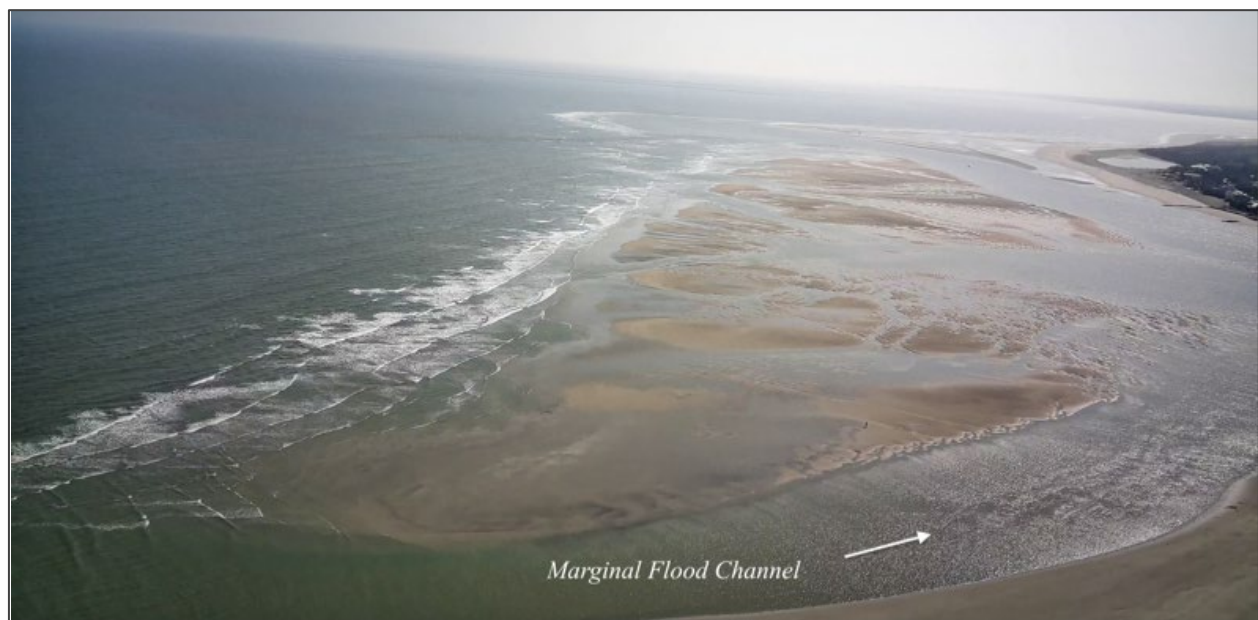
Figure 8. Recent photograph (03/2025) of the nearshore zone at the southern end of the Isle of Palms, showing a well-developed marginal flood channel. The channel enhances wave-driven sediment transport toward Breach Inlet.

The photograph in Figure 8, taken in early spring 2025, shows a well-developed marginal flood channel that enhances flood-driven sand transport. As illustrated schematically in Figure 9, this sediment movement has led to the formation of a subtidal spit advancing into the inlet channel and a supratidal spit encroaching into the marina landward of the bridge. Most recently, sand discharged along southern Isle of Palms continues to be driven southward by longshore currents, building a prominent spit that extends into Breach Inlet (Figure 10).

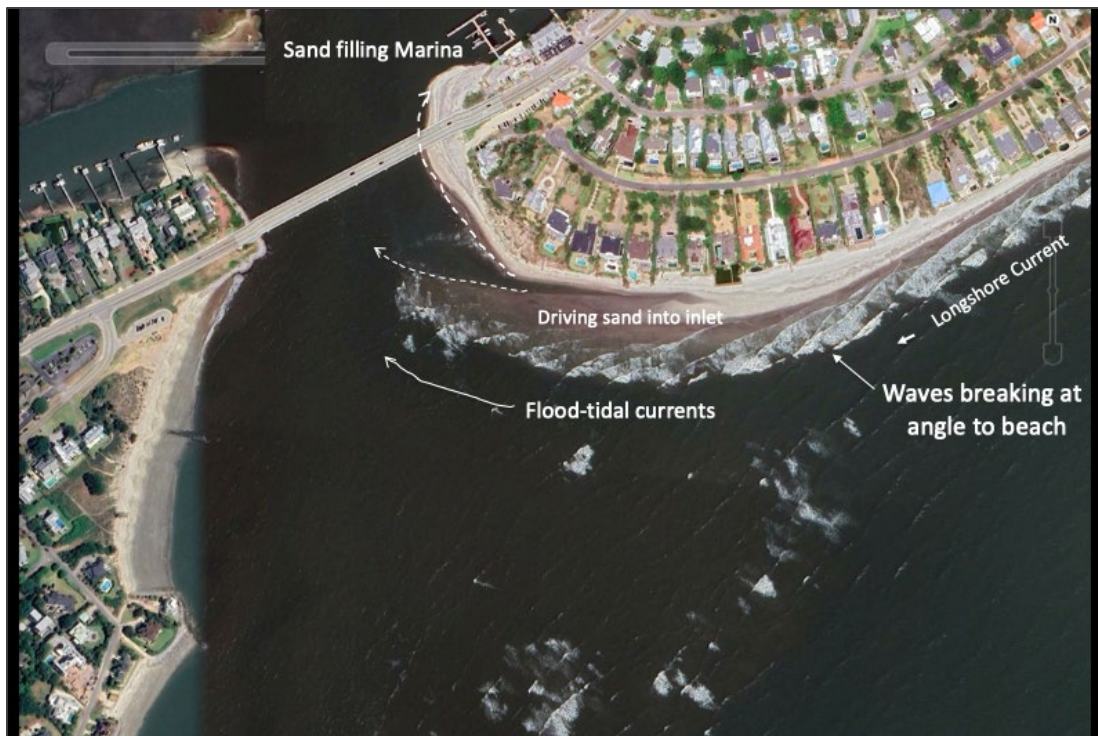
Figure 9. Aerial photo from 04/2024 showing angular wave approach generating southerly longshore currents, which are further enhanced by flood-tidal currents entering Breach Inlet.

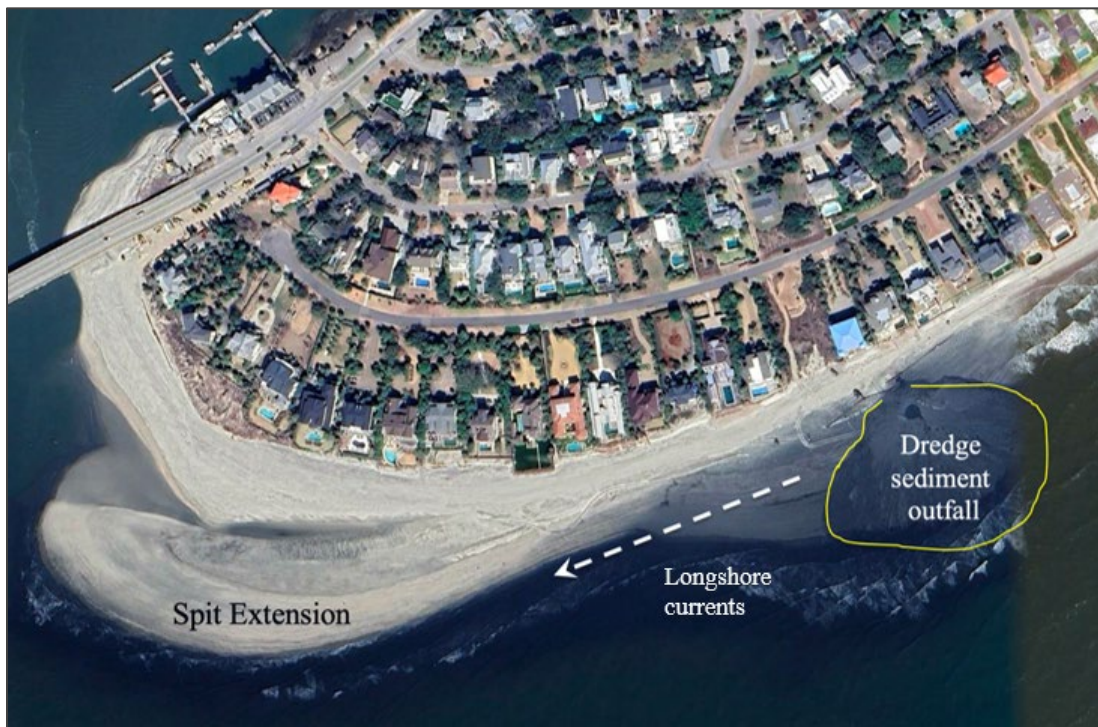
Figure 10. Recent aerial photograph (03/2025) showing the dredging operation and the formation of a sand spit driven by longshore sediment transport.

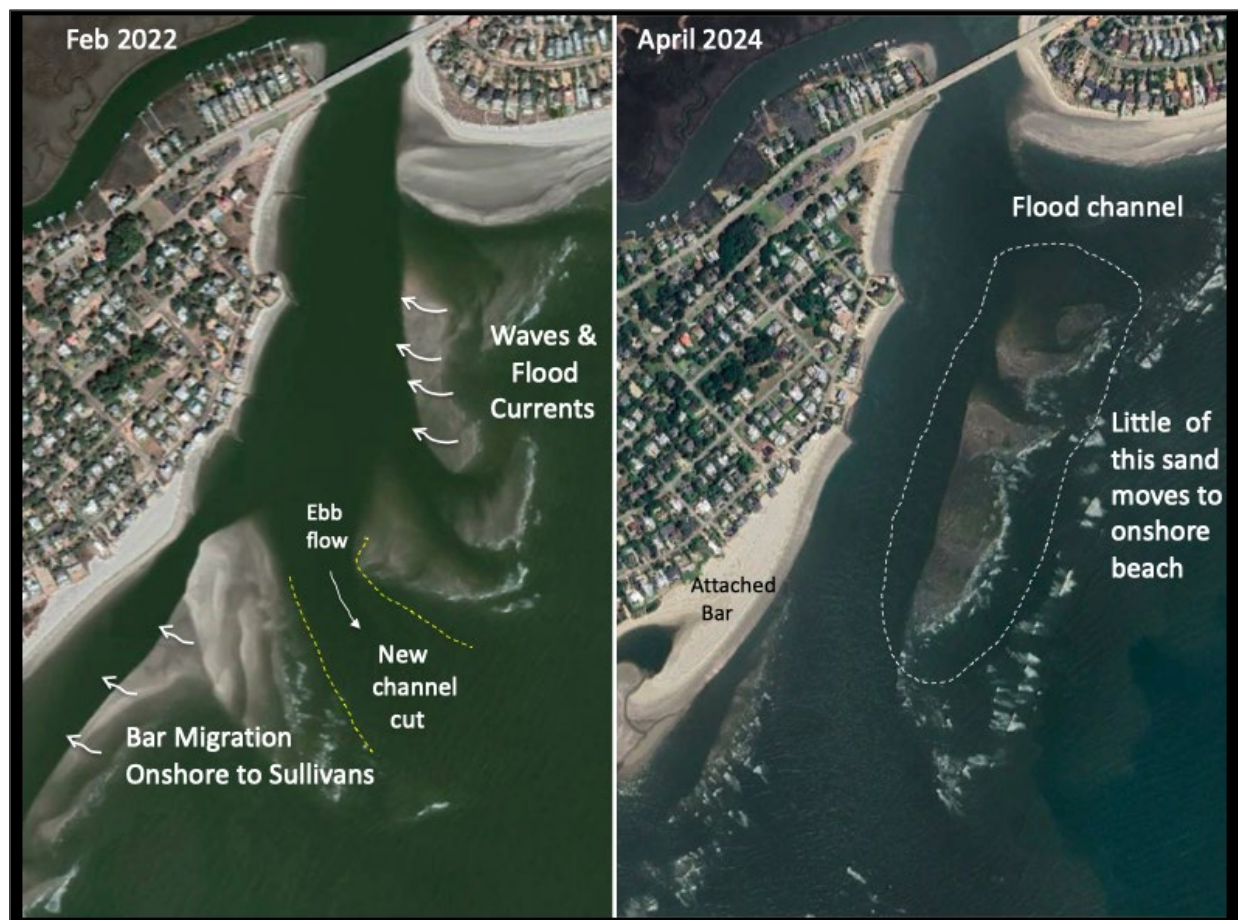
Figure 11. Photographs of the ebb-tidal delta from 2022 and 2024, showing the formation of a new channel across the distal delta in 2022, which facilitated sand bypassing Breach Inlet and led to a bar welding onto Sullivan's Island.

By 2022, a new tidal channel had incised the distal portion of the ebb-tidal delta, while a large ebb-spillover lobe had developed across the location of the former main inlet channel (Figure 11). This lobe represented a temporary storage of sand offshore, interrupting the direct connection between tidal flows and adjacent shorelines. Simultaneously, a marginal flood channel began to form along the Isle of Palms shoreline, enhancing flood-directed sediment transport. By 2024, the ebb-spillover lobe had welded onto Sullivan's Island, reshaping sediment pathways and amplifying the influence of the marginal flood channel along the Isle of Palms. These evolving features have played a major role in modifying sediment transport patterns and altering the adjacent shoreline configuration over time.

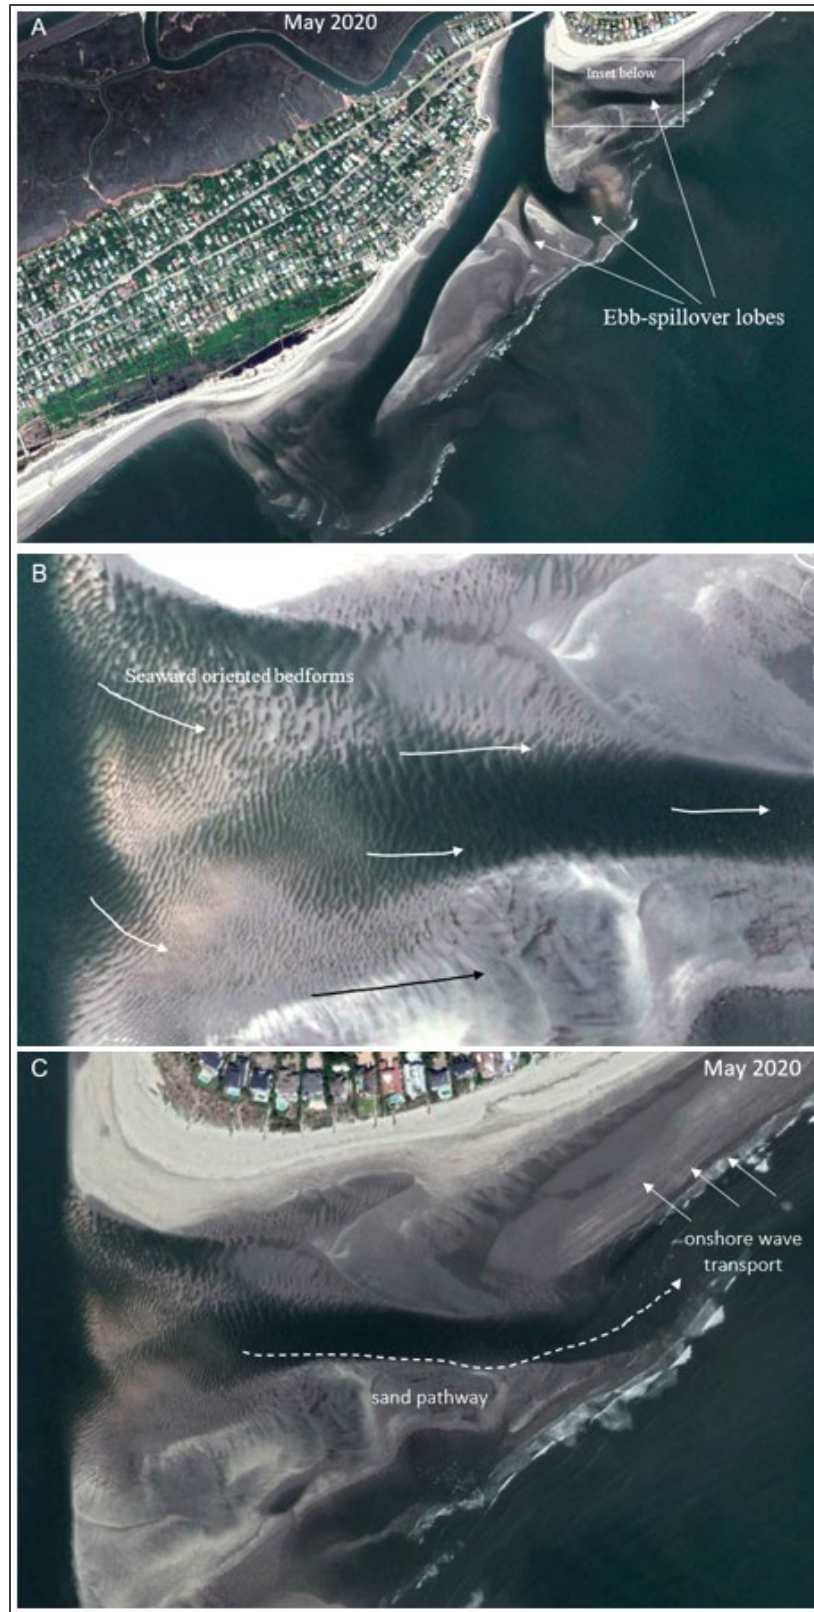
Figure 12. Sand transport seaward through ebb-spillover lobe. A: Inset identifying ebb lobe close to beach. B: Inset showing ebb-oriented bedforms indicating seaward transport to the east. C: Image demonstrating that seaward transport of sand moves onshore by wave action.

Eventually, due to changes in flow within Breach Inlet, the marginal flood channel along the Isle of Palms transitions into an ebb-dominant channel. During the falling tide, strong ebb currents flow through this channel, transporting sand seaward. These channels are referred to as “ebb spillover lobes” and are commonly found along the updrift (northern) side of the ebb-tidal delta at Breach Inlet. As seen in the photograph in Figure 12A, several ebb spillover lobes were present in 2020, including one channel located close to the beach.

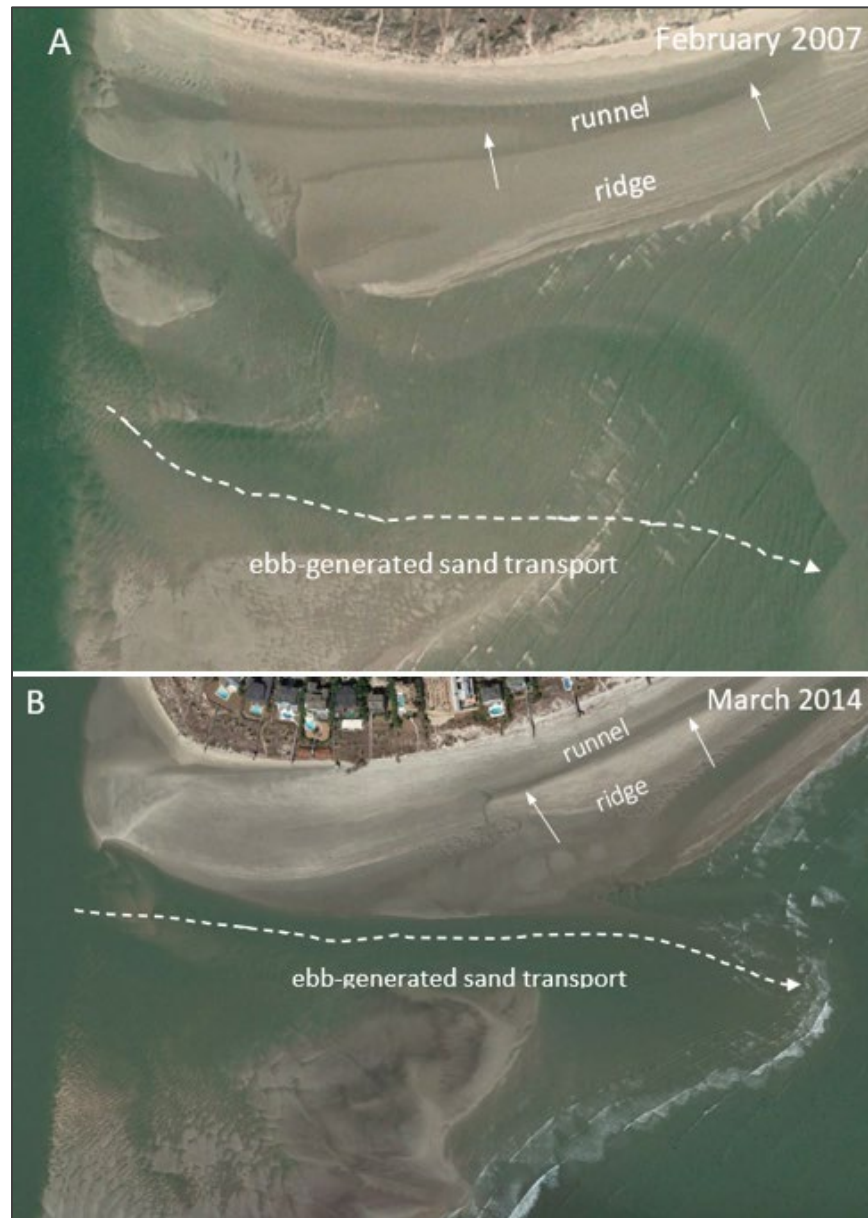
Figure 13. Ebb-spillover lobes at Breach Inlet in 2007 (A) and 2014 (B), showing sand transport pathways and the formation of ridge and runnel systems along the beach.

Historical photo analysis of Breach Inlet and southern Isle of Palms indicates that ebb-spillover lobe channels like the 2020 configuration also existed in 2007 and 2014. As shown in Figure 13, the general pathway of the channel and its extension along the southern Isle of Palms were nearly identical to those documented in 2020. Although the tide was higher in the 2007 and 2014 photographs, ebb-oriented bedforms are still visible, indicating ongoing seaward sand transport. Both sets of images also reveal the presence of sand bars forming ridge and runnel systems along the beach landward of the spillover channel. These ridges, fronted by a steep slipface and separated by runnels, are diagnostic of bars migrating onshore and adding sand to the beach.

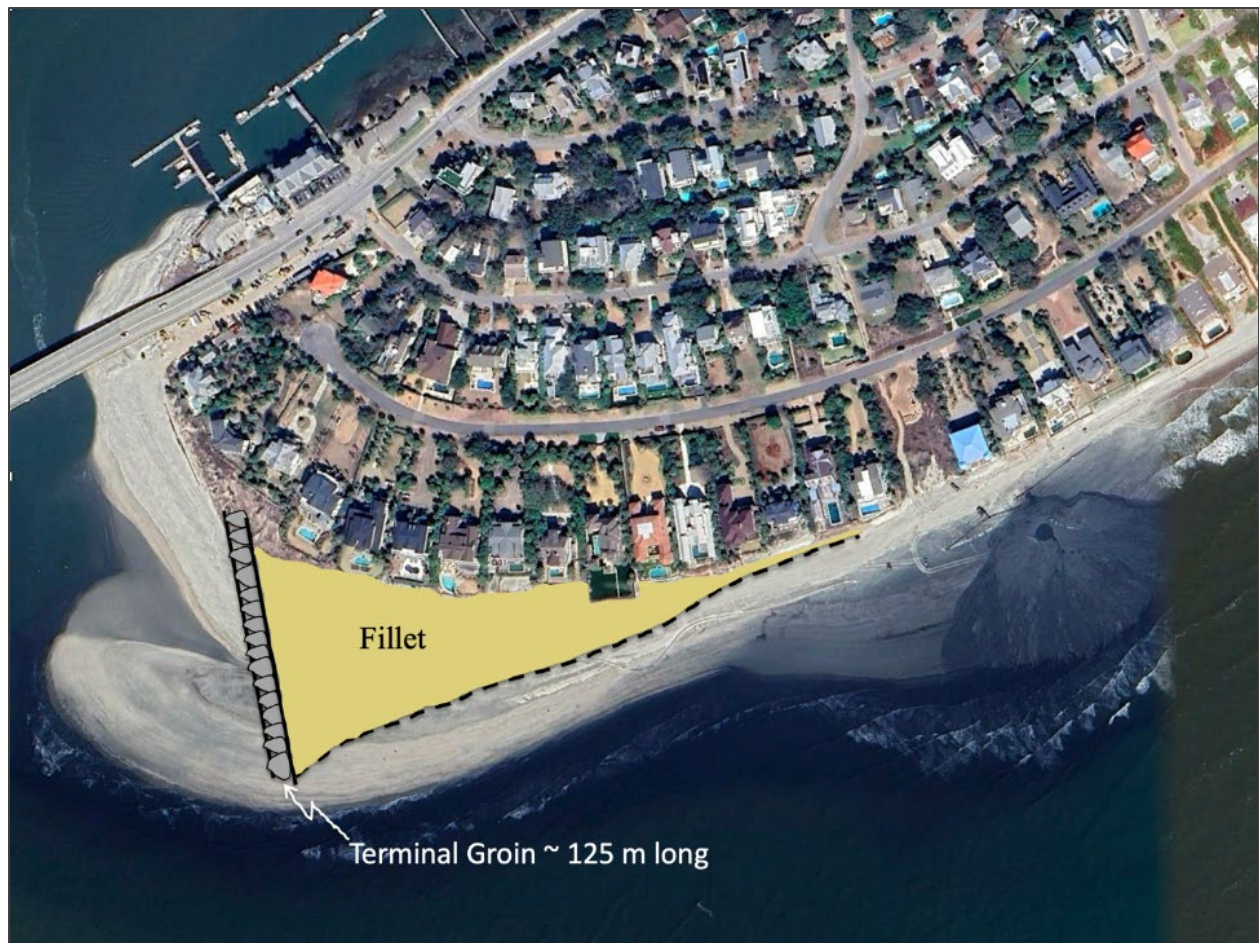
Figure 15. Concept sketch of a terminal groin and associated beach fillet illustrating this concept for the southern end of Isle of Palms adjacent to Breach Inlet.

The terminal groin option appears promising and warrants further consideration; therefore, a more detailed description of this alternative is provided here. To establish a more stable, permanent beach berm width along the southern end of the Isle of Palms, an evaluation of the feasibility of a terminal groin should be conducted. To illustrate this concept, a conceptual sketch of a potential structure is shown in Figure 15. This structure could hypothetically capture a portion of the southwestward longshore sediment transport, creating a wider beach fillet on the updrift side to buffer against erosion, while allowing excess sand to bypass the structure and continue feeding the inlet system, thereby minimizing potential downdrift impacts on Sullivan's Island and the adjacent inlet shoreline. The benefits and potential impacts of this approach should be thoroughly analyzed using established coastal engineering practices, sediment budget development, and numerical modeling of coastal morphology.

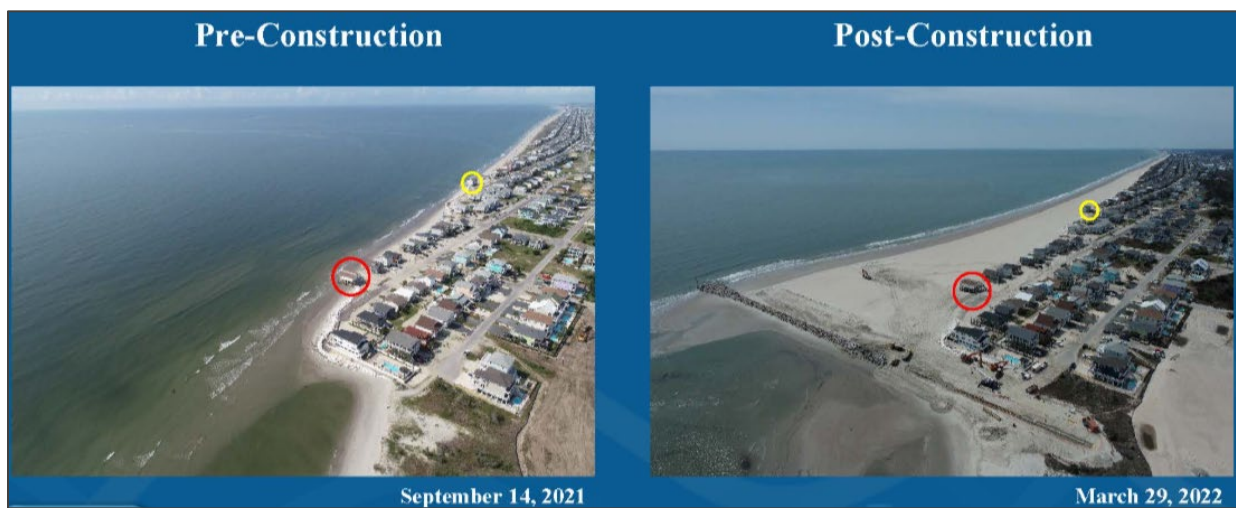
Figure 17. Before/after photos of the terminal groin at Ocean Isle Beach, Brunswick County, NC.

A similar permeable terminal groin at Ocean Isle Beach, North Carolina, designed by CPE, has proven effective in maintaining a stable beach with minimal downdrift erosion, demonstrating the viability of this approach (Figures 16 and 17). Another example is the terminal groin at Bald Head Island (Figure 16), also in North Carolina. Additional alternatives such as altering inlet channels (e.g., constructing a dike to relocate the flood channel) could also be evaluated in the feasibility study, however, these management practices are more ephemeral when compared to the terminal groin, and may have adverse impacts on the north end of Sullivan's Island.

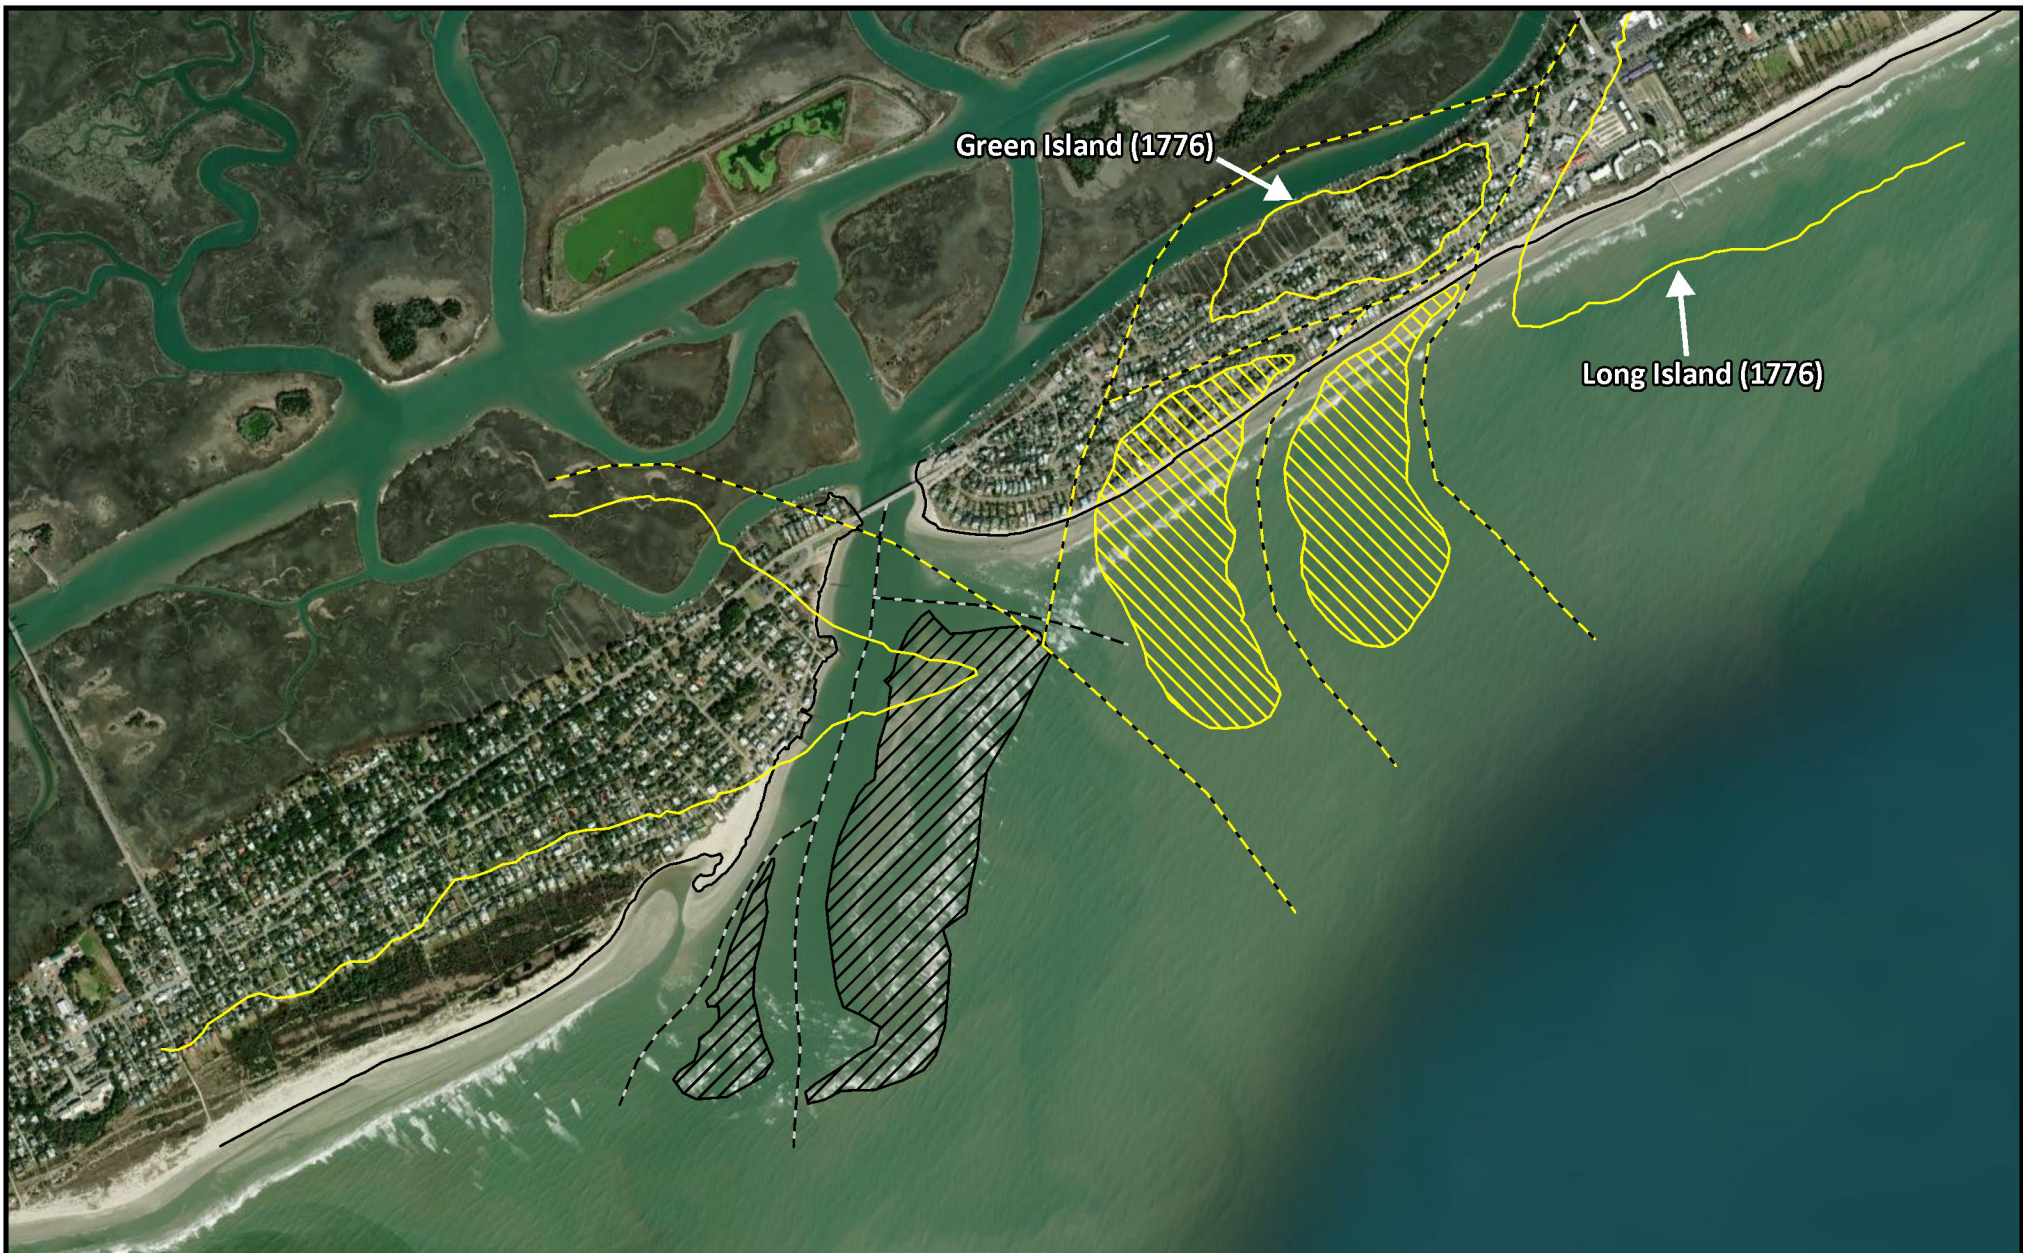
1) 1776 datasets are based on a Revolutionary War Map from June 28, 1776 by Lieutenant Colonel Thomas James. 2024 datasets are based on aerial imagery collected on February 21, 2024 by ESRI Basemap Services.

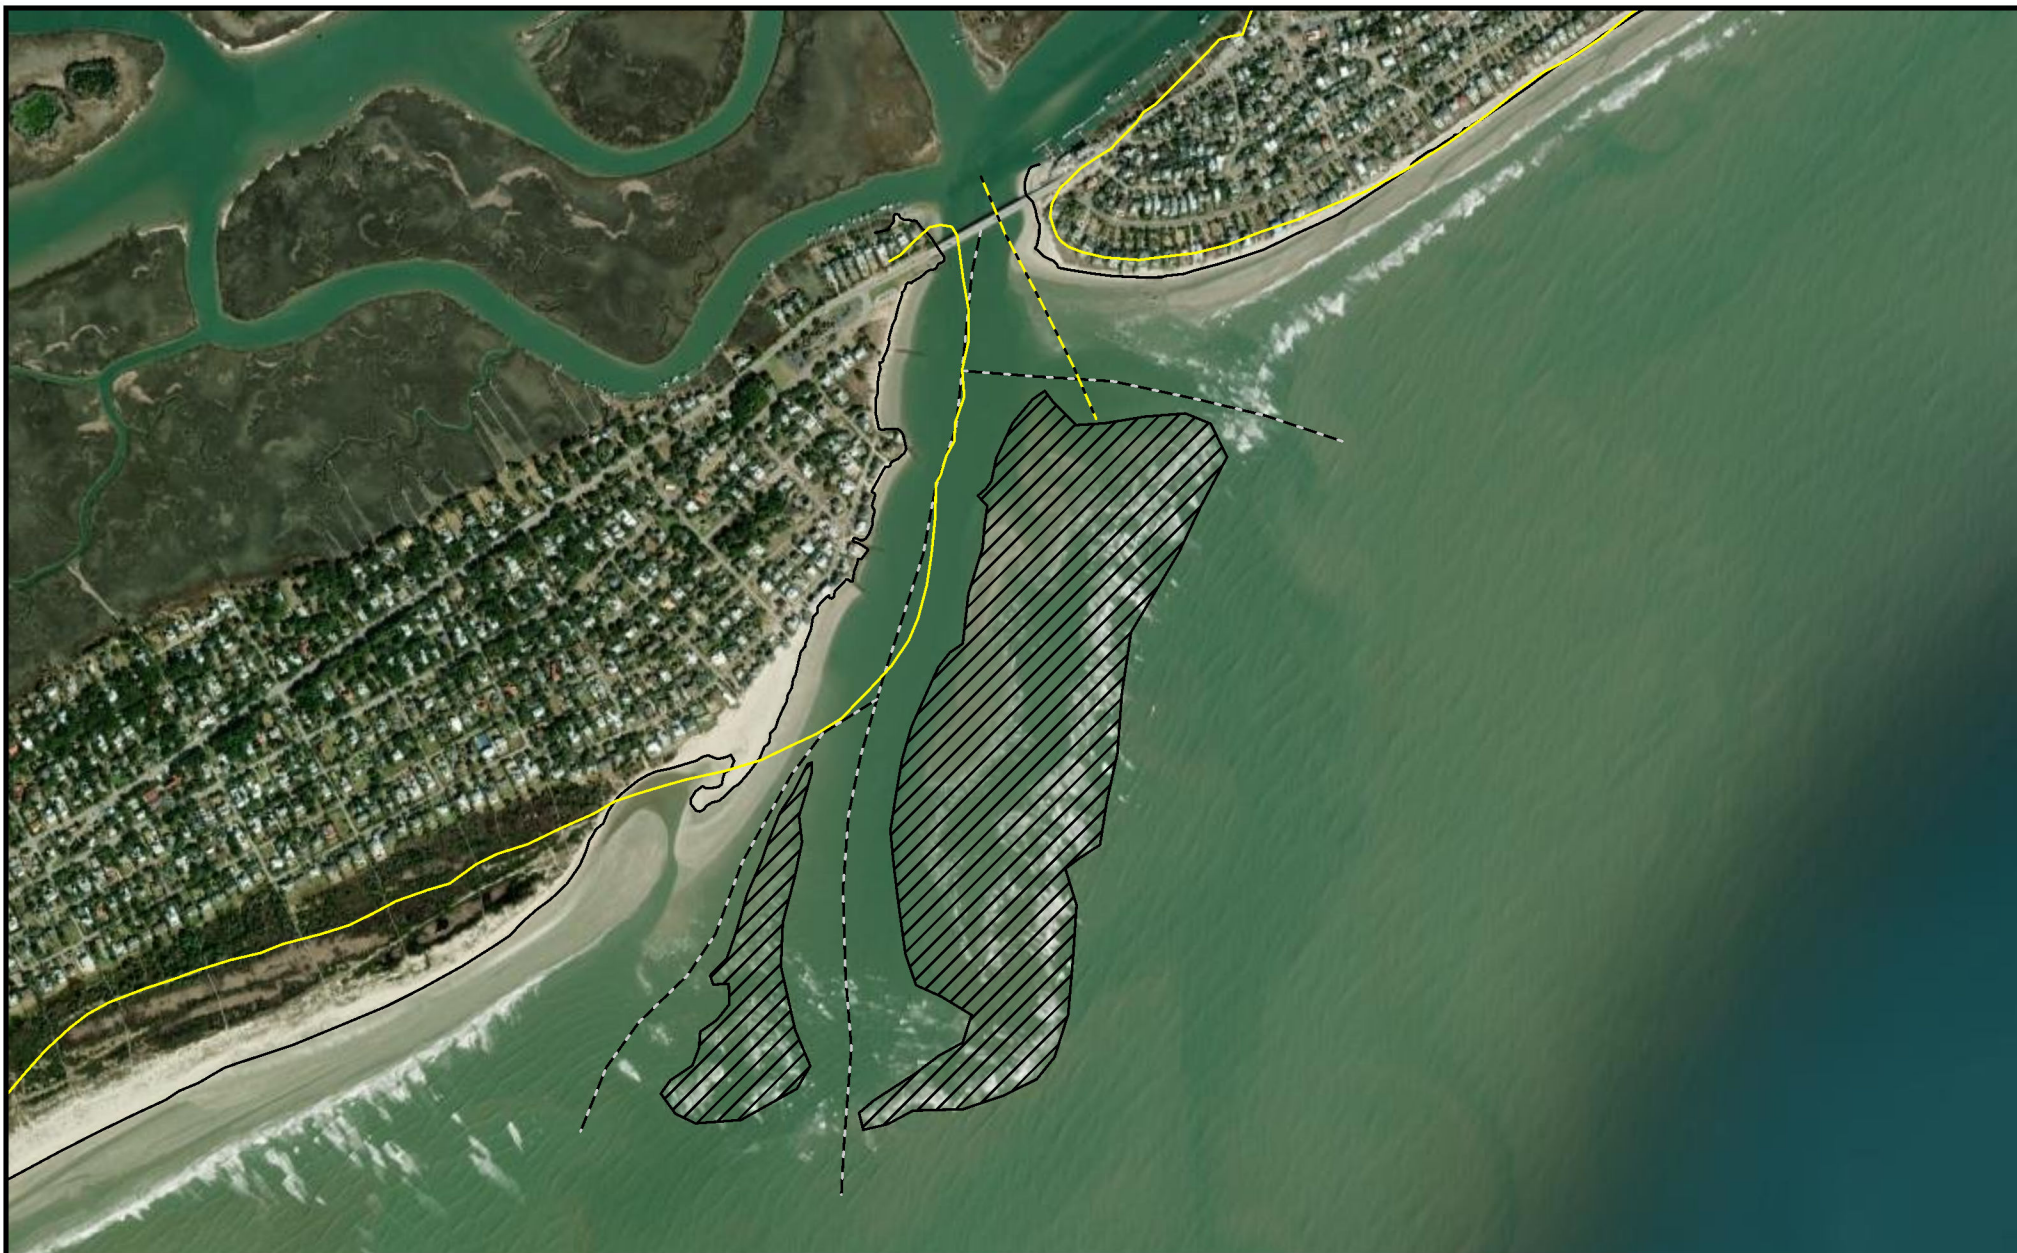
- 1) 1943 datasets are based on a USGS Topographic Map from 1943. 2024 datasets are based on aerial imagery collected on February 21, 2024 by ESRI Basemap Services.
- 2) Background imagery collected on February 21, 2024 and provides by ESRI Basemap Services

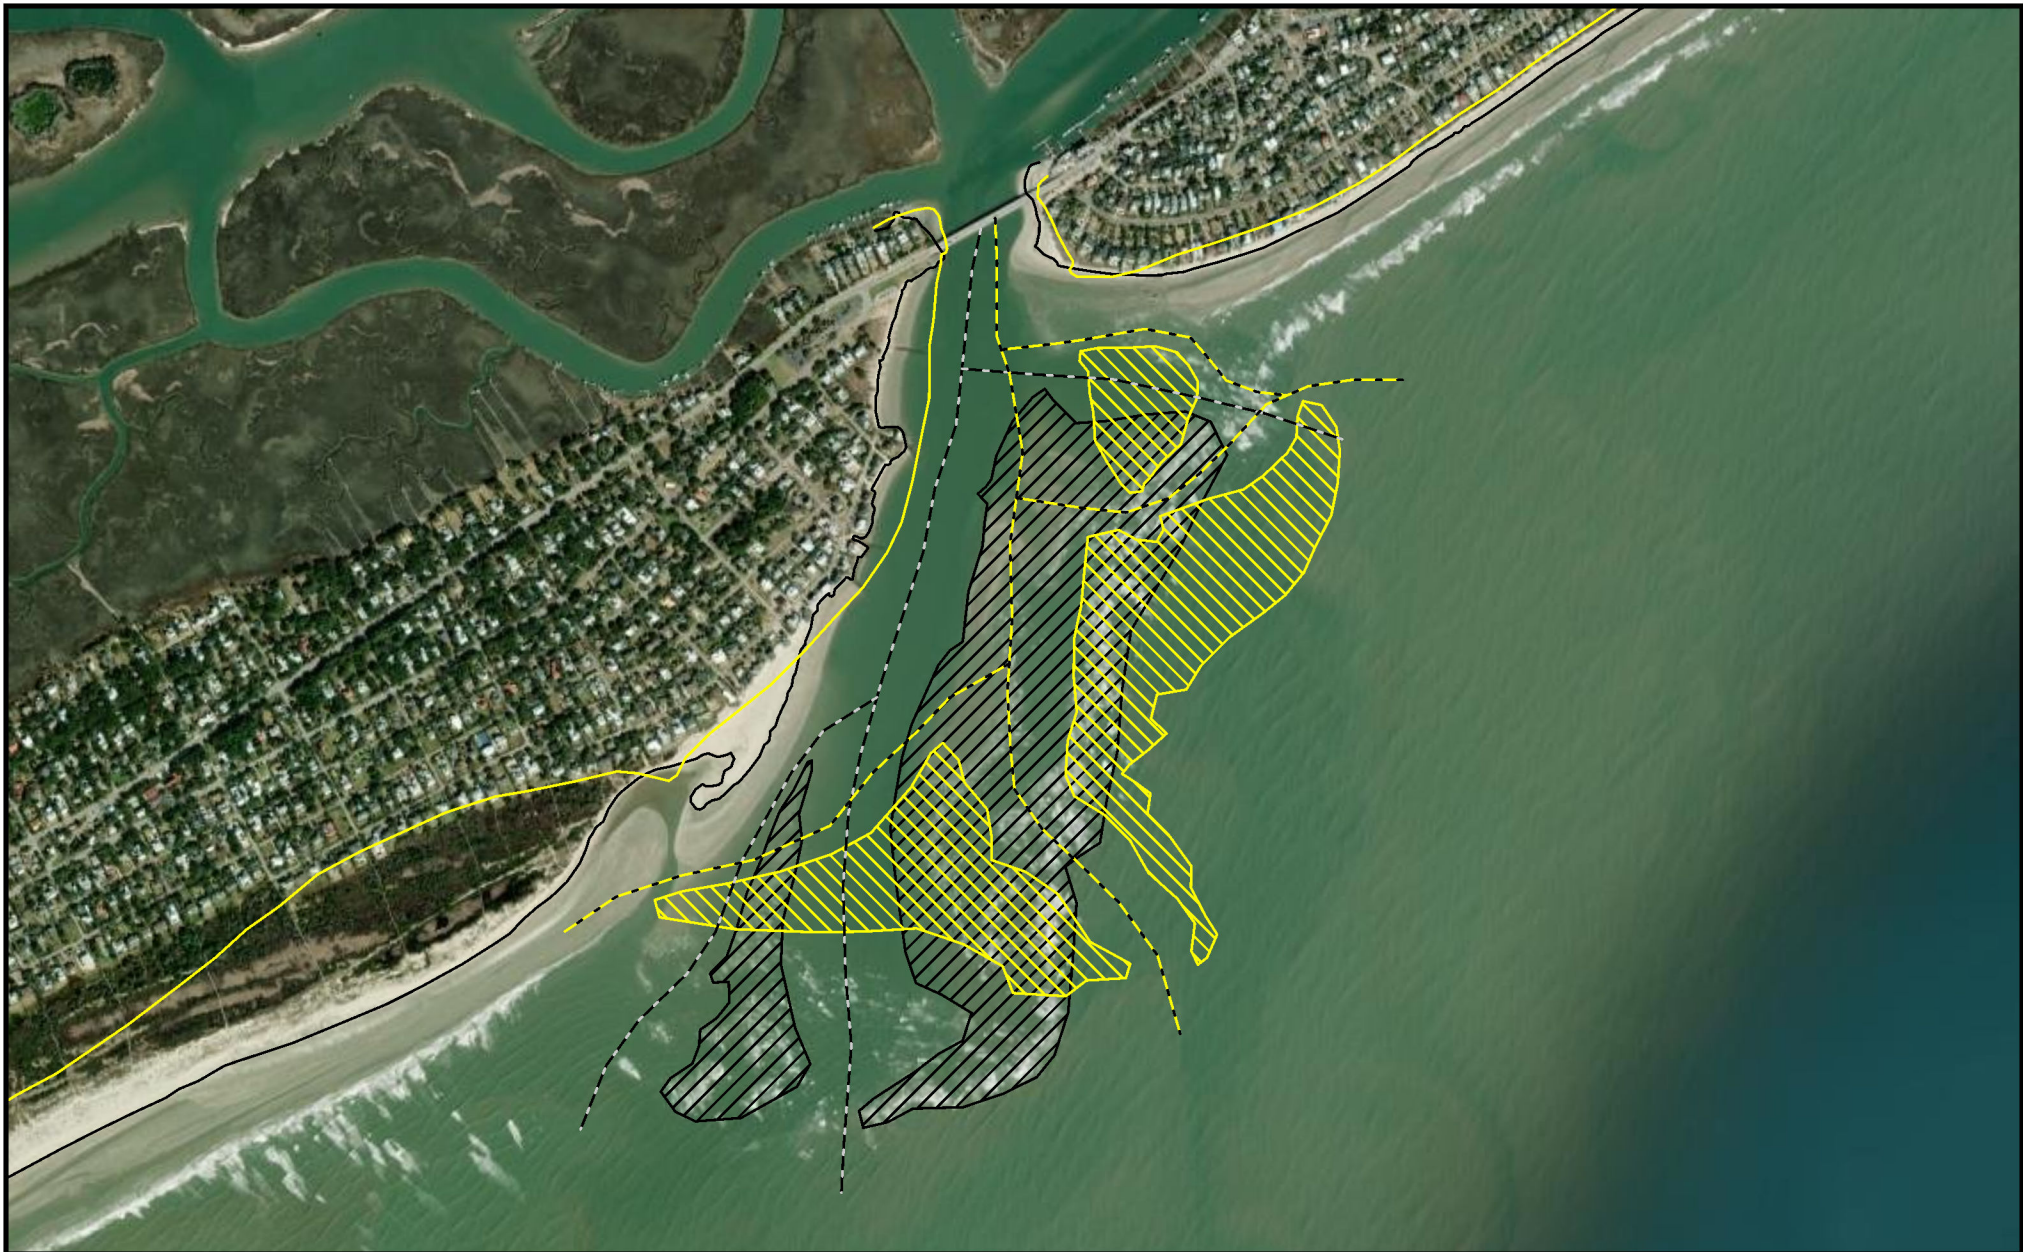
- 1) 1958 datasets are based on a USGS Aerial Imagery from 1958. 2024 datasets are based on aerial imagery collected on February 21, 2024 by ESRI Basemap Services.
- 2) Background imagery collected on February 21, 2024 and provides by ESRI Basemap Services
