**Beach Preservation Ad Hoc Committee
11:00 a.m., Tuesday, August 12, 2025
City Hall Council Chambers
1207 Palm Boulevard, Isle of Palms, SC 29451**

Erosion Assessment of the South End of Isle of Palms

Prepared By
COASTAL PROTECTION ENGINEERING, LLC

May 2025

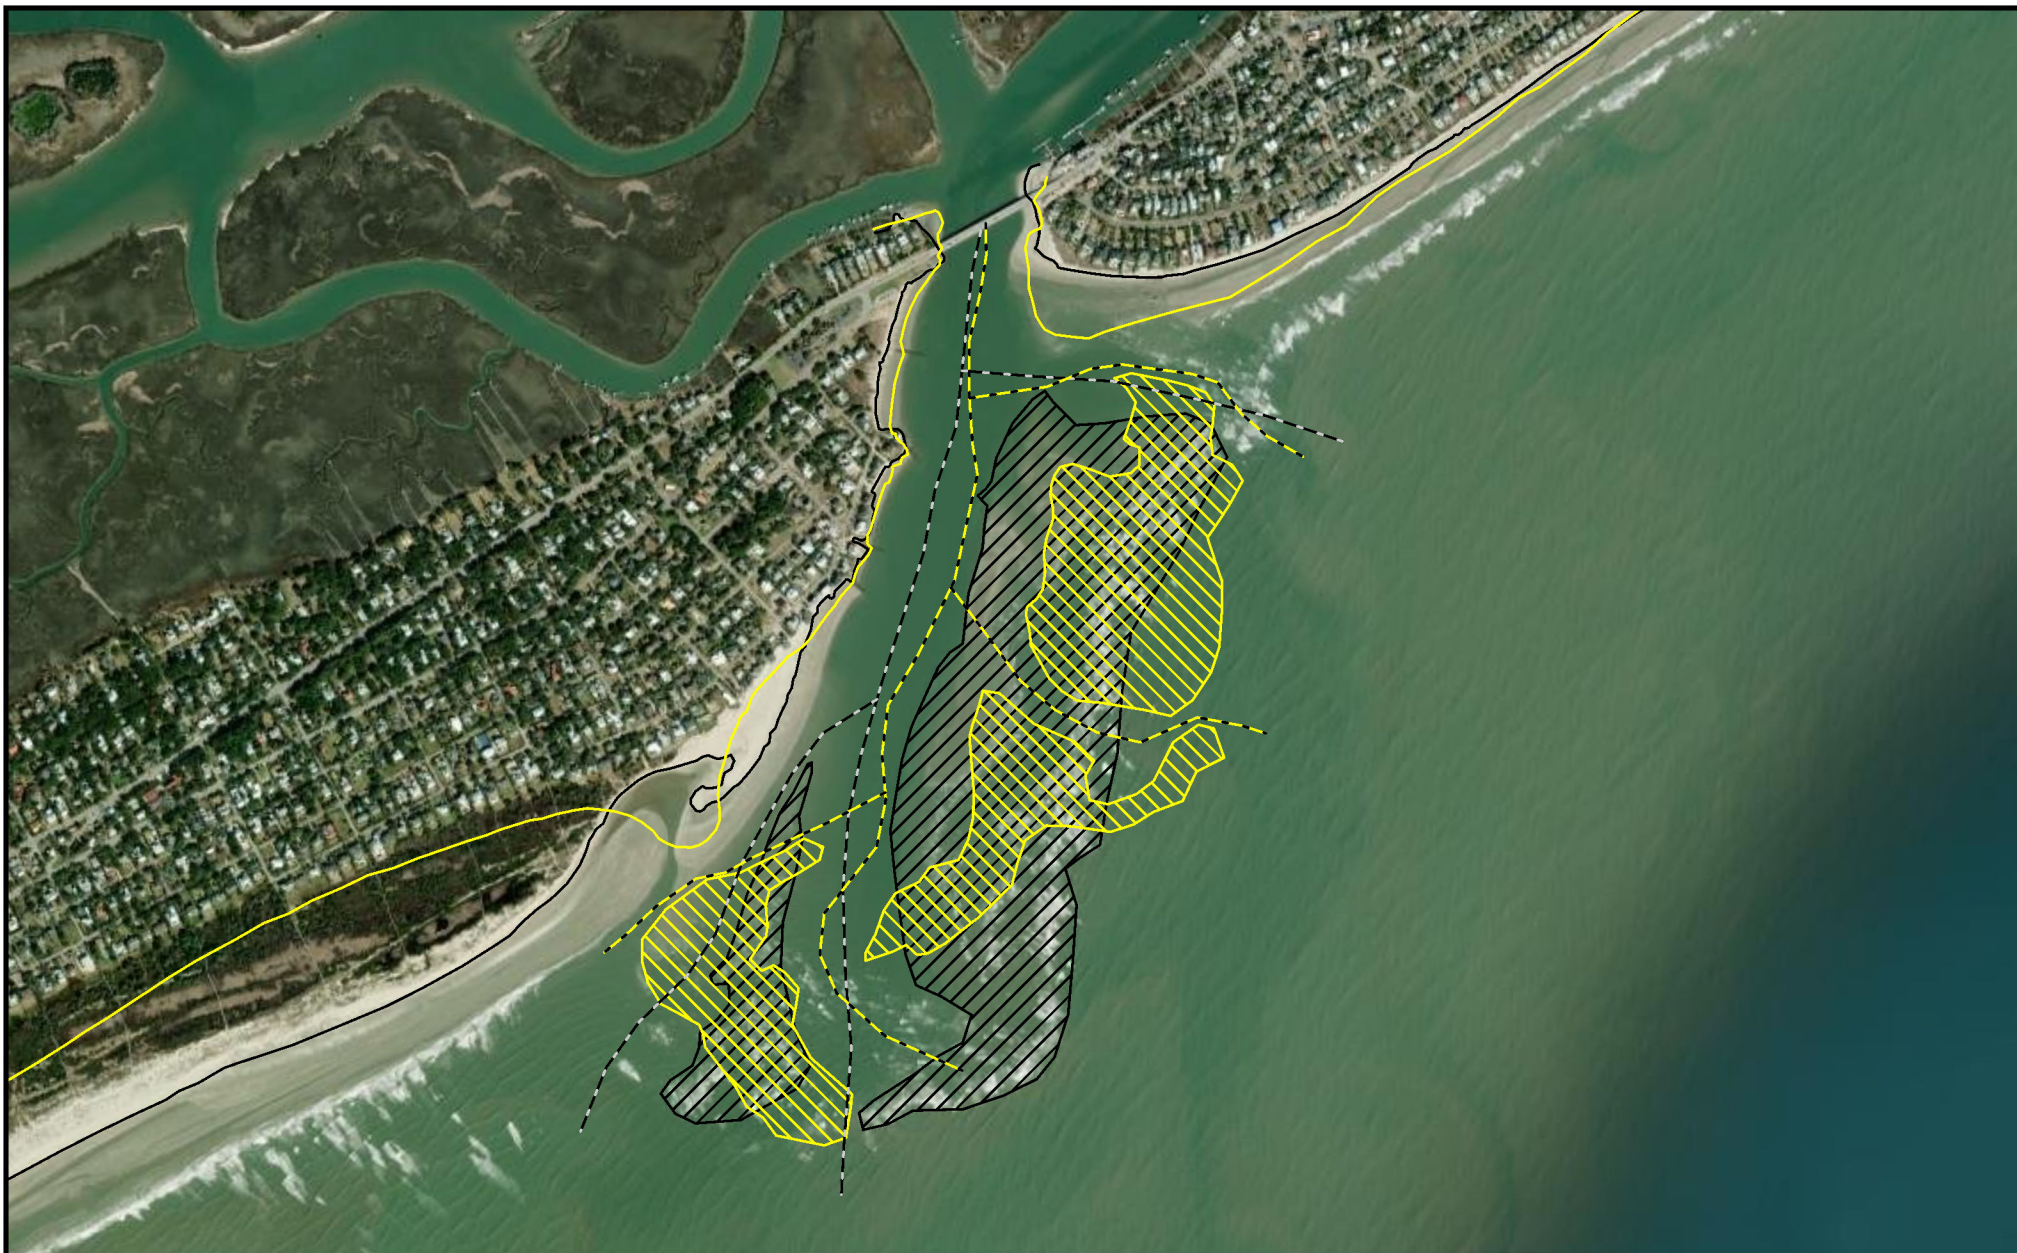
- 1) 1968 datasets are based on a USGS Aerial Imagery from 1968. 2024 datasets are based on aerial imagery collected on February 21, 2024 by ESRI Basemap Services.
- 2) Background imagery collected on February 21, 2024 and provides by ESRI Basemap Services

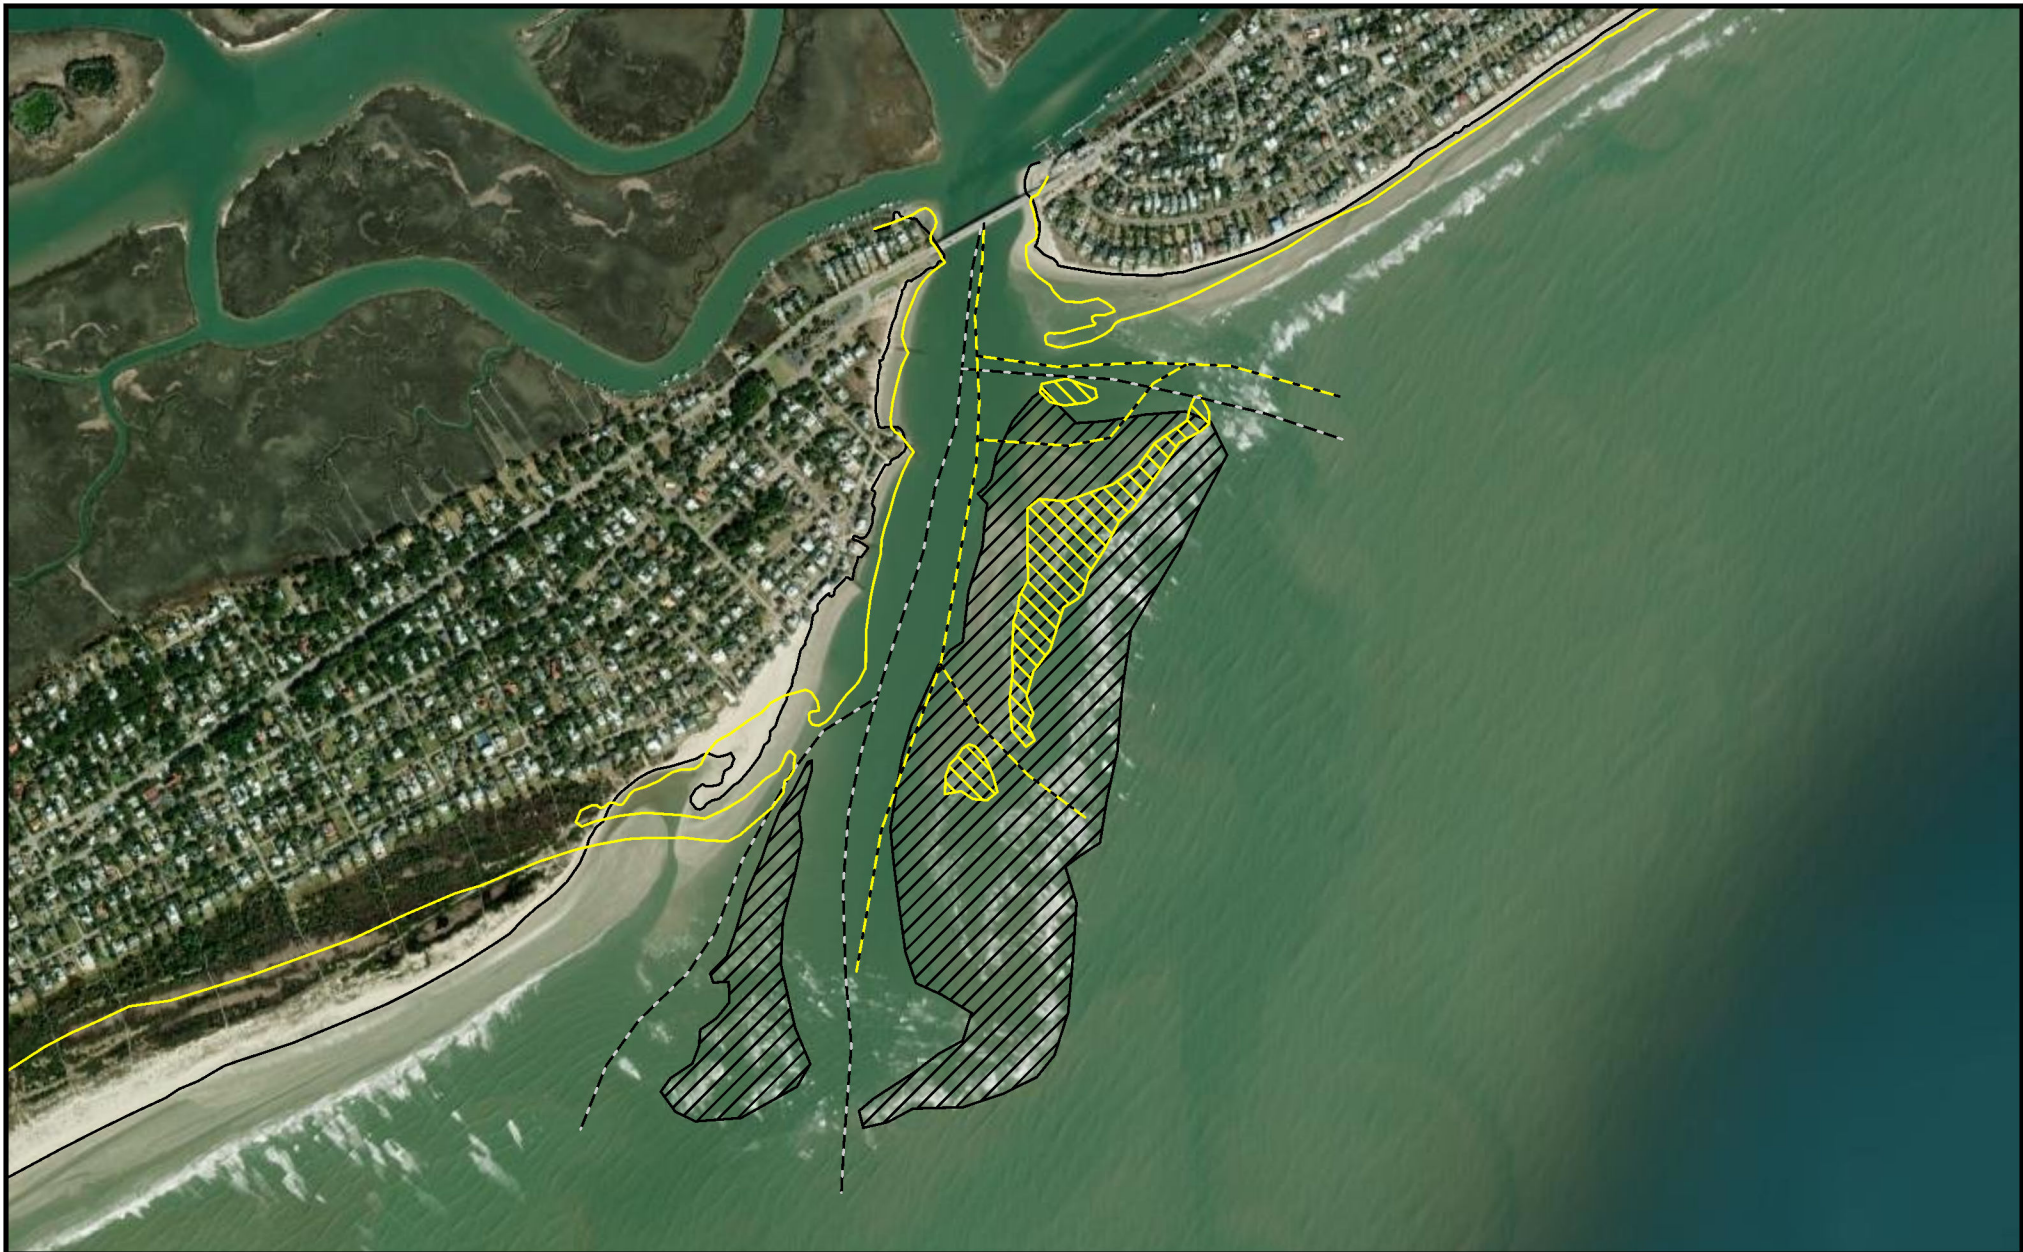
- 1) 1977 datasets are based on NOAA Color Infrared Imagery from 1977. 2024 datasets are based on aerial imagery collected on February 21, 2024 by ESRI Basemap Services.
- 2) Background imagery collected on February 21, 2024 and provides by ESRI Basemap Services

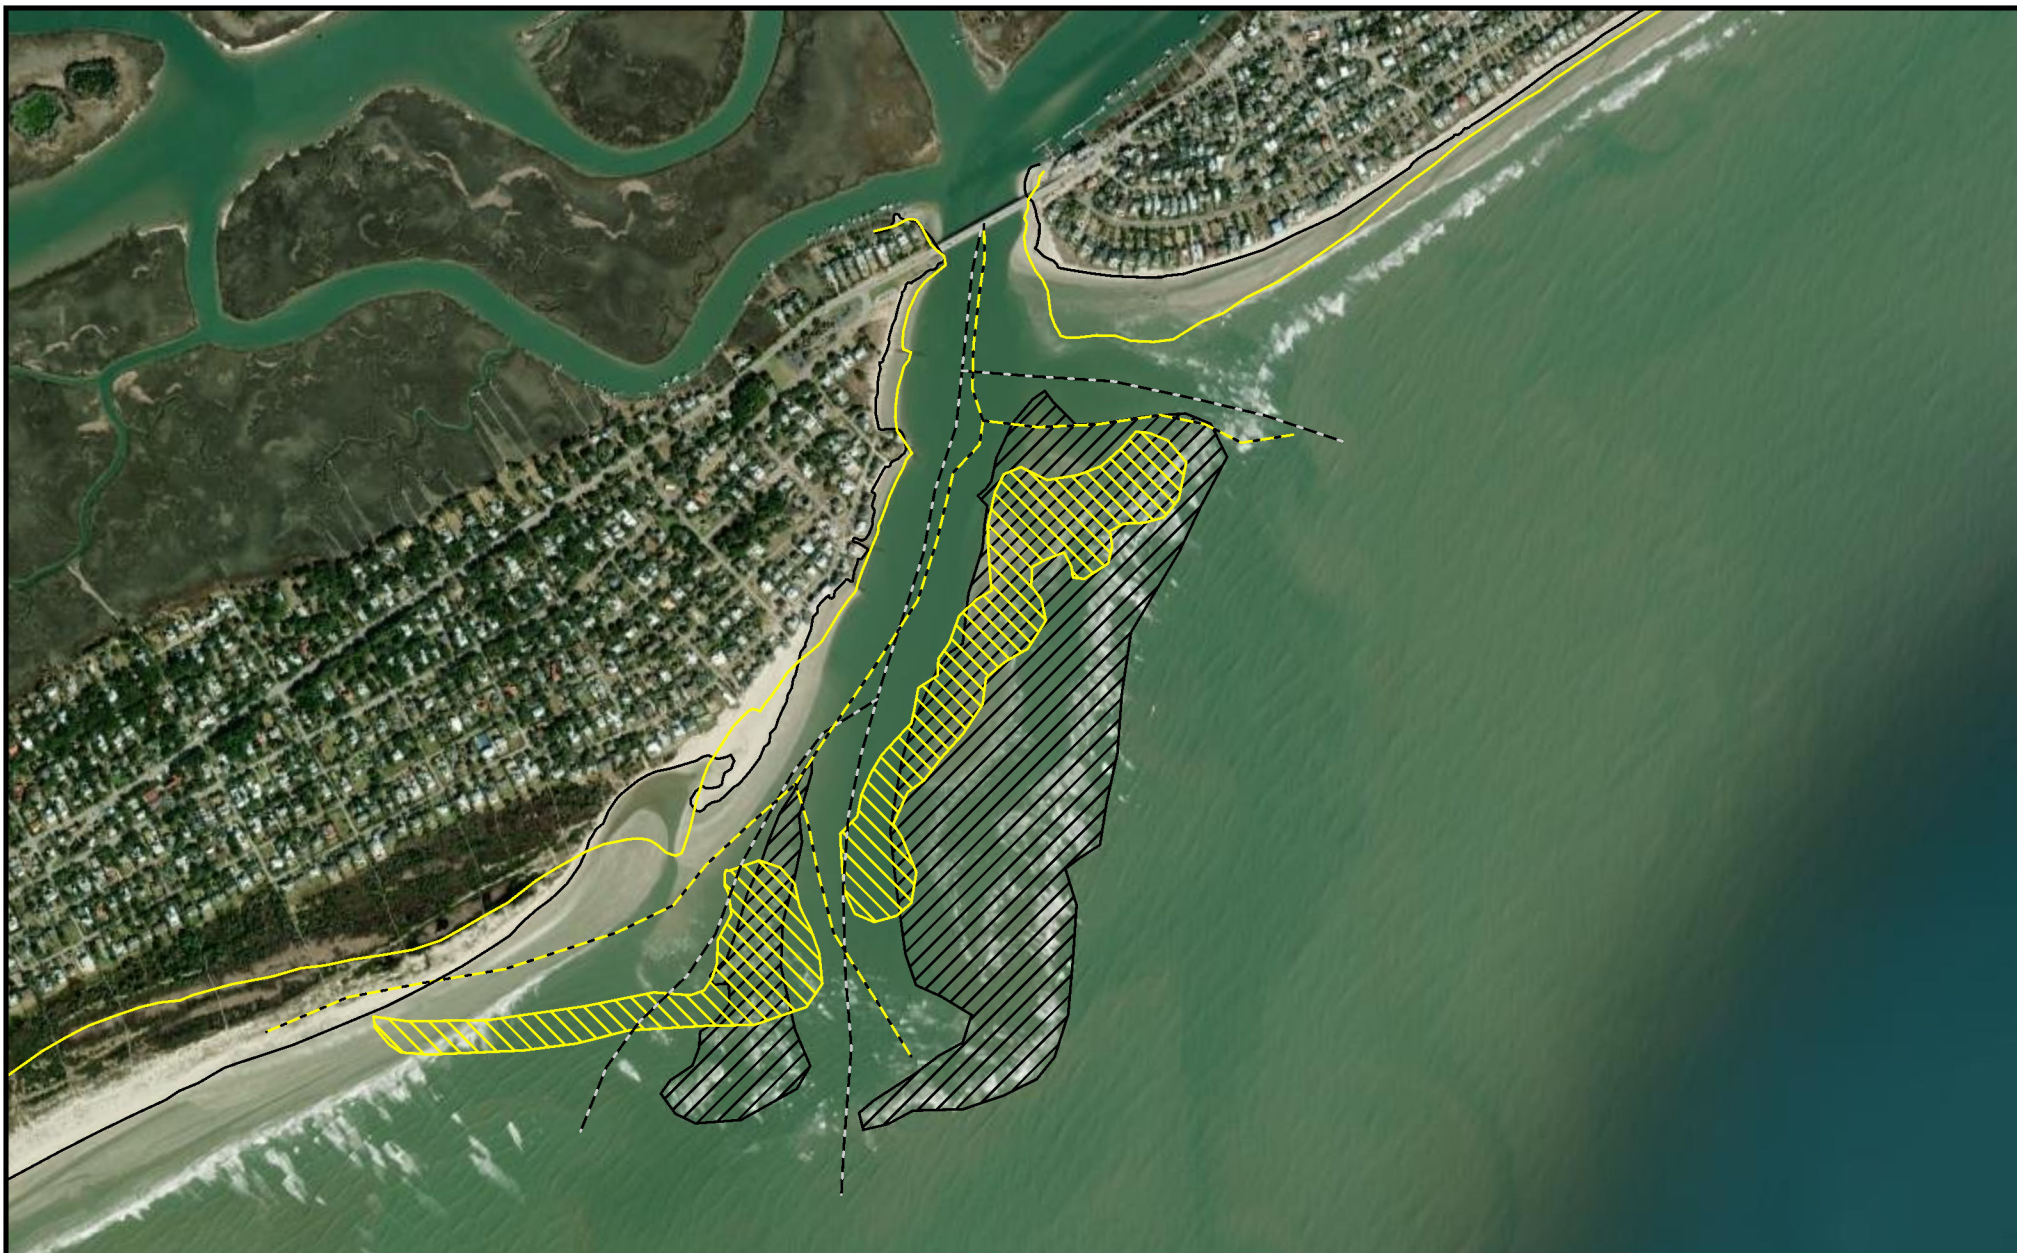
- 1) 1989 datasets are based on a USGS Digital Orthophoto Quadrangle from 1989. 2024 datasets are based on aerial imagery collected on February 21, 2024 by ESRI Basemap Services.
- 2) Background imagery collected on February 21, 2024 and provided by ESRI Basemap Services

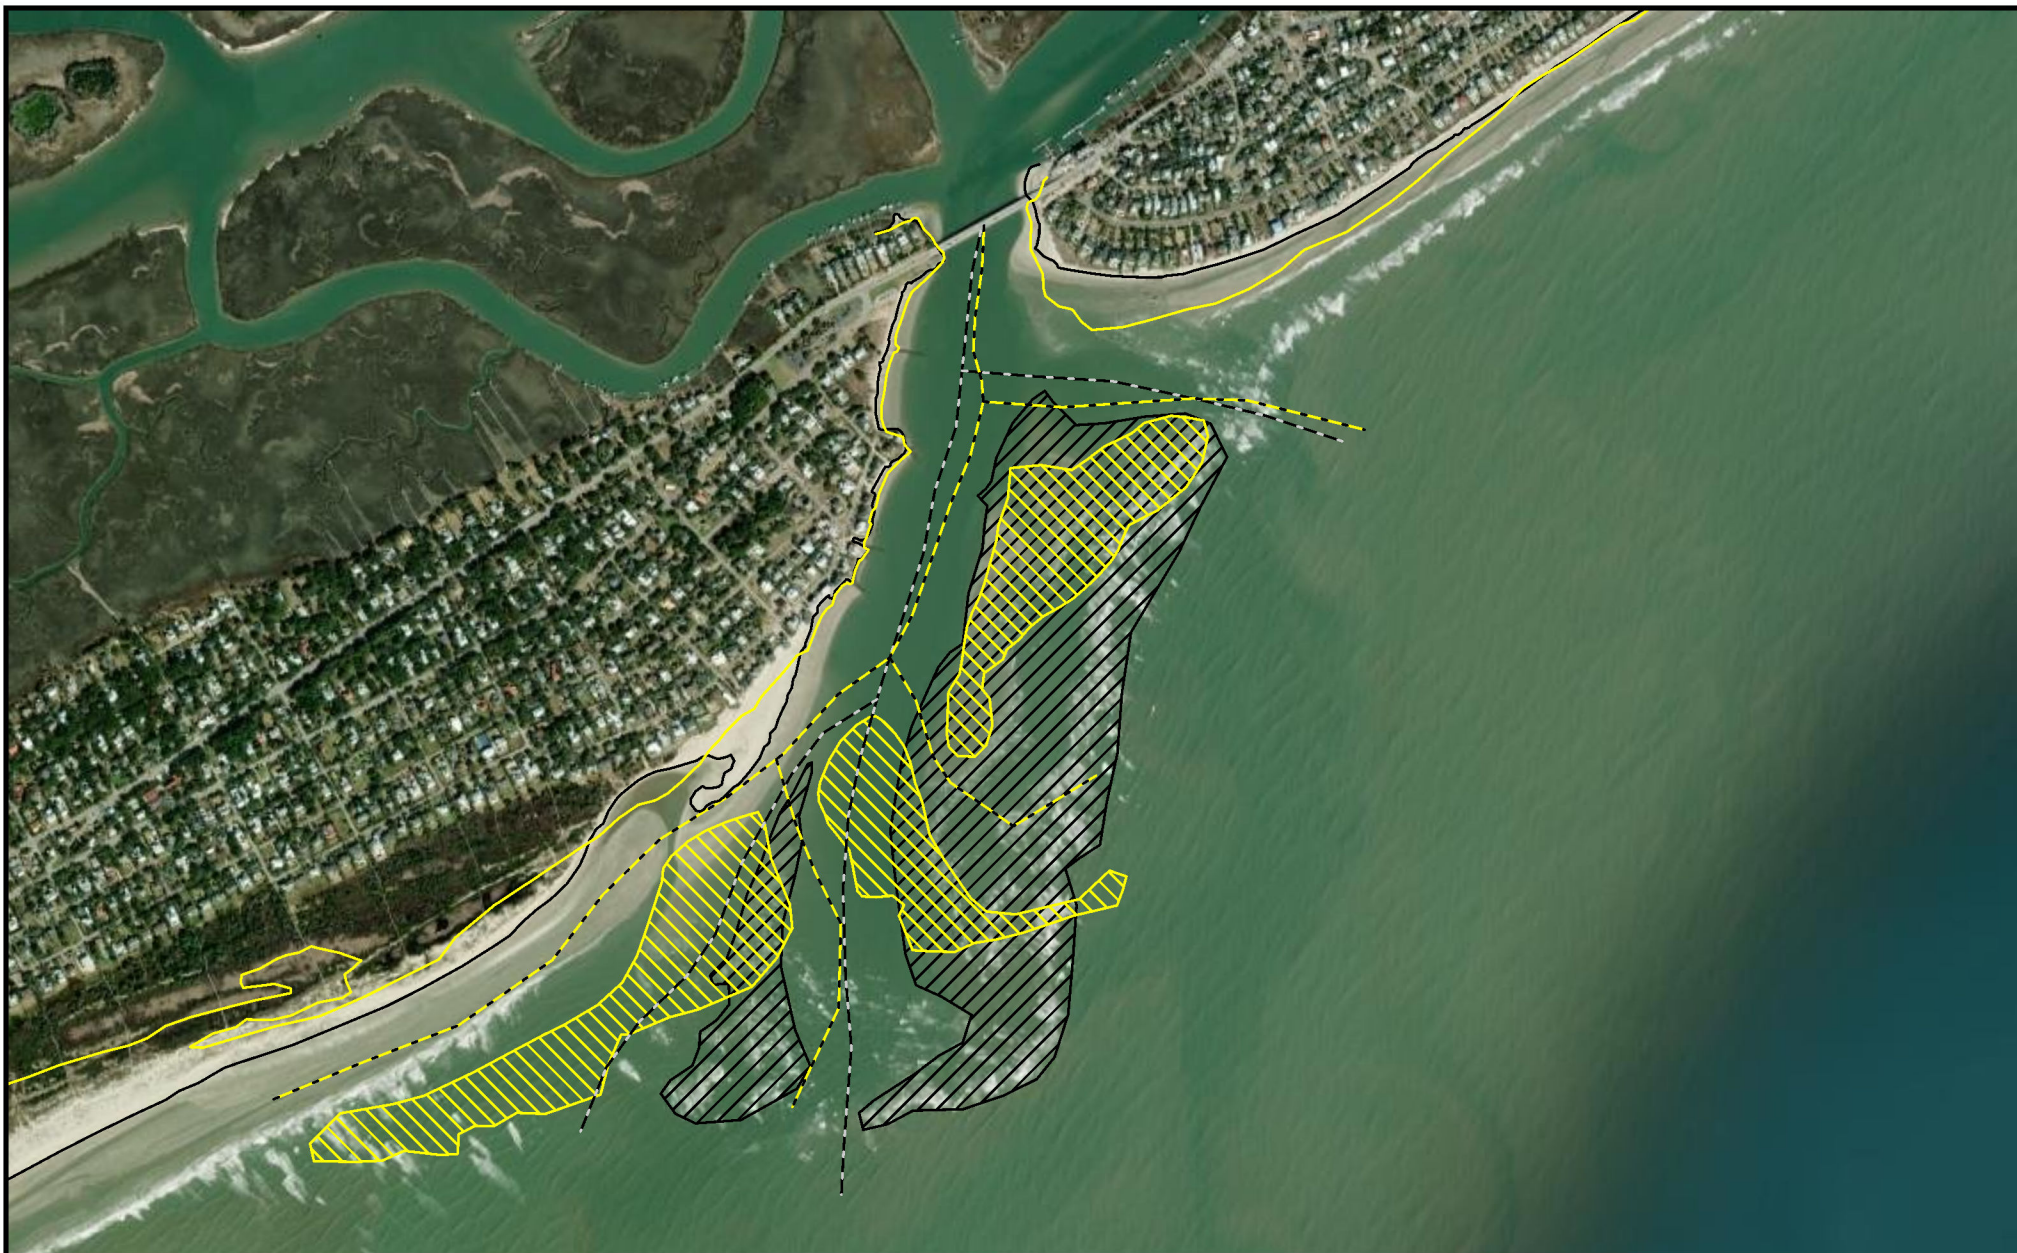
- 1) 1994 datasets are based on a USGS Digital Orthophoto Quadrangle from 1994. 2024 datasets are based on aerial imagery collected on February 21, 2024 by ESRI Basemap Services.
- 2) Background imagery collected on February 21, 2024 and provides by ESRI Basemap Services

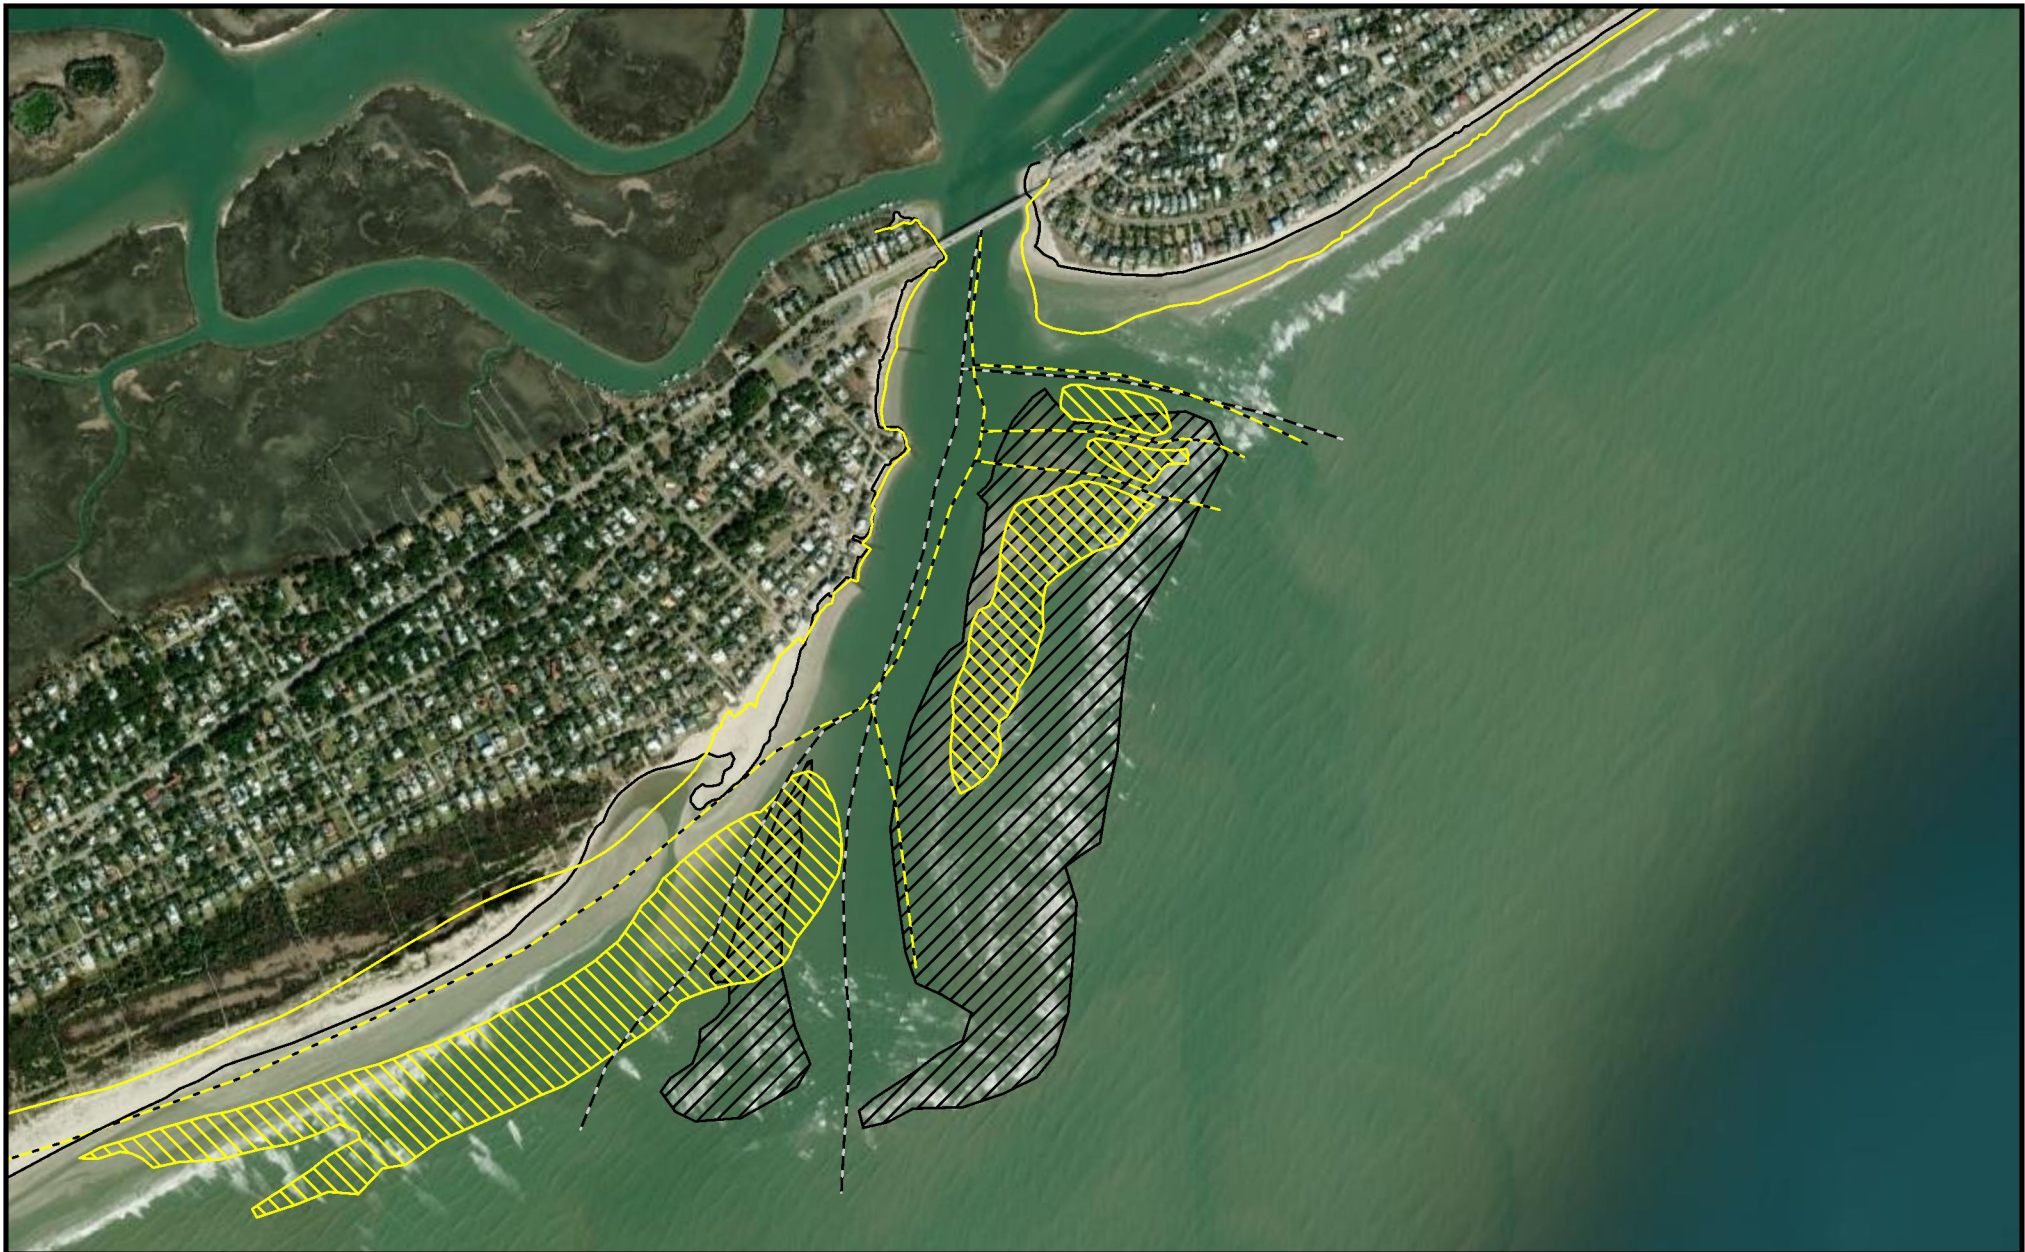
- 1) 2004 datasets are based on a USGS High Resolution Orthoimagery from 2004. 2024 datasets are based on aerial imagery collected on February 21, 2024 by ESRI Basemap Services.
- 2) Background imagery collected on February 21, 2024 and provides by ESRI Basemap Services

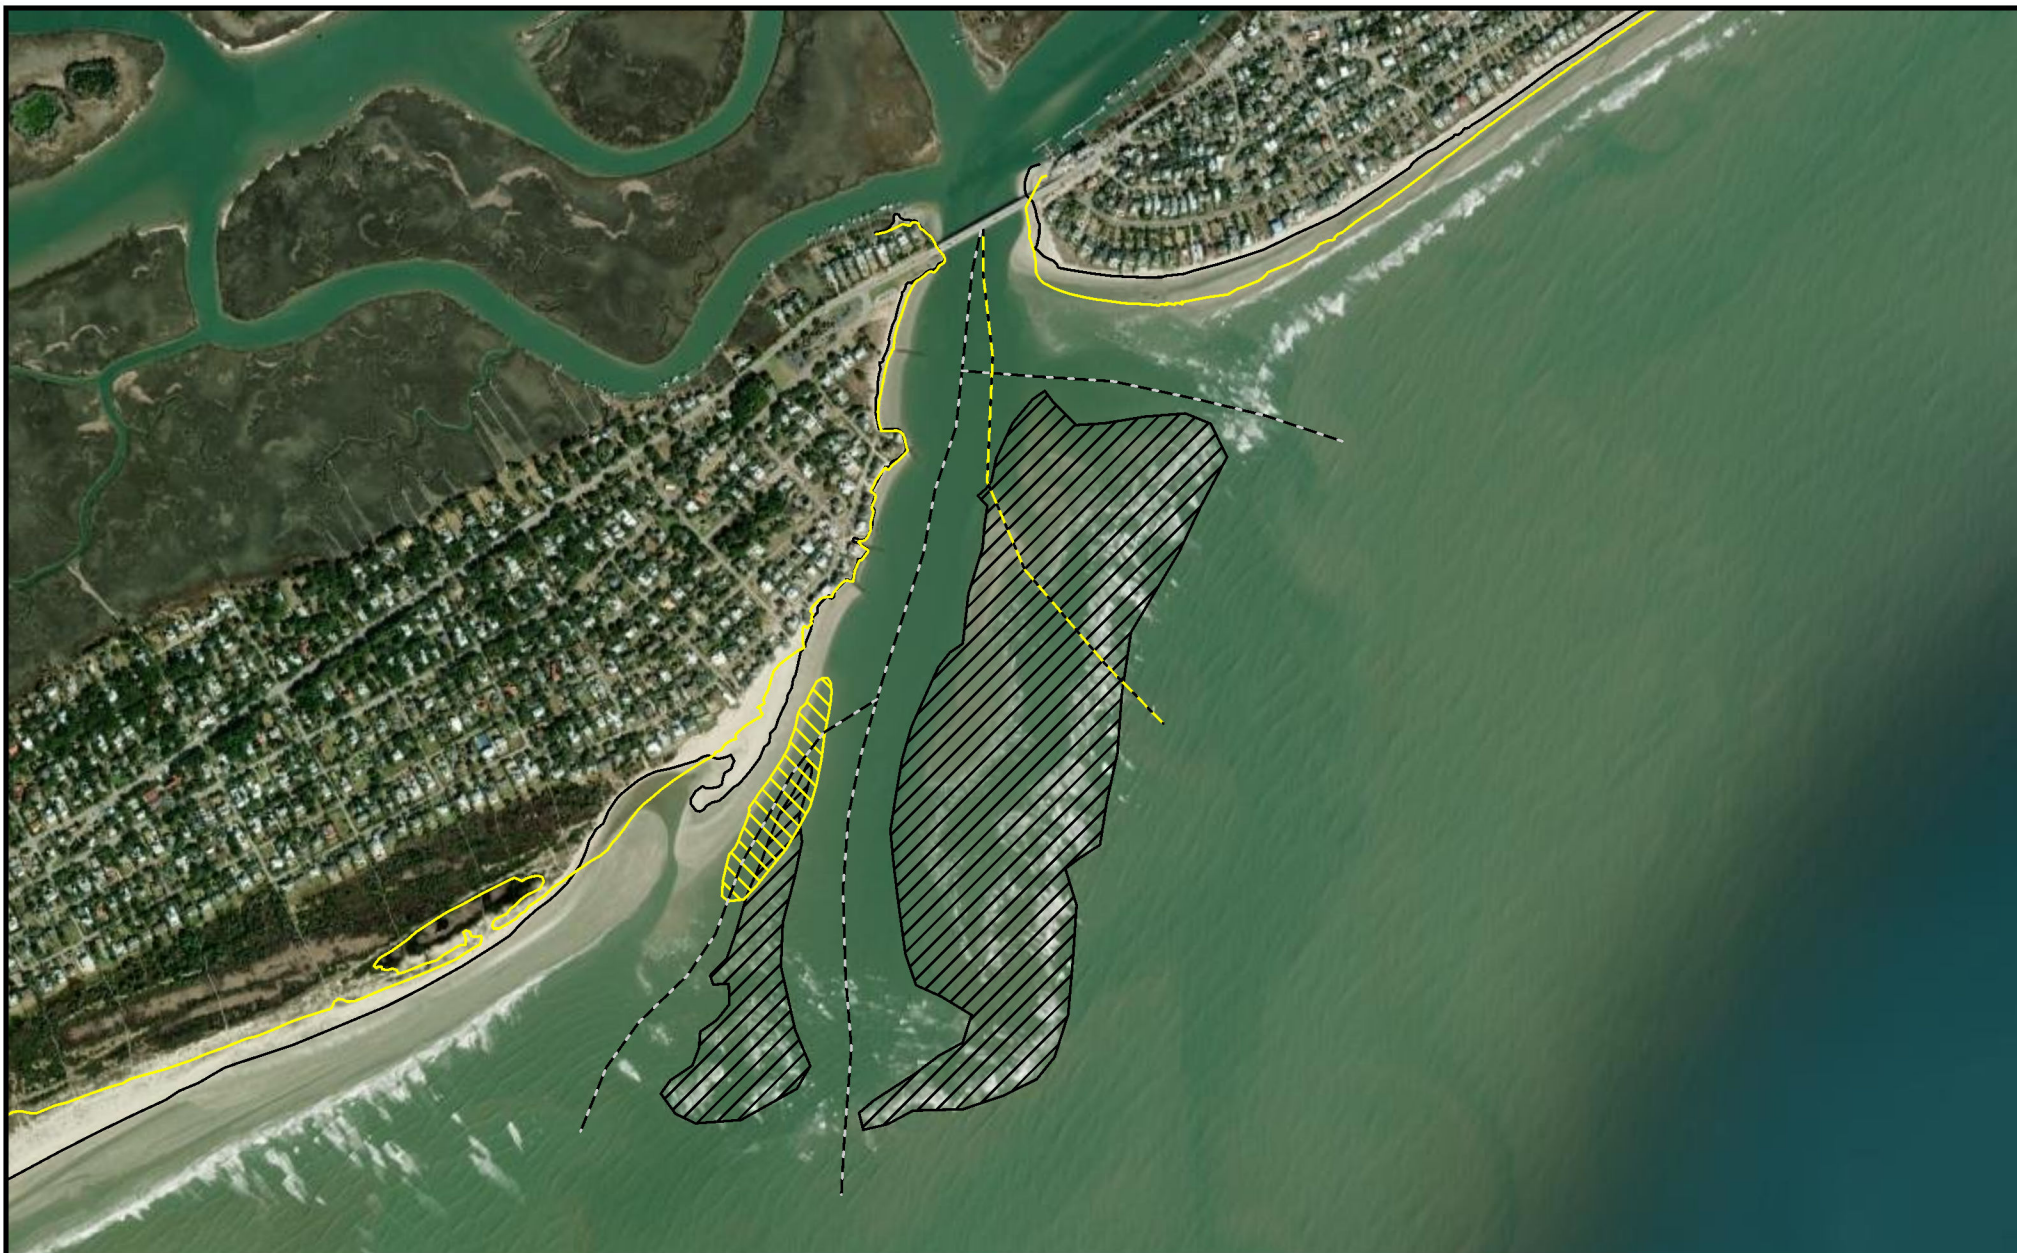
- 1) 2011 datasets are based on a NOAA Aerial Imagery from 2011. 2024 datasets are based on aerial imagery collected on February 21, 2024 by ESRI Basemap Services.
- 2) Background imagery collected on February 21, 2024 and provides by ESRI Basemap Services

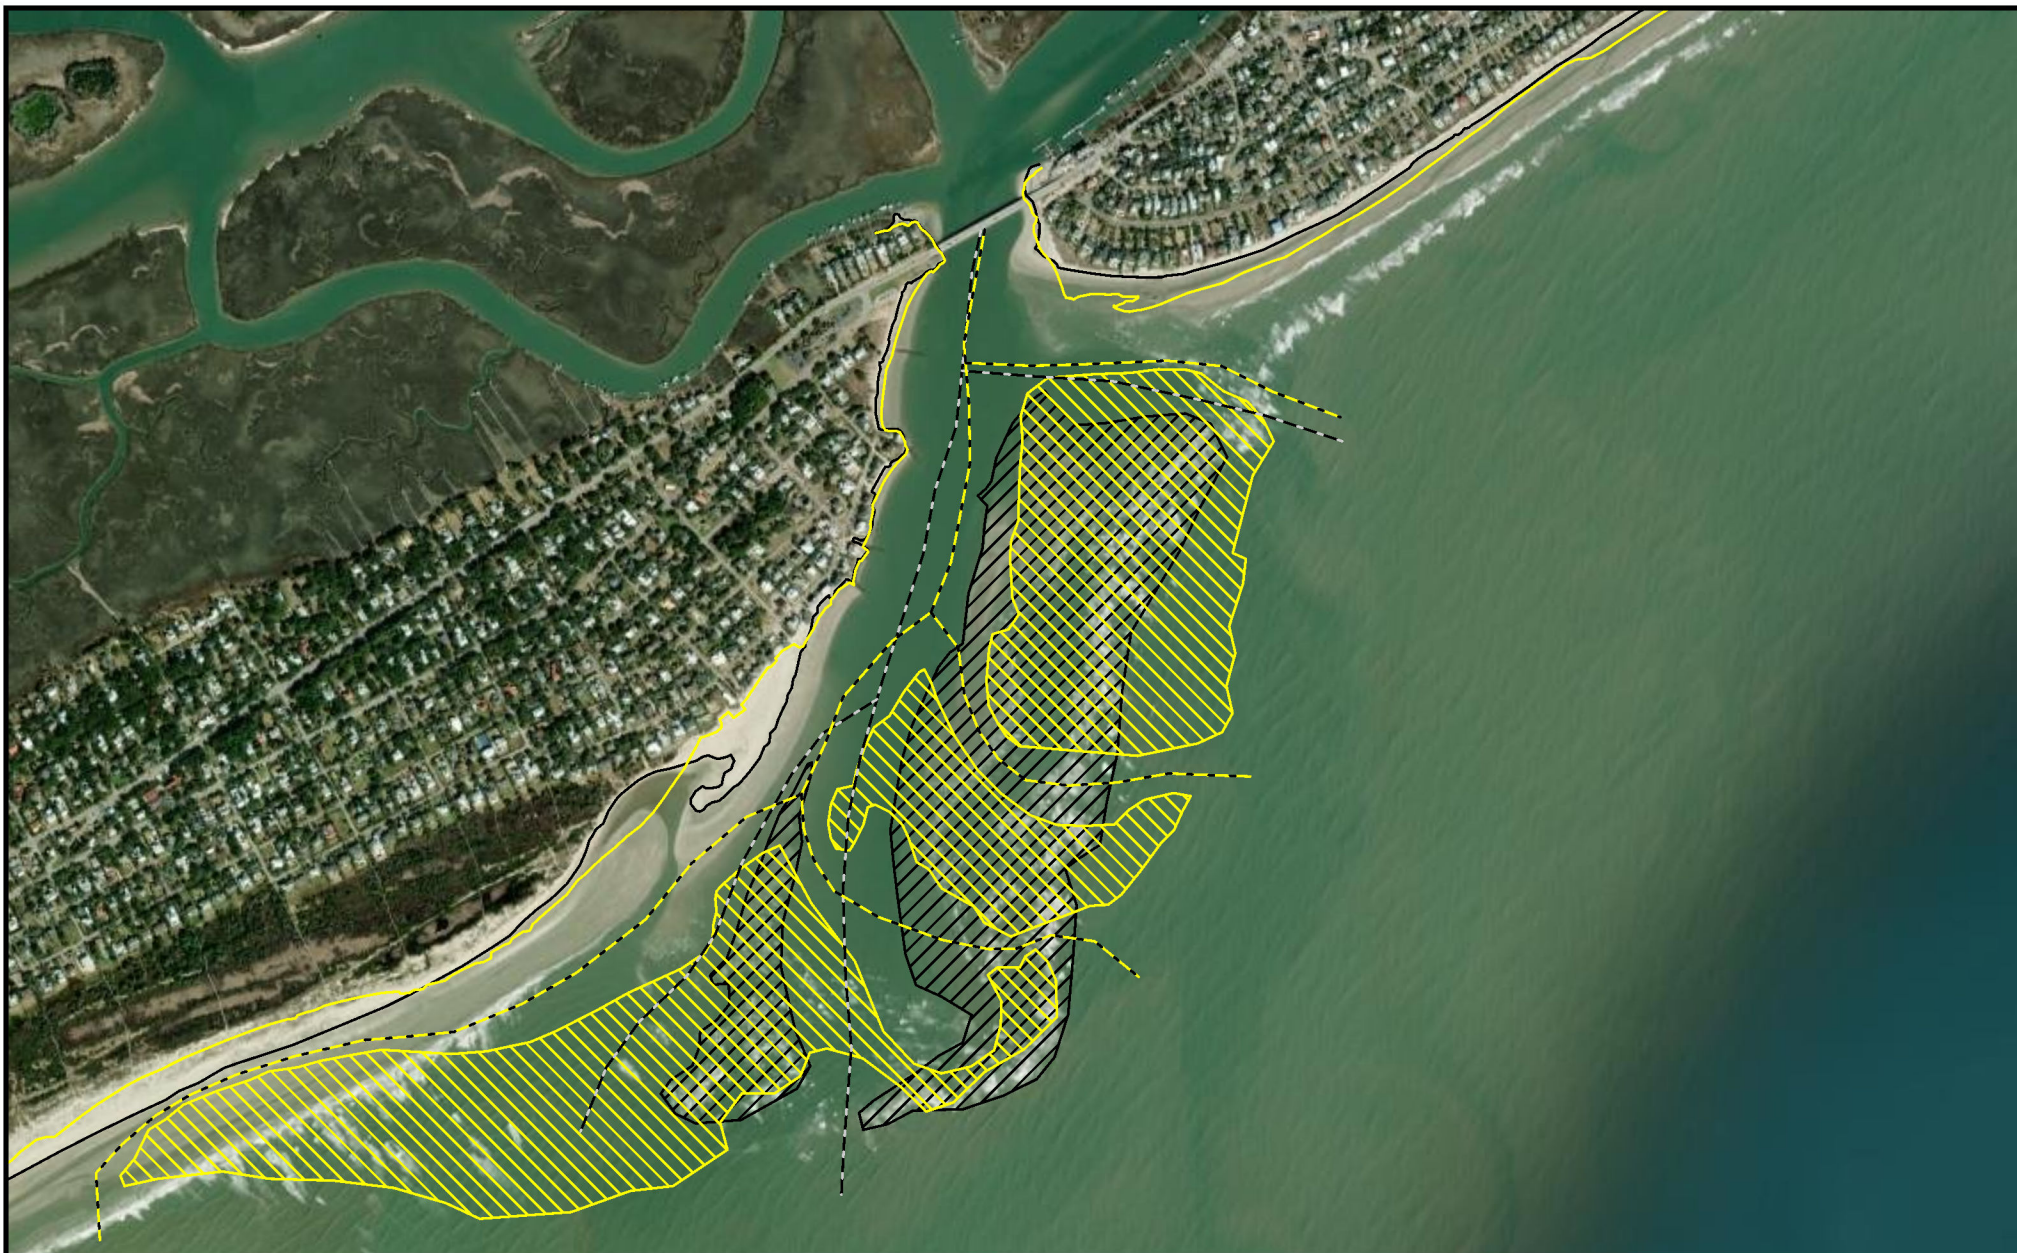
- 1) 2016-2017 datasets are based on a NOAA Aerial Imagery from 2016-2017. 2024 datasets are based on aerial imagery collected on February 21, 2024 by ESRI Basemap Services.
- 2) Background imagery collected on February 21, 2024 and provides by ESRI Basemap Services

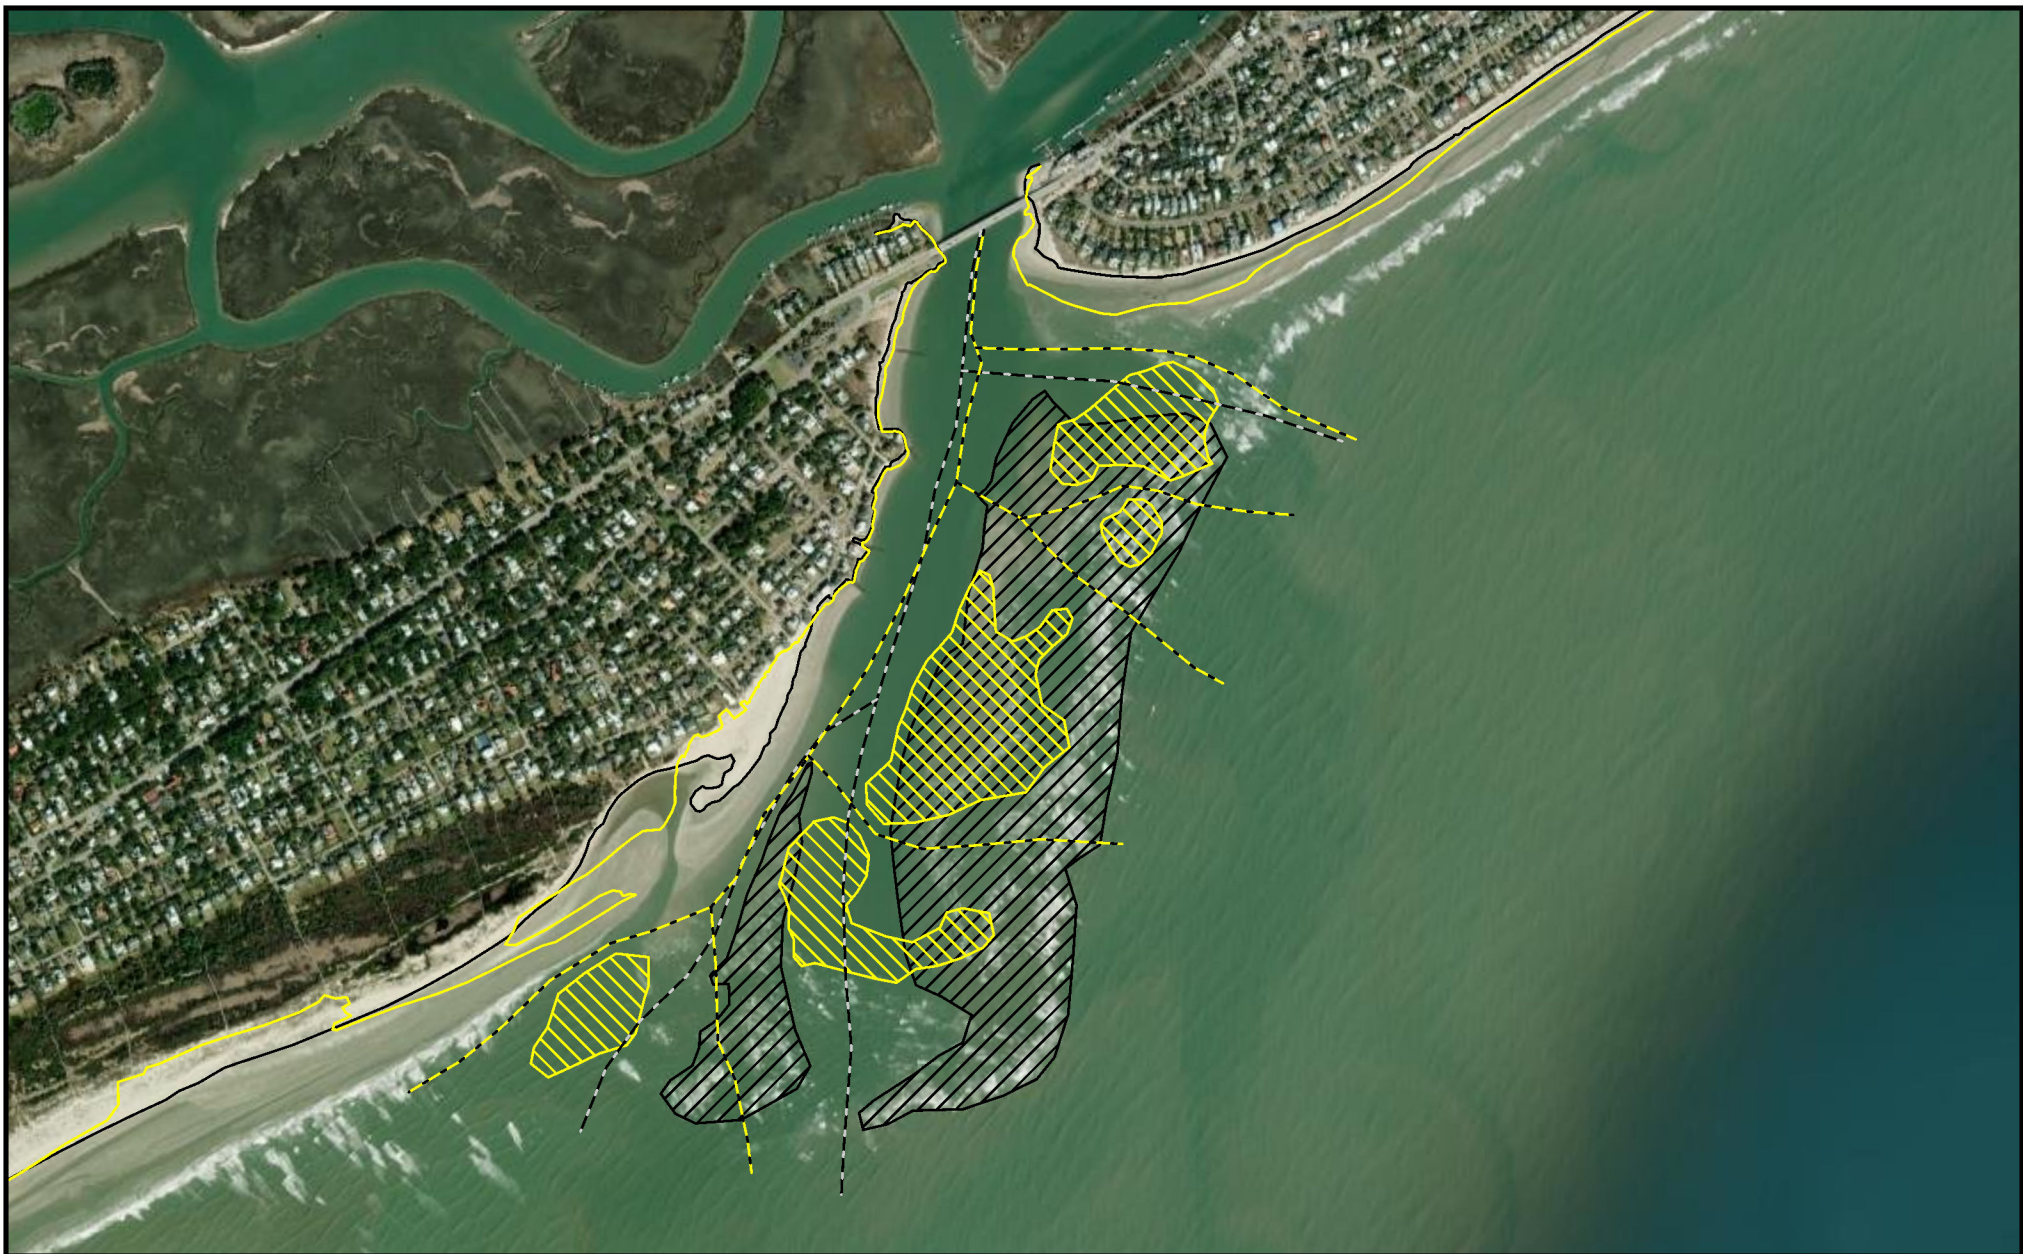
- 1) 2019 datasets are based on Charleston County Aerial Imagery from 2019. 2024 datasets are based on aerial imagery collected on February 21, 2024 by ESRI Basemap Services.
- 2) Background imagery collected on February 21, 2024 and provides by ESRI Basemap Services
