**Beach Preservation Ad Hoc Committee
11:00 a.m., Tuesday, August 12, 2025
City Hall Council Chambers
1207 Palm Boulevard, Isle of Palms, SC 29451**

Erosion Assessment of the South End of Isle of Palms

Prepared By
COASTAL PROTECTION ENGINEERING, LLC

May 2025

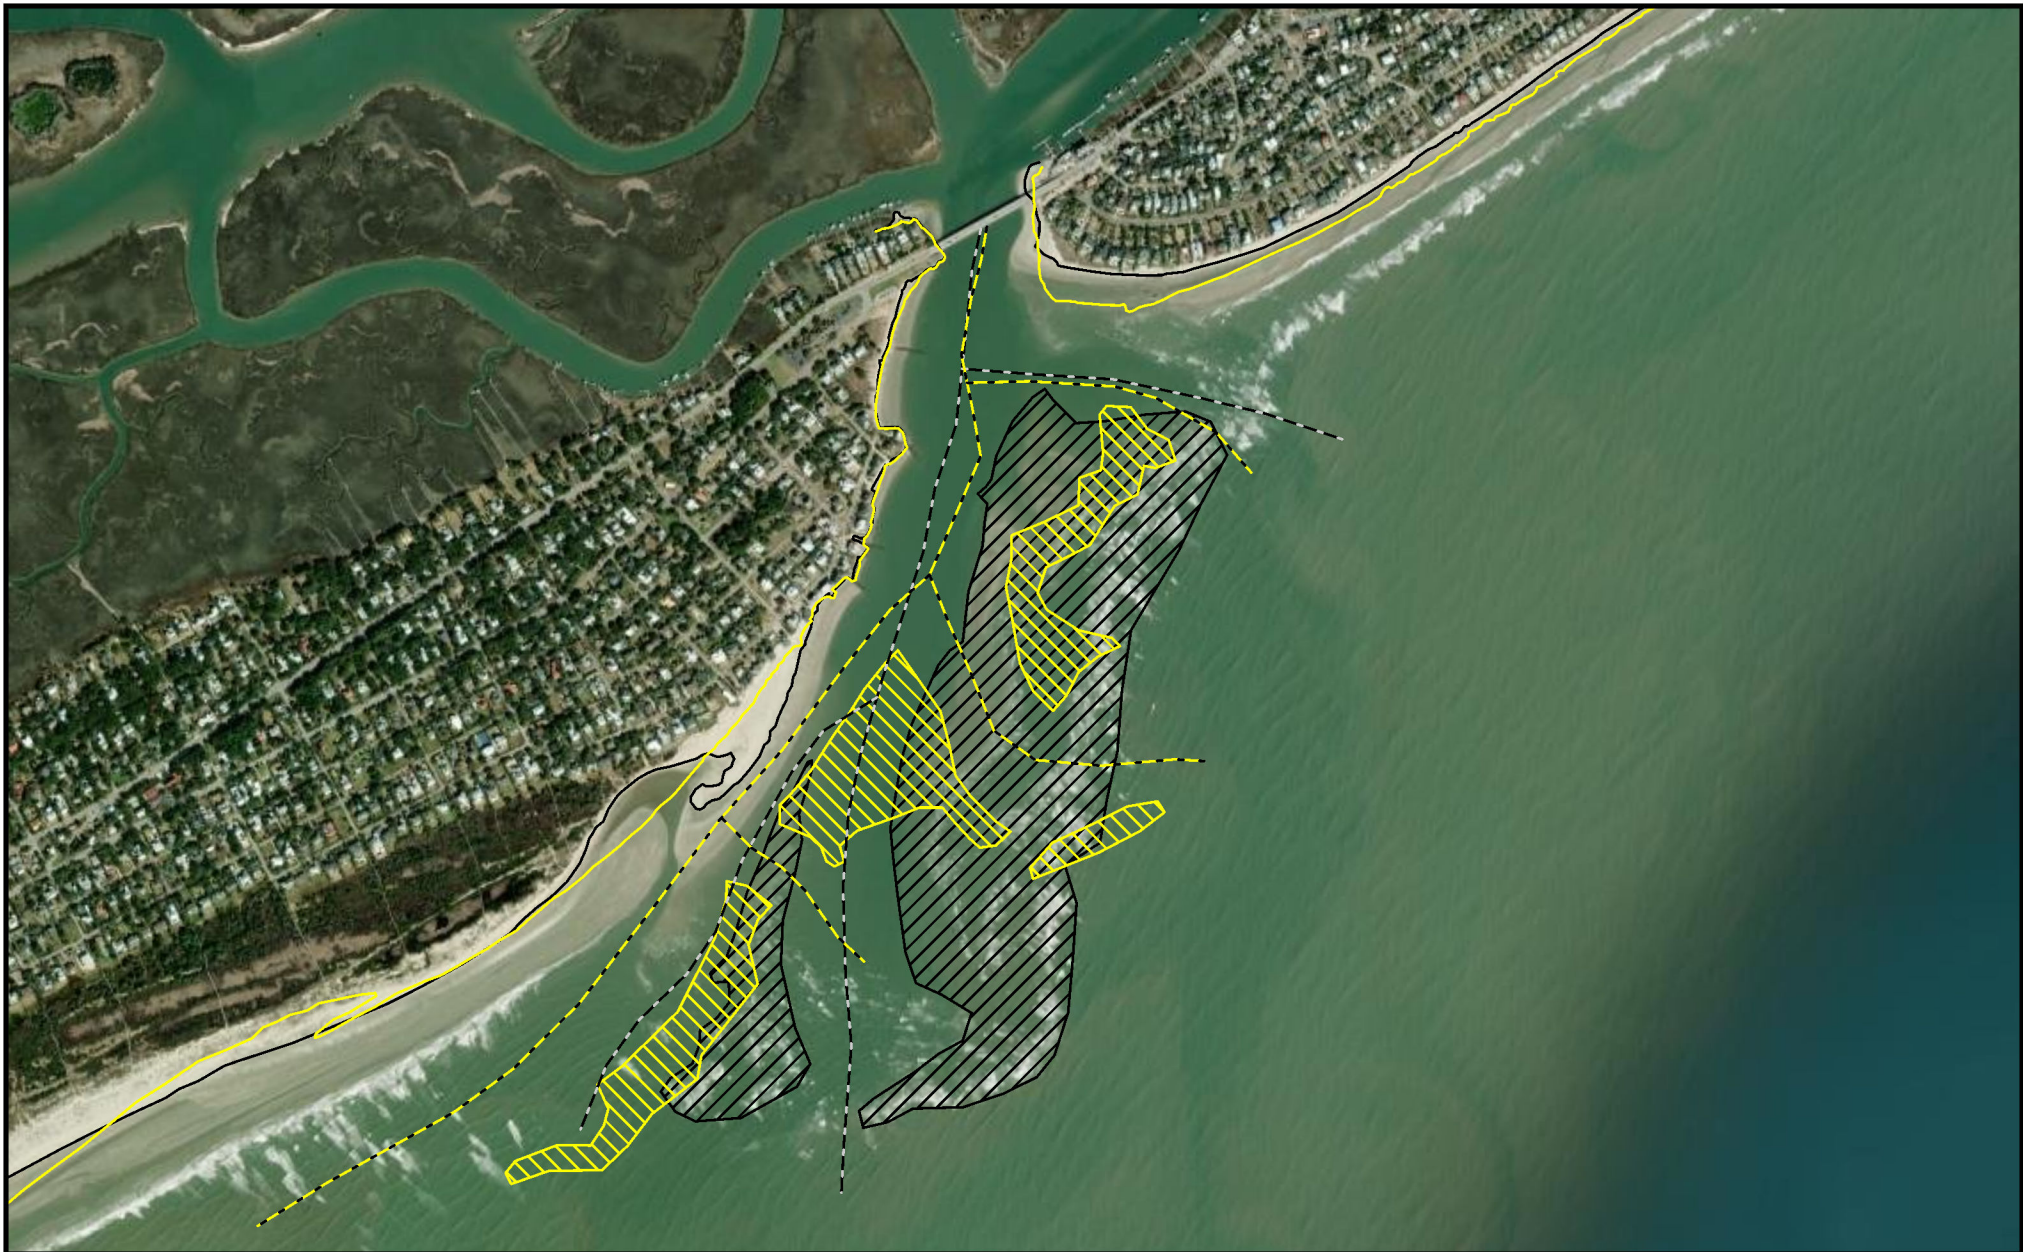
- 1) 2021 datasets are based on USDA NAIP 4-Band Imagery from 2021. 2024 datasets are based on aerial imagery collected on February 21, 2024 by ESRI Basemap Services.
- 2) Background imagery collected on February 21, 2024 and provides by ESRI Basemap Services

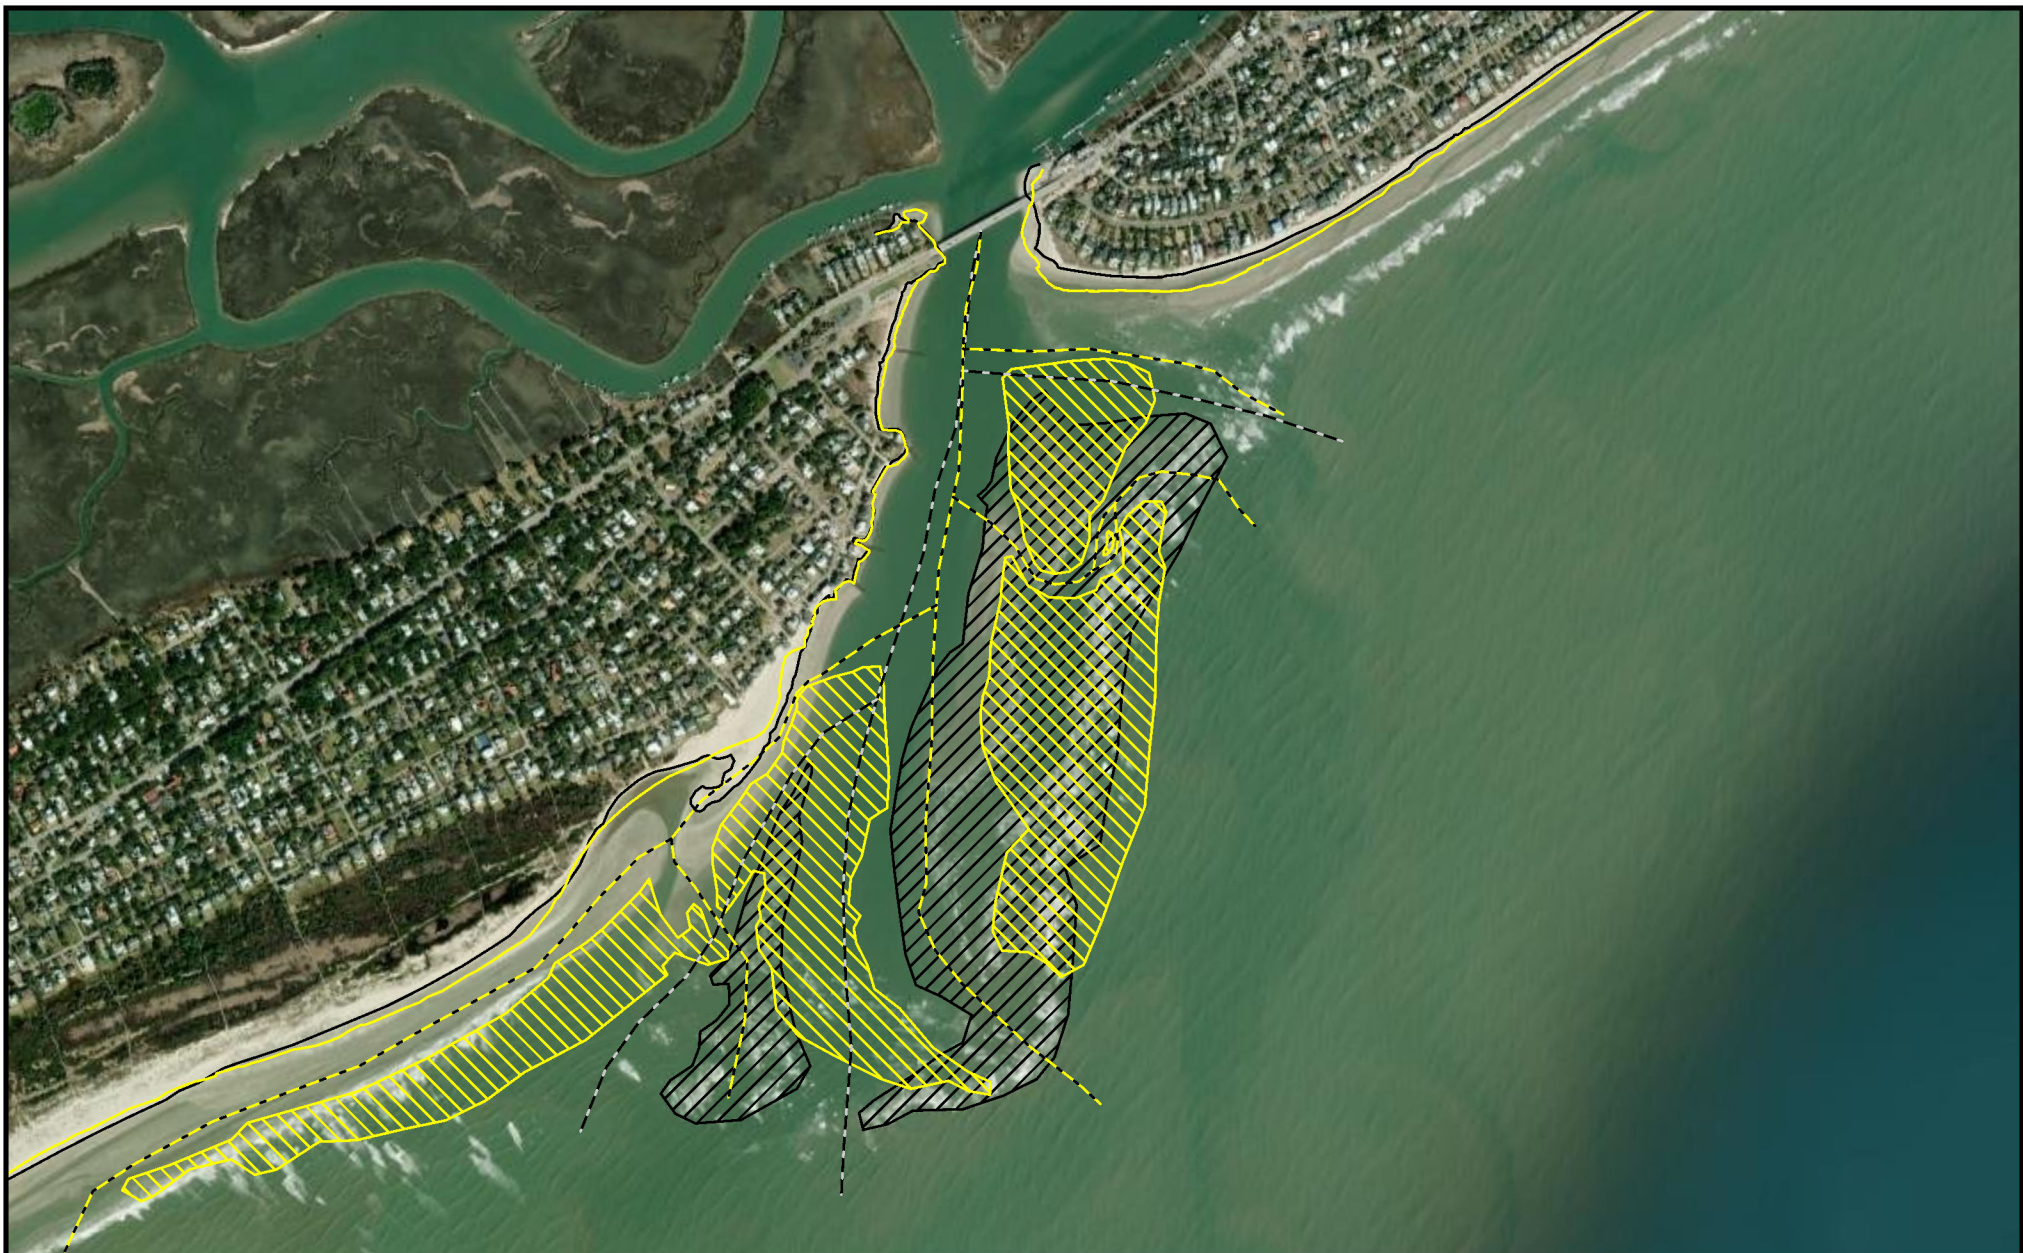
- 1) 2023 datasets are based on Charleston County Aerial Imagery from 2023. 2024 datasets are based on aerial imagery collected on February 21, 2024 by ESRI Basemap Services.
- 2) Background imagery collected on February 21, 2024 and provides by ESRI Basemap Services
