Beach Preservation Committee
1:00 p.m., Monday, March 23, 2026
1207 Palm Boulevard
City Hall Council Chambers

MEMORANDUM

RE: Interim Monitoring Report From August 2025 to February 2026

Isle of Palms Beach Nourishment

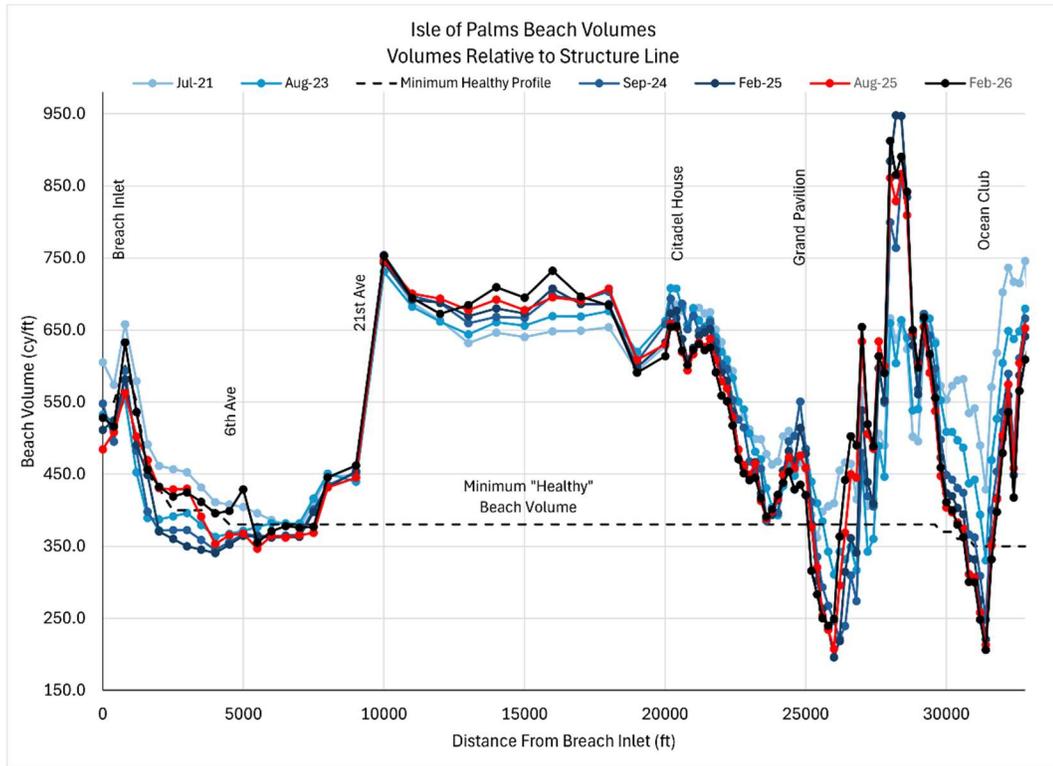
Figure 1: CSE's Minimum Healthy Beach Profile

Minimum Healthy Beach Volume – This is a template profile volume that contains sufficient sand to meet the goals of a community’s management effort and is based on an existing healthy beach condition (if it exists) at a site. The minimum healthy beach volume should contain sufficient quantity to be able to support a protective dune and a dry-sand beach width that is resilient to modest storms and spring tide events. It is the standard by which a beach’s condition can be measured against in long-term planning efforts. It is site specific, determined by the physical parameters shaping the beach profile and the community’s goals.

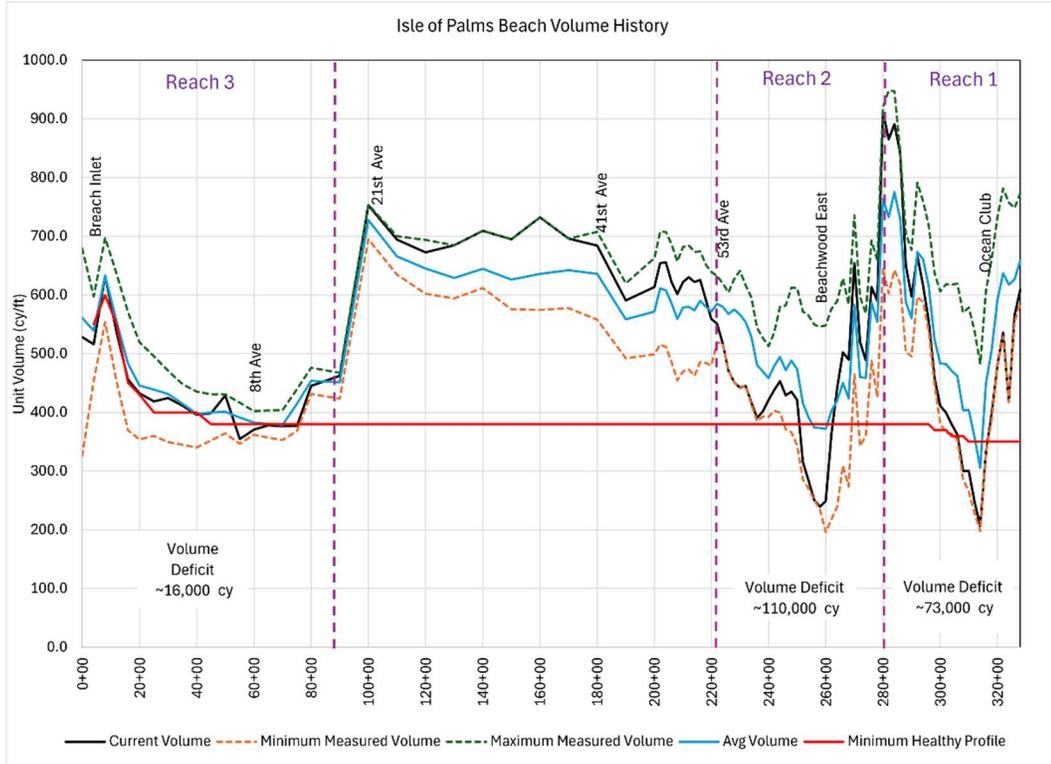
Figure 2: Isle of Palms Beach Volume History

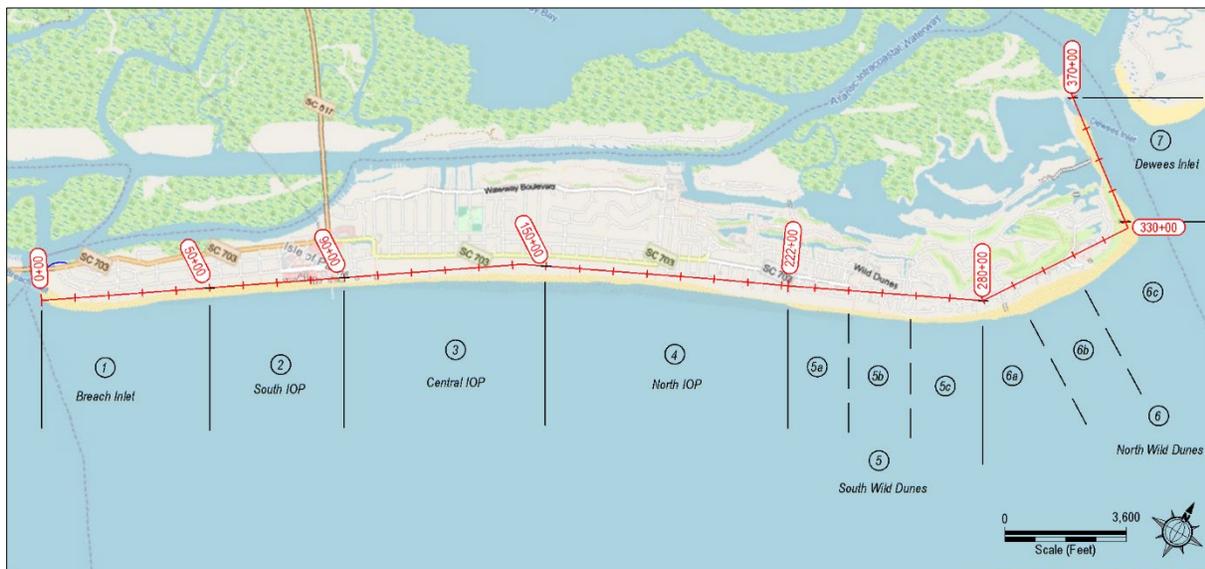
Figure 1. Isle of Palm Survey Baseline and Reaches

Figure 1 shows the survey baseline and boundaries for reaches defined in earlier reports. Note that the monitoring reaches differ from the reaches identified in construction documents for the upcoming beach nourishment project. CSE recently subdivided Reaches 5 and 6 to provide more localized information on beach condition along the dynamic northeastern end of the island.

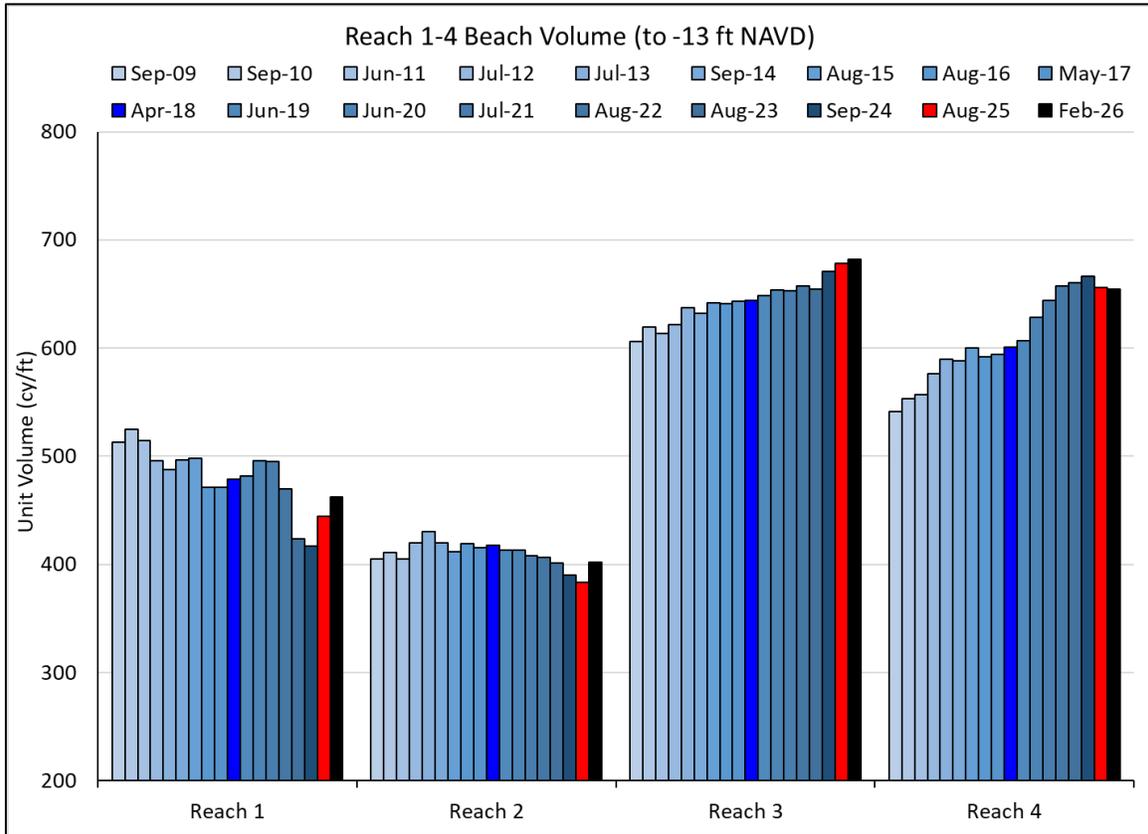
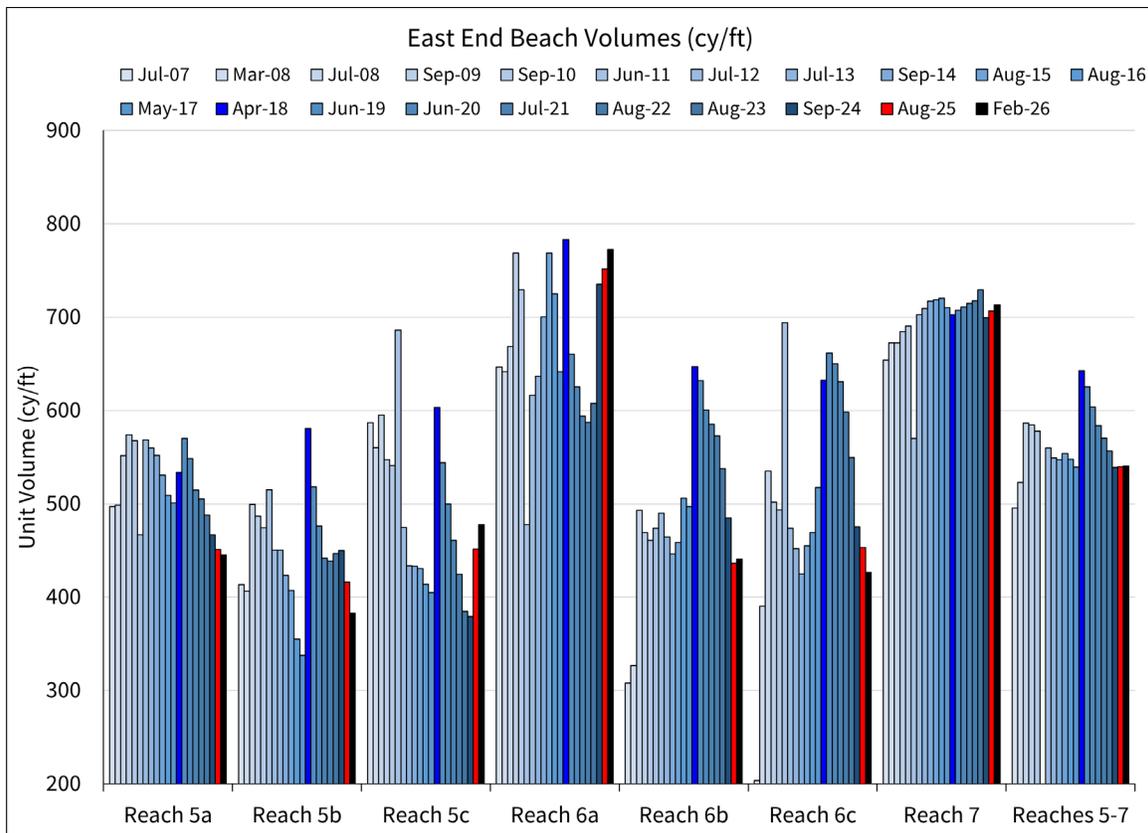
Figure 2. Graphs showing beach volumes for each reach since monitoring began in 2007–2009.

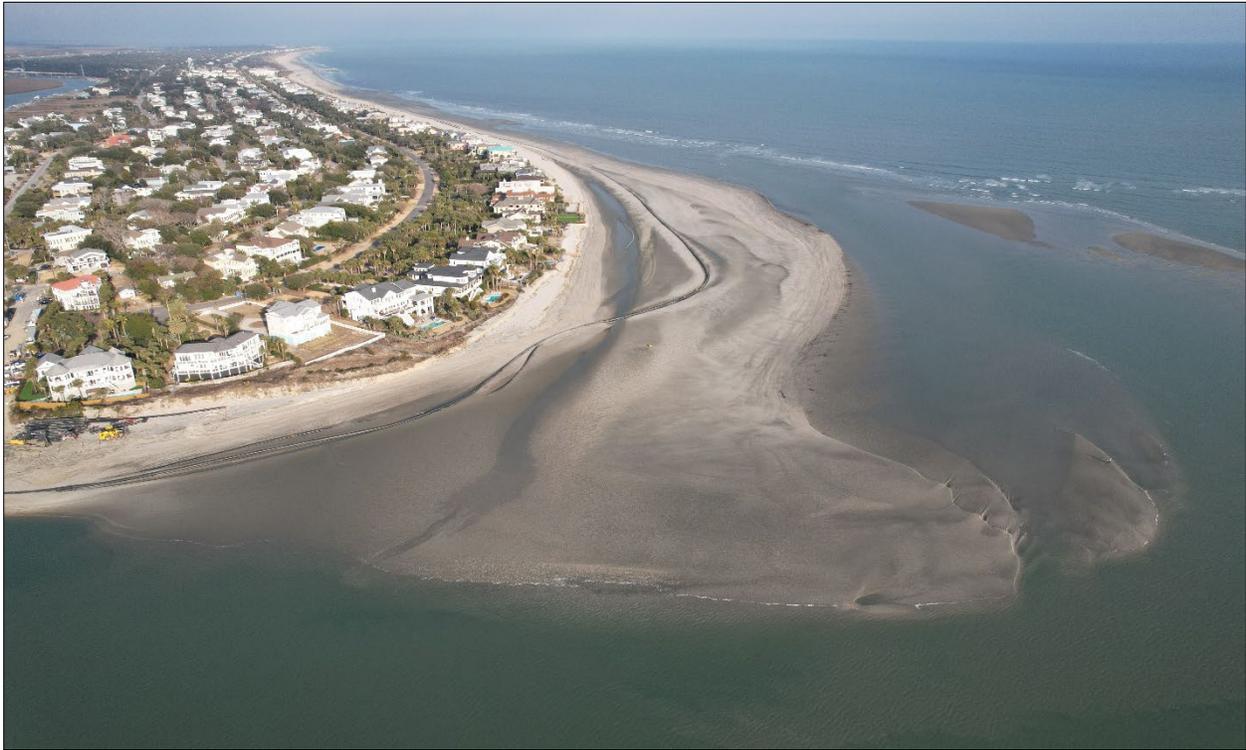
Figure 3. Aerial image of the south end of IOP on 5 February 2026 showing a large intertidal ridge migrating higher on the beachface. While the dry-sand beach remains narrow in this area, the intertidal beach gained 35–75 cy/ft between August 2025 and February 2026.

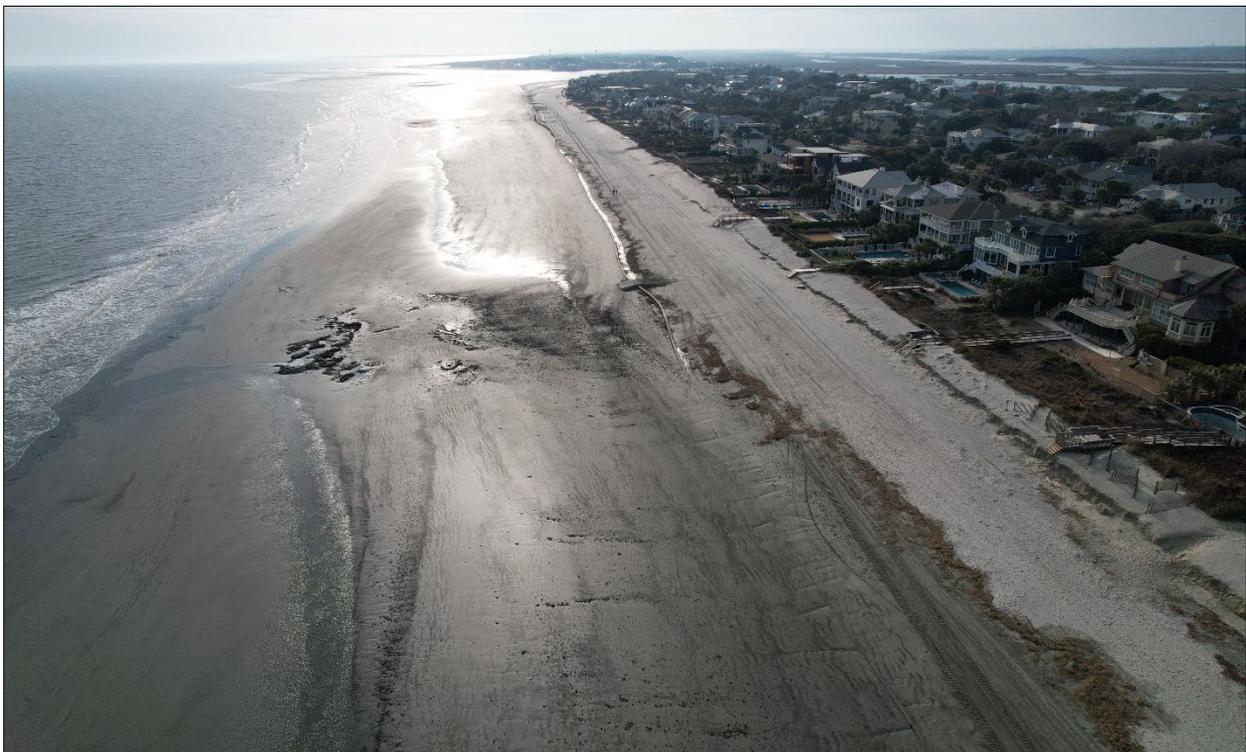
Figure 4. Photo from 6th Ave looking south on 5 February 2026. Note the wrack line showing the dry-sand beach 80–100 ft wider than the vegetation line. The vegetation line marks the approximate location of the escarpment formed in 2024.

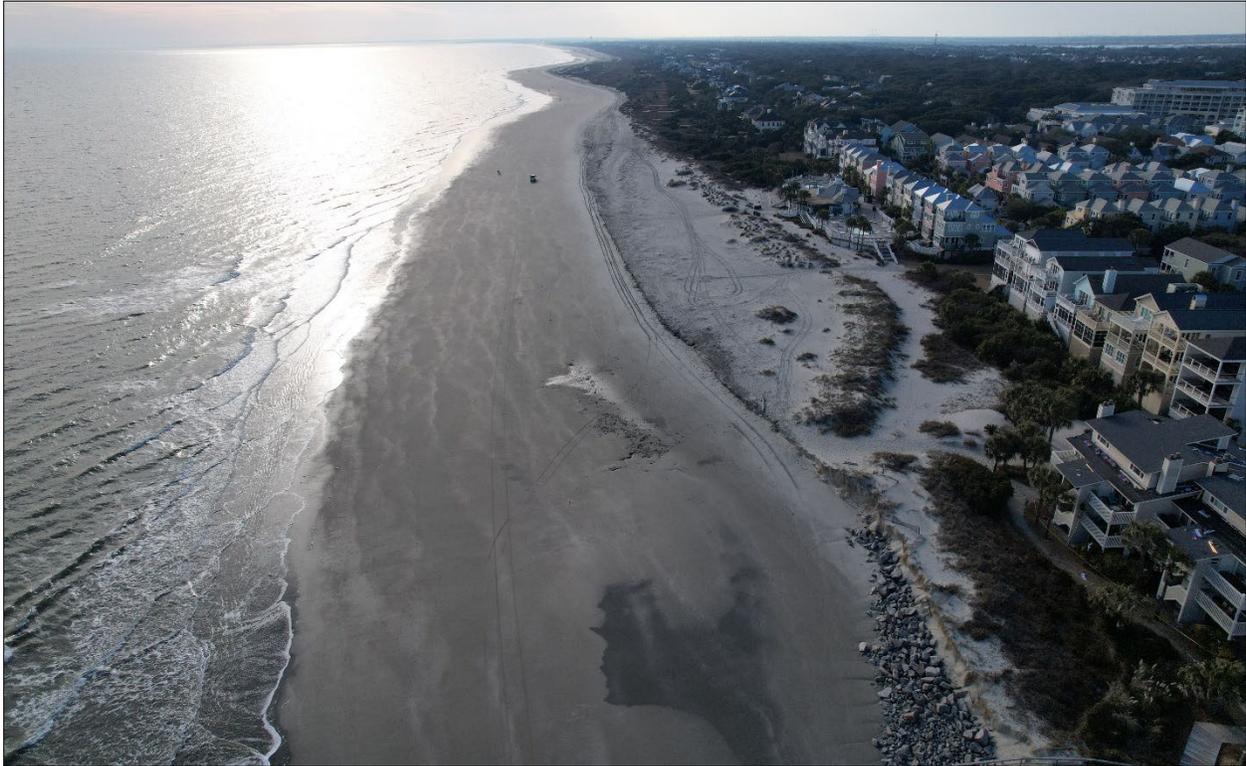
Figure 5. Photo from the Wild Dunes Grand Pavilion area. This area was the most eroded part of the beach from Aug 2025 to Feb 2026.

The area fronting the Grand Pavilion lost sand, as the erosional trend that affected Beachwood East is now shifting to the west. CSE expects this trend to reverse quickly as the accretional wave moves south. Near Seascape and Ocean Club, erosion has slowed over the past six months, and is now the lowest loss rate observed since 2018. CSE anticipates accretion of this area beginning in the next few months. Overall, Reaches 5 and 6 show a net loss of 15,000 cy over the past six months. Accretion along the shoal attachment site has been offset by erosion along southern Wild Dunes and along the 18th hole of the Links Course.

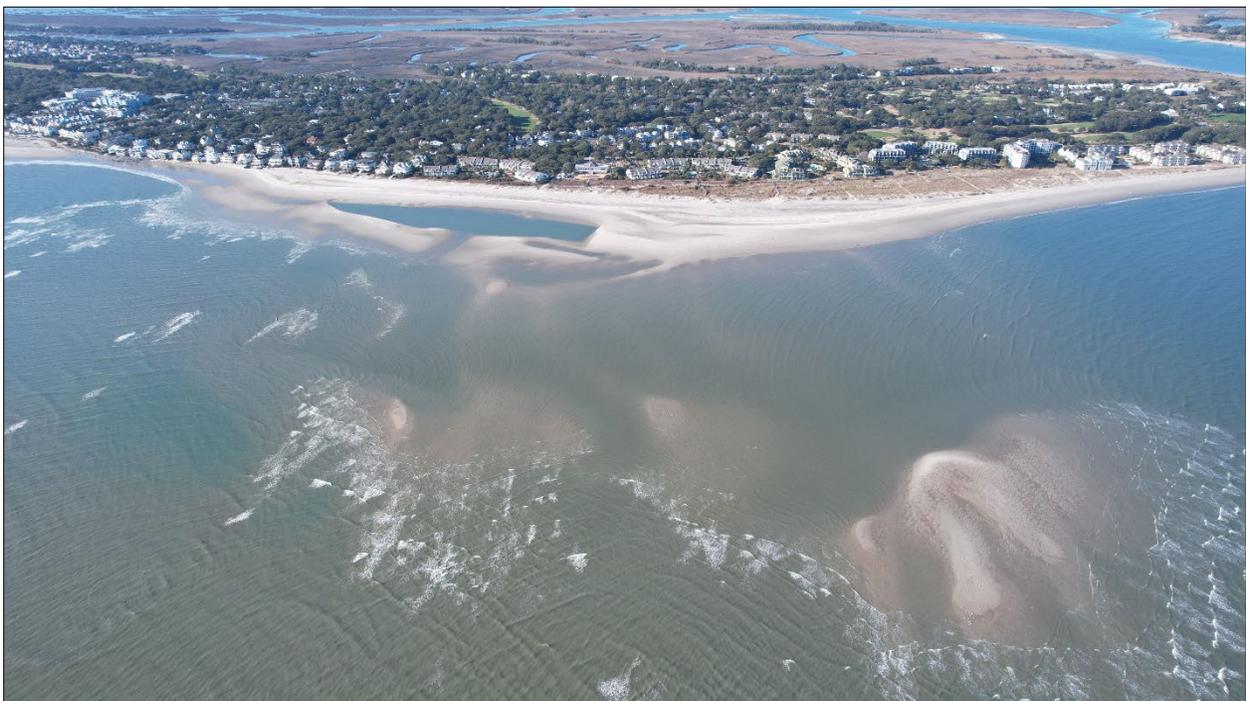
Figure 6. January 5, 2026 photo of the shoal attachment zone along Wild Dunes. The leading shoal has attached and is spreading sand laterally along the beach. Further offshore, a secondary shoal moved ~500 ft closer to the beach over the last 6 months. This event (containing multiple emergent shoals) is expected to add 600,000–800,000 cy to the beach. CSE estimates that around half of this total is currently included in the volume changes reported herein.

Reaches 5 and 6 are the most dynamic, highly developed shoreline in South Carolina. The current shoal attachment event is actively bringing sand to the center portions of Wild Dunes, while the ends of Wild

Dunes are still in the erosional phase of the shoal-bypass cycle. Individual stations immediately adjacent to the attachment site are gaining substantial amounts of sand, up to 73 cy/ft (cubic yards per foot) in six months. Accretion is occurring along Beachwood East and Dunecrest Ln, and Mariner's Walk to Summer Dunes Ln. At Dunecrest Ln, the dry-sand beach grew by ~150 ft over six months.
