2025
MONITORING REPORT

Prepared for
City of Isle of Palms
Isle of Palms, South Carolina

COASTAL SCIENCE & ENGINEERING

This monitoring report is submitted to the City of Isle of Palms, SC (IOP) by Coastal Science & Engineering (CSE) as part of an ongoing beach monitoring effort that began in 2007 during planning for the 2008 Isle of Palms Beach Restoration Project (P/N 2007-02631-2IG) (CSE 2008). This report follows earlier monitoring reports submitted annually to the City, as well as additional reports and engineering documents related to shoal management and beach nourishment activities (P/N 2010-1041-2IG; 2016-00803 (CSE 2019)). The report details the beach condition as surveyed in February and August 2025 and compares these conditions with selected earlier dates, including the pre-2018 project condition. This is the seventh annual monitoring report following the 2018 nourishment project. Certain portions of this report detail monitoring efforts required by state and federal permit conditions for the 2018 project.

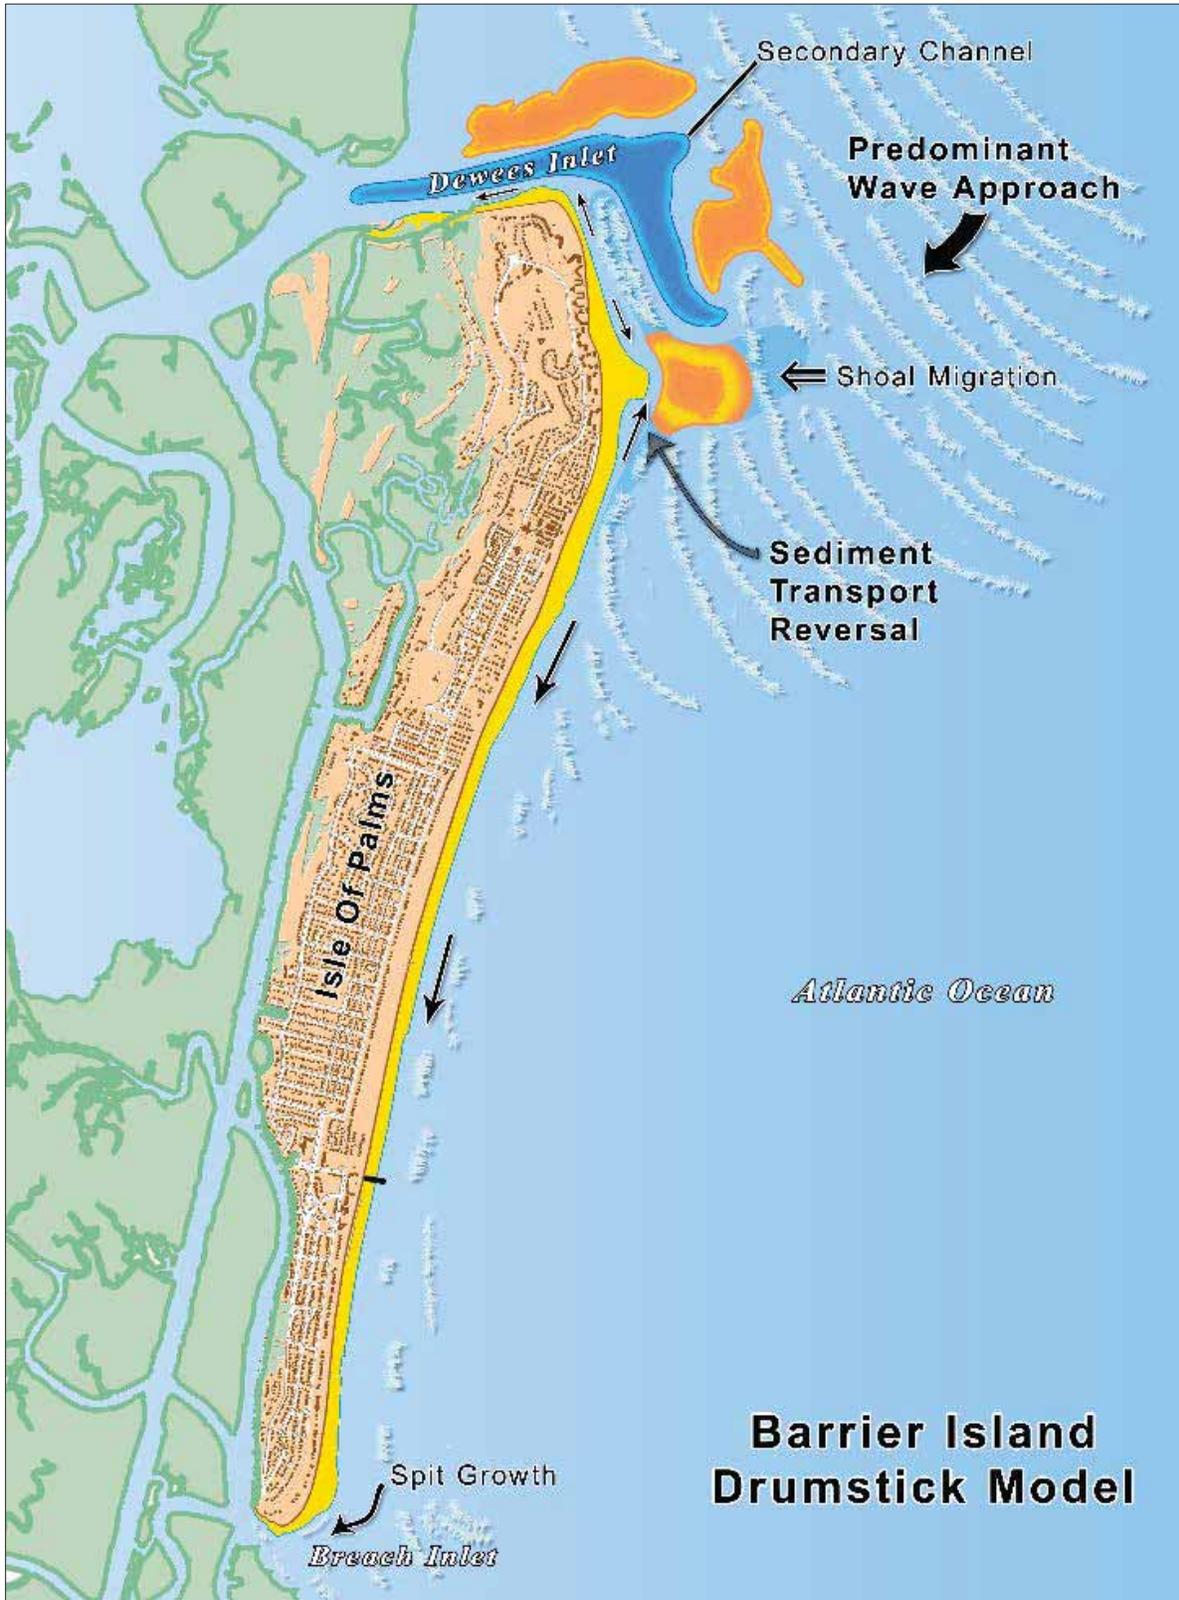
FIGURE 2.1. Schematic of the Isle of Palms showing the wider northeast end characteristic of a 'drumstick' barrier island.

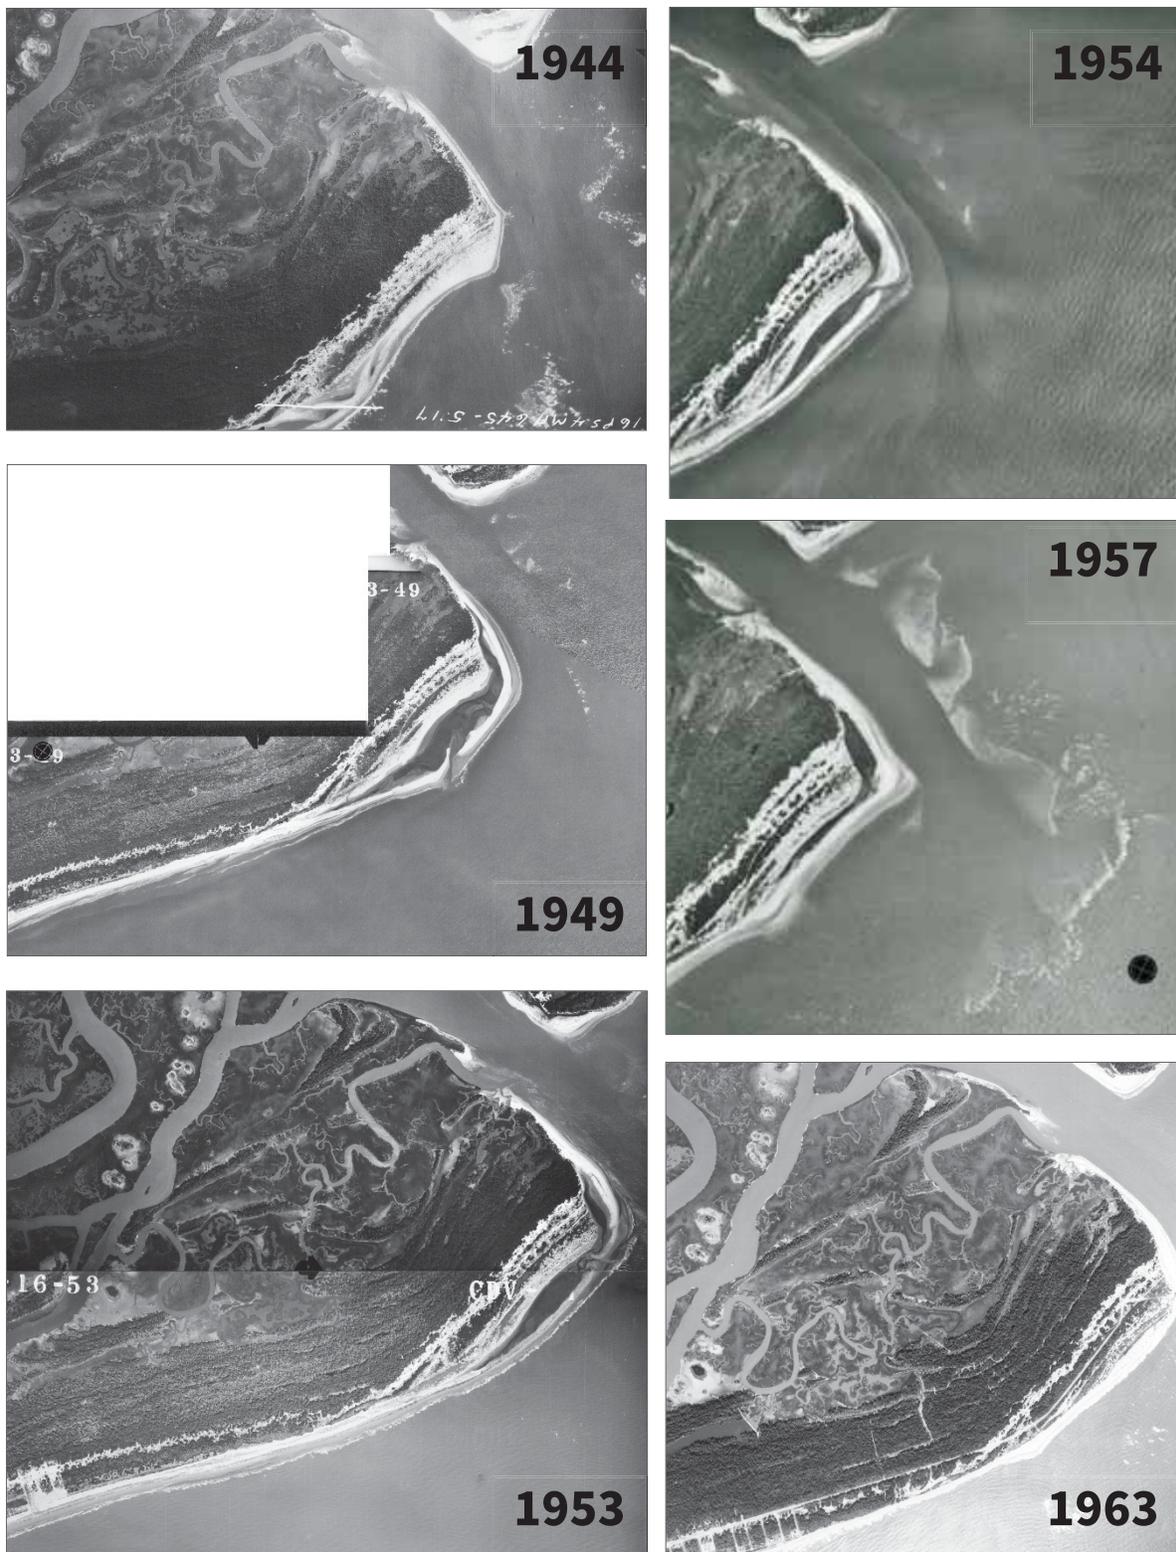
FIGURE 2.2. Historical aerals from CSE 2010 report page 56 (Figure 3.35). Photo sequence begins (left column from top) in 1944, 1949, and 1953, then continues (right column from top) through 1954, 1957, and 1963. [Note that images are not at the same scale.]

The emergence of this large shoal may be a result of the merging of several shoals in the delta, partially visible in the 1944 image (Fig 2.2, upper left), including two visible shoals at the northeastern tip of the island. These shoals were likely, at one point, a trailing ebb spit (see Kana 2002), and the sand from this spit merged with a shoal further west to create the large sand body that formed the lagoon. The shoal ultimately added well over 1,000,000 cubic yards (cy) of sand to the beach.

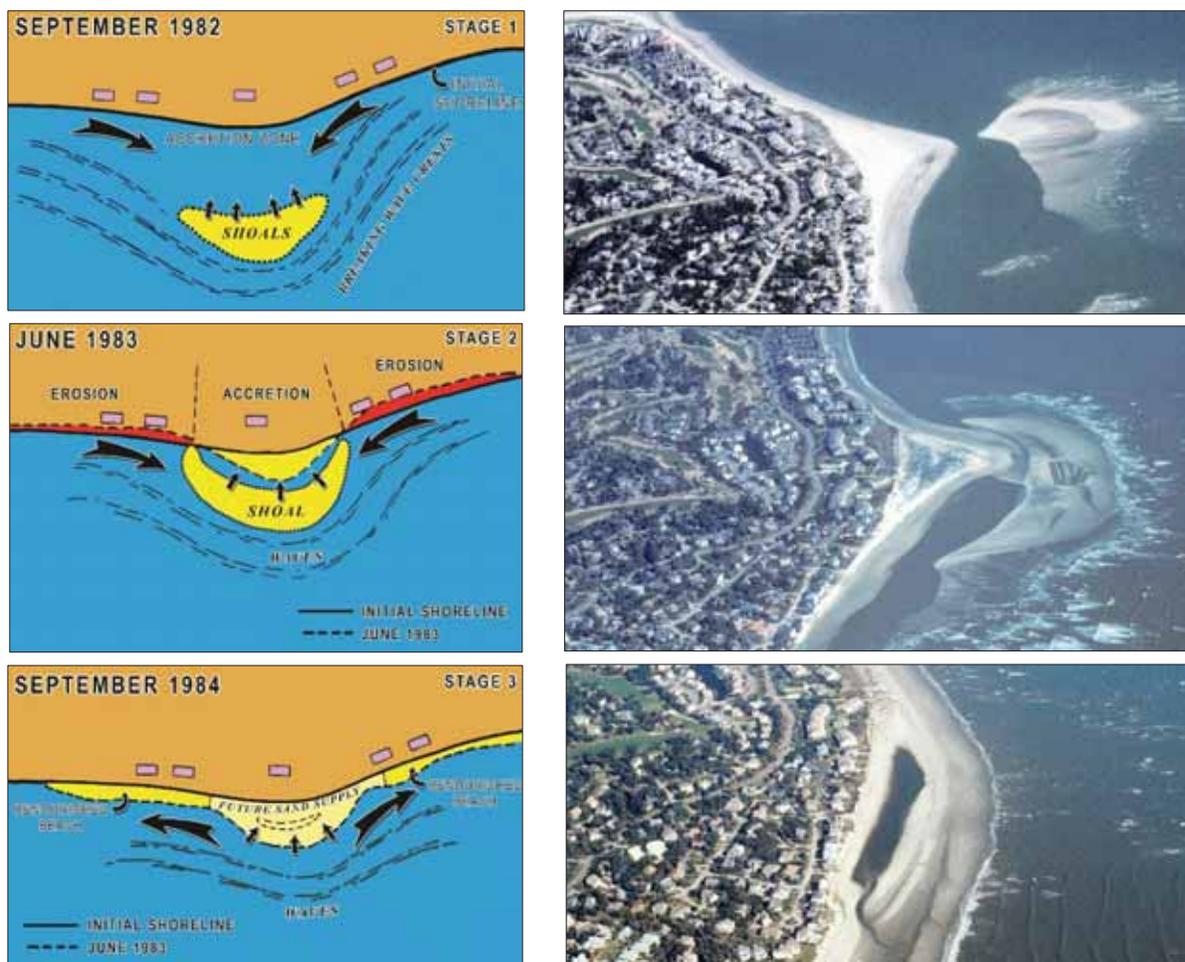
FIGURE 2.3. [LEFT] Schematic of the shoal-bypass cycle originally modeled from a bypass event at Isle of Palms. **[RIGHT]** A shoal-bypass event at northeastern Isle of Palms corresponding to the schematic. The upper photo shows a shoal in Stage 1 (1996). The middle image illustrates Stage 2 (1997). The bottom photo shows Stage 3 (1998).

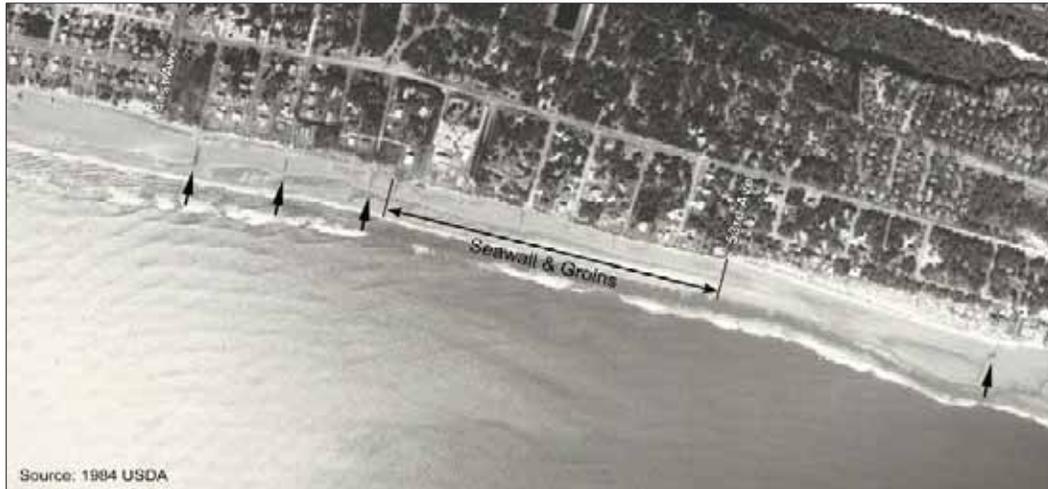
FIGURE 2.4. A seawall and groins were in place in 1984 between 46th Ave to 53rd Ave. Today, due to continuous accretion, these groins and seawalls have been buried.

The addition of sand from shoal bypassing at the east end of the island has contributed to relatively steady accretion along the central and western portions of the island, resulting in a wide setback for most properties west of 58th Avenue. In the 1970s, properties along 46th Ave to 53rd Ave installed a seawall, and several groins were installed by 1984, as shown in Figure 2.4. Since 1984, the beach has accreted continuously, and all groins and seawalls have been buried.

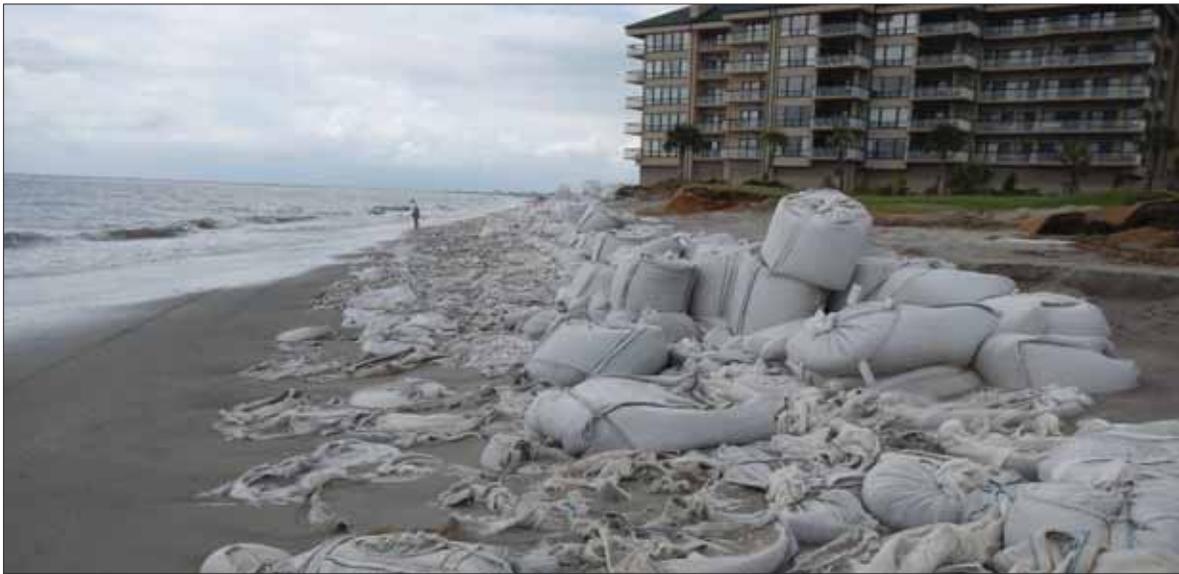
FIGURE 2.5. To prevent additional erosion, sandbags were installed along several structures from Shipwatch to Ocean Club from 2004 to 2007.

From 1984 to 2007, sand scraping from accretional areas was the only mitigation attempted to combat shoal-induced erosion. CSE and its predecessors documented scraping efforts circa 1983, 1987, and 1998 (Figure 2.3) that attempted to move sand from accreting areas to erosional arcs. From 2004–2007, sandbags were installed to protect several structures from Shipwatch to Ocean Club and prevent additional shoreline retreat (Figure 2.5).

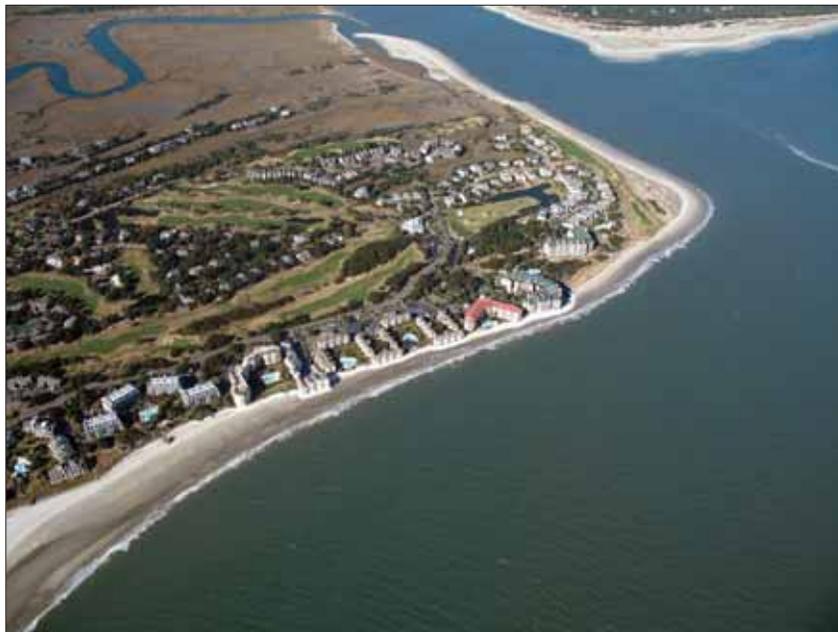
FIGURE 2.6. Isle of Palms in 2007 prior to beach nourishment.

Erosion reached such severe conditions in 2007 that there was little-to-no beach along portions of the east end of the island, even at low tide (Figure 2.6). The Wild Dunes Community Association contracted with CSE to evaluate the causes of erosion and prepare a feasibility study outlining alternatives for restoration (CSE 2007). CSE recommended nourishing the beach using sand from an offshore borrow area and began the steps to obtain a permit for the work. The City of Isle of Palms then took ownership of the project and served as the permit applicant. Permits were obtained (P/N 2007-02631-2IG), and the City contracted with Weeks Marine for a project involving the nourishment of 847,000 cy of sand over 10,200 lf (linear feet) of beach. The project extended from 200 ft north of 53rd Avenue to the 17th green of the Links Course.

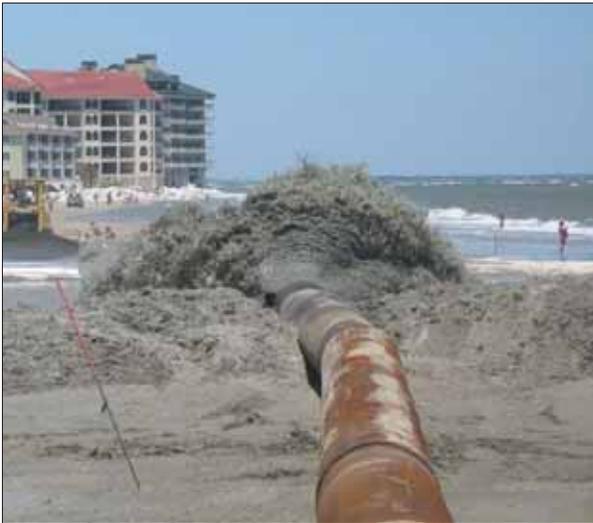
FIGURE 2.7. [ABOVE] 2008 beach nourishment project (completed on 15 July 2008).

The 2008 project was completed between 15 May and 15 July 2008 (Figure 2.7). As part of the project, Weeks Marine removed all sandbags from the project area, which totaled ~9,400 bags. Homeowners removed an additional 4,680 bags from under buildings. Averaging ~25,000 cy of sand per day, the dredge *RS Weeks* pumped sand from three borrow areas 2–3 miles from the beach. The nourishment was placed in three reaches and included ~270,000 cy between 53rd Ave and Dune Crest Ln (Reach A), 552,400 cy from Mariners Walk to the 18th fairway (Reach B), and 25,000 cy from the 18th tee to the 17th fairway (Reach C). Figure 2.8 shows the layout of the 2008 project. Figure 2.9 shows a post-project aerial photo (2008) that compares to the project area before renourishment (2007).

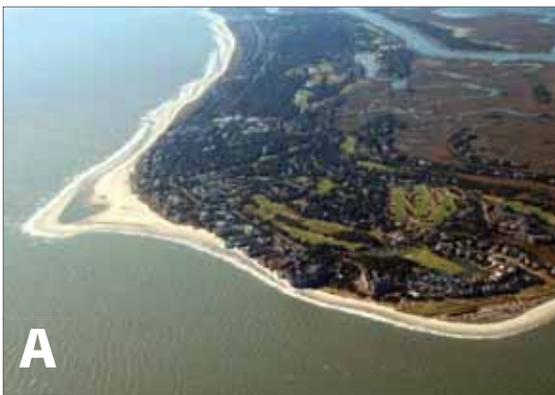
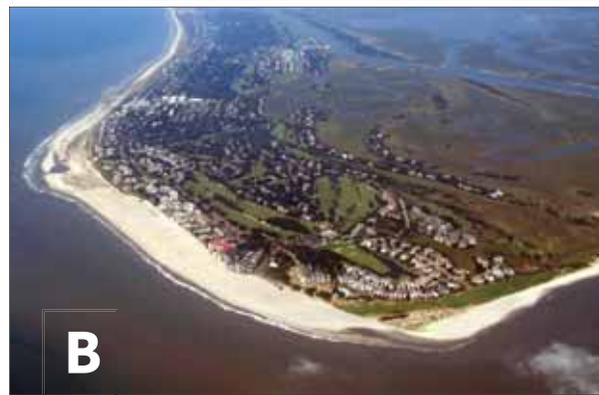
FIGURE 2.9. [LEFT] Isle of Palms in 2007 prior to nourishment. **[RIGHT]** The project area in 2008 following nourishment.

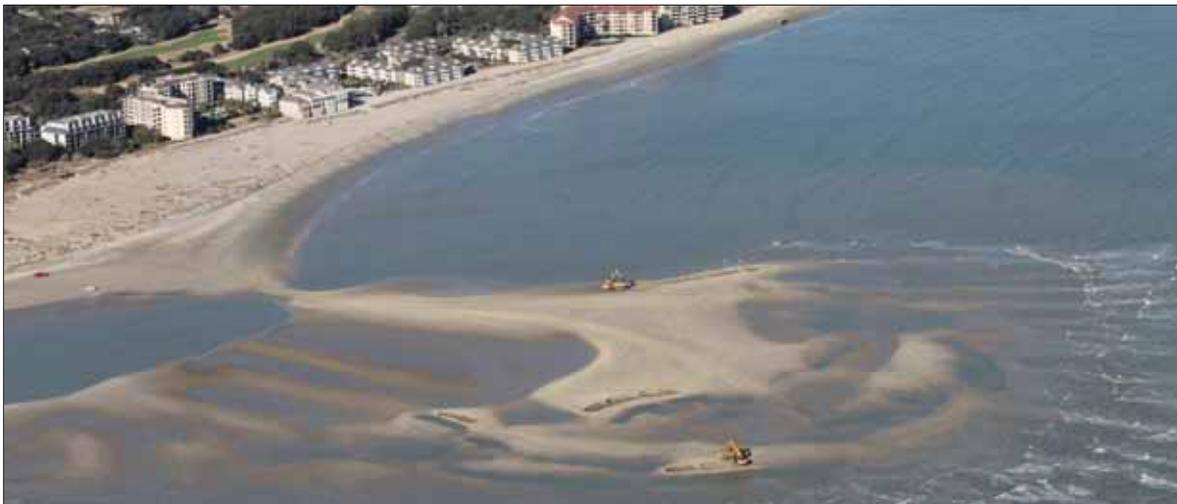
FIGURE 2.10. January 2015 aerial image of the 2014–2015 shoal management project showing equipment transferring sand from an attaching shoal to the eroded beach.

Following the 2008 project, CSE monitored the beach at least annually to document beach volume changes and project performance. Two shoal-bypass events occurred in 2009 and 2010, and another larger event began to emerge offshore in 2010. In anticipation of the need for potential remediation (and after observation of an erosional hotspot forming near the Ocean Club/Seascape area), the City sought a permit to manipulate the accretional shoal area, expedite attachment, and move sand to the erosional hotspots. An initial project was completed in 2012 that transferred ~80,000 cy of sand from the central portion of Wild Dunes to the east end near the Ocean Club. A larger project was completed in late 2014 through early 2015, which moved ~280,000 cy from two accretional areas (an attaching shoal centered near Beach Club Villas and from 53rd to 56th Avenues) to the beach fronting Beachwood East (~70,000 cy) and the area fronting Seascape/Ocean Club/18th hole (~210,000 cy). The project sought to transfer as much sand as possible from the shoal to the beach (Figure 2.10).

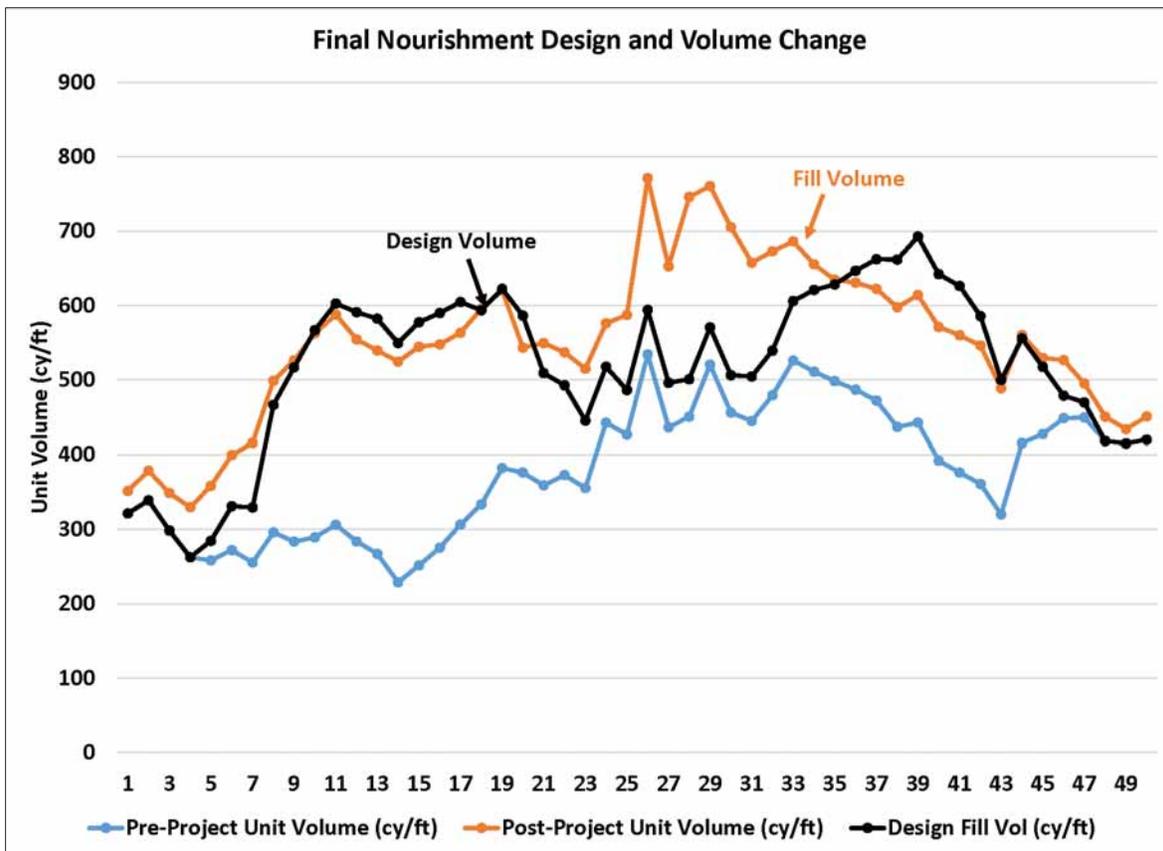
FIGURE 2.11. A graphic representation of the 2018 final fill template.

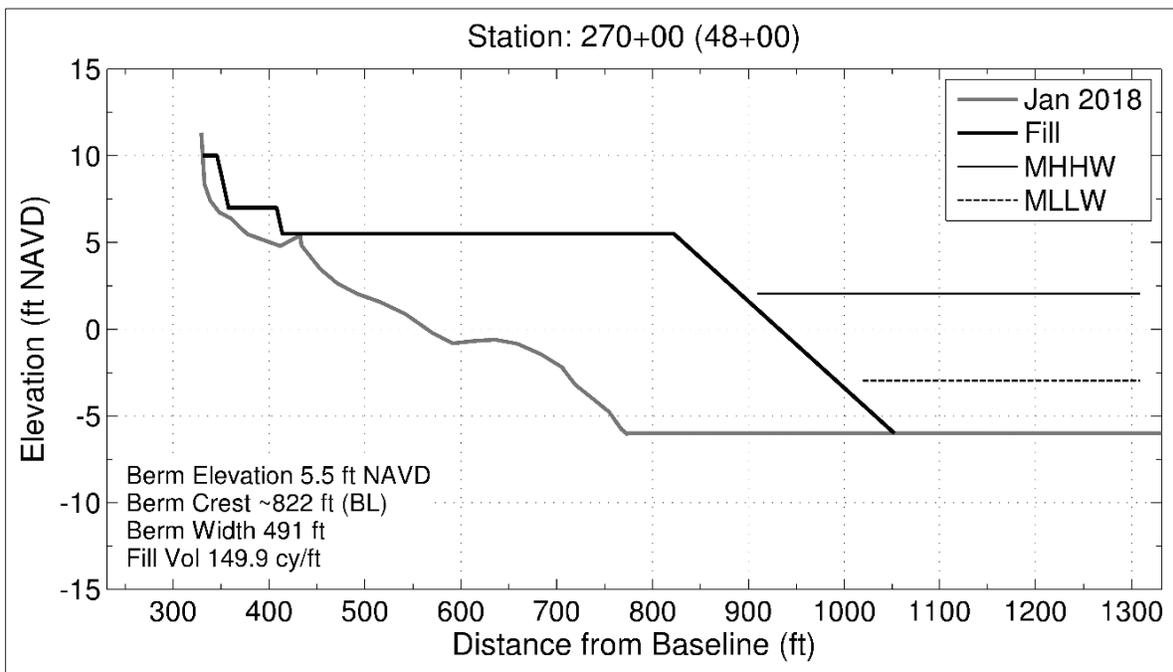
FIGURE 2.12. The 2018 design fill profile incorporated a dune, storm berm, wide fill berm, and sloping section.

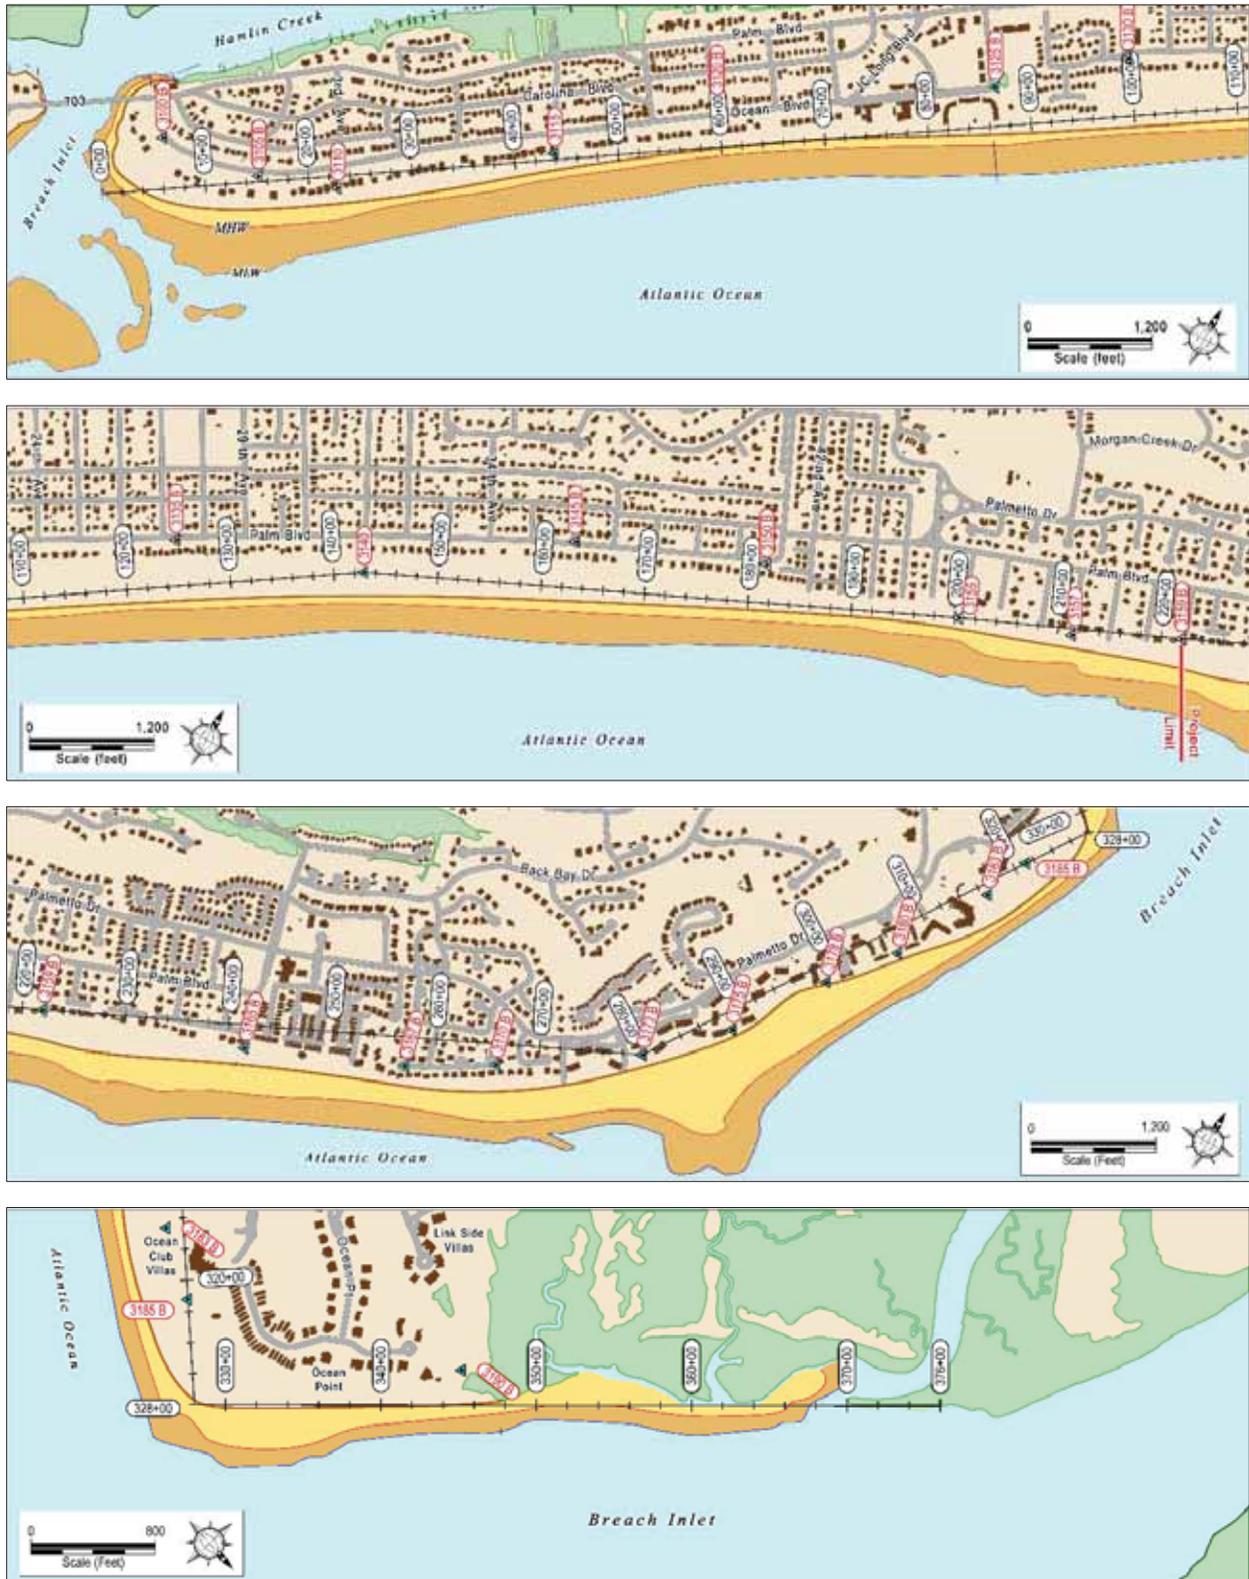
FIGURE 3.1. Baseline map of Isle of Palms showing the reference line used to establish monitoring profiles. Stationing increases to the north from Breach Inlet. Blue triangles mark SCDES-DCM reference stations.

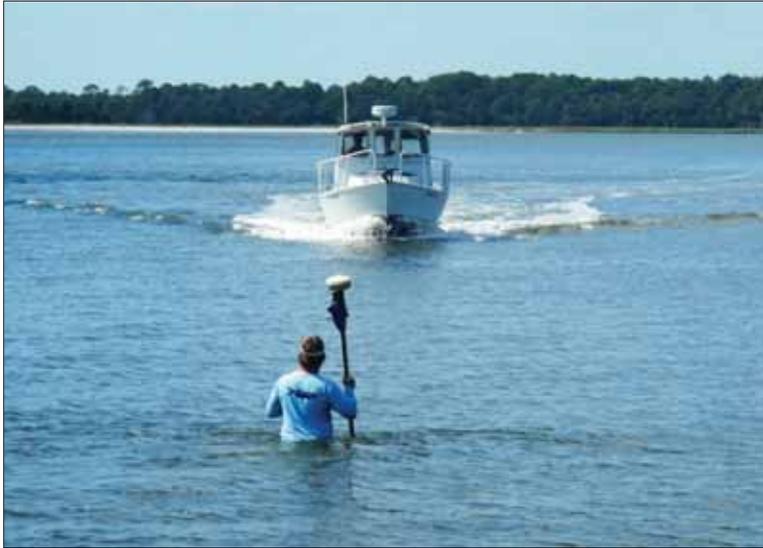
FIGURE 3.2.
 Surveying beach profiles involves collecting land-based data at low tide and hydrographic data overlapping the land-based work at high tide.

Topographic data were collected via RTK-GPS (Trimble™ R10 and R12 GNSS), which provides position and elevation measurements at centimeter accuracy. Beach profiles were obtained by collecting data at low tide along the dunes, berm, and active beach to low tide wading depth. Overwater work was then performed at high tide to overlap the land-based work (Fig 3.2) and was collected with RTK-GPS coupled with an Odom CV100™ precision echosounder mounted on CSE's survey vessel, the *RV Southern Echo*.

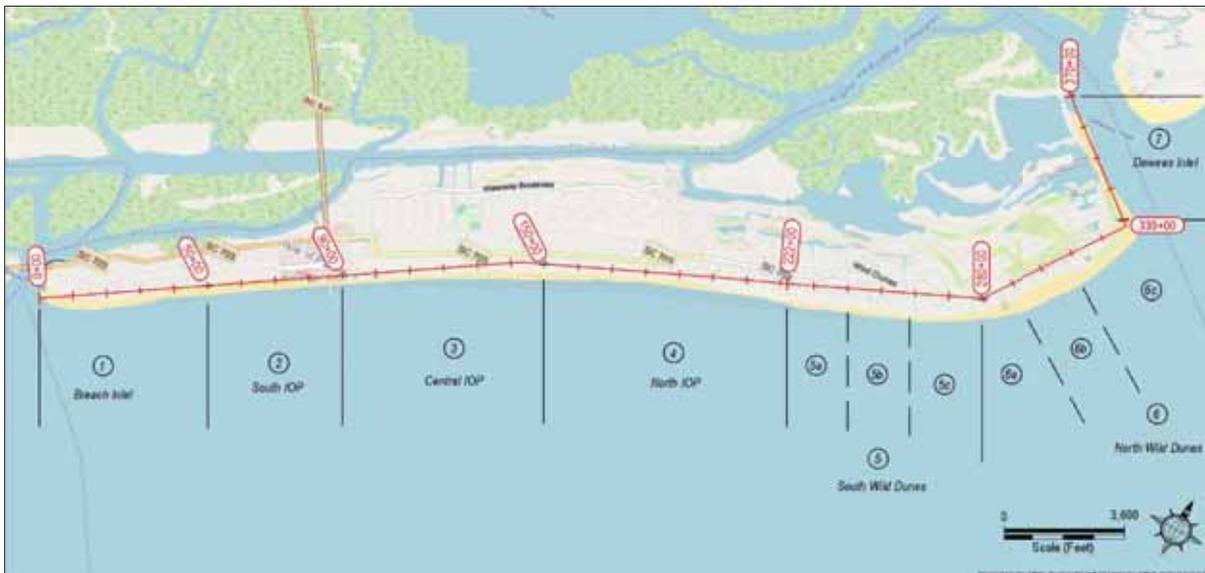
FIGURE 3.3. Reach limits used in the present monitoring report.

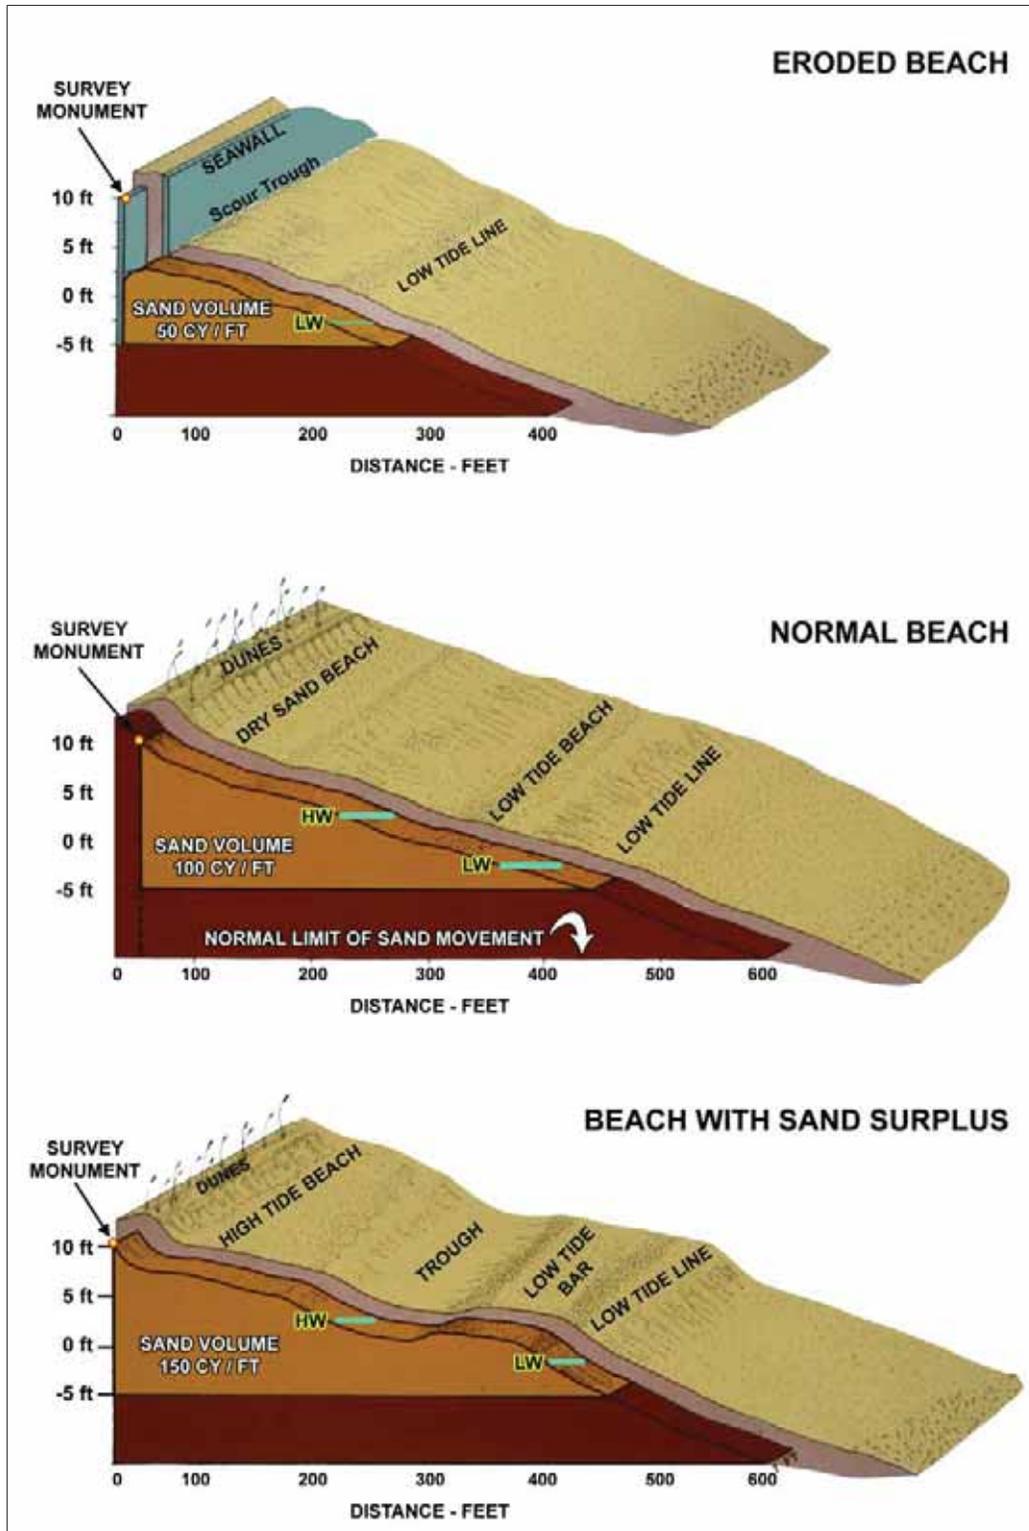
FIGURE 3.4. Illustration of the profile volume concept.

To determine changes in beach volume along Isle of Palms, beach profile data were entered into CSE’s in-house custom software, Beach Profile Analysis System (BPAS), which converts 2D profile data in x–z (distance–elevation) format to 3D volumes. The software provides a quantitative and objective way of determining ideal minimum beach profiles and how the sand volume per unit length of shoreline compares with the desired condition. It also provides an accurate method of comparing historical profiles—as the volume method measures sand volumes in the active beach zone rather than extrapolating volumes based on single-contour shoreline position (ie – from aerial photography). Unit-volume calculations can distinguish the quantity of sediment in the dunes, on the dry beach, in the intertidal zone to wading depth, and in the remaining area offshore to the approximate limit of profile change (closure depth).

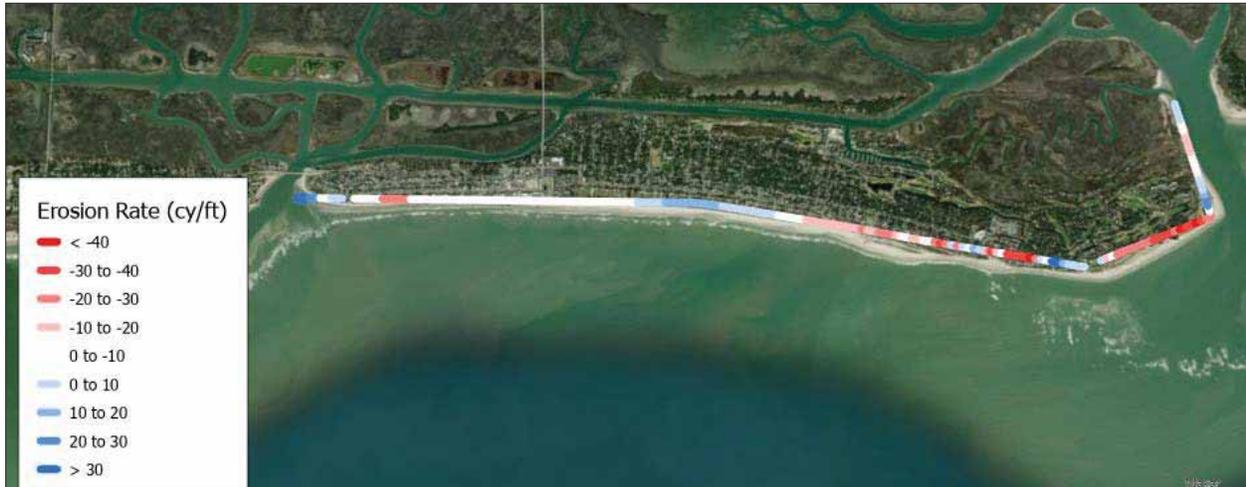
FIGURE 4.1. Line map showing variations in erosion and accretion patterns over Isle of Palms from September 2024 to August 2025. The shoal attachment zone along the eastern third of the island was the most dynamic over the last year. The central portion of the island exhibited a slightly positive beach volume change, while the Breach Inlet portion of the island lost sand at a greater rate than has been observed since 2021.

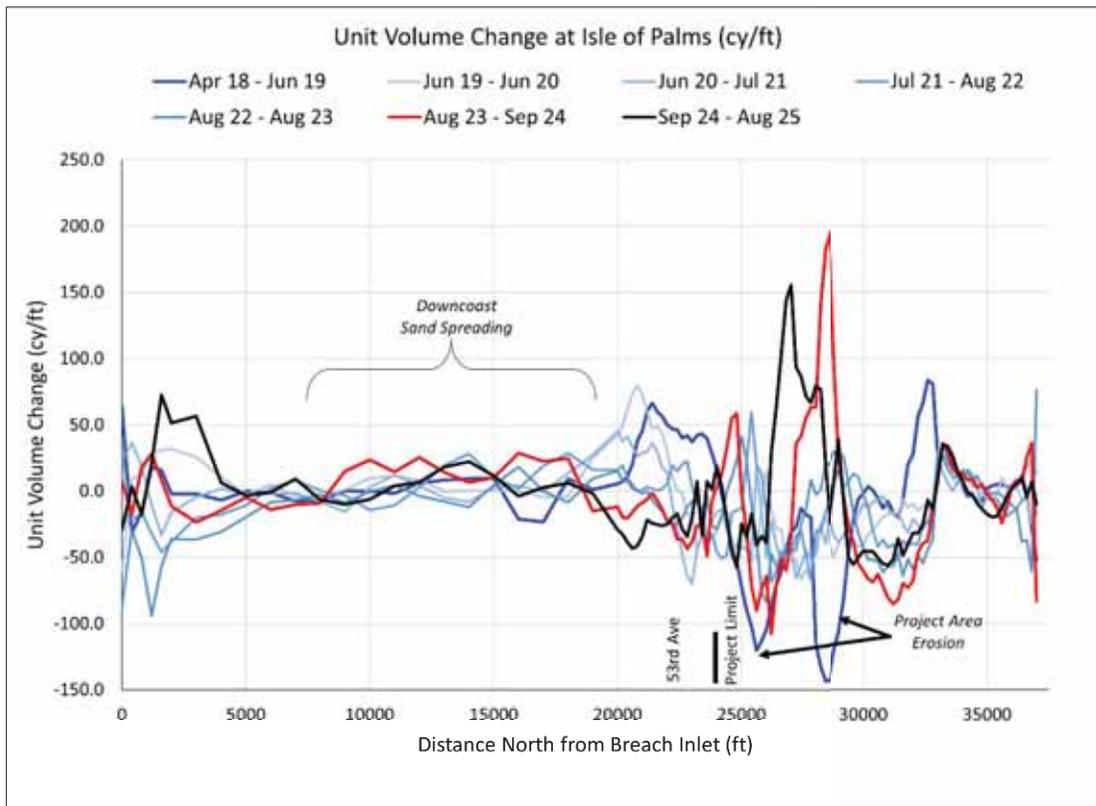
FIGURE 4.2. Beach unit volume change between each monitoring event at Isle of Palms. The X axis represents distance from Breach Inlet. This graph highlights the erosion occurring in the project area and the accumulation of spreading sand adjacent to the project area.

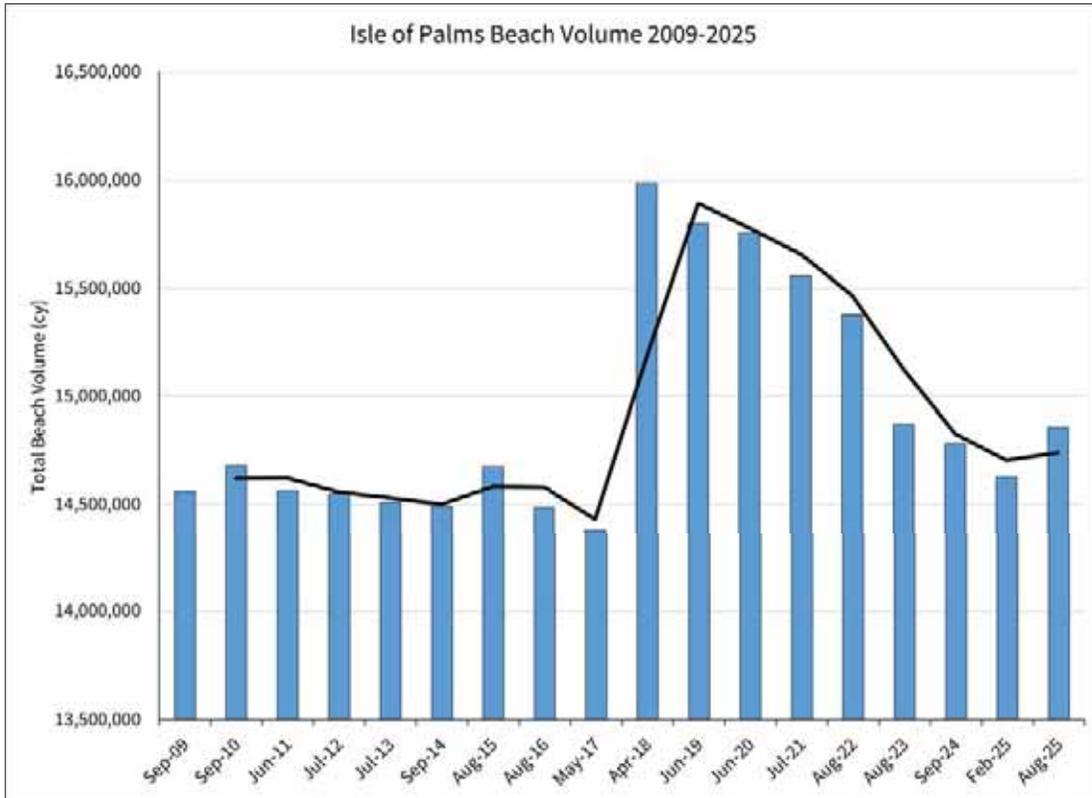
FIGURE 4.3. Total beach volume at Isle of Palms from 2009 to 2024. Effects of the 2018 project are seen in the rapid increase in the April 2018 island-wide beach volume.

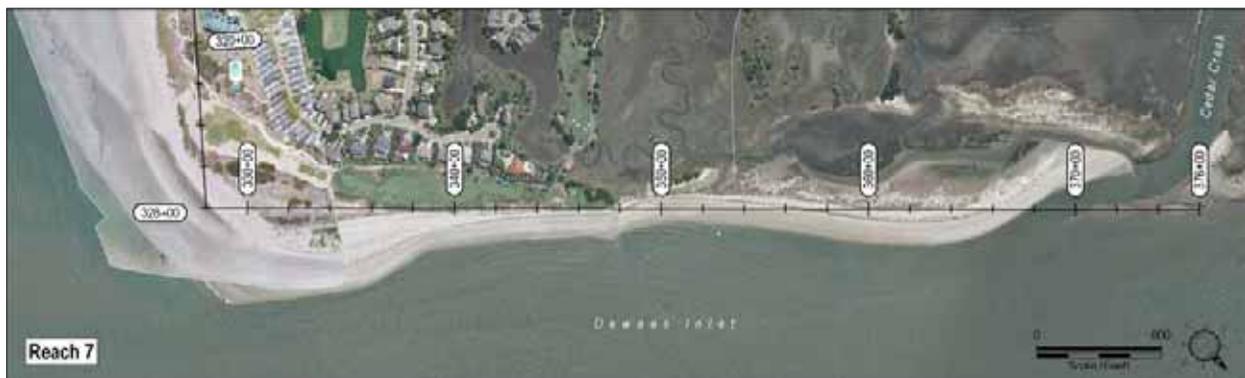
FIGURE 4.4. Baseline stationing along Reach 7 encompassing the length of beach between Lines 330 and 370.

Reach 7 encompasses 4,000 ft between Lines 328 and 370 that span the shoreline fronting the Dewees Inlet channel (Figure 4.4). The inlet shoals shelter this portion of beach from the largest open-water waves, so the profile features a narrow, dry-sand berm and a steep beach face. The steep beach face reduces the total profile volume needed for a stable profile compared to oceanfront areas. The seaward end of the reach was included in the 2008 nourishment project and has traditionally exhibited relative stability in beach volumes.

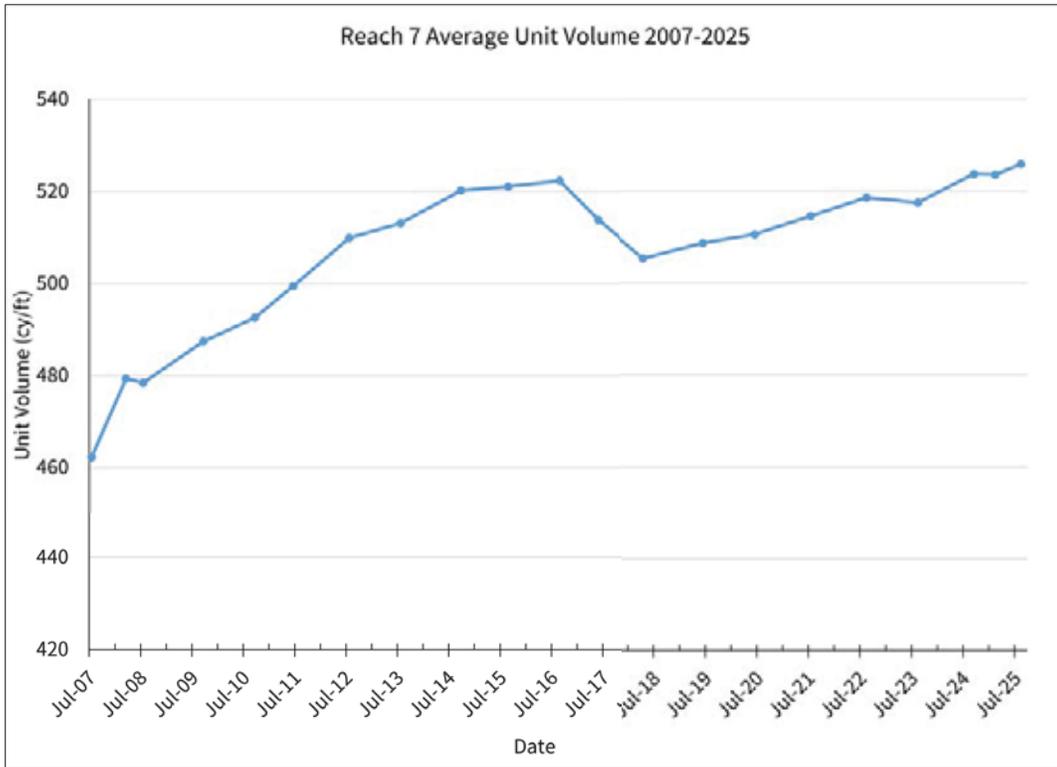
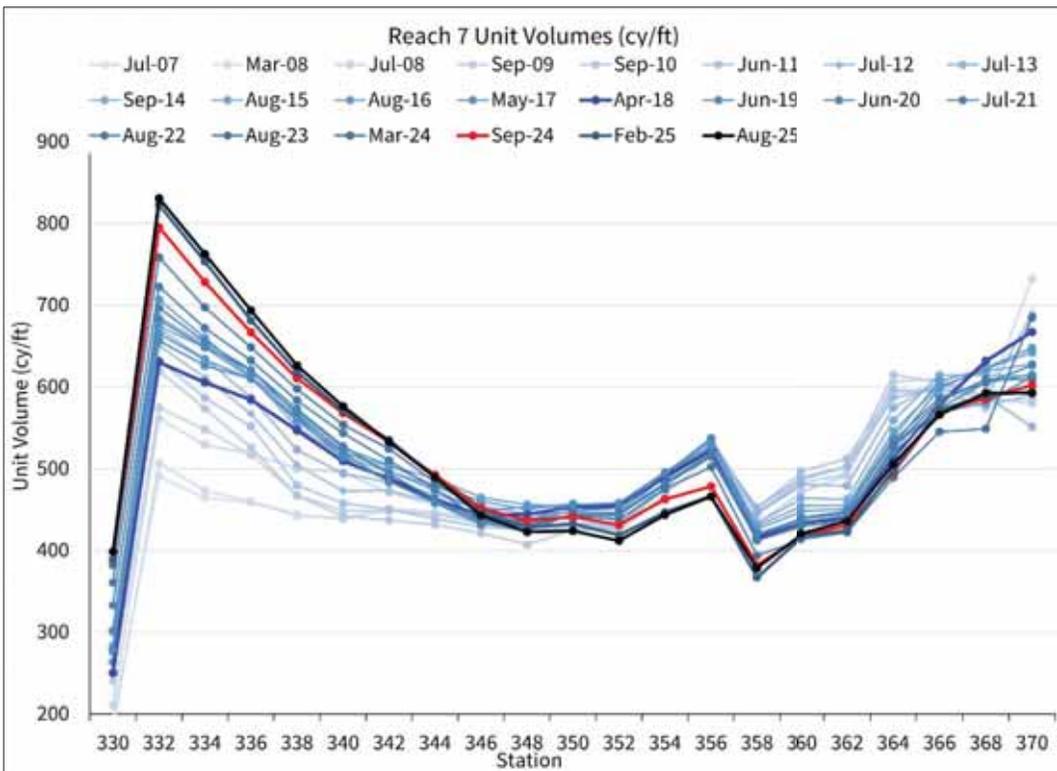
FIGURE 4.5. [UPPER] Average beach volume in Reach 7 since 2007. **[LOWER]** Profile unit volumes for each monitoring line in Reach 7.

All the stations seaward of the 17th tee (groin) show accretion at least 4.5 cy/ft more sand than the most eroded condition since 2008 (Fig 4.5). Stations 330 to 338 (along the eastern side of the 17th green), closer to Reach 6, showing significant accretion averaging 198.4 cy/ft. Ground photos from the reach reflect continued stability along the backshore, reflected by the maturing dune grass plant communities. Escarpments persist west of Station 350, in the lee of the exposed groin at the 17th tee. Ground photos highlight the continued maturation of dune habitat in areas east of the groin and scarping in stations west of the groin (Fig 4.6). As the profiles in Figure 4.6 show, the main channel of Dewees Inlet has not migrated toward Isle of Palms and remains positionally stable. Accretion along the upper profile (see Station 338+00 – Upper left in Figure 4.6) has moved the margin of the channel seaward despite its direct exposure to storm waves out of the Northeast. This is an important result of nourishment spreading from the oceanfront project area.

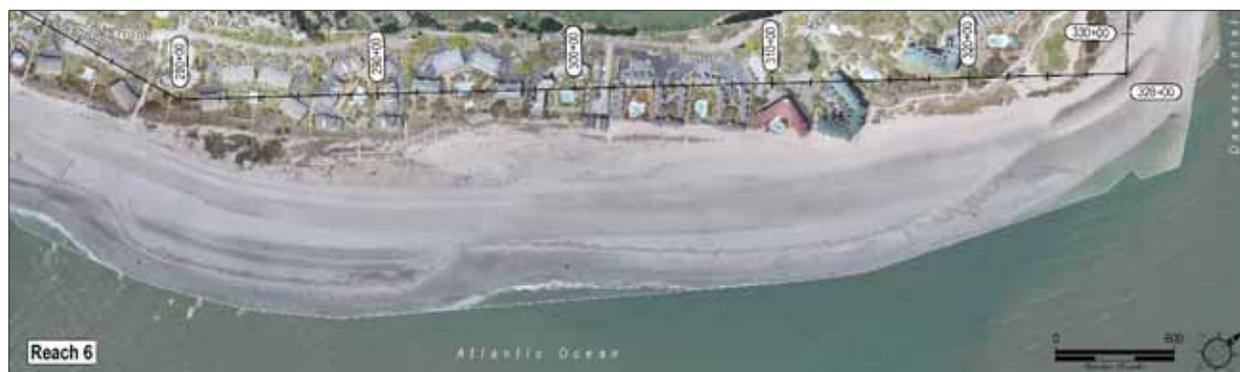
FIGURE 4.7. Baseline stationing along Reach 6 encompassing ~5,000 lf of beach between Wild Dunes Property Owners Beach House and the 18th hole of the Links Course.

Reach 6 encompasses ~5,000 linear feet of beach between the Wild Dunes Property Owners Beach House (Station 280) and the 18th hole of the Links Course (Station 328) (Figure 4.7). This area is along the 'corner' of the shoreline between Dewees Inlet and the open ocean and is where shoals attach as part of cyclical bypass events from the inlet. Depending on the location and magnitude of the bypass, the shoreline can move hundreds of feet landward or seaward over the course of just a few months (Kana et al 1985, Gaudio 1998).
