2025
MONITORING REPORT

Prepared for
City of Isle of Palms
Isle of Palms, South Carolina

COASTAL SCIENCE & ENGINEERING

This monitoring report is submitted to the City of Isle of Palms, SC (IOP) by Coastal Science & Engineering (CSE) as part of an ongoing beach monitoring effort that began in 2007 during planning for the 2008 Isle of Palms Beach Restoration Project (P/N 2007-02631-2IG) (CSE 2008). This report follows earlier monitoring reports submitted annually to the City, as well as additional reports and engineering documents related to shoal management and beach nourishment activities (P/N 2010-1041-2IG; 2016-00803 (CSE 2019)). The report details the beach condition as surveyed in February and August 2025 and compares these conditions with selected earlier dates, including the pre-2018 project condition. This is the seventh annual monitoring report following the 2018 nourishment project. Certain portions of this report detail monitoring efforts required by state and federal permit conditions for the 2018 project.

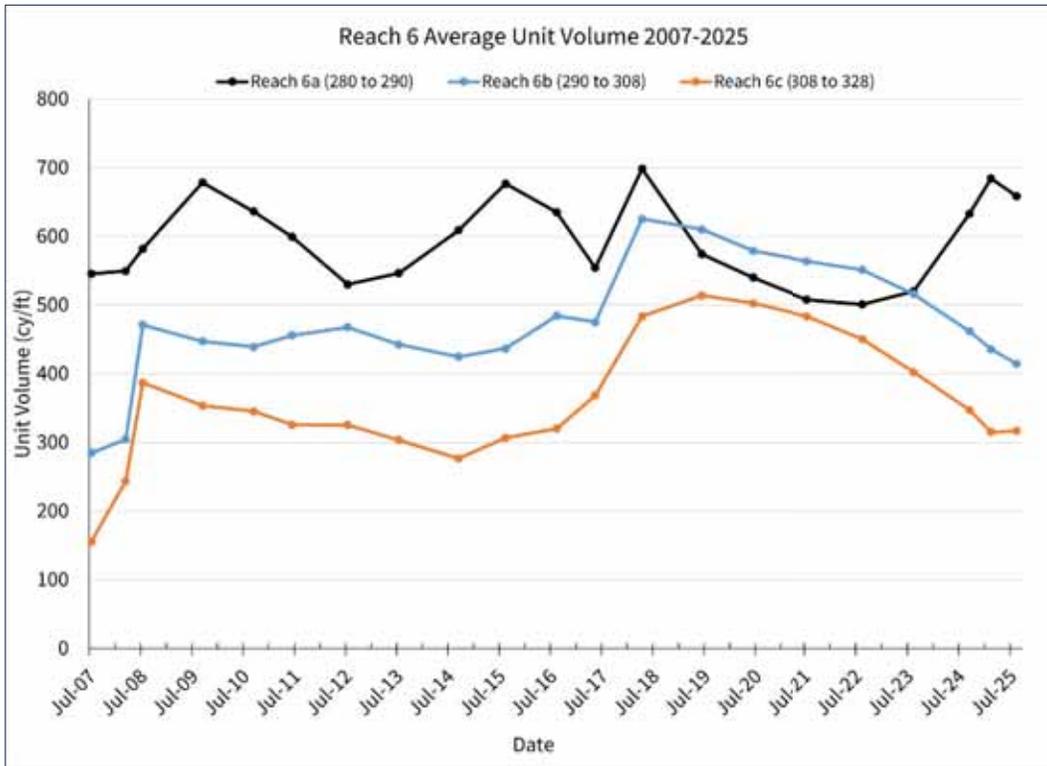
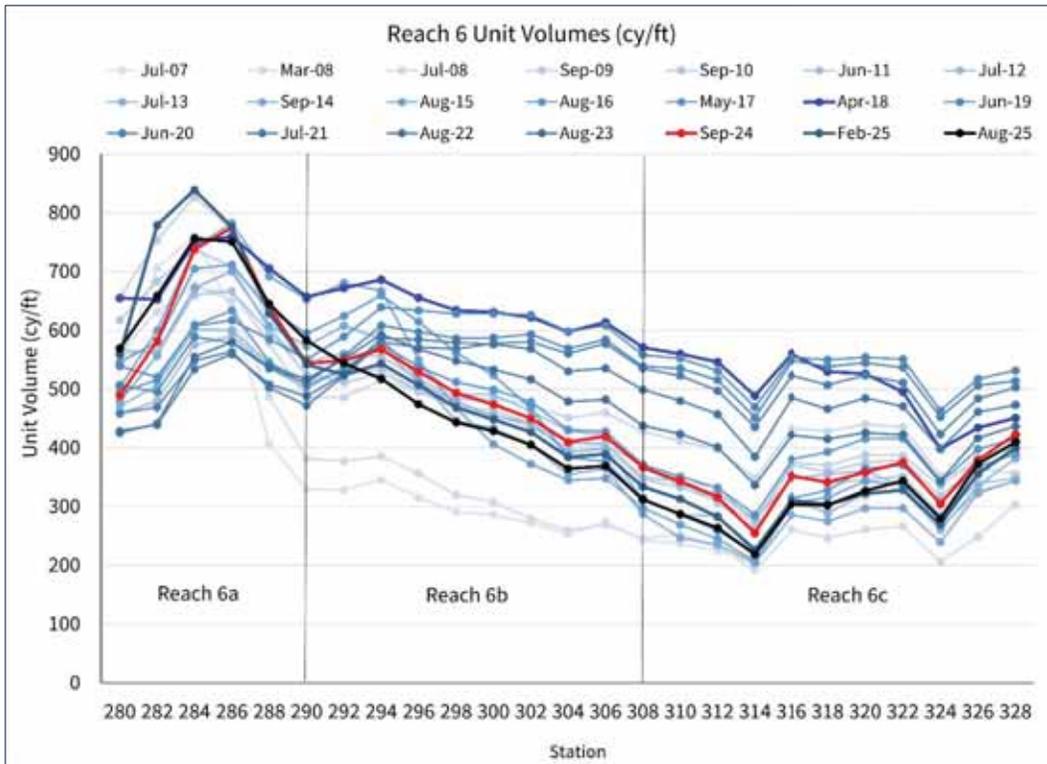
FIGURE 4.8. [UPPER] Average beach volume in Reach 6 since 2007. **[LOWER]** Profile unit volumes for each monitoring line in Reach 6.

Reach 6's erosion rate of 116,100 cy (-23.2 cy/ft) of sand from September 2024 to August 2025 is slightly higher than the long-term average losses since 2010 (-83,000 cy/yr). Since completing the 2018 project, Reach 6 has lost -761,200 cy (-152.2 cy/ft). This represents more than 113% of the nourishment volume added in 2018; almost every station retains less sand than before that project. The only stations in Reach 6 containing more sand than the pre-2018 condition are 280 and 292 (Beach Club Villas), where the current shoal is attaching. Average erosion along all other stations is around 171.1 cy/ft compared to 2018.

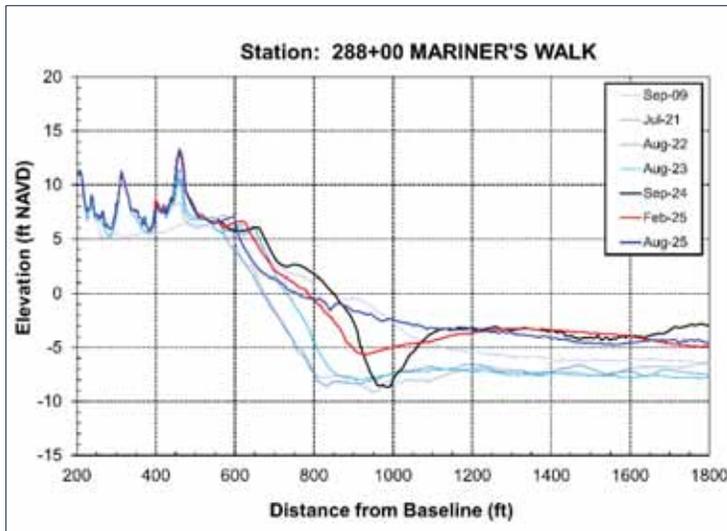
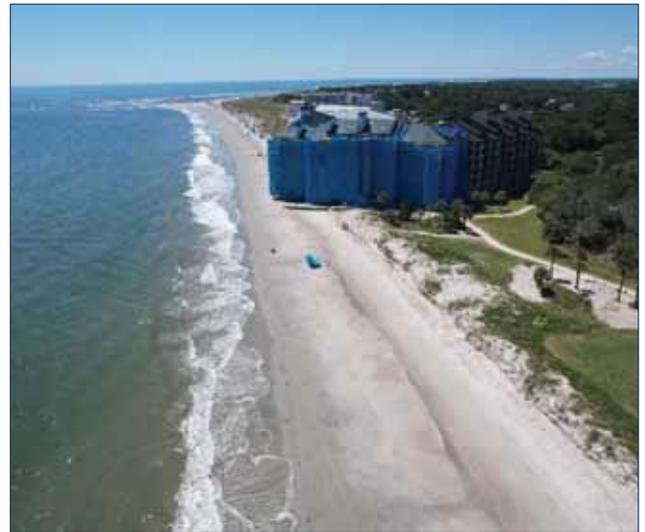
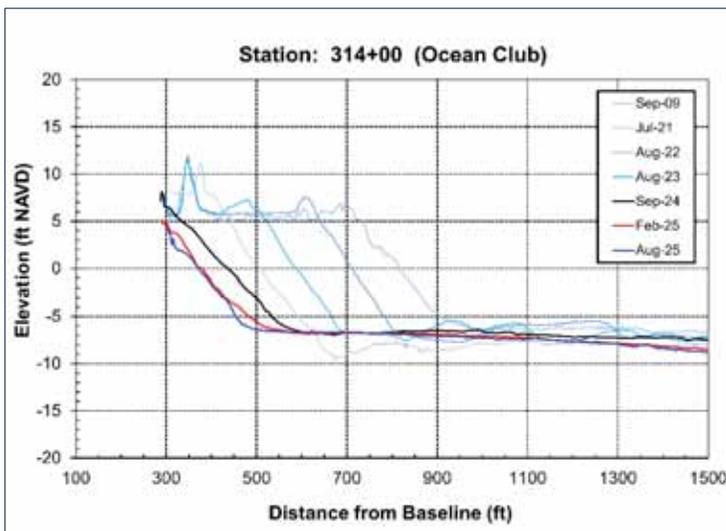
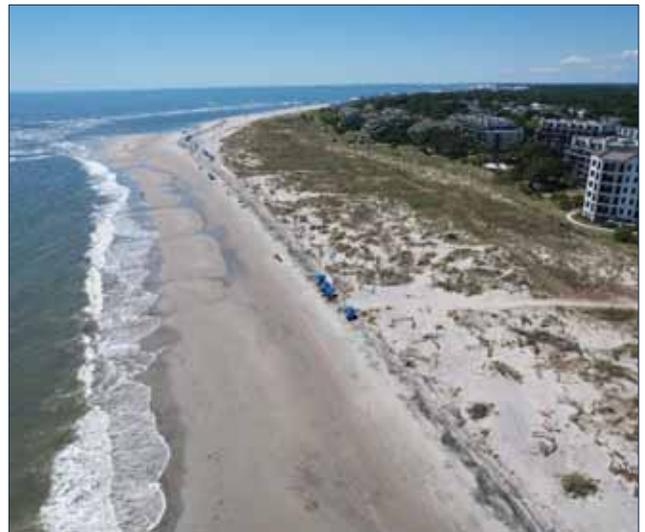
FIGURE 4.9. [LEFT] Reach 6 profiles. The erosion observed in this reach since 2018 has followed typical patterns of historic shoal bypassing. Over the past two years, the eastern end of the reach has eroded while the western end has been stable or accretional. **[RIGHT]** Aerial photos collected in September 2025.

Aerial and ground photos of the reach taken in September 2025 document the recent variability in beach and dune volumes (Figs 4.9 and 4.10). The western portion of the reach contains relatively healthy and continuous vegetation along the upper dry-sand beach and dunes, whereas vegetation along the eastern portions of the reach is sparse to nonexistent. Around the Ocean Club, there is little-to-no dry-sand beach protecting the buildings. Figure 4.8 (lower) shows that the beach volumes in August 2025 are near the lowest in 18 years around Stations 310 to 314.

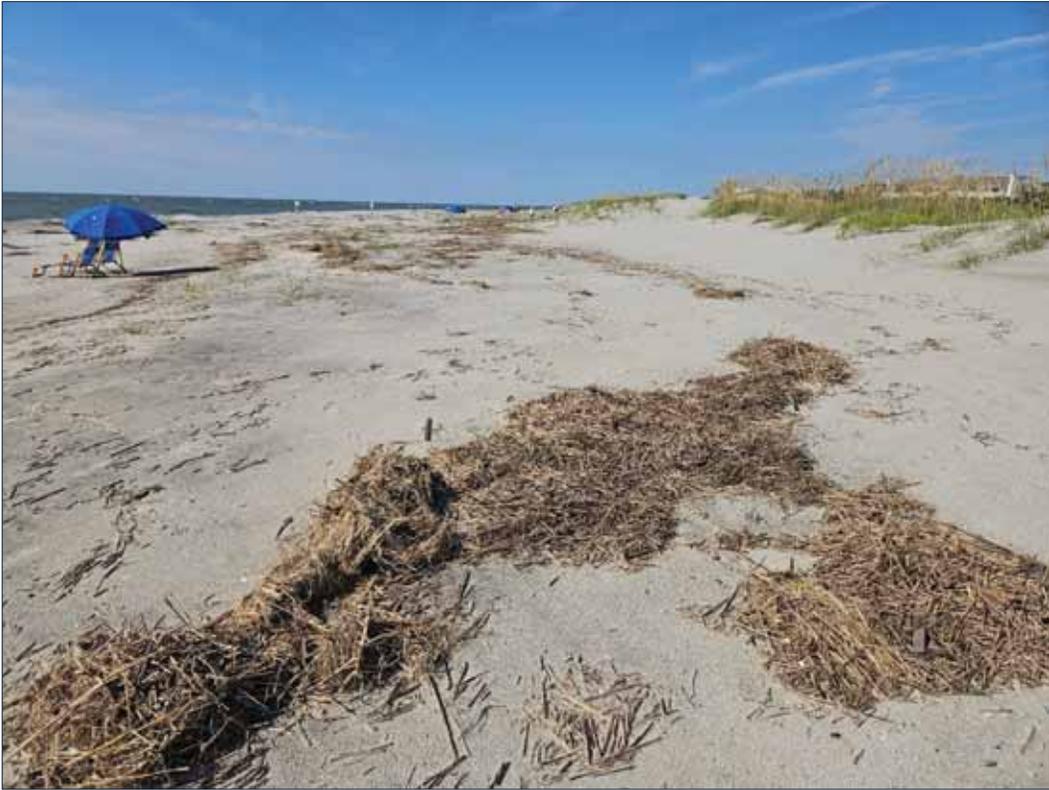
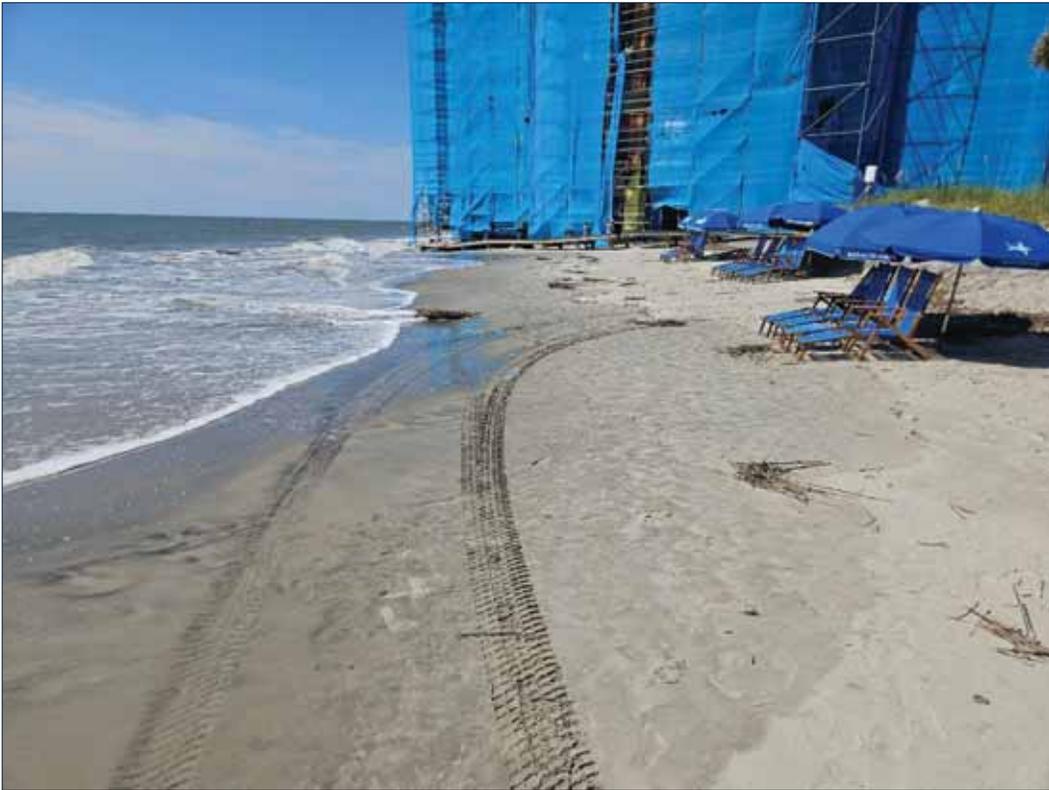
FIGURE 4.10. Ground photos from Station 288 [UPPER] and Station 316 [LOWER] in August 2025.

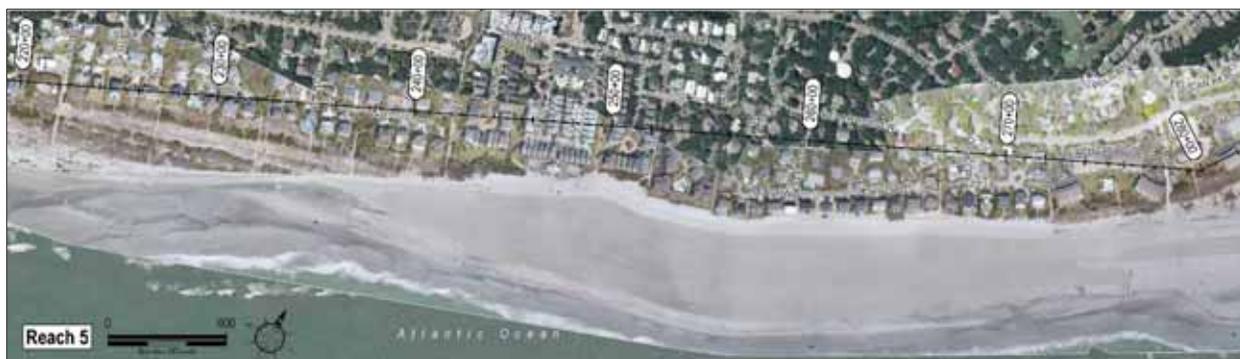
FIGURE 4.11. Baseline stationing along Reach 5, which spans ~5,800 lf of beach between 53rd Avenue and Wild Dunes Property Owners Beach House. The background photo is from just after the 2018 nourishment project.

Reach 5 includes ~5,800 lf of beach between 53rd Avenue and the Wild Dunes Property Owners Beach House (Stations 222–280 – Figure 4.11). The central and eastern portions of Reach 5 are strongly influenced by shoal-bypass events, much like Reach 6. Reach 5 tends to experience the waves of erosion and accretion during and after each shoal bypass event. Portions of the reach have experienced critically eroded conditions requiring emergency protective measures over the past 50 years.

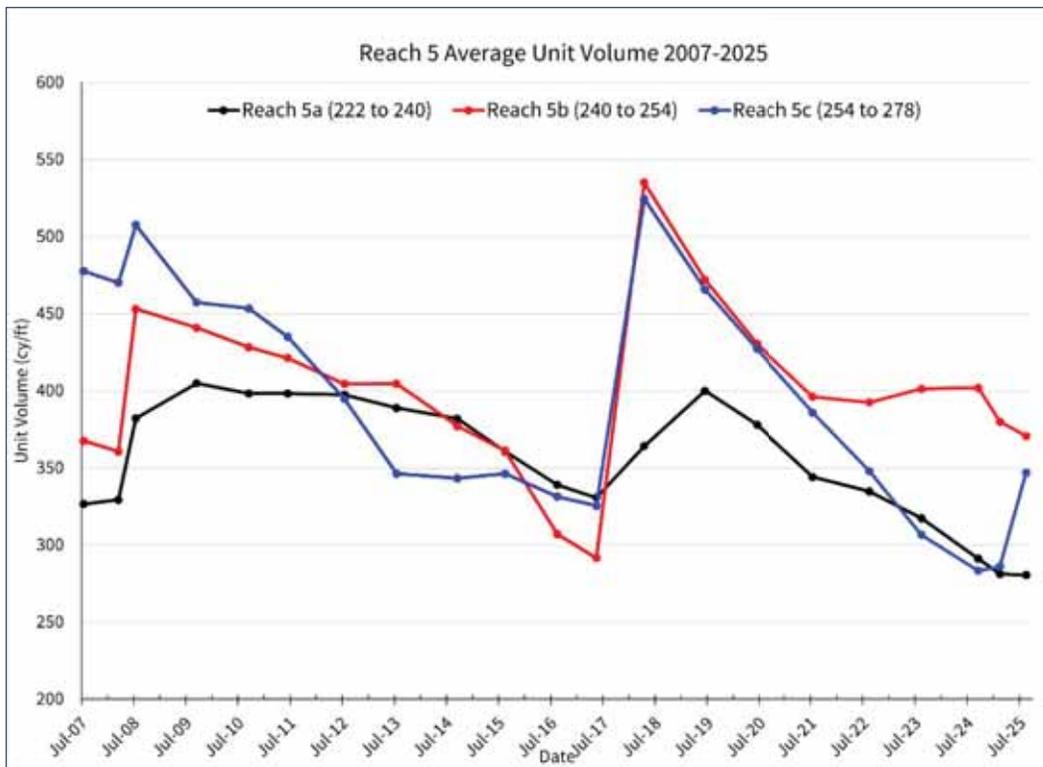
FIGURE 4.12a. Average beach volume in Reach 5 since 2007.

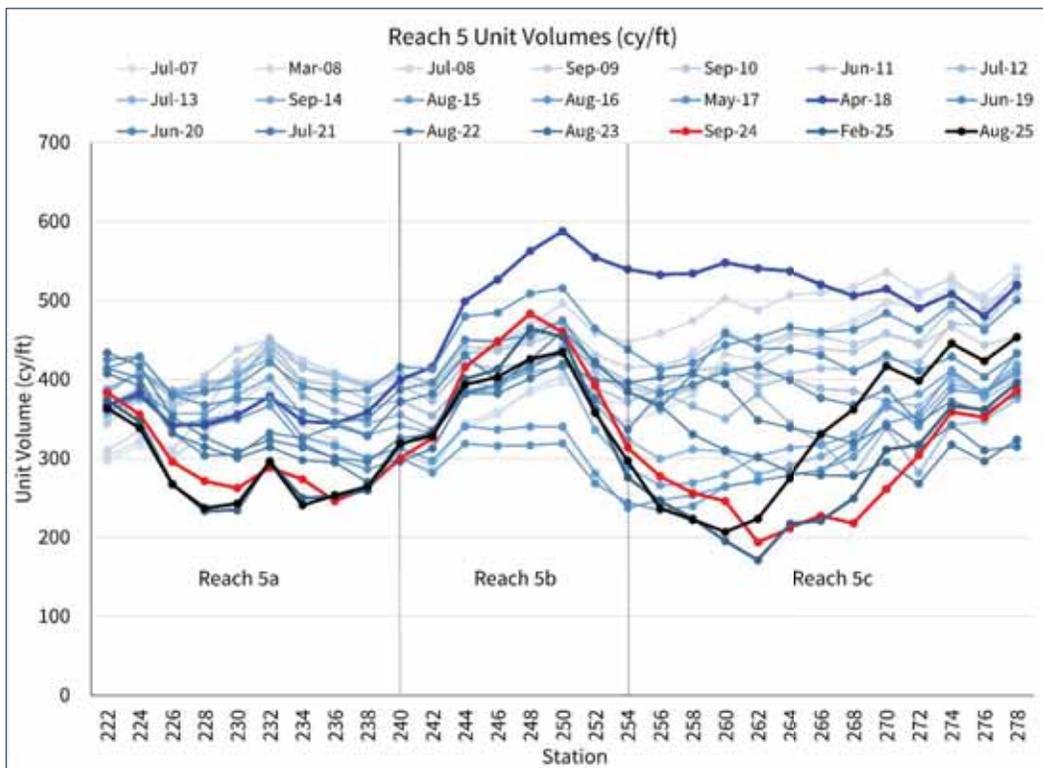
FIGURE 4.12b. Profile unit volumes for each monitoring line in Reach 5.

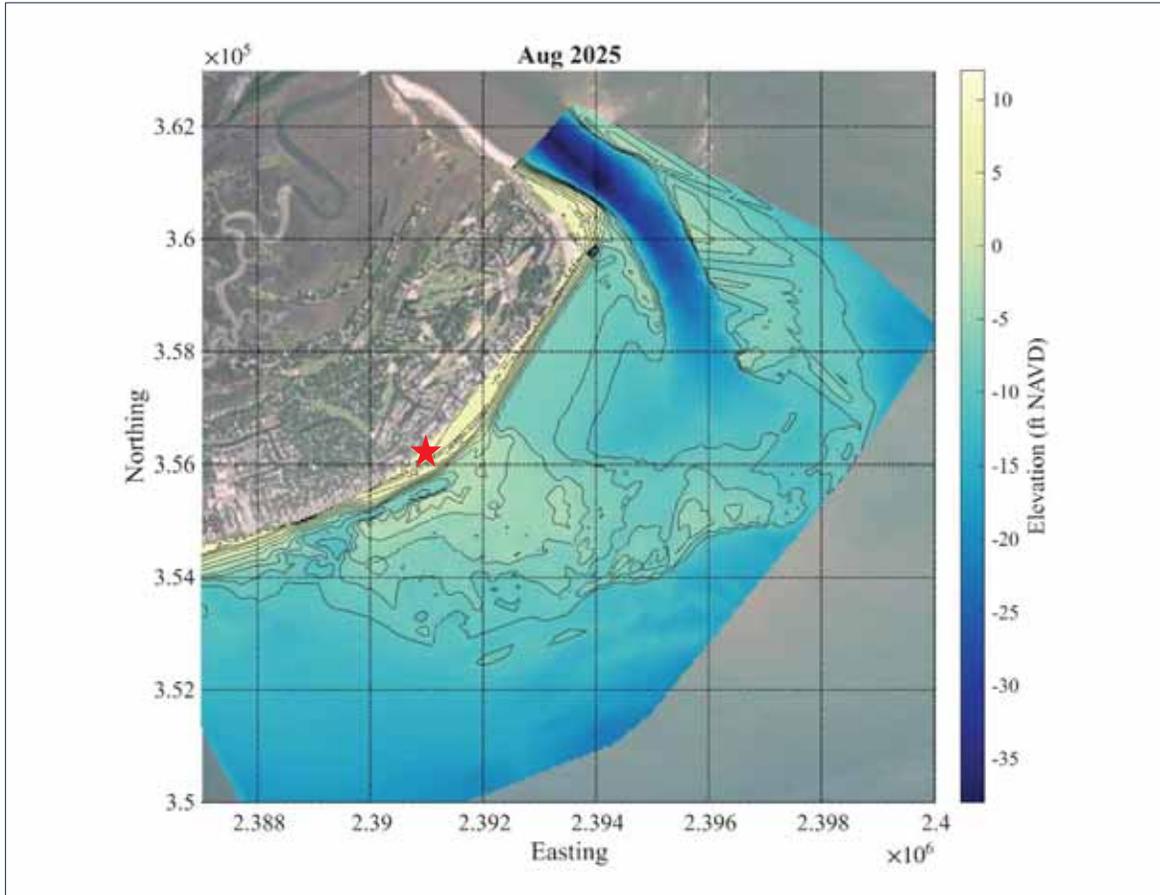
FIGURE 4.13. Shoal attachment in August 2025 with the red star on Beach Club Villas.

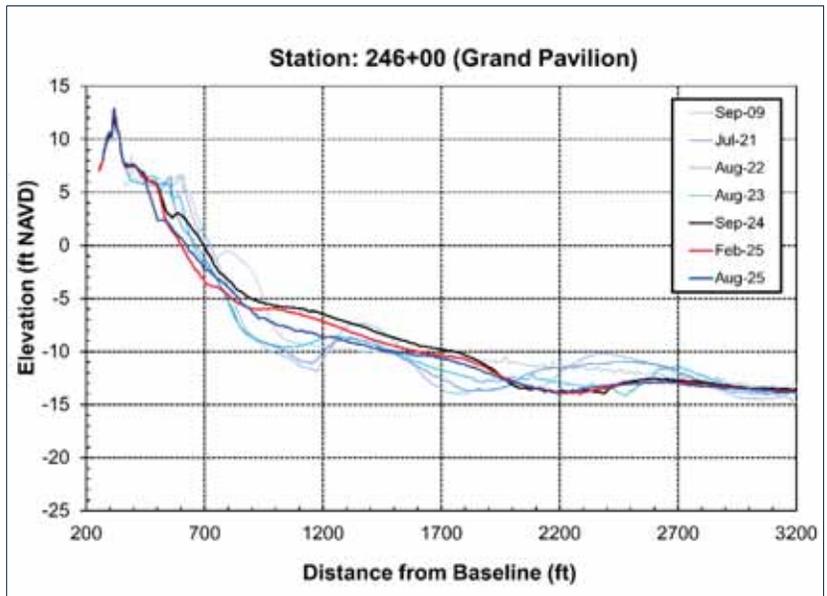
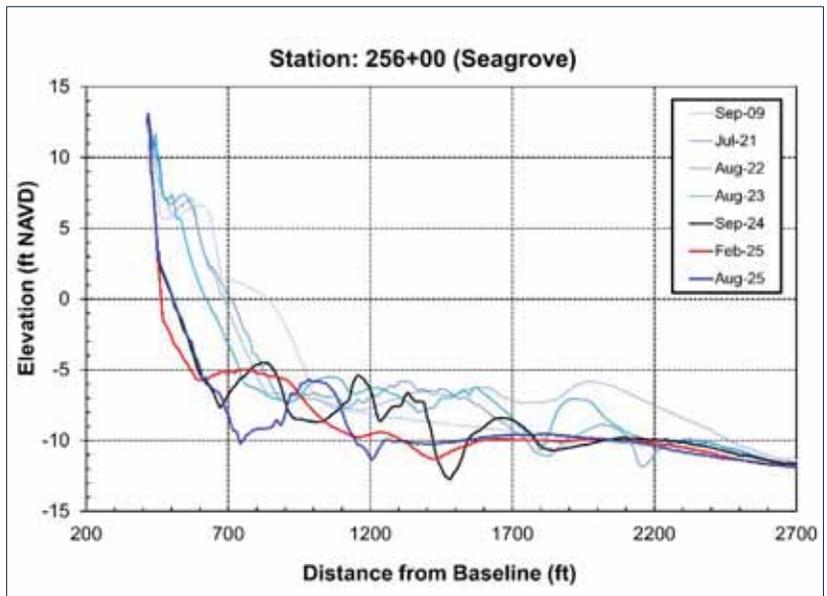
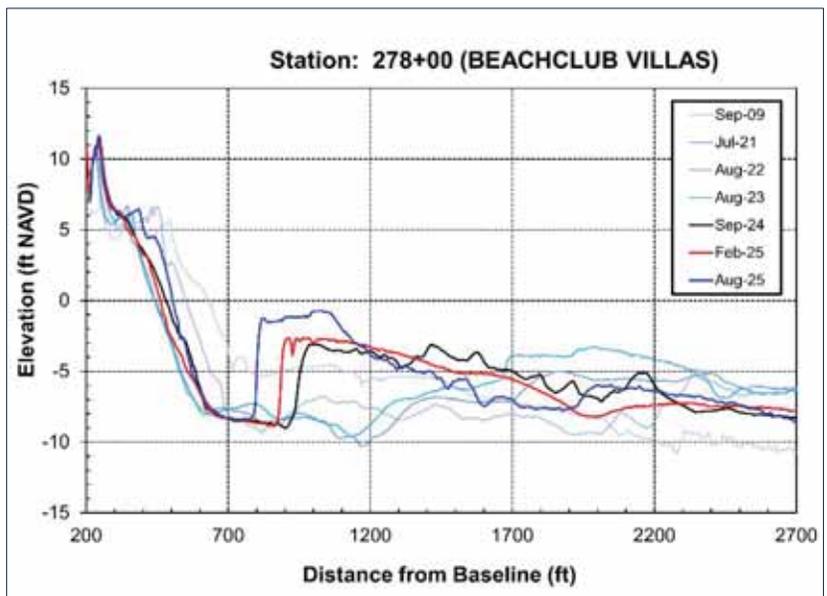
FIGURE 4.14. Reach 5 profiles. Note the distinct bypassing shoal at Station 278+00 migration landward and upward off of Beach Club Villas.

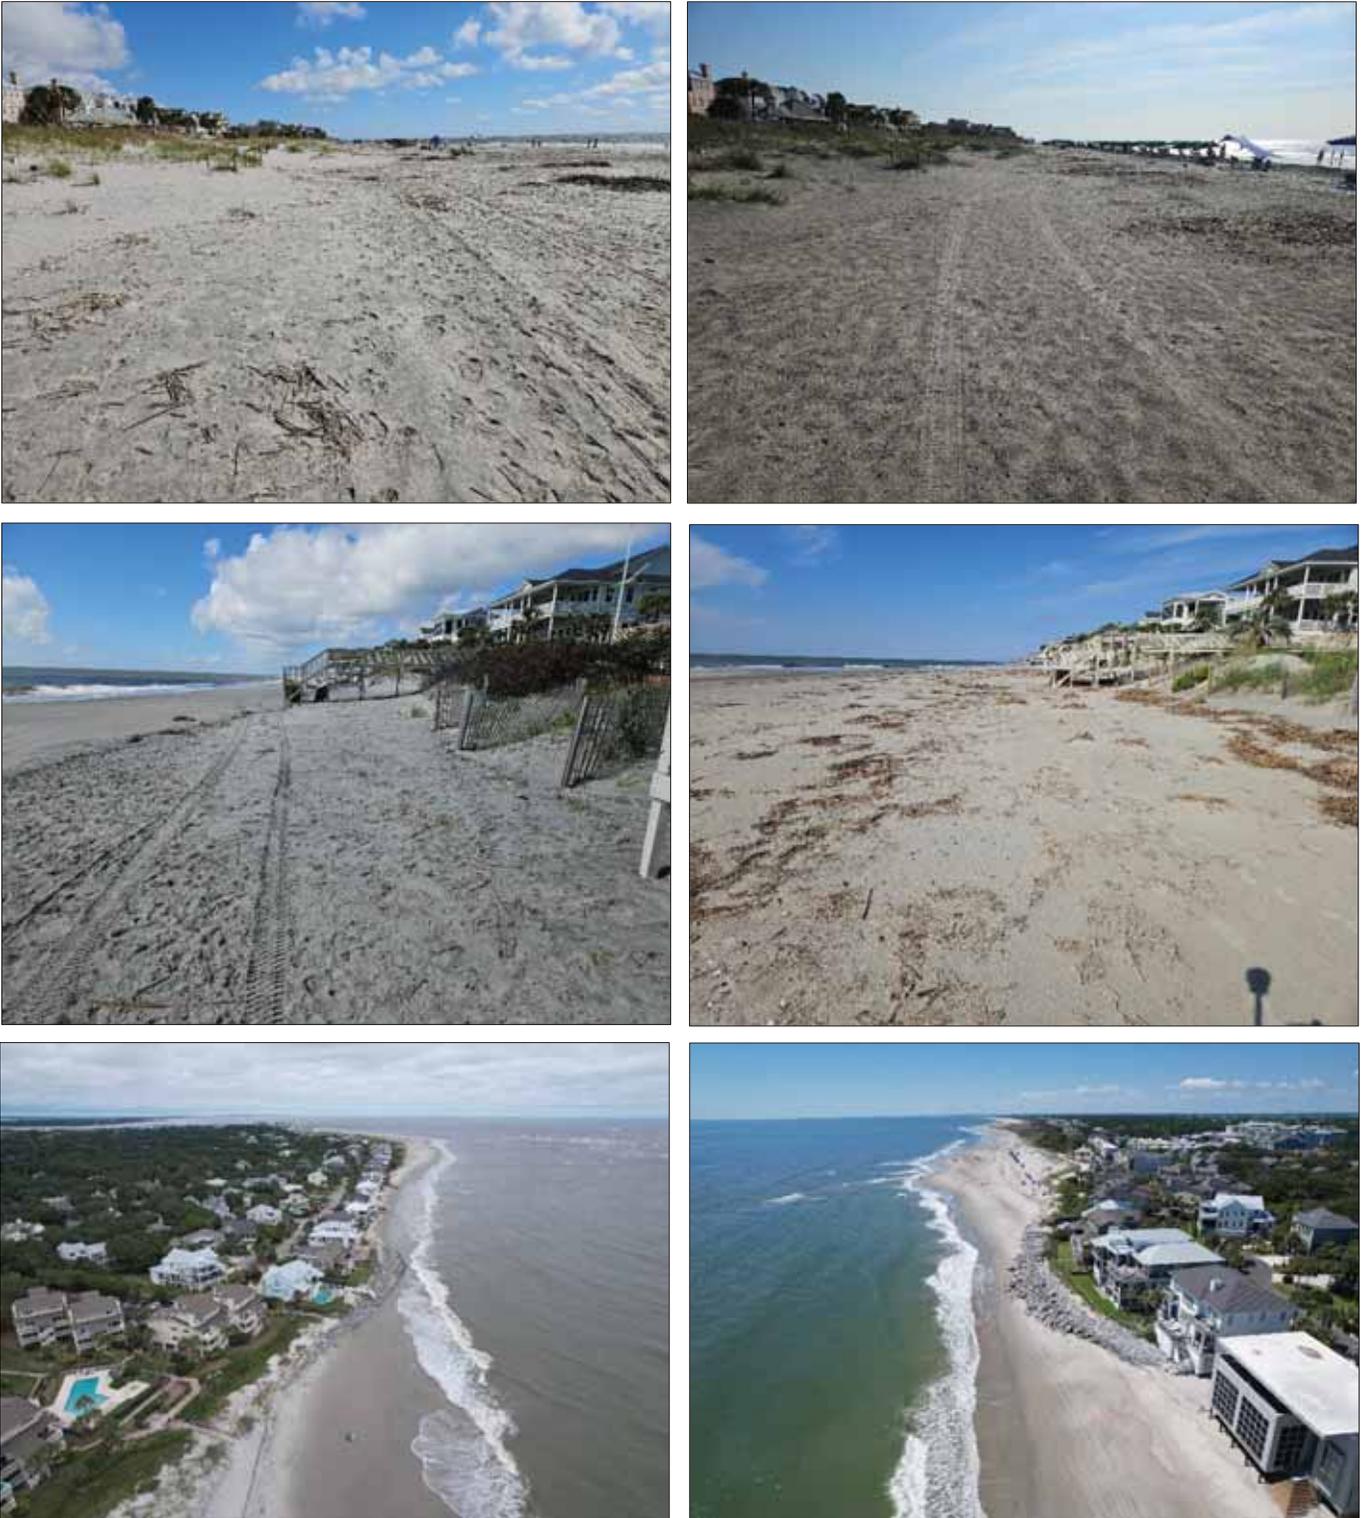
FIGURE 4.15. Ground photos of Reach 6 showing Station 244 in 2024 [UPPER LEFT], Station 244 in 2025 [UPPER RIGHT], Station 272 in 2024 [MIDDLE LEFT], and Station 272 in 2025 [MIDDLE RIGHT]. Aerial photo from August 2024 [BOTTOM LEFT] and September 2025 [BOTTOM RIGHT].

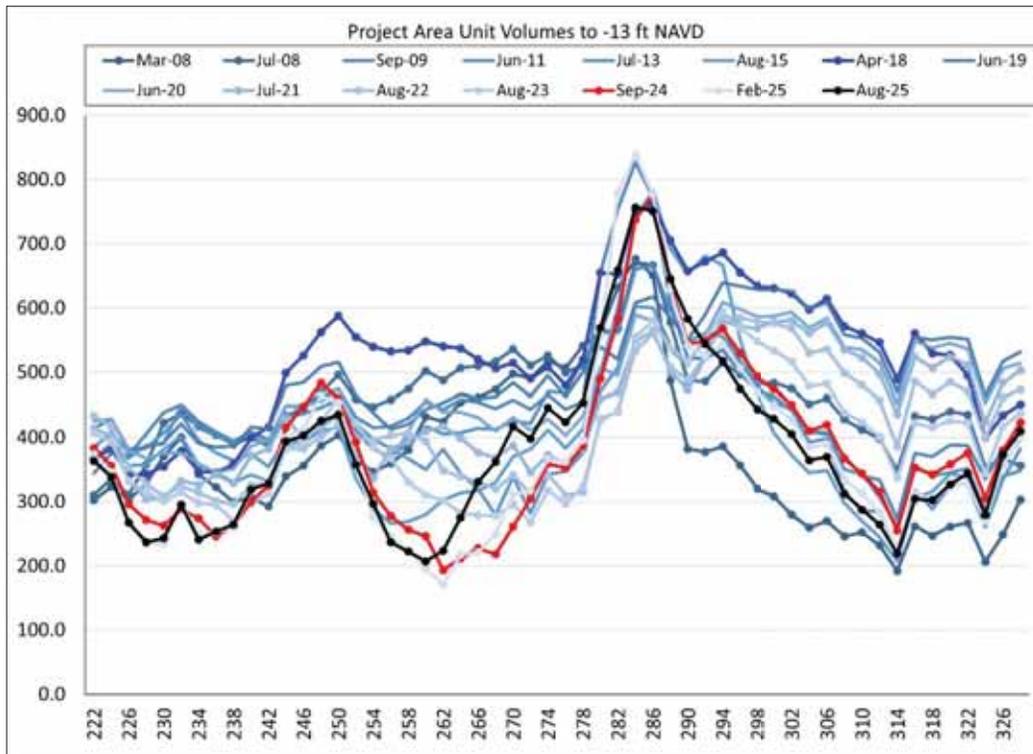
FIGURE 4.16a. Beach width changes along the area spanning the Citadel House to the 18th hole of the Links Course. Note the greater losses around Stations 222–262 and 290–326. Note the extensive accretion present south of the 2018 project area (left side of the image from Stations 262–282).

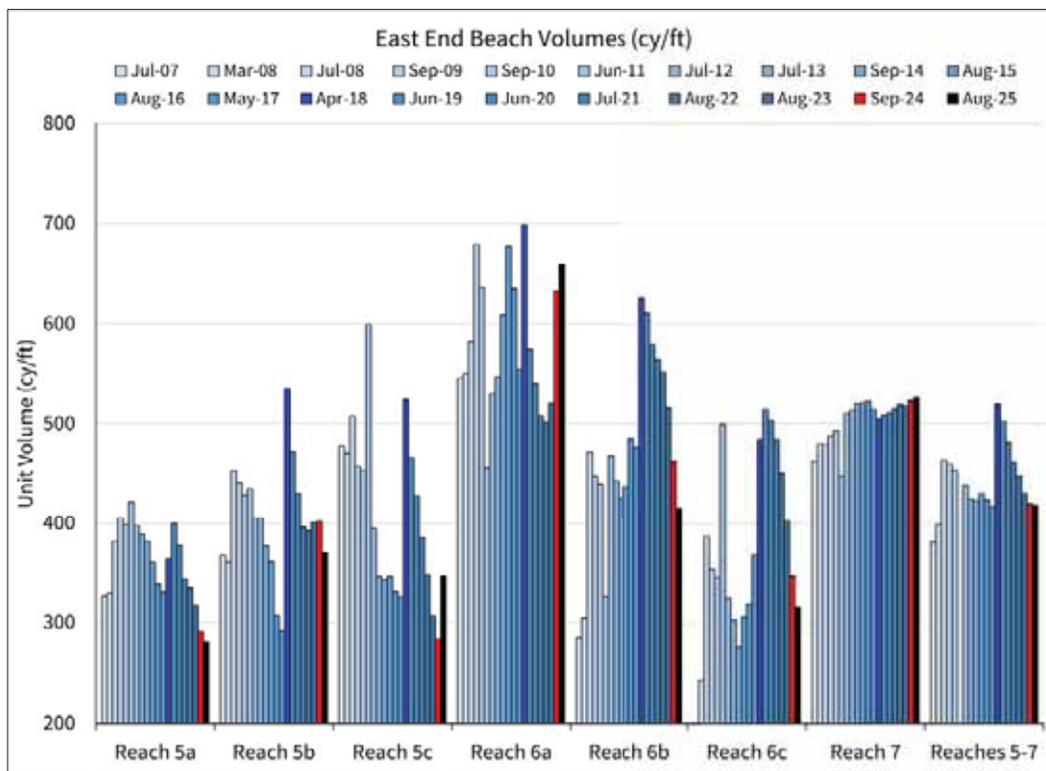
FIGURE 4.16b. The beach volume history of the eastern end of the island since 2007, with dates following nourishment indicated.

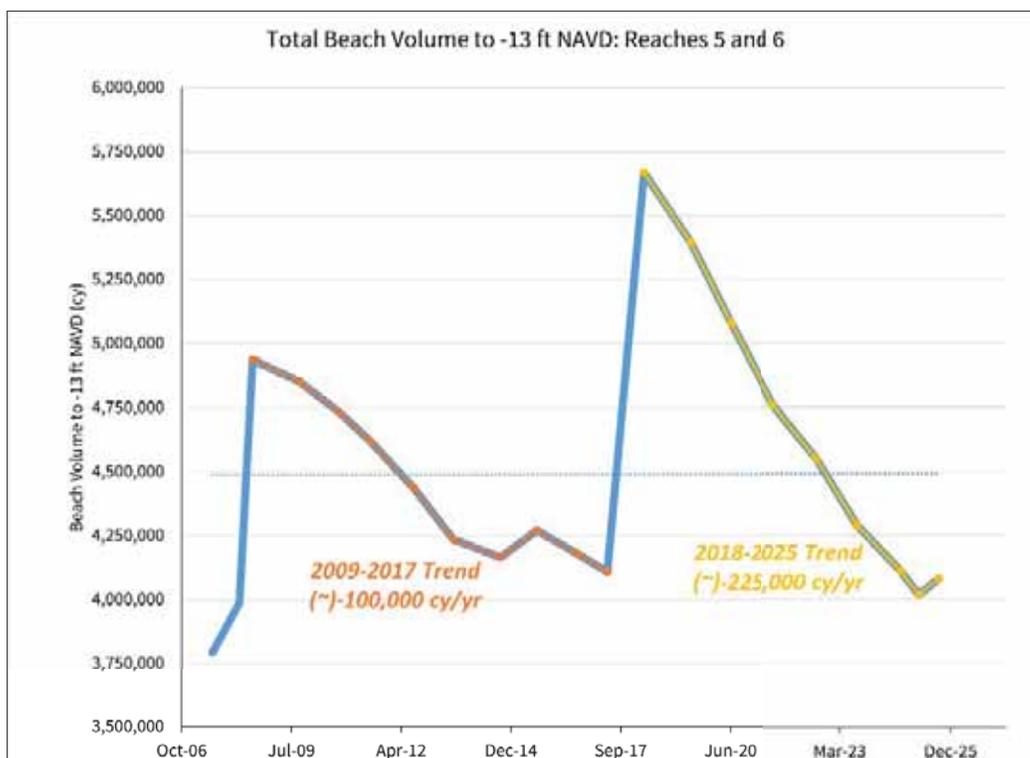
FIGURE 4.17. Total beach volume history of the eastern end of the island since 2007. The graph illustrates the overall erosional trend along Reaches 5 and 6 between nourishment projects.

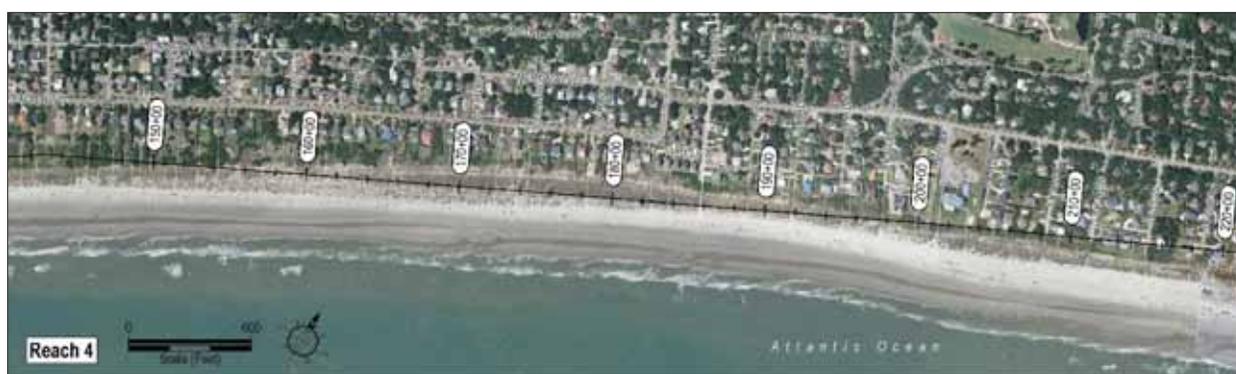
FIGURE 4.18. Baseline stationing along Reach 4 spanning the length of beach between 31st Ave and 53rd Ave.

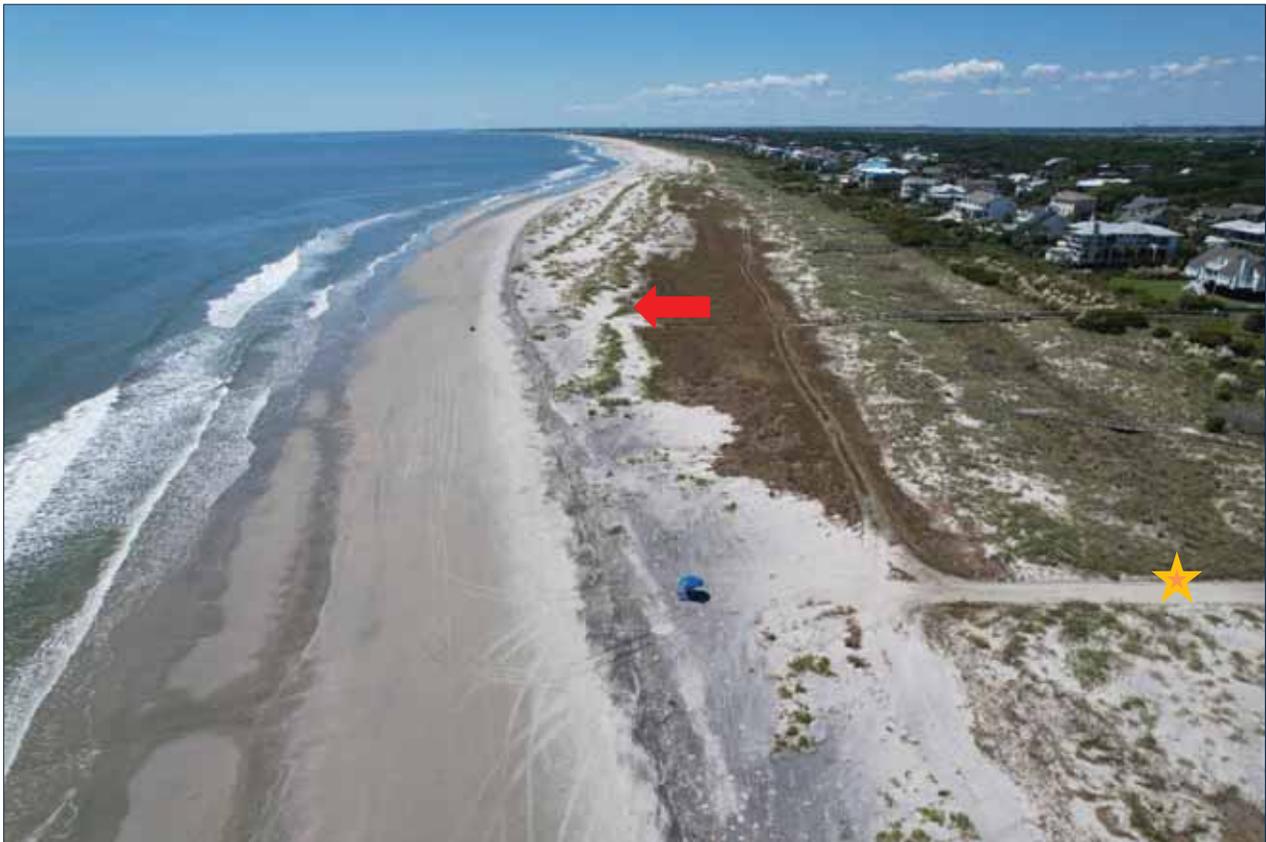
FIGURE 4.19. September 2025 aerial photo of Reach 4 (53rd Avenue is marked by the orange star). By being positioned downdrift of the nourishment area, Reach 4 receives nourishment sand spreading from the placement area as well as spreading shoal sand. This reach has gained sand every year since 2009, except in 2016 and 2025. As the vegetated dunes expand, sheltered locations (such as low-lying areas behind protective dune ridges) will gradually transform into a shrub habitat with larger areas of wax myrtle replacing dune grasses. The 2008 dune line is shown by the red arrow.

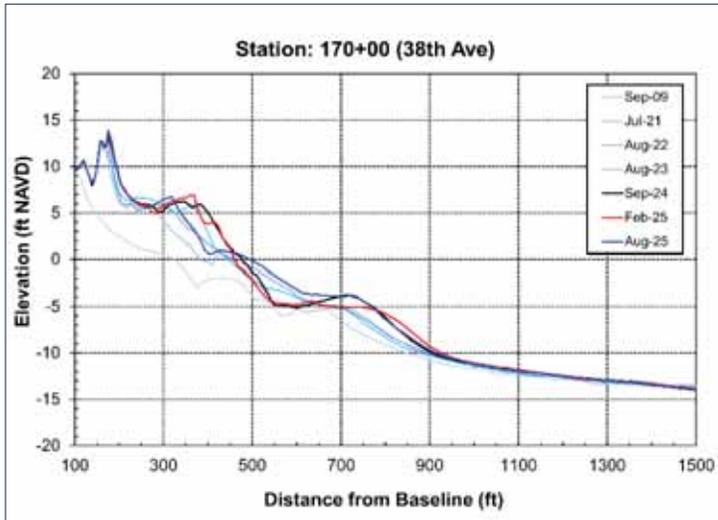
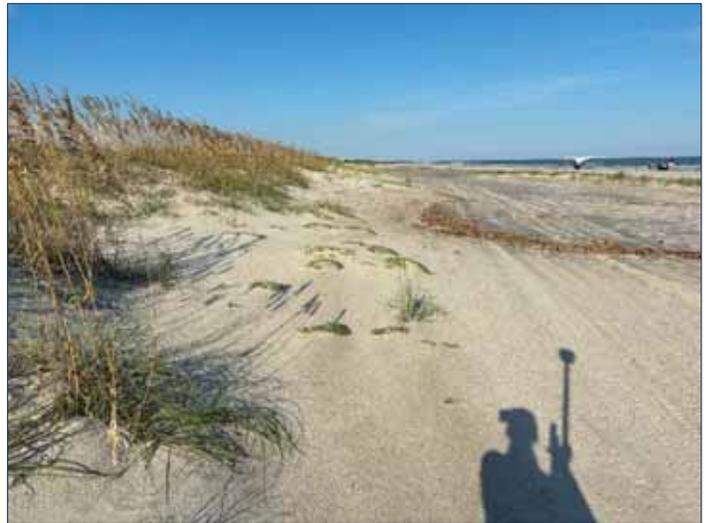
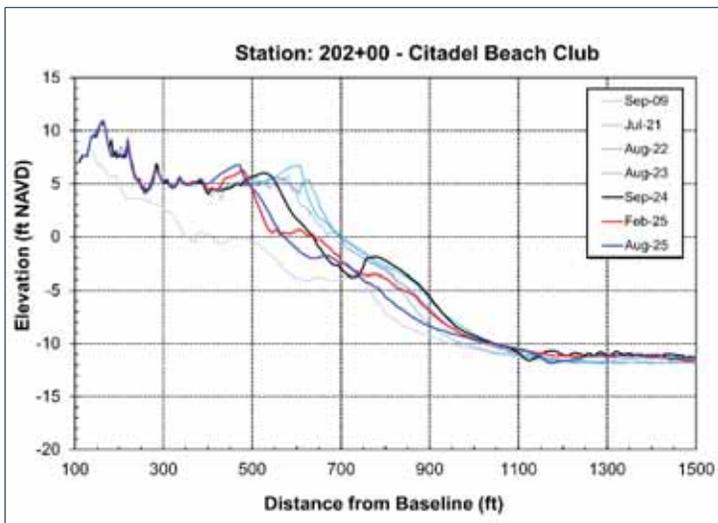
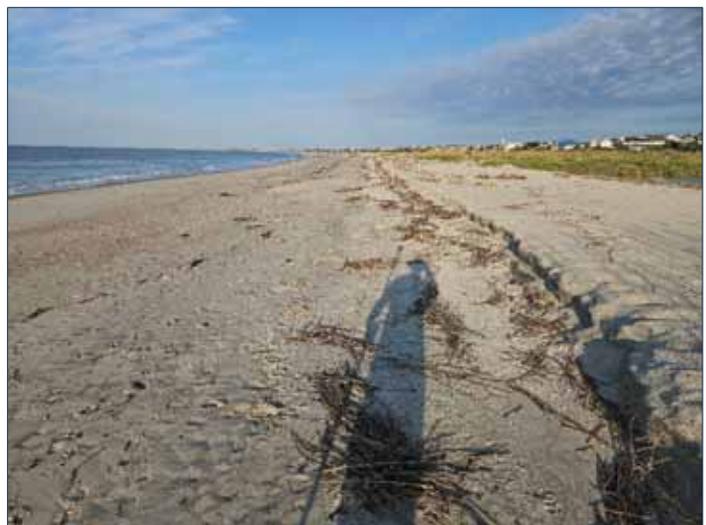
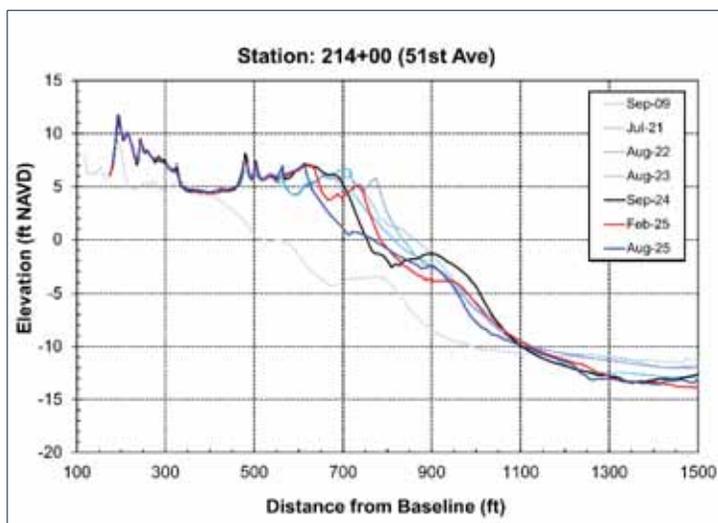
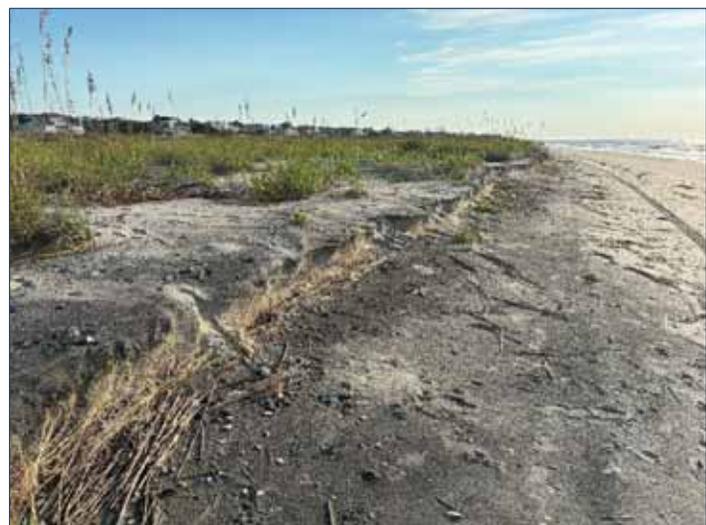
FIGURE 4.20. [LEFT] Profiles along Reach 4 show accretion has led to gains of over 300 ft of dry-sand width and formation of new dune ridges. [RIGHT] Ground photos from Station 170 [UPPER], Station 202 [MIDDLE], and Station 214 [LOWER] in September 2024.

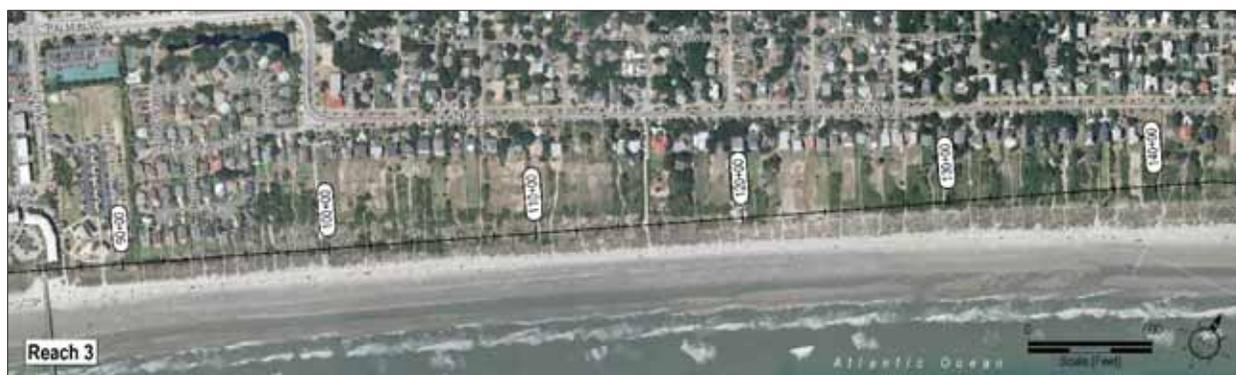
FIGURE 4.21. Baseline stationing along Reach 3 spanning the length of beach from the Sea Cabins Pier to 31st Ave.

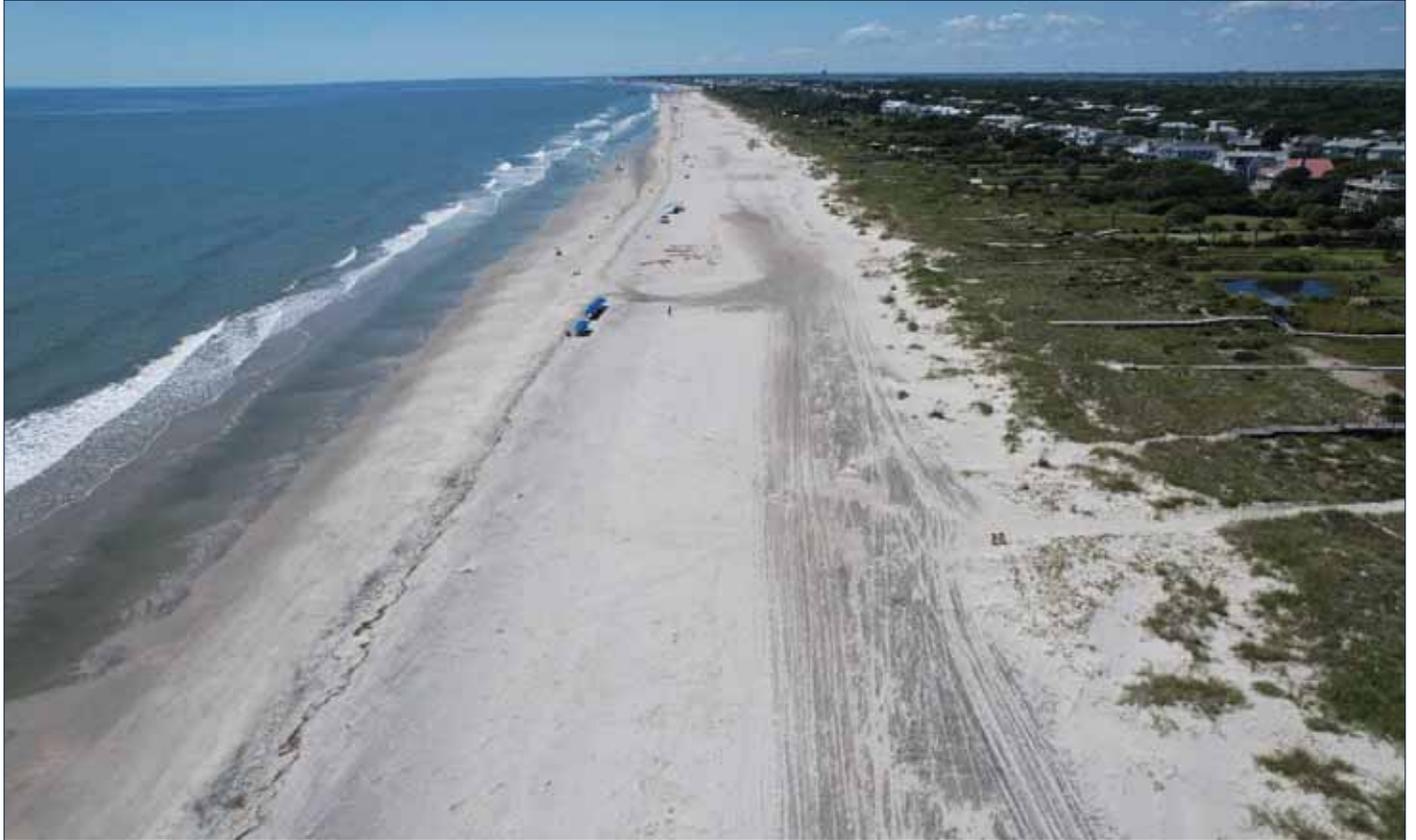
FIGURE 4.22. Aerial photo of Reach 3 in September 2025 (24th Ave in the foreground). The long-term trend for Reach 3 is stable to accretional. Dwellings in the reach are generally set back from the beach between 400 ft and 500 ft.

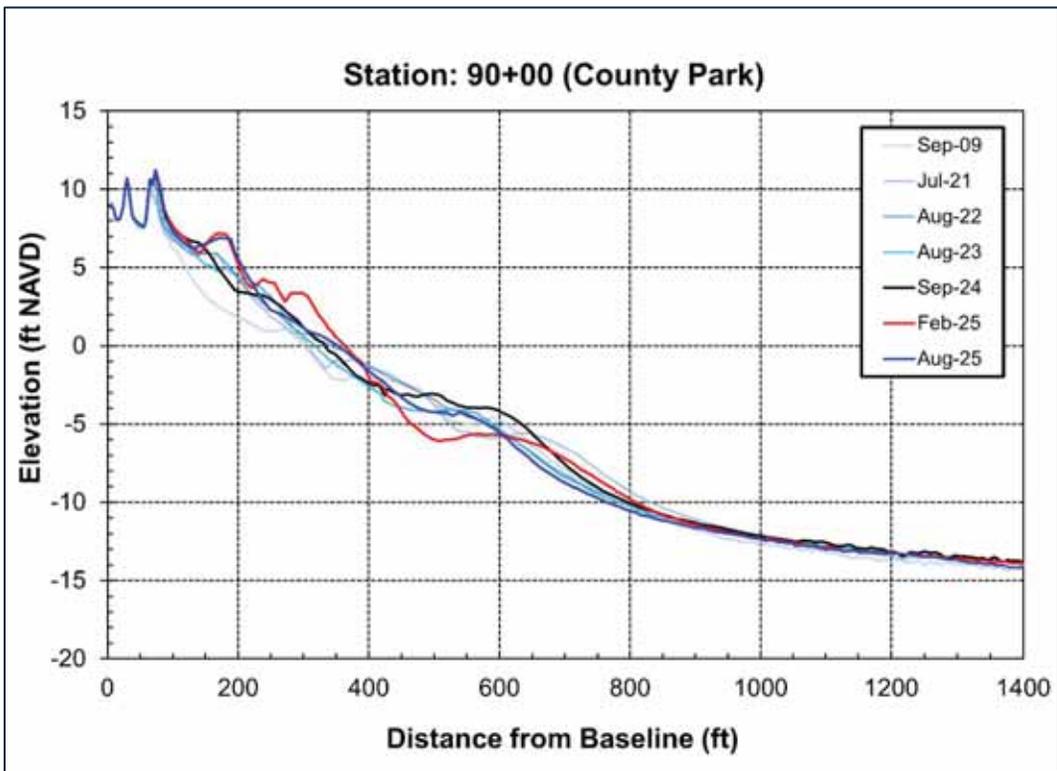
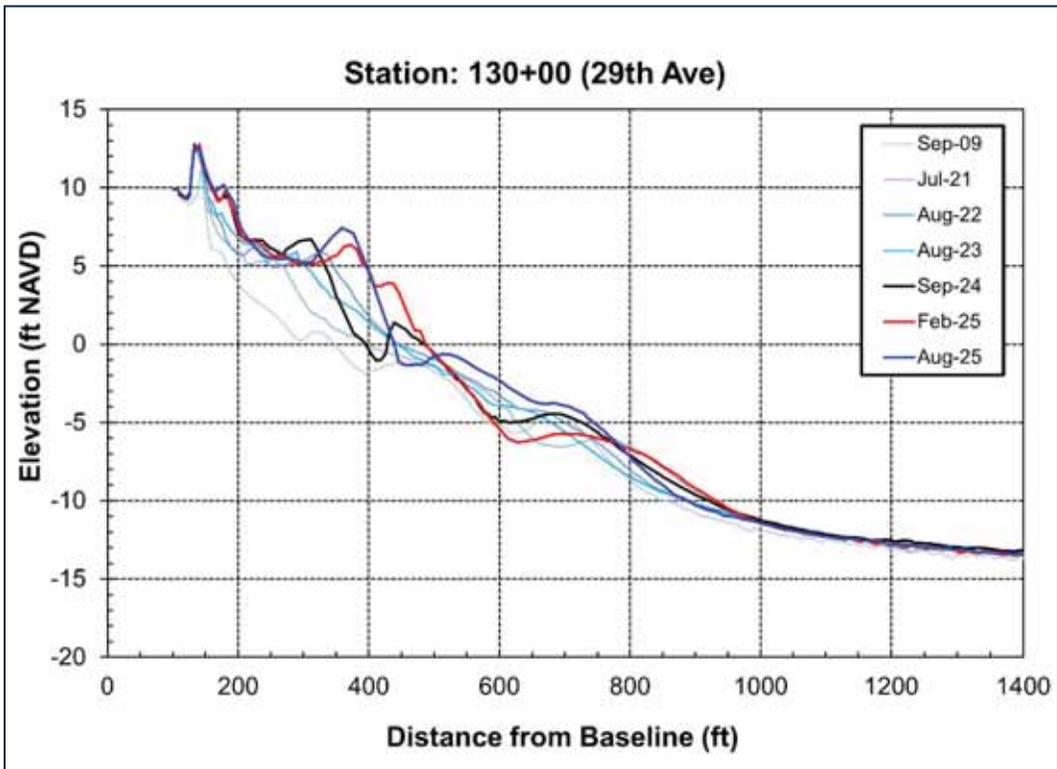
FIGURE 4.23. Example profiles from Reach 3. At Station 90+00, there was a net loss of volume due to movement of the underwater sandbar and a slight decrease in the dry beach portion.
