2025
MONITORING REPORT

Prepared for
City of Isle of Palms
Isle of Palms, South Carolina

COASTAL SCIENCE & ENGINEERING

This monitoring report is submitted to the City of Isle of Palms, SC (IOP) by Coastal Science & Engineering (CSE) as part of an ongoing beach monitoring effort that began in 2007 during planning for the 2008 Isle of Palms Beach Restoration Project (P/N 2007-02631-2IG) (CSE 2008). This report follows earlier monitoring reports submitted annually to the City, as well as additional reports and engineering documents related to shoal management and beach nourishment activities (P/N 2010-1041-2IG; 2016-00803 (CSE 2019)). The report details the beach condition as surveyed in February and August 2025 and compares these conditions with selected earlier dates, including the pre-2018 project condition. This is the seventh annual monitoring report following the 2018 nourishment project. Certain portions of this report detail monitoring efforts required by state and federal permit conditions for the 2018 project.

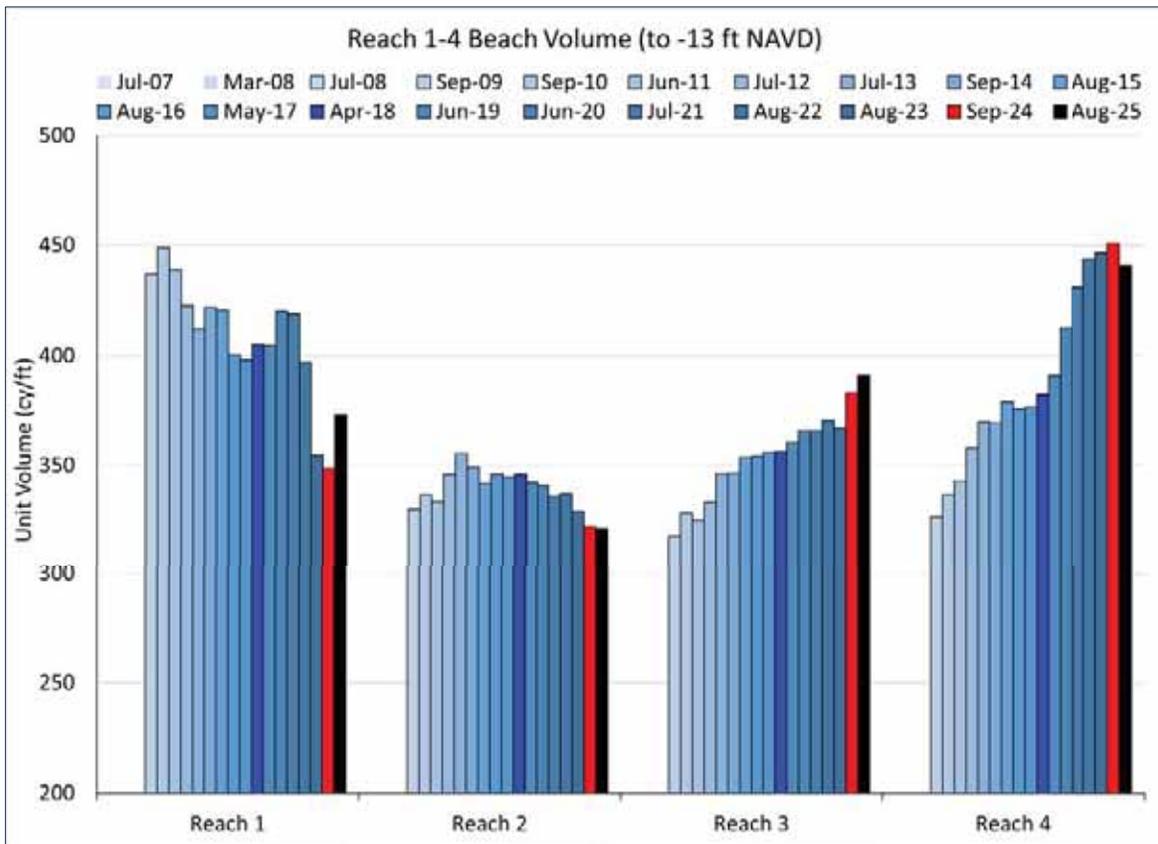
FIGURE 4.24. Reaches 3 and 4 have steadily gained sand since 2007, while Reaches 1 and 2 have experienced more erosion over the last 2–3 years relative to the long-term trends. This recent shift towards erosion in Reaches 1 and 2 is related to the dynamics of Breach Inlet and is addressed later in the report.

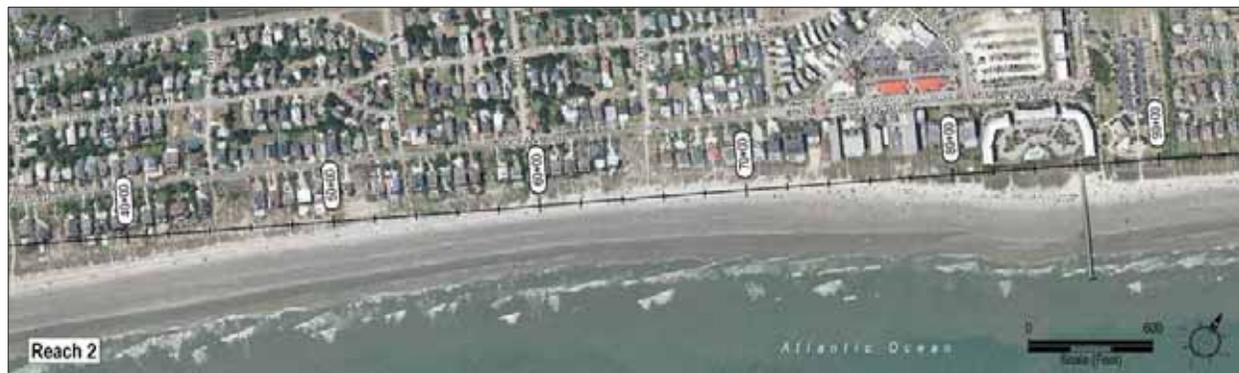
FIGURE 4.25. Baseline stationing along Reach 2 spanning between 6th Avenue and the Sea Cabins Pier.

Reach 2 spans 4,000 ft between south of 6th Avenue and Beach Access 13 (Stations 40 to 80 – Fig 4.25 and Fig 4.26). It includes the oceanfront commercial area at the eastern end of the reach. Reach 2 shows a shoreline change pattern like Reach 3, with intermittent periods of accretion and erosion and a long-term trend of accretion. Since monitoring began in 2009, Reach 2 has been the most stable reach, with lower magnitude volume changes than all other reaches.

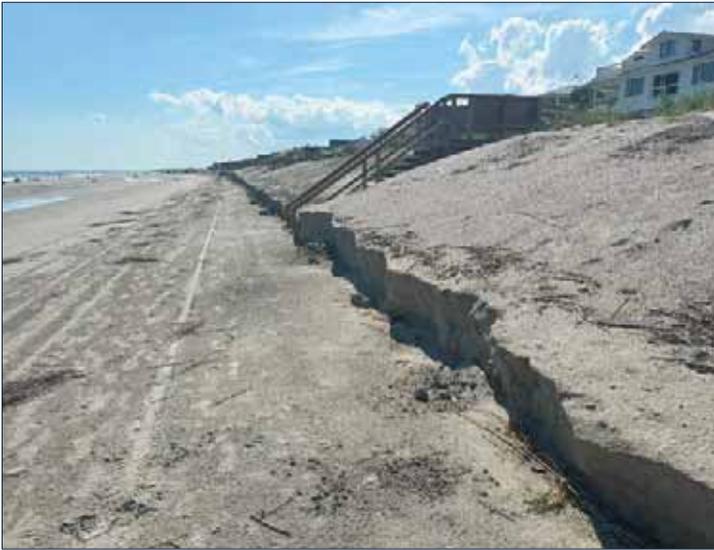
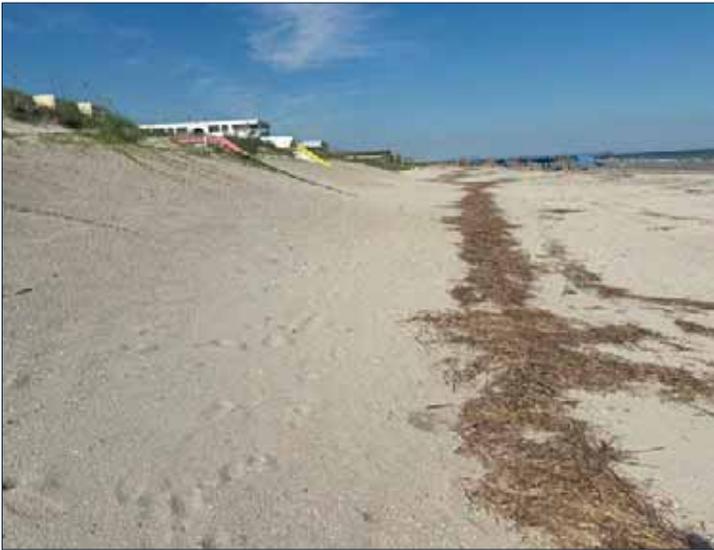
FIGURE 4.26. September 2025 photos of Reach 2. [UPPER LEFT] View south from Station 50. [LOWER LEFT] View north from Station 70. The top photo highlights the slight escarpment forming at the dune line toward the south of Reach 2 and the bottom photo shows a healthy beach around Station 70.

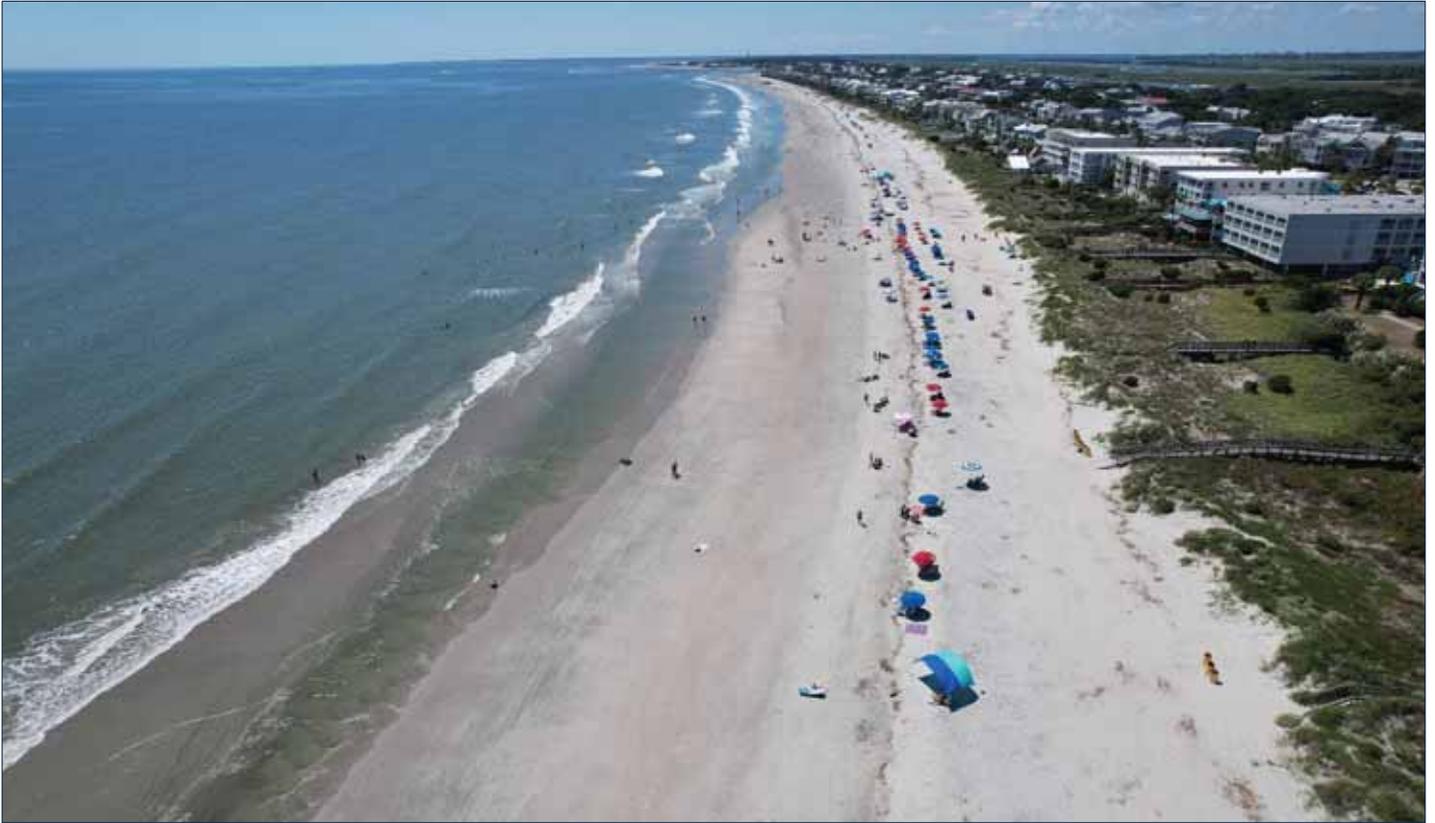
FIGURE 4.27. Aerial view of Reach 2 in September 2025. Since monitoring began in 2009, Reach 2 has been the most stable reach, typically showing lower magnitudes of volume change compared to the other reaches along Isle of Palms. The arc in the shoreline west of the pier indicates that the structure impacts waves, particularly during winds from the north, thereby modifying sand transport and erosion rates along Reach 2.

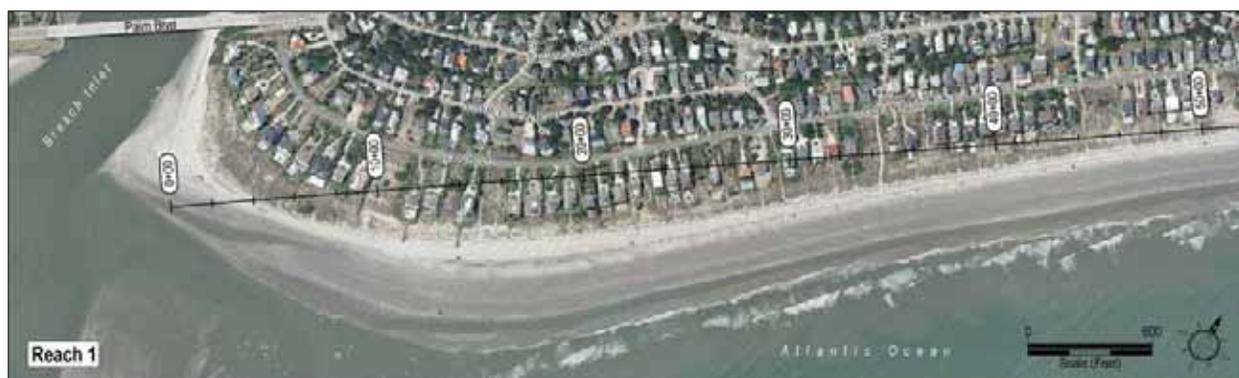
FIGURE 4.28. Baseline stationing along Reach 1, which encompasses the beach between Breach Inlet and 6th Avenue.

Reach 1 encompasses 5,000 lf of beach between Breach Inlet and South of 6th Avenue (Fig 4.28) and is classified as an unstabilized inlet erosion zone due to the dynamic nature of the shoals associated with the inlet delta.

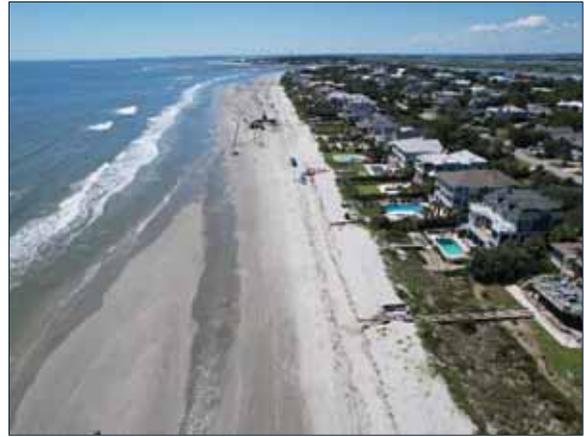
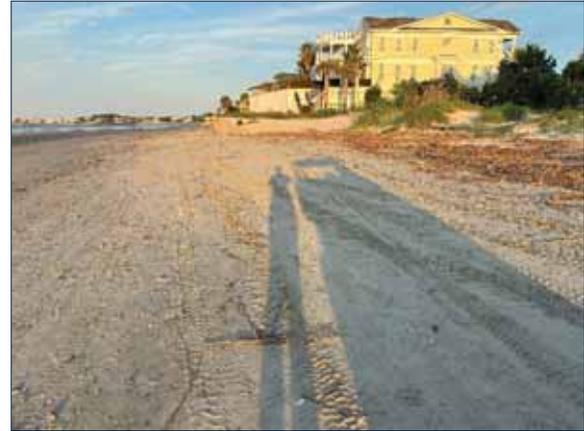
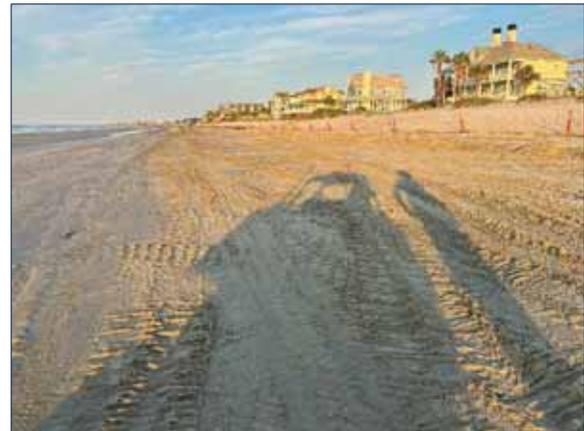
FIGURE 4.29. [LEFT] Profile plots for Reach 1 showing a significant loss of the dune area over the past two years. [TOP RIGHT] September 2025 aerial photo of Reach 1. [MIDDLE RIGHT] Ground photo of Station 16 looking south. [BOTTOM RIGHT] Ground photo of Station 30 looking south.

Currently, the USACE's "beneficial use project" to place sand along the southern reaches of Isle of Palms is still ongoing. The total plan was to add around 500,000 cy of material to Reaches 1 and 2. Most of the sand that has been placed as of August 2025 has been around the south end of Reach 1. As of September 2025, the project was at Station 16+00, near 2nd Ave. Much of this volume has been placed near mean low water (MLW). Typically, sediment placed in the MLW zone creates bars that dissipate wave energy (a beneficial effect in this case). However, when the nourished sediment contains a high portion of high-grained sediment, which is the case for the USACE dredge spoil sediments, much of the material will shift offshore as it is transported by wave action. The coarse, sandy material tends to eventually move onshore or downcoast into Breach Inlet. While this project has offered some improvement in beach widths, a general erosional trend persists. Photos of the 2025 condition are shown in Figures 4.29 and 4.30.

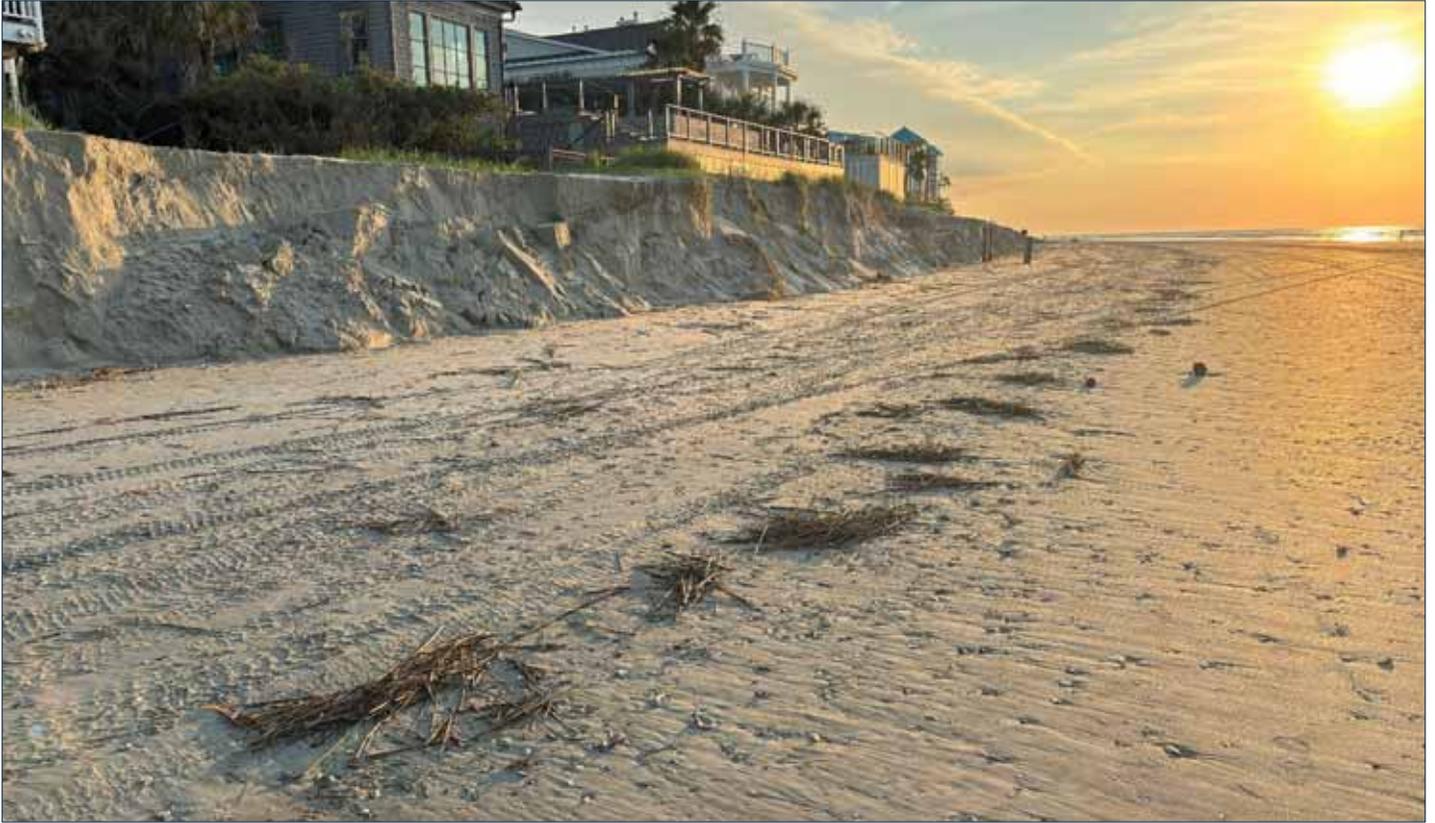
FIGURE 4.30. Ground photo of Station 12 looking east on August 26th, 2025, highlighting the erosion that is affecting the 100 block of Ocean Blvd.

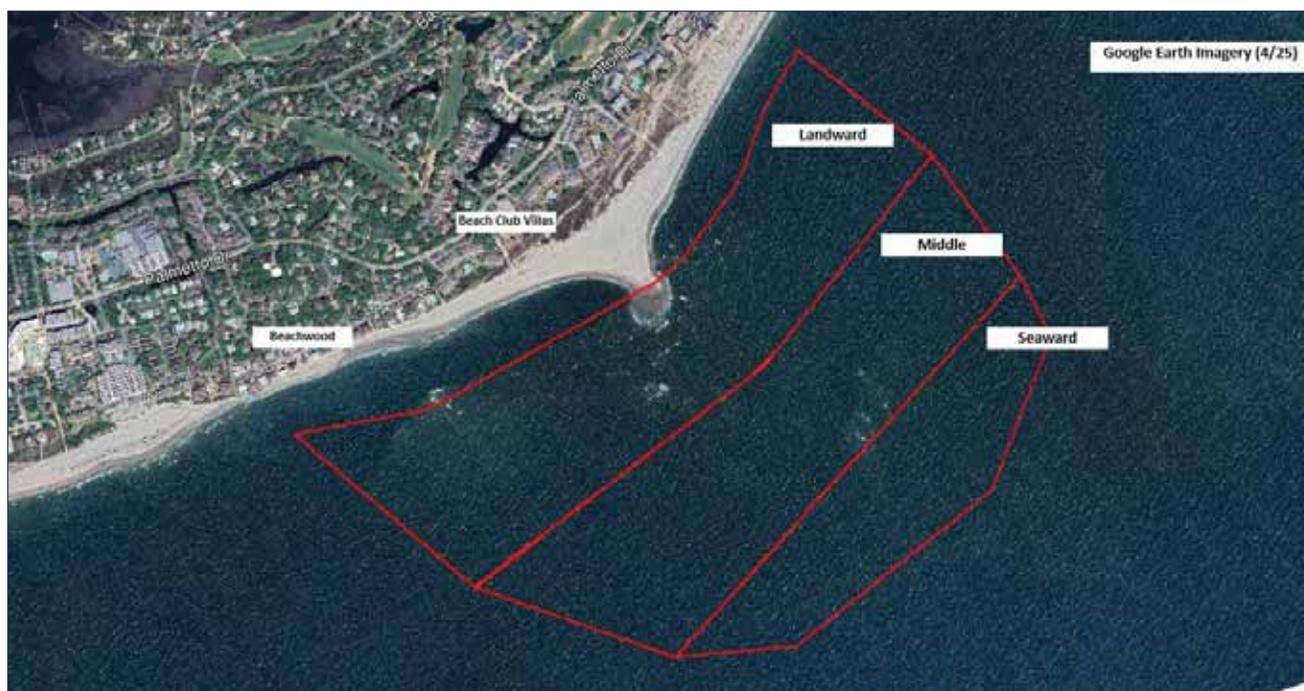
FIGURE 4.31. Google Earth aerial imagery showing the control areas used to compute volumes relative to offshore condition lacking any bypassing shoal.

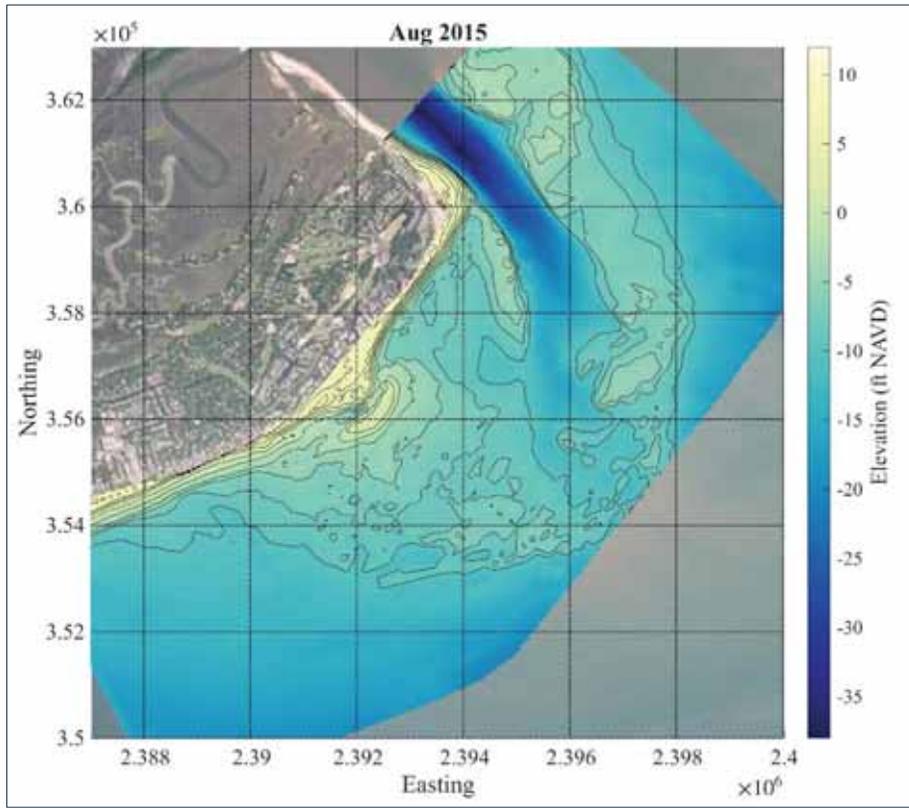
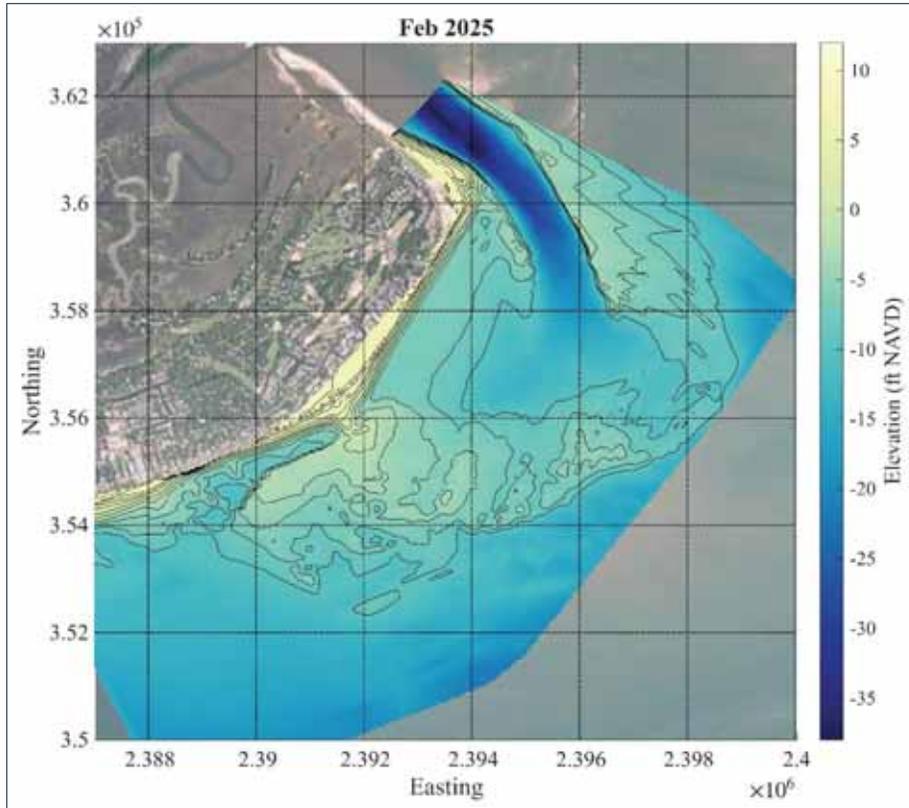
FIGURE 4.32. Shoal Contour Map from August 2015 compared to February 2025. Note the southwesterly extension of the 2025 shoal and associated channel landward of the shoal that is the cause of recent erosion at Beachwood East.

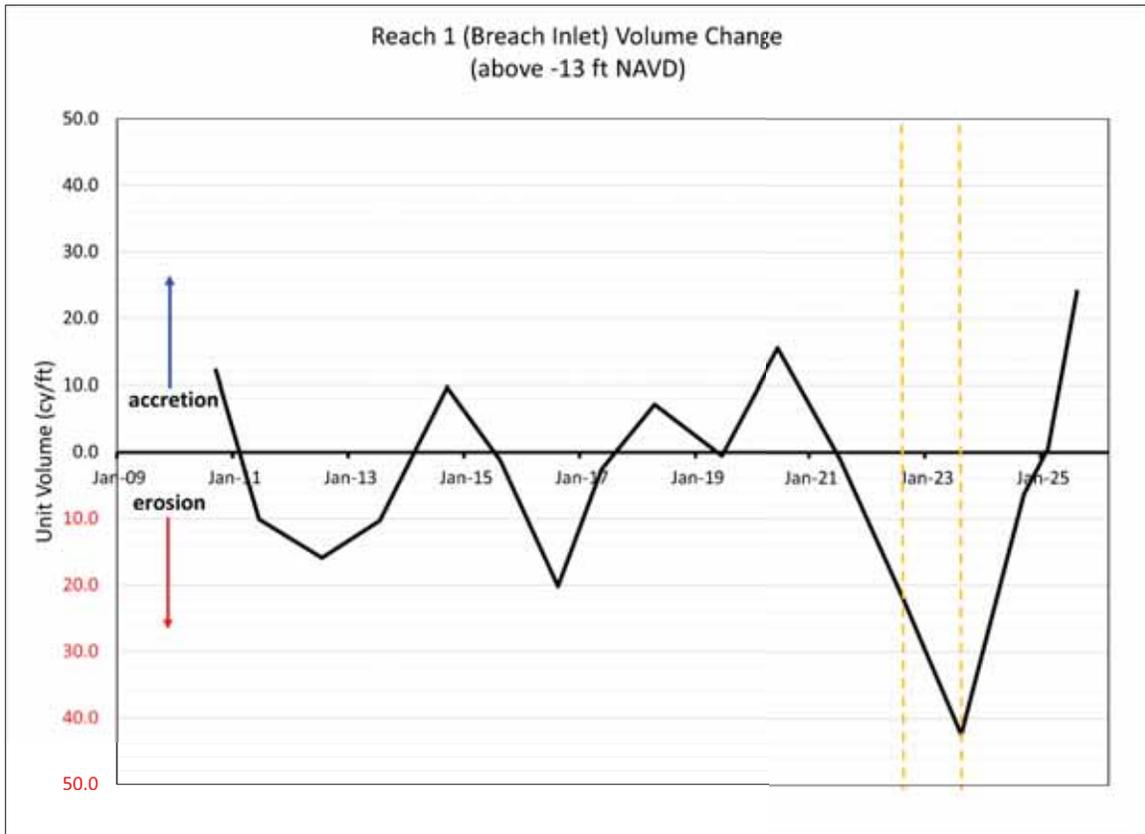
FIGURE 4.34. Breach Inlet unit volume change by year, with dotted orange lines depicting 2022 to 2023, a time period of abnormally high erosion rates. Volume changes along Reach 1 are highly cyclical and alternate between periods of moderate erosion and accretion. This is a common dynamic equilibrium around relatively small inlets like Breach Inlet, which tend to experience shoal bypass events at a greater frequency – but generally lower magnitude – than the larger inlet systems like Dewees Inlet at the east end. As the underwater bars and channels of Breach Inlet shift back and forth from the Isle of Palms to Sullivan’s side of the system, there are likewise changes in shoreface steepness, wave energy, and beach volumes on either side of the inlet. This is a natural feature of systems such as Breach Inlet and has been well documented in other mixed-energy settings worldwide (Beck and Wang 2019, Nienhuis and Ashton 2016, Gaudiano and Kana 2001, FitzGerald 2000).

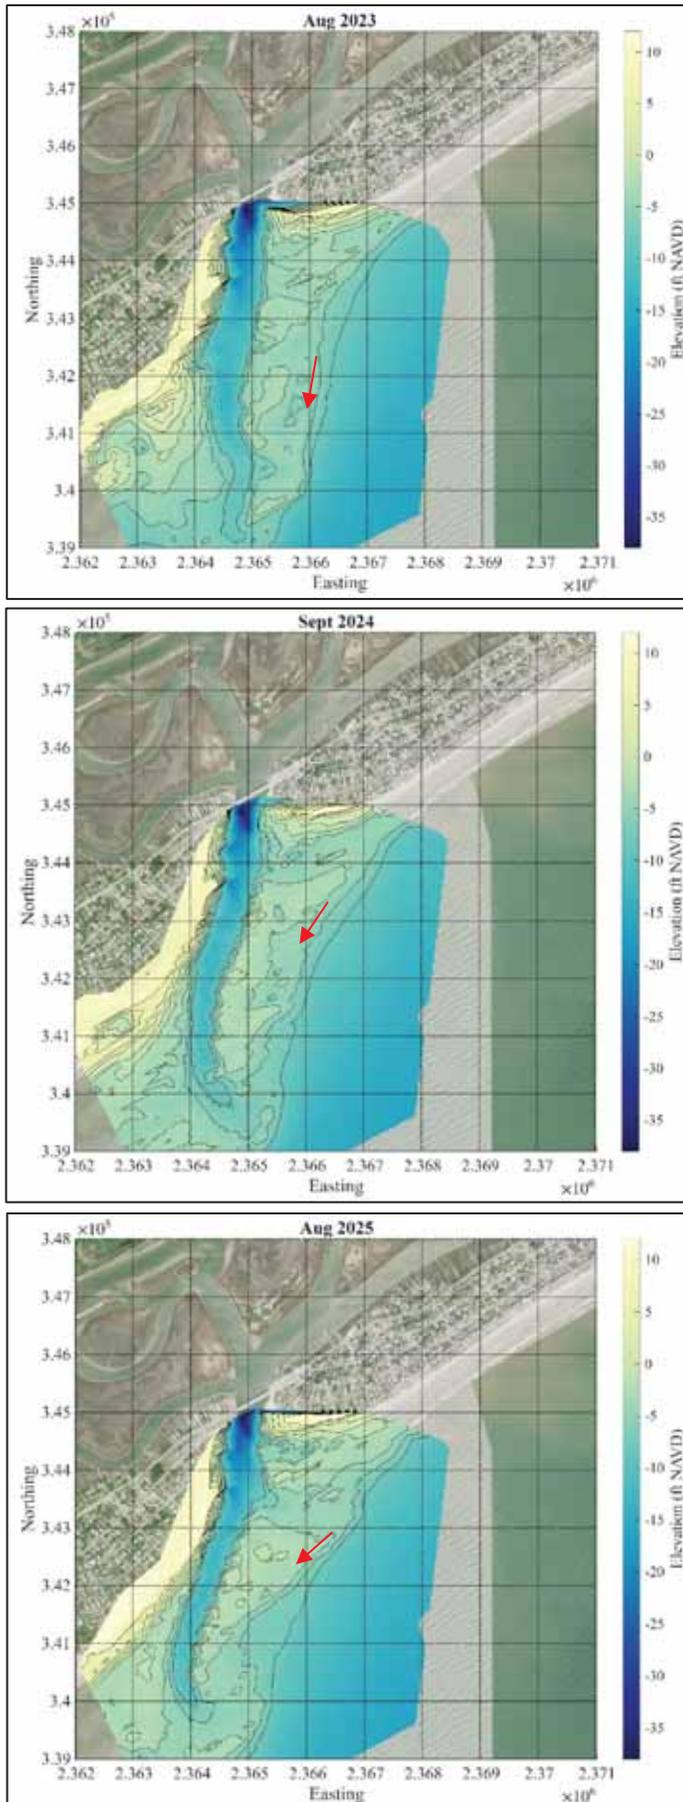
FIGURE 4.35. Breach Inlet contour maps showing the changes in shoal position and size, along with the changes to the inlet channel. With arrows showing the growth of the shoal and its seaward movement toward Sullivans Island.

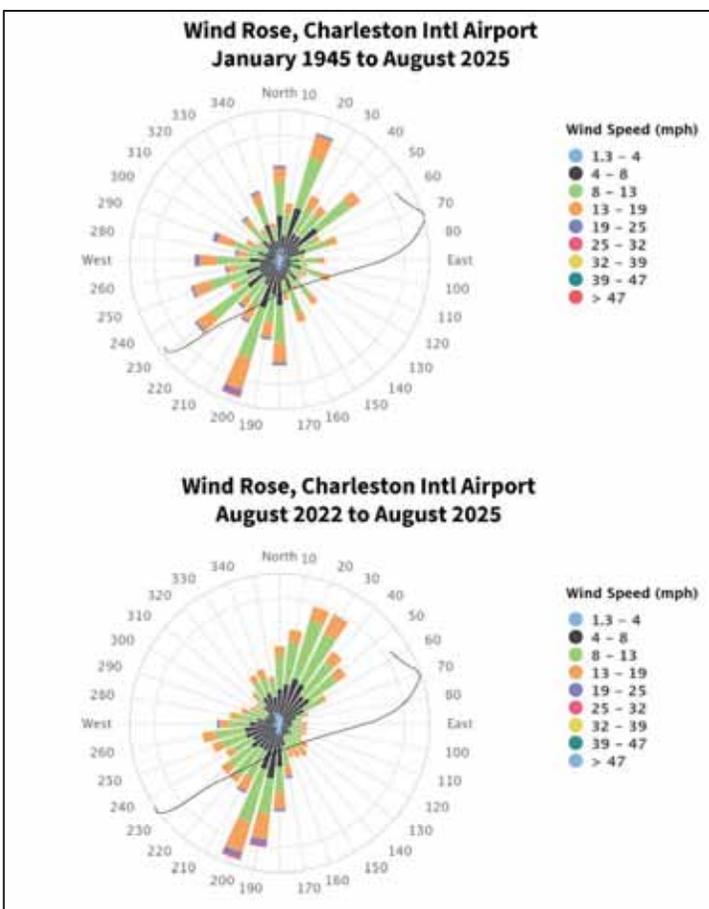
FIGURE 5.1. Wind roses showing the direction and magnitude of winds measured at Charleston International Airport from January 1945 to September 2025 [UPPER] and from September 2024 to September 2025 [LOWER].

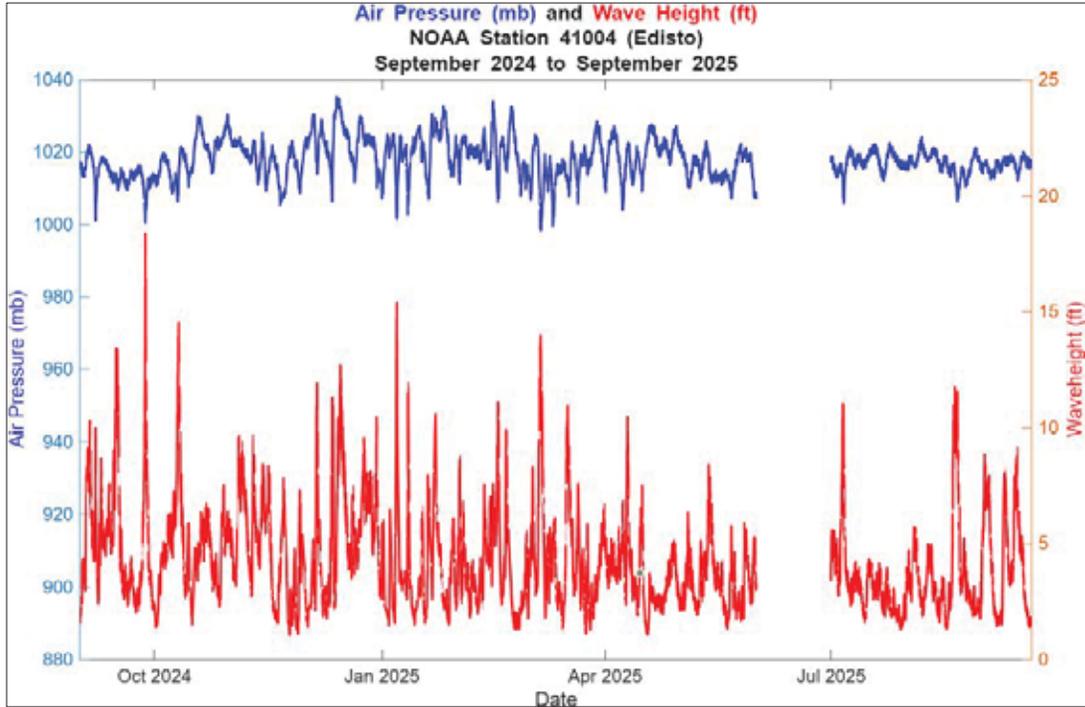
FIGURE 5.2. Atmospheric pressure and wave height at NDBC 41004 from September 2024 to September 2025. Wave heights exceeded 10 ft multiple times during the study period, and atmospheric pressure dropped below 1000 mb during a few low-pressure systems occurring during the winter, spring, and summer months.

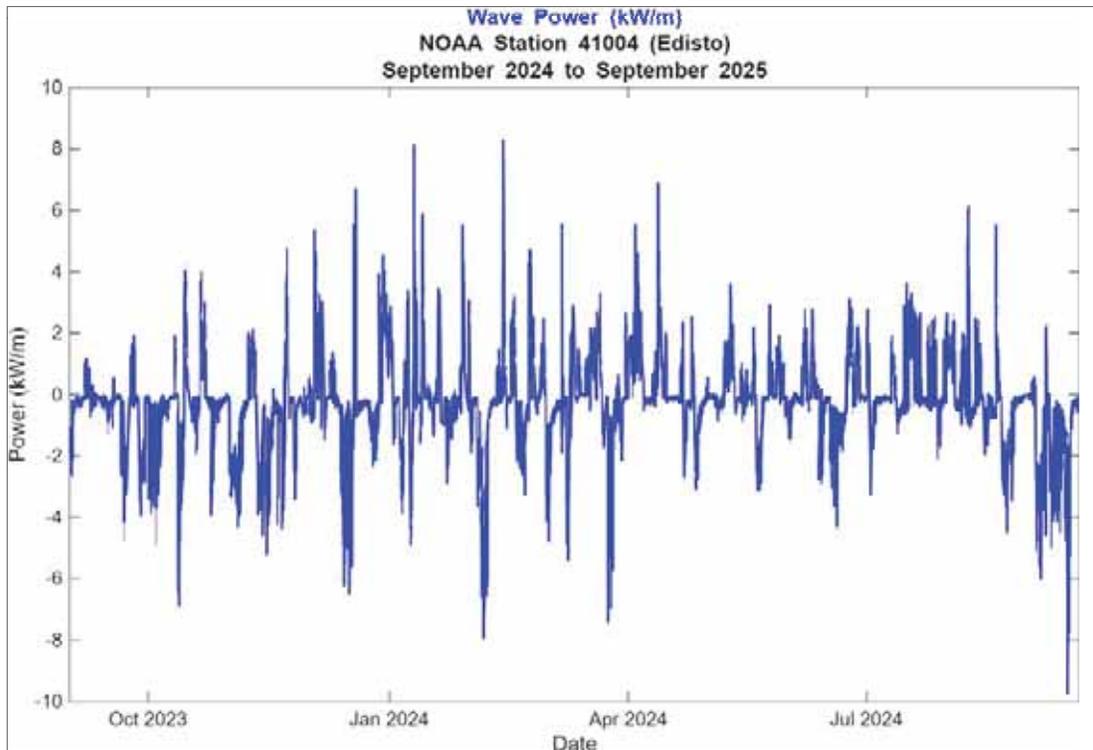
FIGURE 5.3. Wave power (in kW/m) and wave height (in m) for NDBC 41008 from September 2024 to September 2025. Wave power is a useful parameter for determining the relative magnitude and direction of wave energy in an alongshore direction along a beach. Positive values indicate waves move from south to north (ie – northerly transport), while negative values indicate a predominance of north-to-south (ie – southerly) transport.

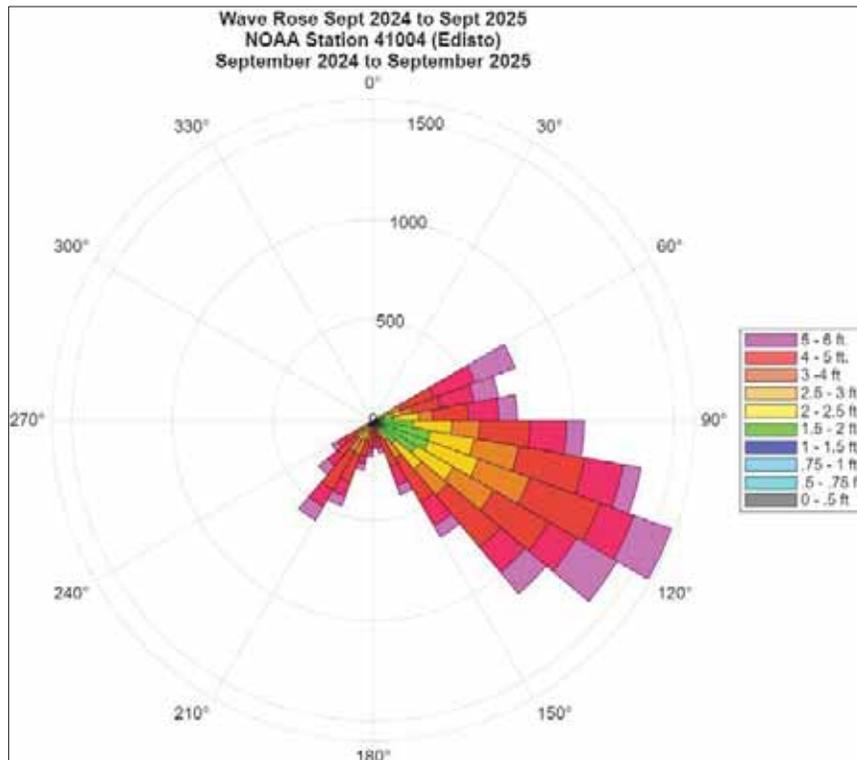
FIGURE 5.4. Wave rose in Isle of Palms from September 2024 to September 2025.

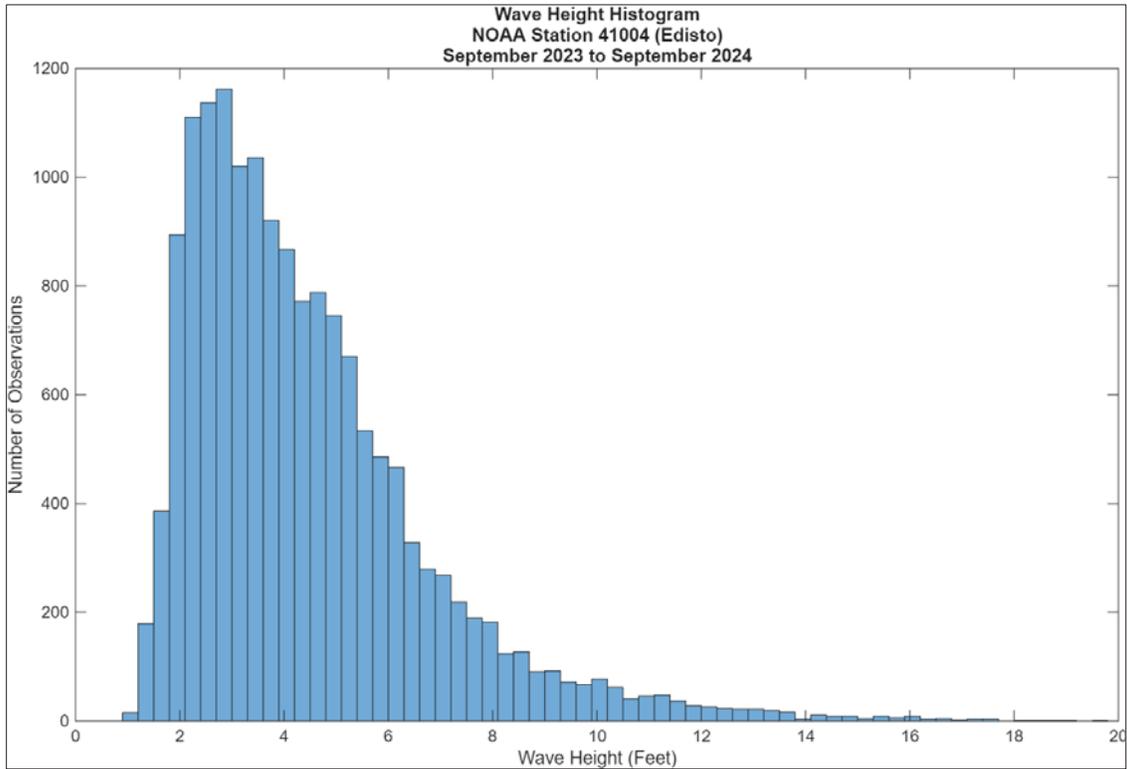
FIGURE 5.5. Wave Histogram in Isle of Palms from September 2023 to September 2024.

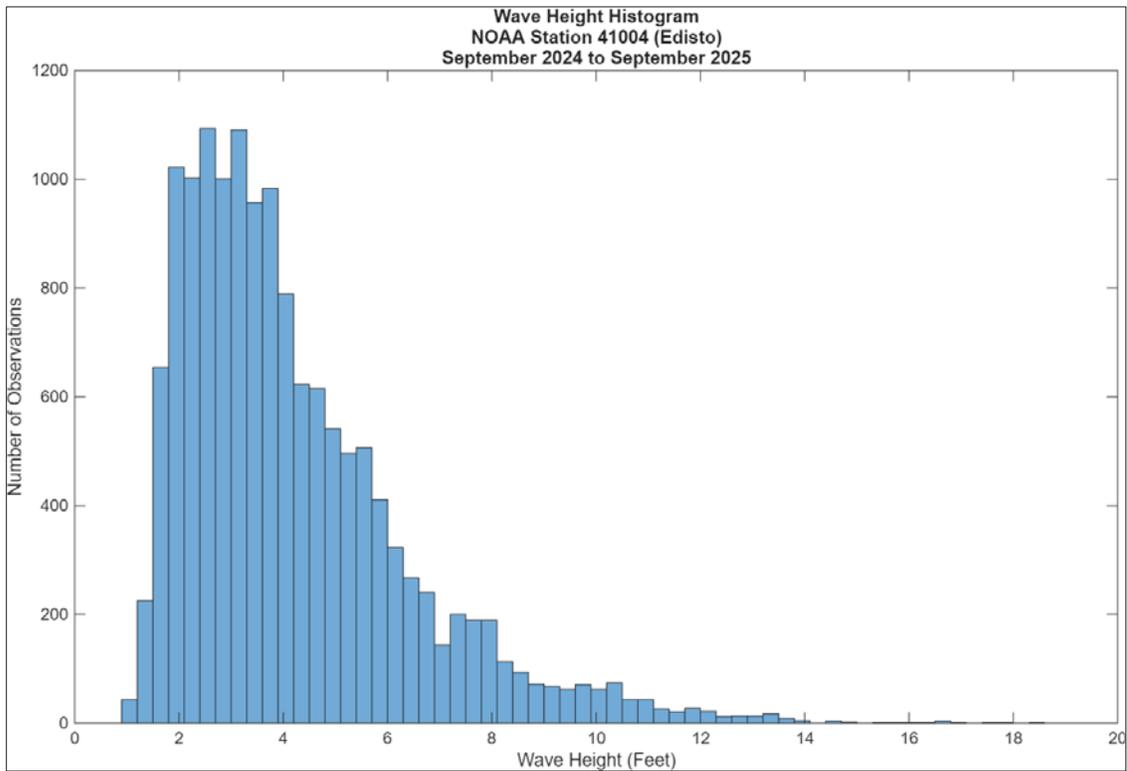
FIGURE 5.6. Wave Histogram in Isle of Palms from September 2024 to September 2025.

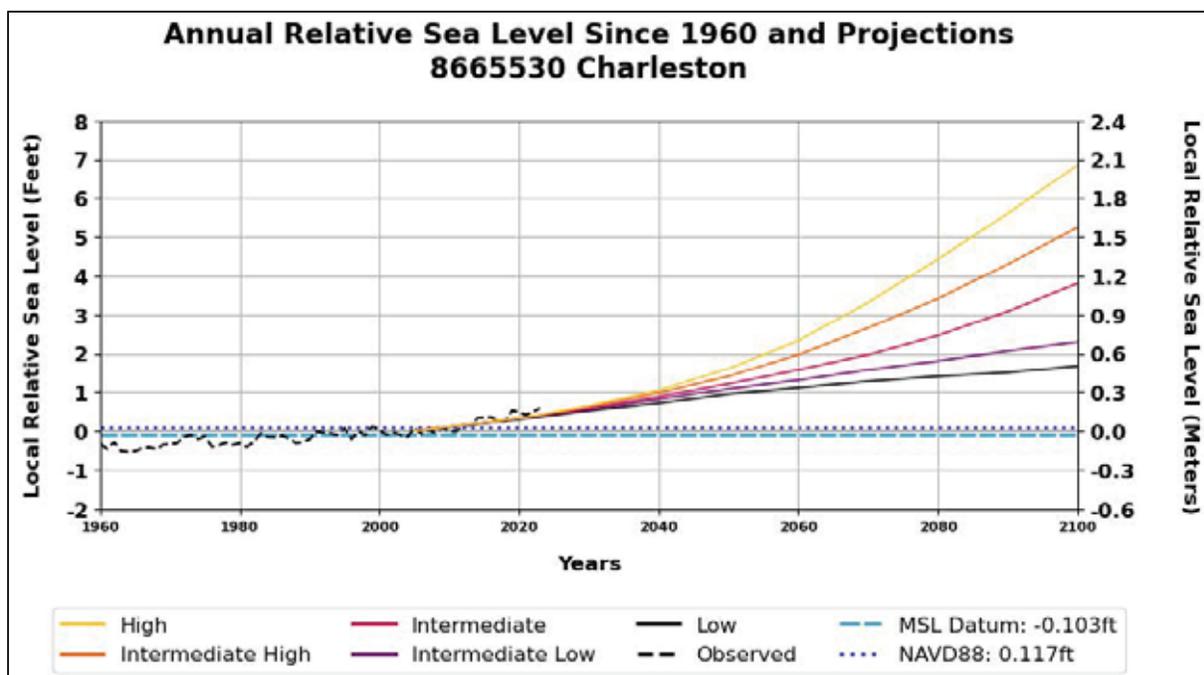
FIGURE 5.7. Projected MSL values under an ‘Intermediate’ emissions scenario average ~2 ft by 2060, and ~4 ft by 2100 at Charleston Harbor. These projections are global-scale predictions of future water levels (based on emissions) adapted to the Lowcountry by accounting for regional and localized changes in ocean circulation, vertical movement in the ground surface, and other factors. (source: https://tidesandcurrents.noaa.gov/sltrends/sltrends_station.shtml?id=8665530#tabscenario). Note higher rate of sea level rise for Charleston since 2010 based on observed data (bold dashed line).

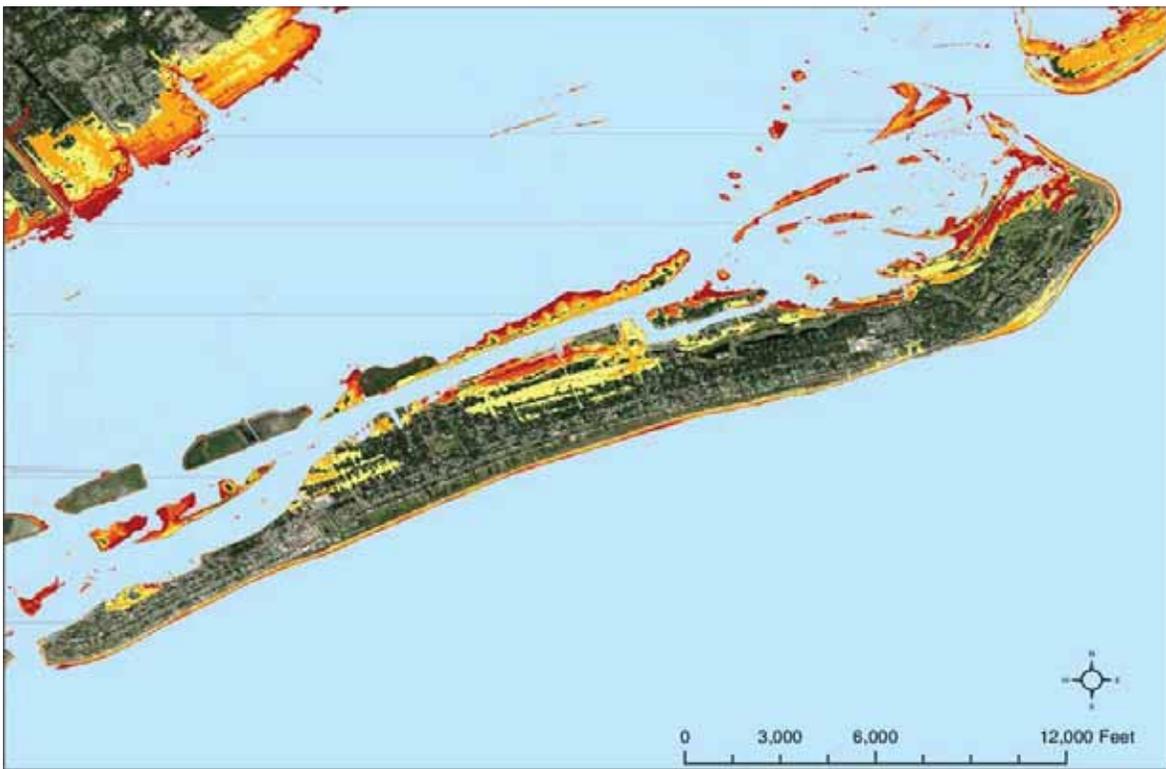
FIGURE 5.8a, b. Sea level inundation models around the Isle of Palms generated using data from NOAA (<https://coast.noaa.gov/digitalcoast/tools/slr.html>). Shades of yellow, orange, red, and maroon are used to signify SLR of 1, 2, 3, and 4 ft above present-day MHHW.

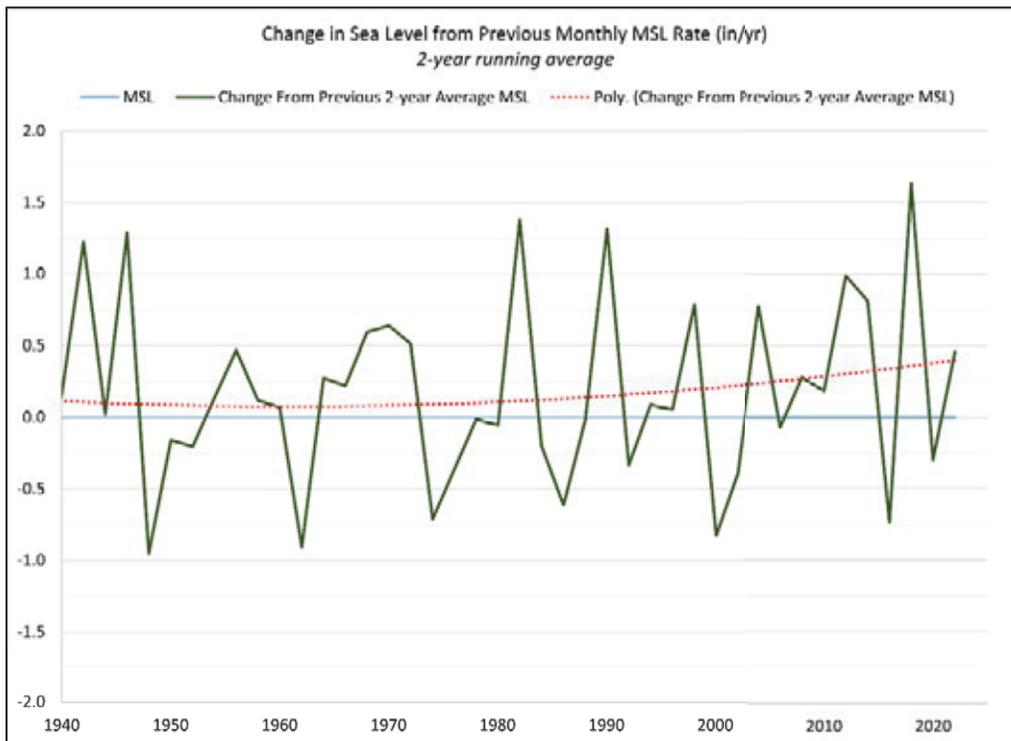
FIGURE 5.10. Change in sea level rate (in/yr) based on a 2-year running average, showing short-term variability and a long-term upward trend since the 1940s.
