**2008 BEACH RESTORATION PROJECT
ISLE OF PALMS SOUTH CAROLINA**

**Monitoring Report No 6
April 2015**

YEAR 6 (2014) MONITORING REPORT

Coastal Science & Engineering (CSE)

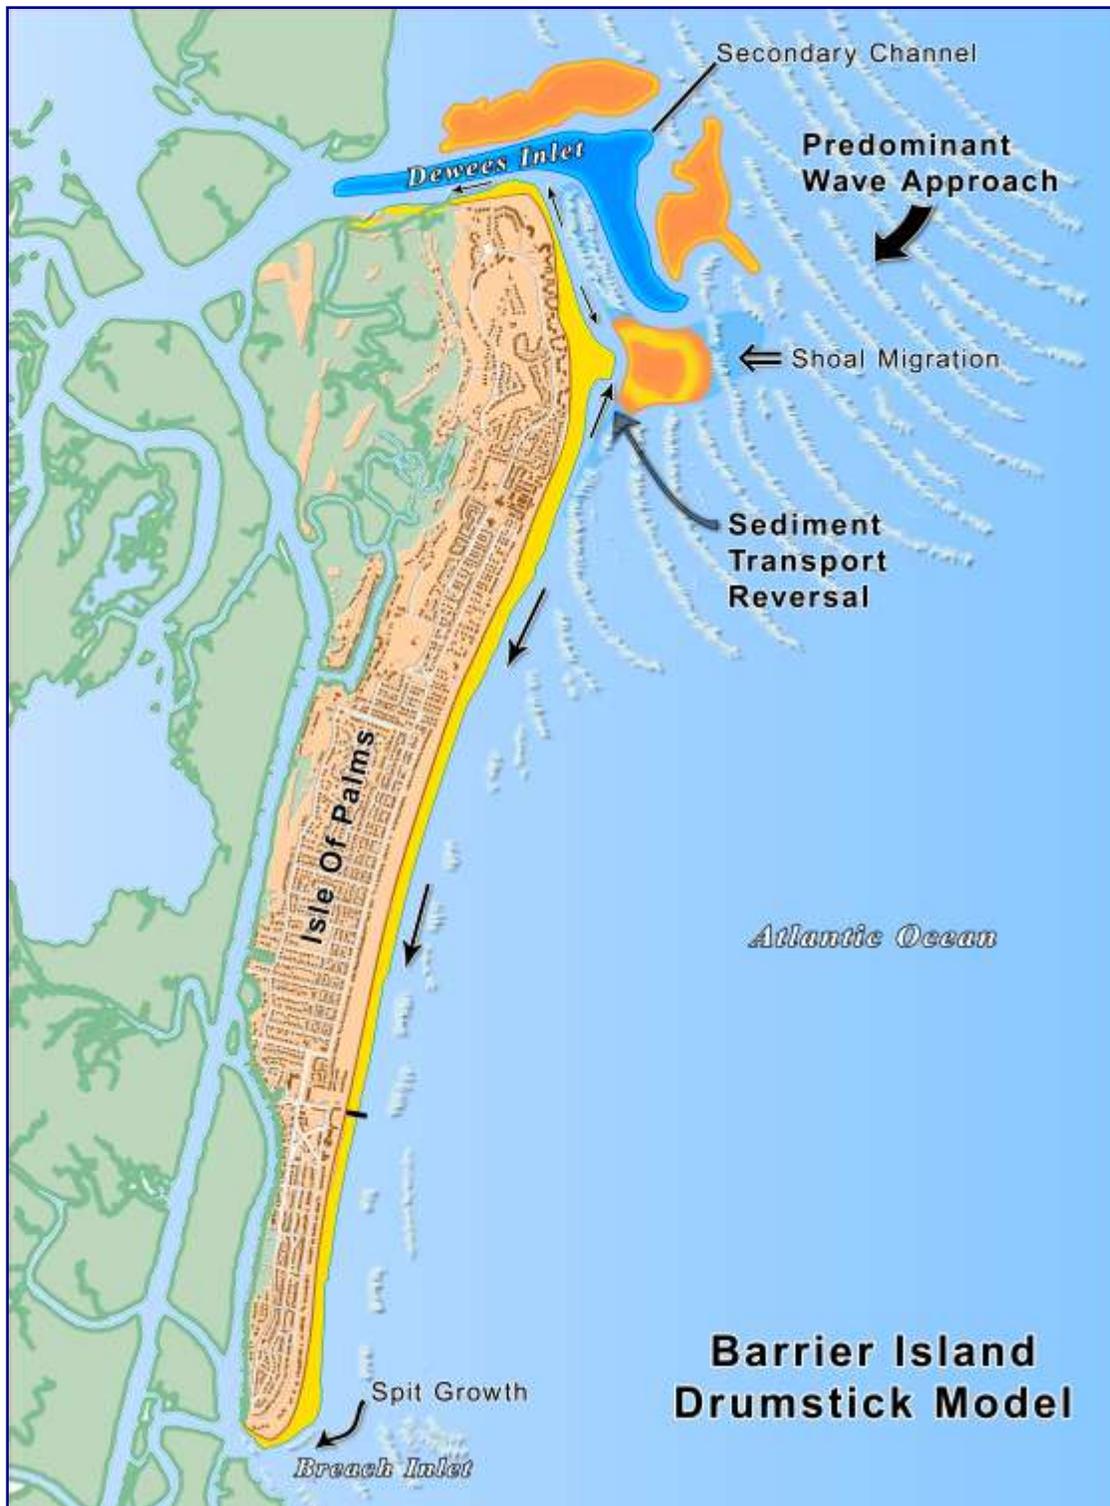
FIGURE 1.1. Isle of Palms is a typical “drumstick” barrier island (after Hayes 1979), where the upcoast end is wider due to sediment accumulation through shoal-bypass events, and the downcoast end usually forms a growing recurve spit. Other examples of drumstick barrier islands along South Carolina are Bull Island, Kiawah Island, and Fripp Island. Zones of sediment transport reversal generally occur in the lee of delta shoals which are situated offshore. Upon shoal attachment to the beach, transport directions in the vicinity of the shoal switch, spreading sand away from the attachment point (see for example – Fig 1.2).

The wider end of the island is influenced by shoal bypassing, a process whereby sand is periodically released from the inlet delta and moved onshore through wave action (Fig 1.2). This process occurs at somewhat regular intervals (average interval between events from 1941 to 1997 is 6.6 years, Gaudio 1998) and contributes to the overall health of the island. However, it also can cause focused erosion in areas adjacent to the shoal attachment zone (Kana et al 1985).

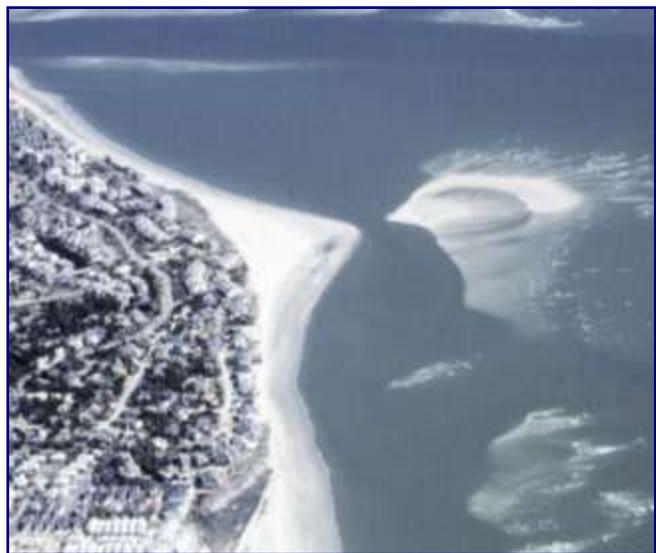
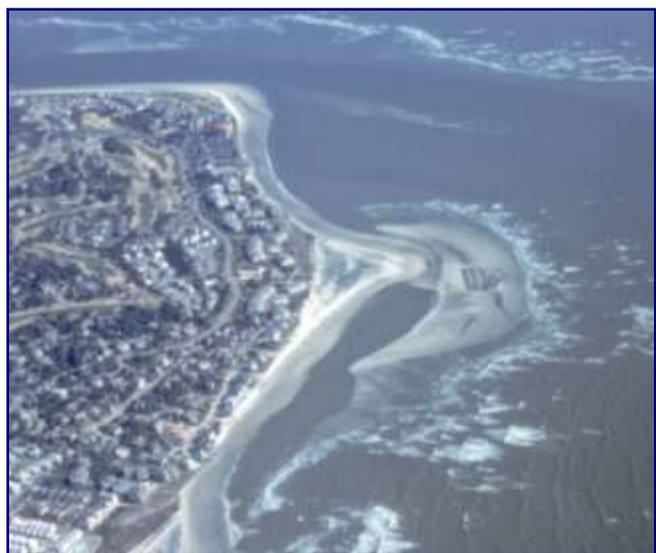
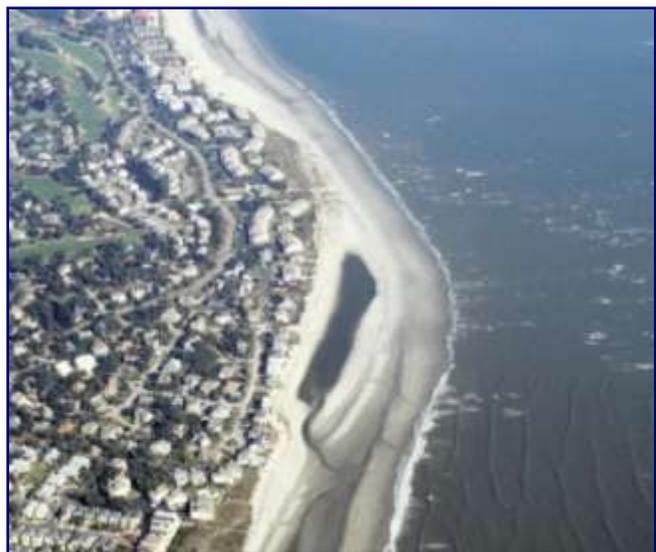
FIGURE 1.2.

[LEFT]

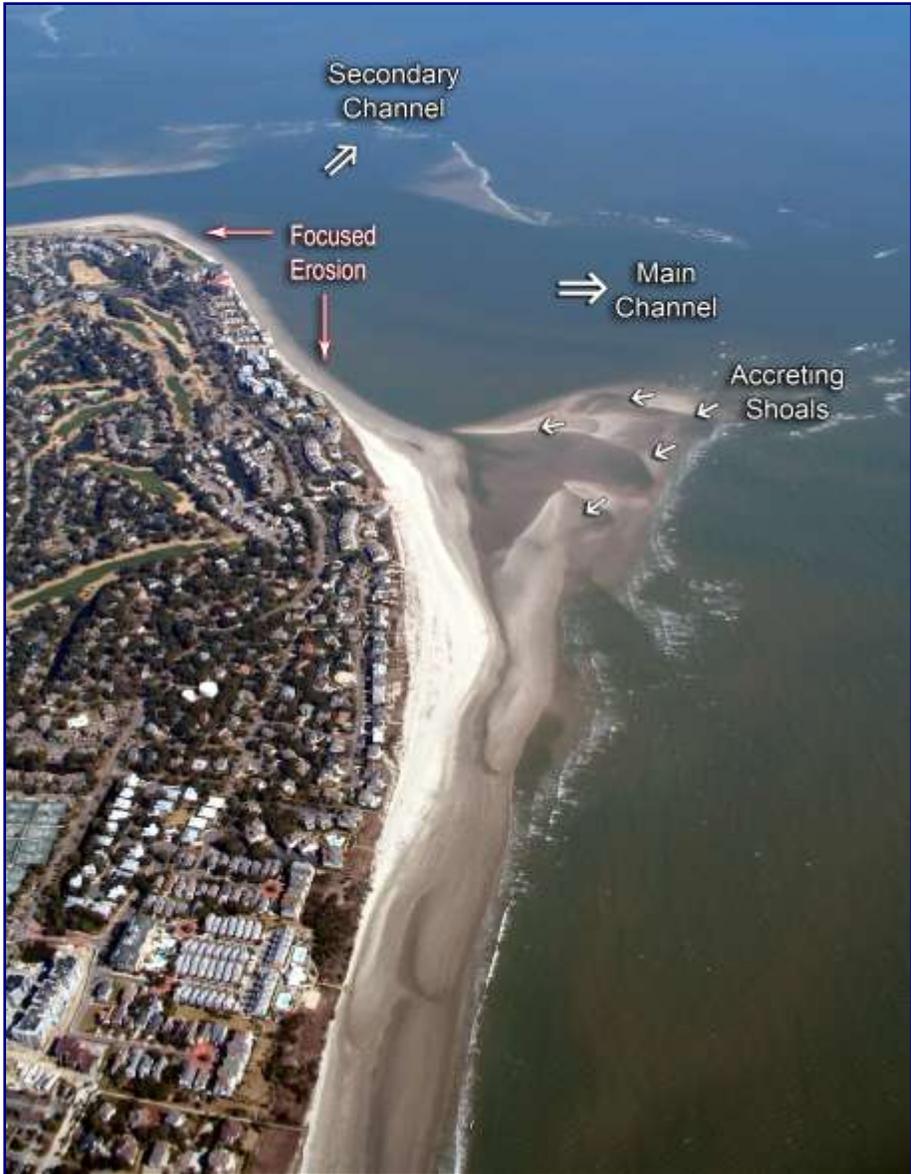
FIGURE 1.3.

[UPPER]

Prior to the 2008 project, little to no beach was present at low tide near the Ocean Club condominiums.

Prior to nourishment in June 2008, most of Reach 6 was severely eroded with profile volumes seaward of development well below an ideal condition. Property owners had piled sand bags against buildings for protection, and little or no dry beach was present (see Fig 1.3). The condition was beginning to improve just before the nourishment as the shoal attaching at the western end of the reach was in Stage 3 of the bypass cycle. Sand was moving from the shoal toward Dewees Inlet, but not quickly enough to restore the beach along most properties north of the Wild Dunes Property Owners Beach House (WDPOBH).

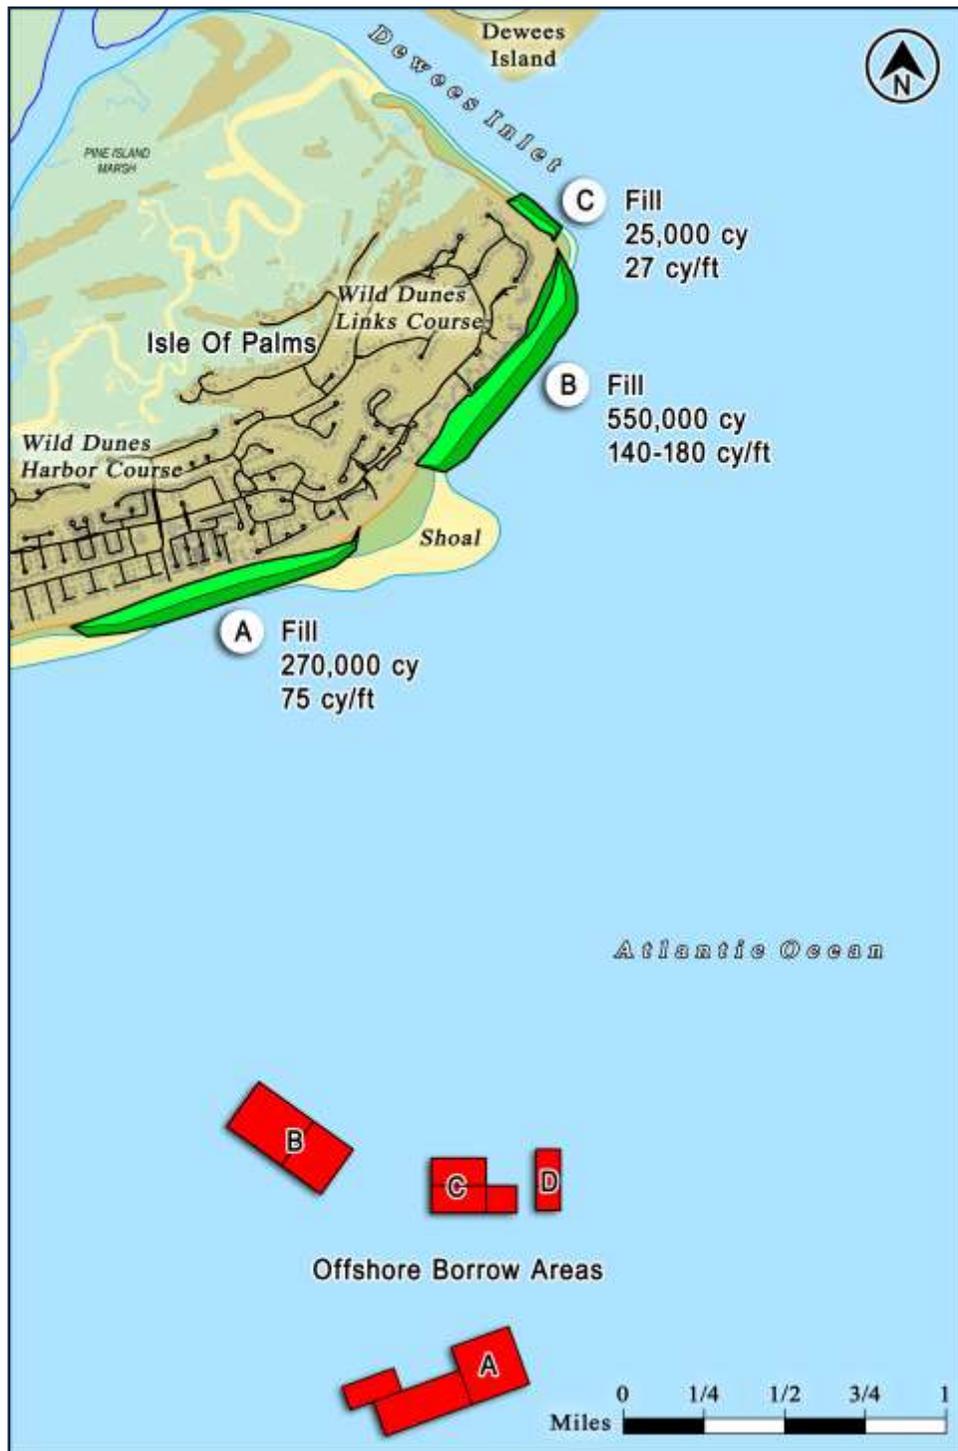
FIGURE 1.4. Project map of the 2008 IOP restoration project. The project was designed to nourish sections of the beach and provide sufficient sand to offset losses associated with long-term erosion as well as an ongoing shoal-bypass event. Borrow areas were located 2-3 miles offshore. Area D was not dredged.

The final volume added to the beach calculated from Weeks Marine's surveys was 933,895 cy, which was ~10 percent greater than the design volume of 847,400 cy. The overage of 86,495 cy was not a pay quantity as stated in the contract; therefore, the City was only required to pay for the contract volume of 847,400.

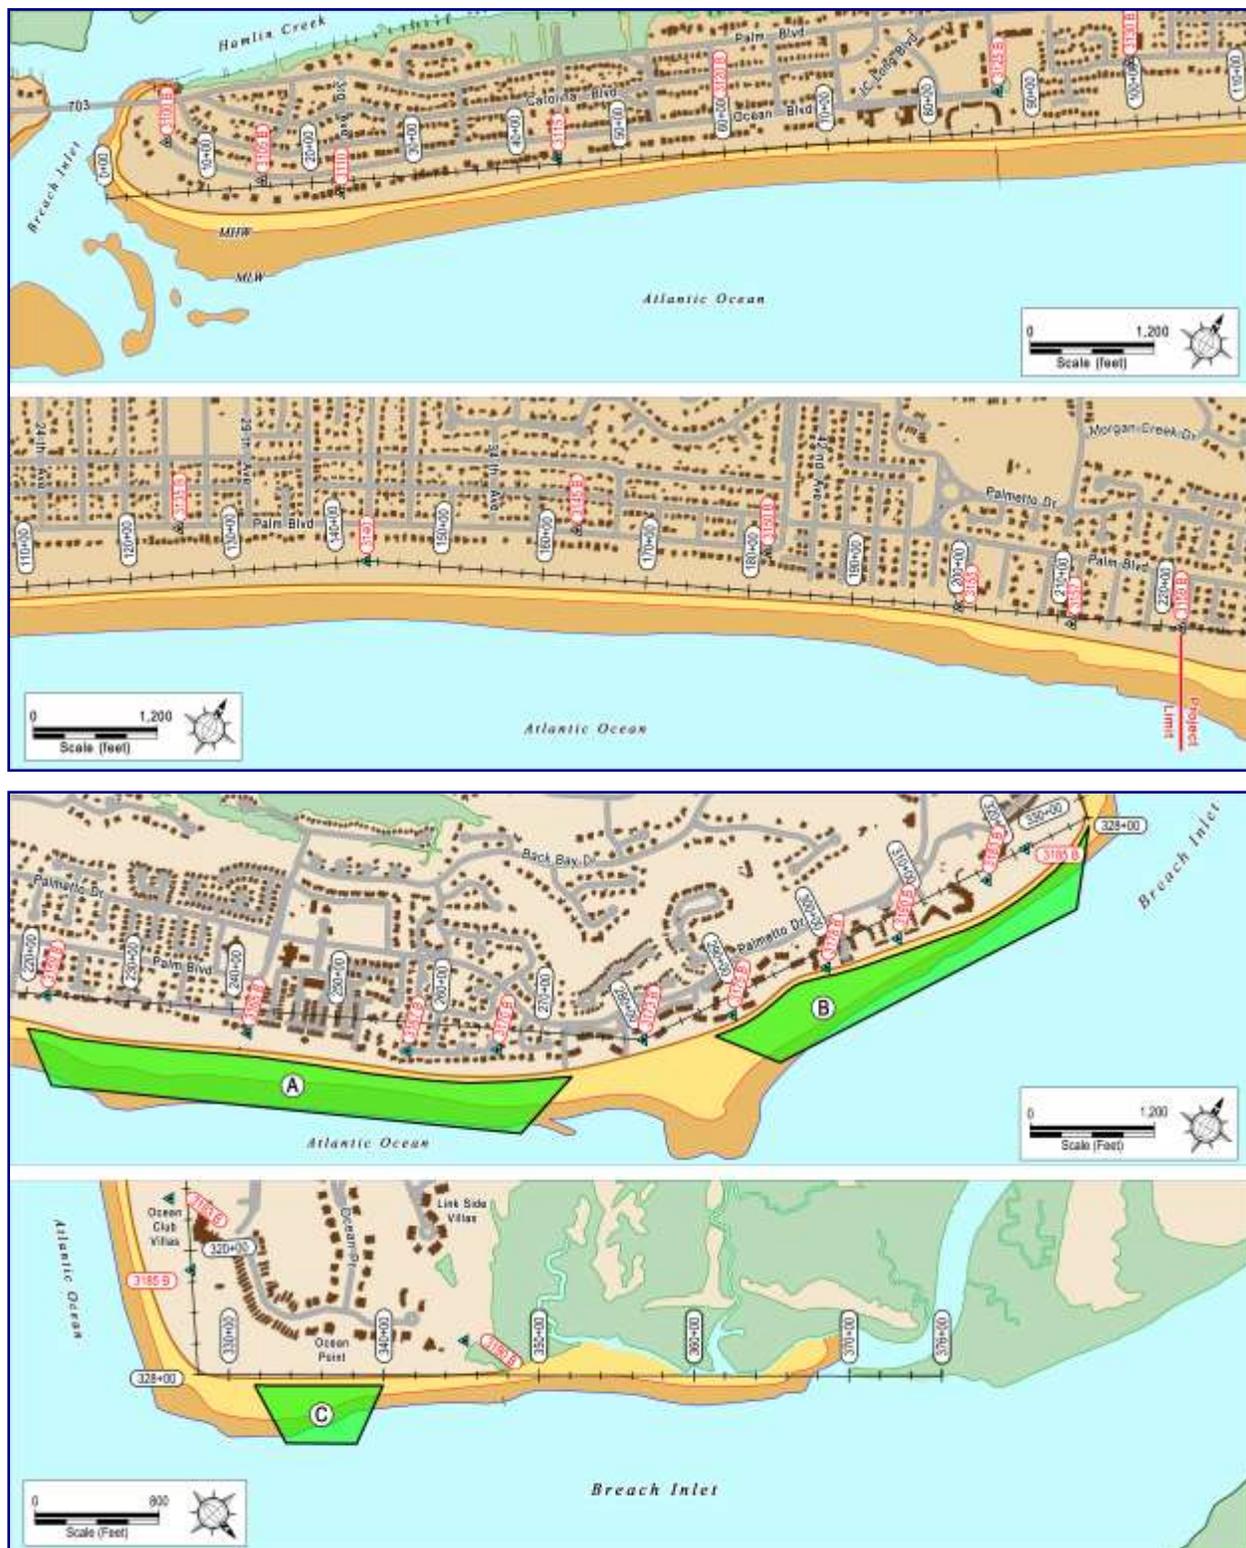
FIGURE 2.1 CSE established a monitoring baseline to encompass the length of IOP. The baseline between stations 222+00 and 376+00 corresponds to the baseline used in the 2008 project (project stations 0+00 through 174+00). Red labels indicate locations of OCRM survey monuments. Green areas show limits of the 2008 nourishment project. CSE profile sections are oriented perpendicular to the baseline while OCRM profiles are perpendicular to the local beach azimuth. [CSE and OCRM azimuths are only significantly different at Breach Inlet.]

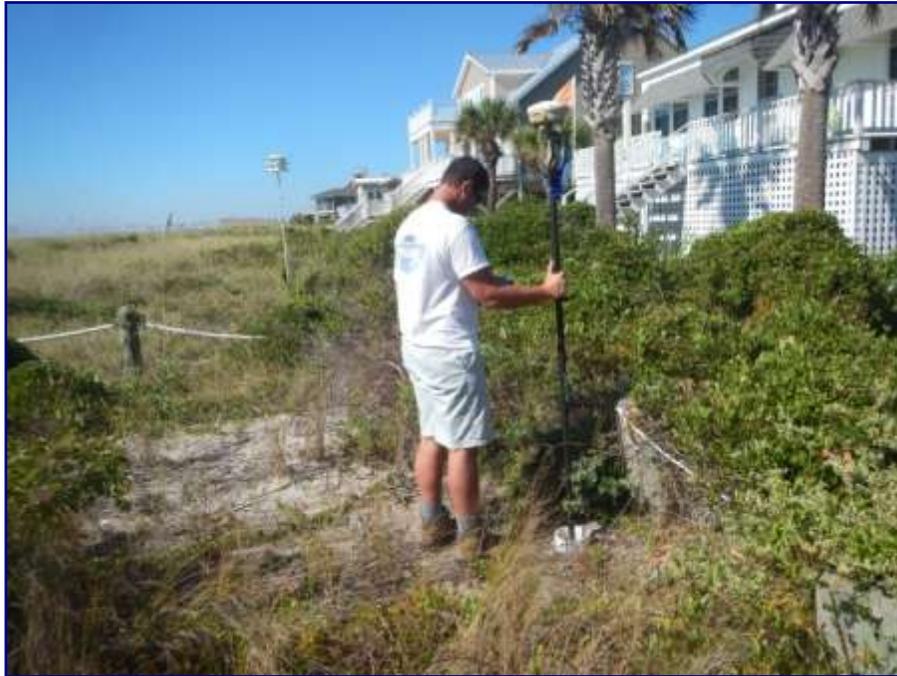
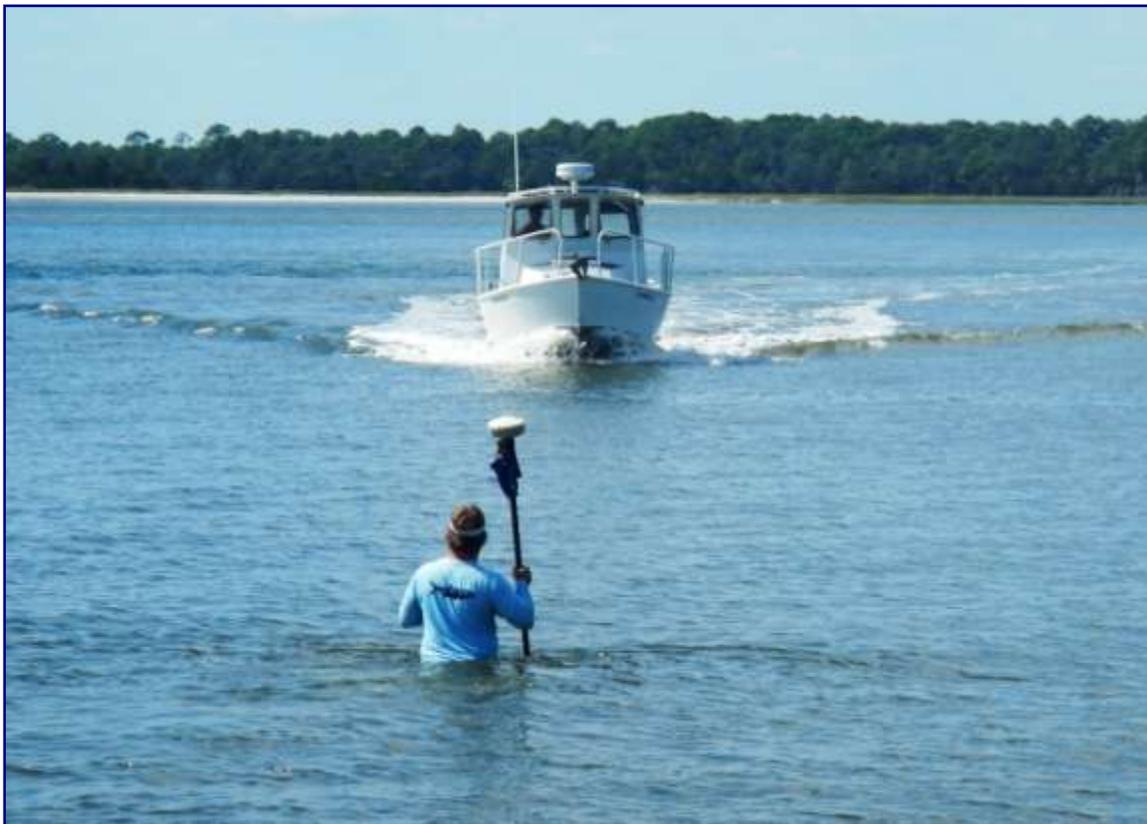
FIGURE 2.2. CSE beach monitoring methods include land-based data collection using Trimble™ RTK GPS from the backshore to low-tide wading depth and over-water work using RTK GPS linked to a precision echosounder aboard CSE's survey boat (RV *Southern Echo*).

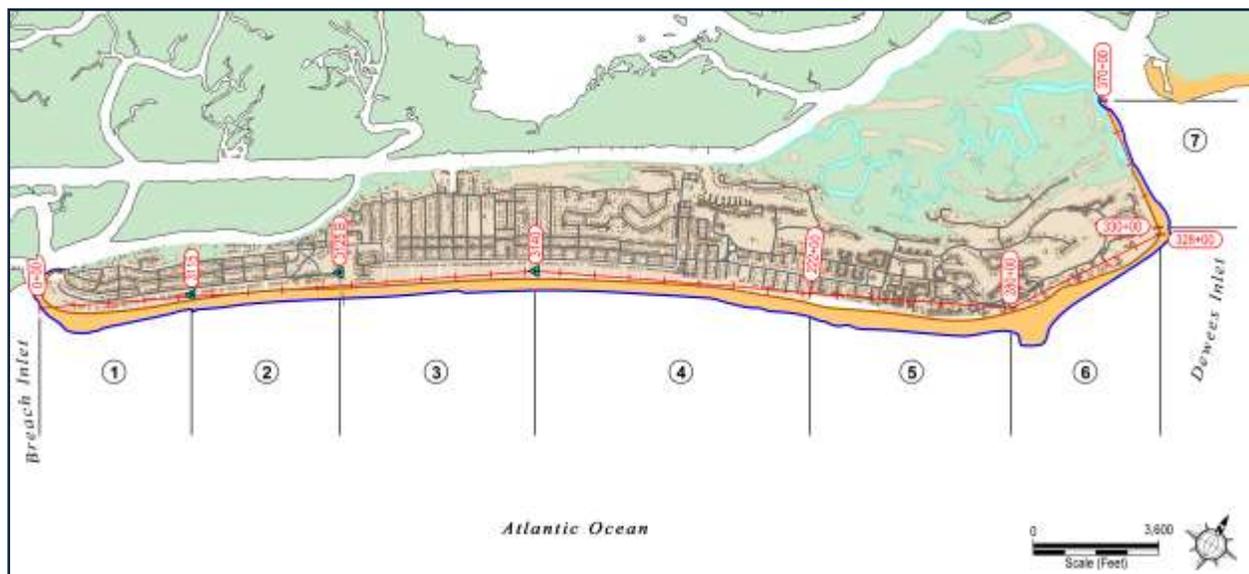
FIGURE 2.3. Location map of the reaches used in post-project monitoring at Isle of Palms. The 2008 beach restoration project occurred in subareas within Reaches 5, 6, and 7.

Reach 1	0+00 to OCRM 3115	Breach Inlet to 6 th Avenue
Reach 2	OCRM 3115 to OCRM 3125	6 th Avenue to Sea Cabins Pier
Reach 3	OCRM 3125 to OCRM 3140	Sea Cabins Pier to 31 st Avenue
Reach 4	OCRM 3140 to 222+00	31 st Avenue to 53 rd Avenue
Reach 5	222+00 to 280+00	53 rd Avenue to Wild Dunes Property Owners Beach House
Reach 6	280+00 to 328+00	Wild Dunes Property Owners Beach House to Dewees Inlet
Reach 7	330+00 to 370+00	Dewees Inlet Shoreline

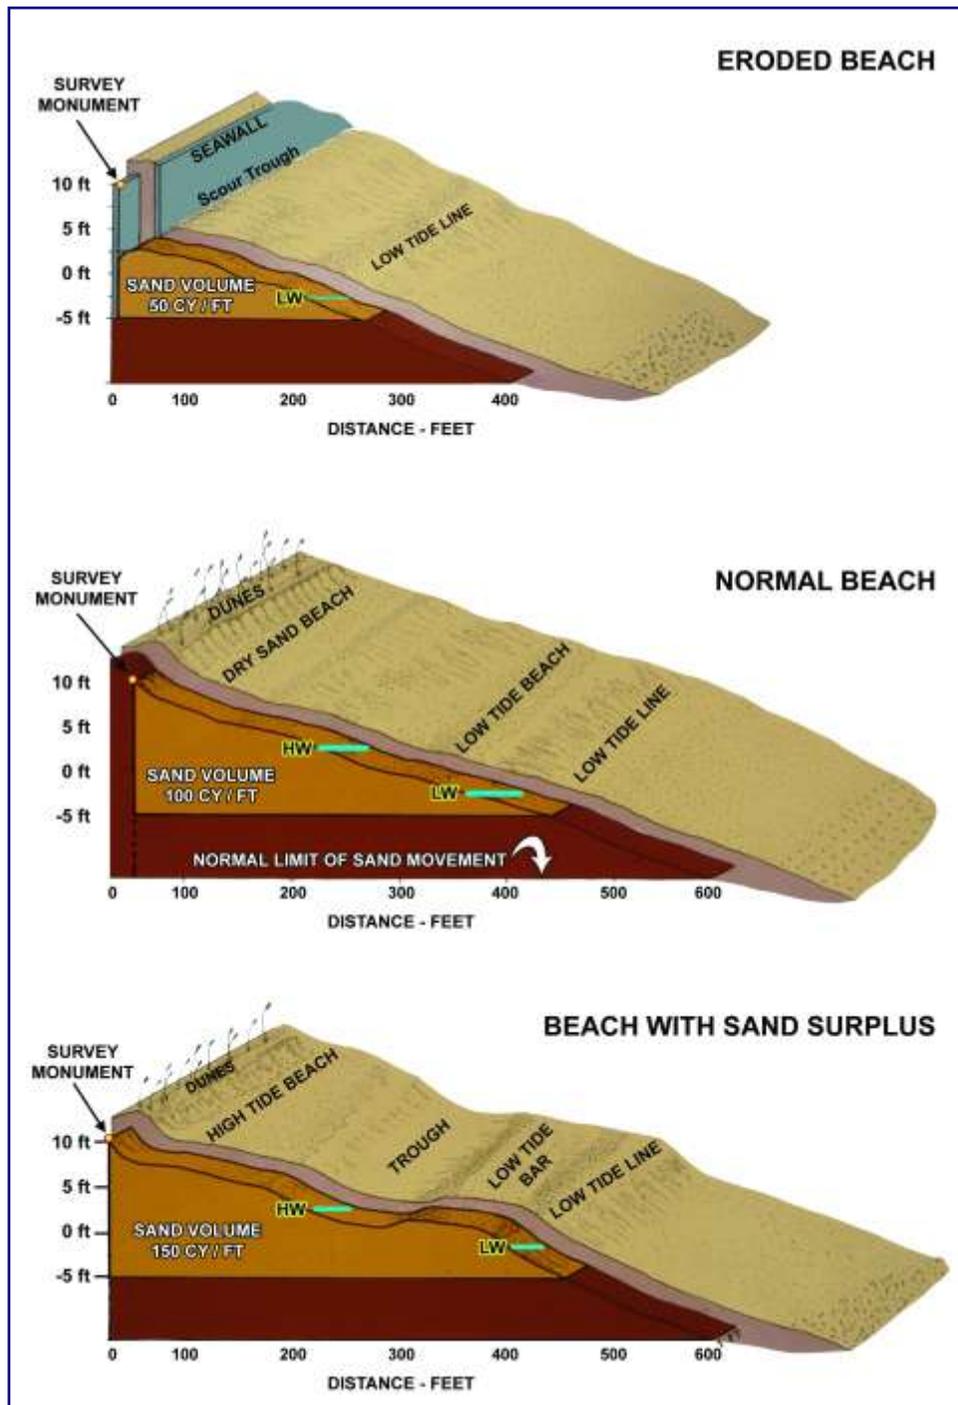
FIGURE 2.4. Calculation of unit-width profile volumes is a means of comparing the condition of one section of beach with another. Profile volumes are the amount of sand contained in a one-foot length of beach between specified elevations. [After Kana 1990]

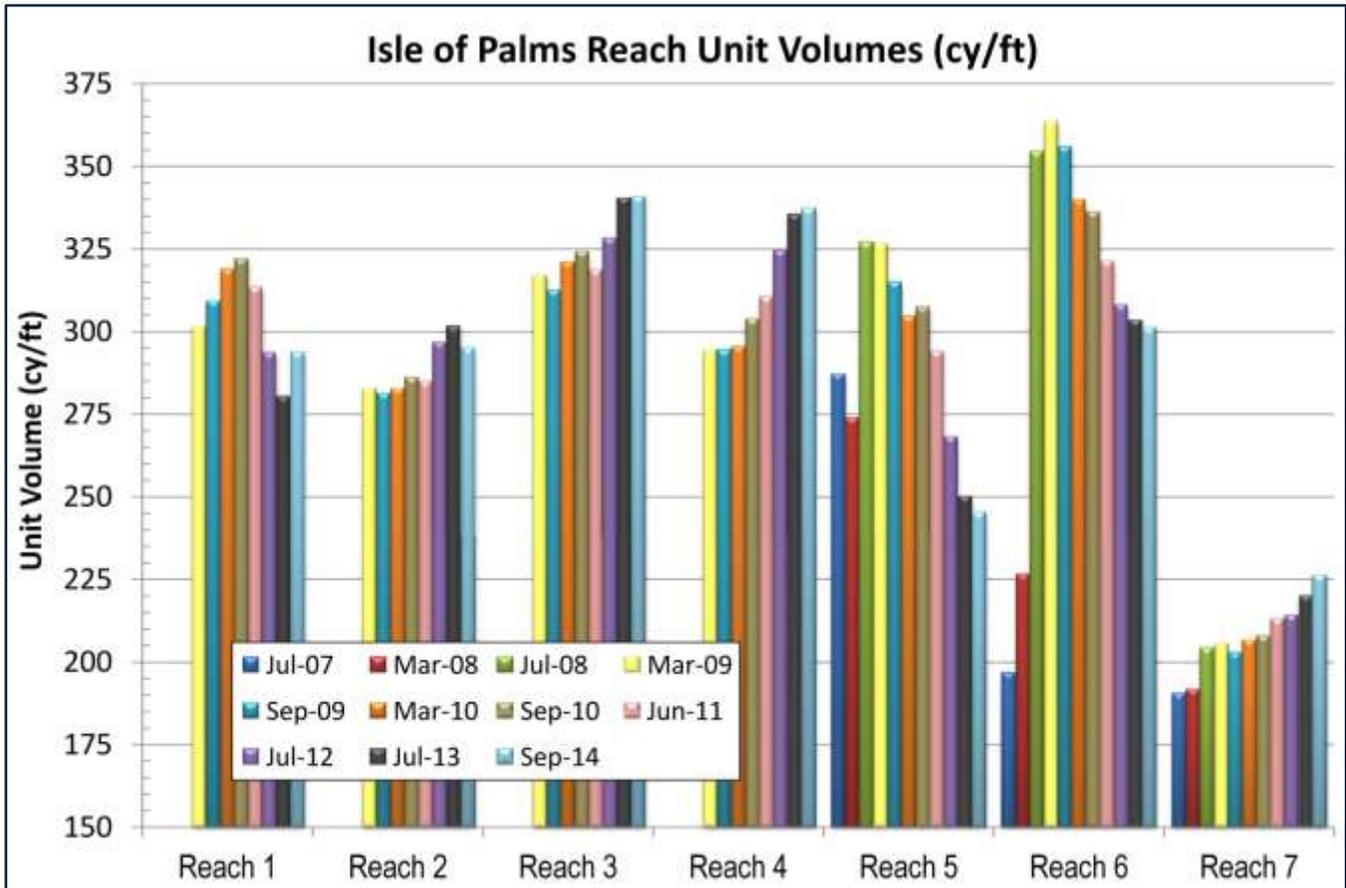
FIGURE 3.1. Average unit-width volumes for each monitoring reach at Isle of Palms. See Figure 2.3 for reach boundaries. Unit volumes were calculated from the primary dune to a profile-specific depth, generally between -9 ft and -13 ft NAVD for the beachfront. Nourishment occurred prior to the July 2008 data collection in Reaches 5, 6, and 7. Design-fill unit volumes for full sections were ~75 cy/ft in Reach 5, ~140-180 cy/ft in Reach 6, and ~27 cy/ft in Reach 7. See Figure 2.1 for beach nourishment locations.

The results of the 2014 monitoring survey show that the island gained ~30,200 cy (0.8 cy/ft) of sand from July 2013 to September 2014. Reaches 2, 5, and 6 were erosional; however, Reaches 5 and 6 lost less sand than the previous year (continuing the trend from 2012–2013). Reach 1 (near Breach Inlet) gained nearly all of the sand lost during the prior year (~55,000 cy) while portions of Reach 2 (near 6th Avenue) eroded significantly. Reaches 3 and 4 were fairly stable, gaining ~3,000 and 13,500 cy (respectively), although localized erosion was observed near 29th–30th Avenues and 47th–48th Avenues. Reaches 5 and 6 showed the least amount of volume losses since 2009; however, localized areas were highly erosional. Reach 7 continued its accretional trend observed since 2008. Volume change data for each monitoring station and reach are given in Figure 3.1, and Table 3.1a,b and Table 3.2.

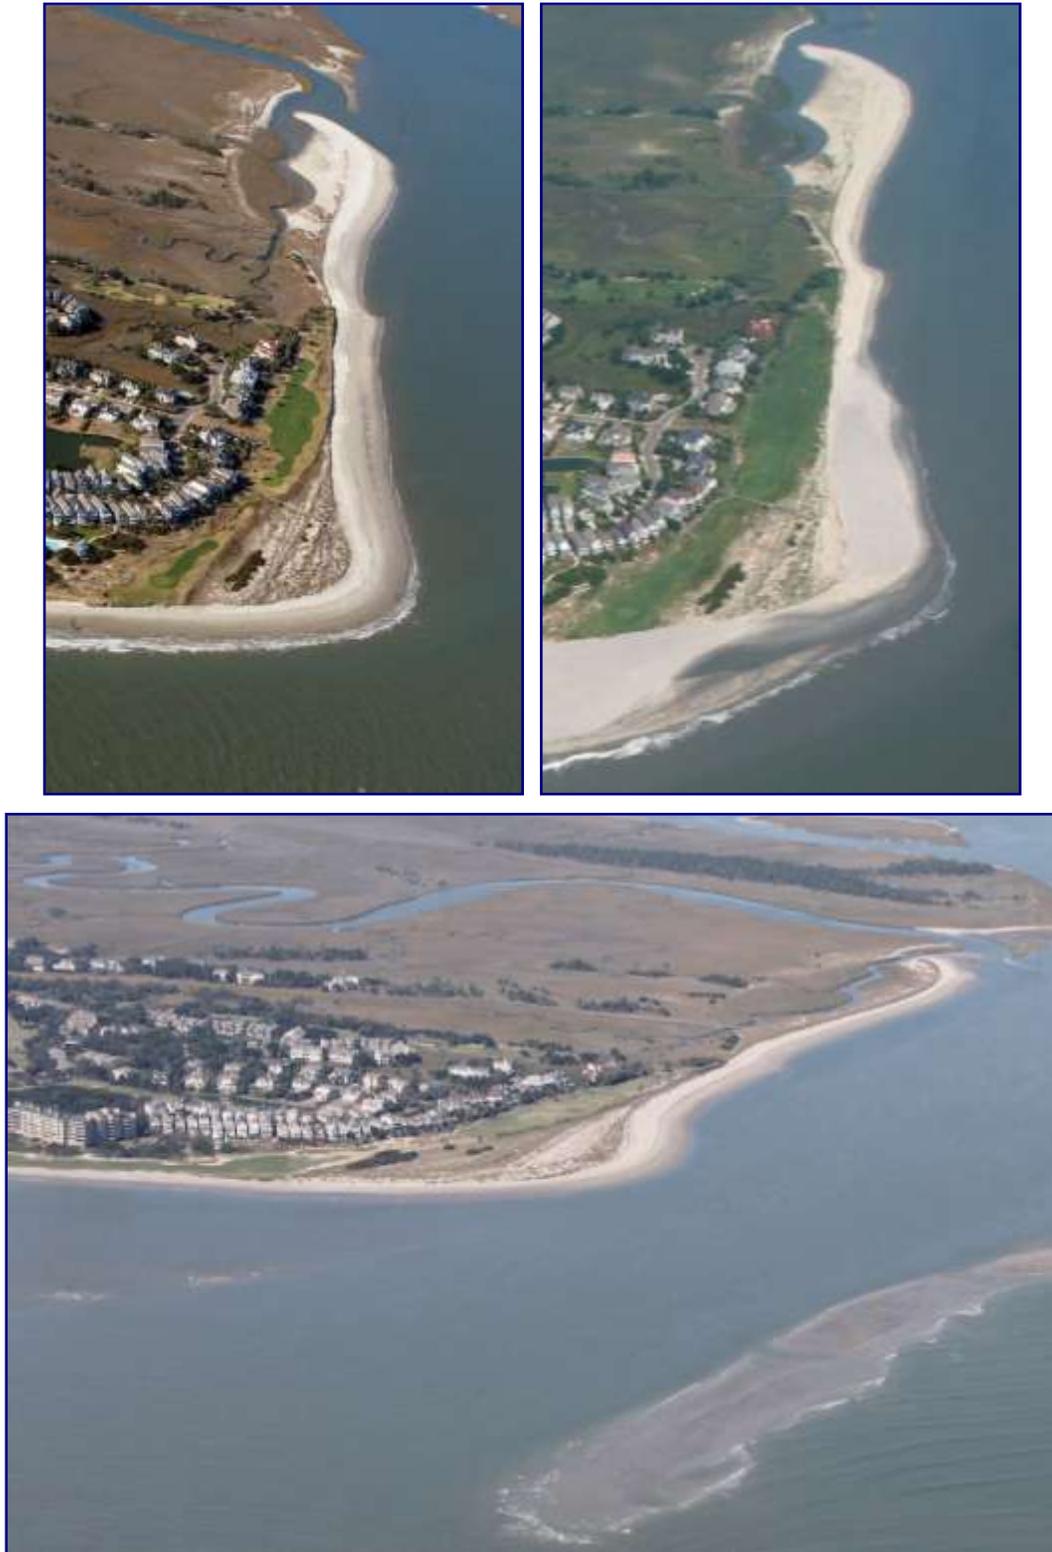
FIGURE 3.2. Reach 7. [UPPER LEFT] December 2007. [UPPER RIGHT] June 2008 following nourishment. [LOWER] October 2014. [Upper images by TW Kana] [Lower image by S Traynum]

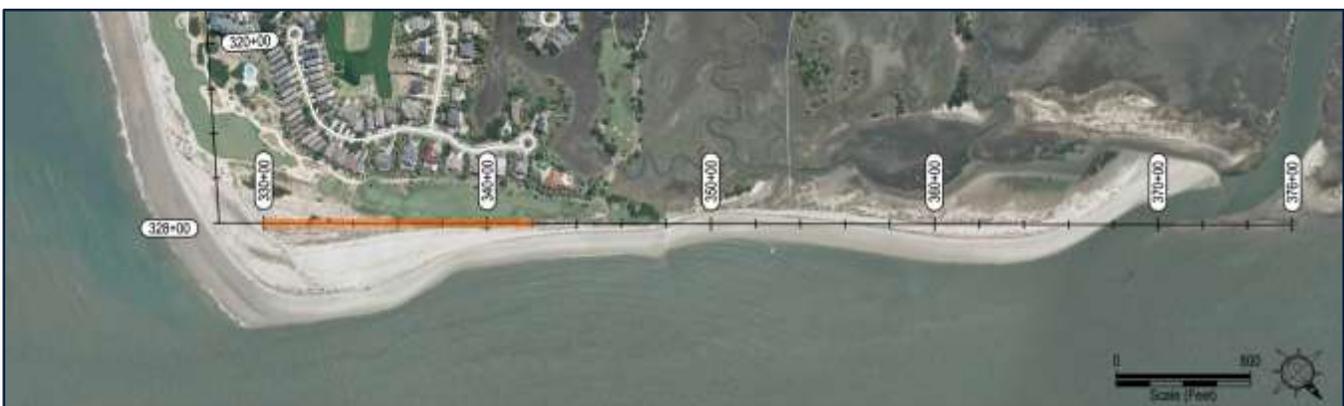
FIGURE 3.3. Station map of the Dewees Inlet area (Reach 7). Reach 7 spans from station 330+00 near the 18th tee to station 368+00 near Cedar Creek spit. The approximate limits of Reach C nourishment are identified by the orange-highlighted bar. The 1981 low profile groin is positioned near station 348+00. [July 2011 aerial image by Independent Mapping Consultants Inc]

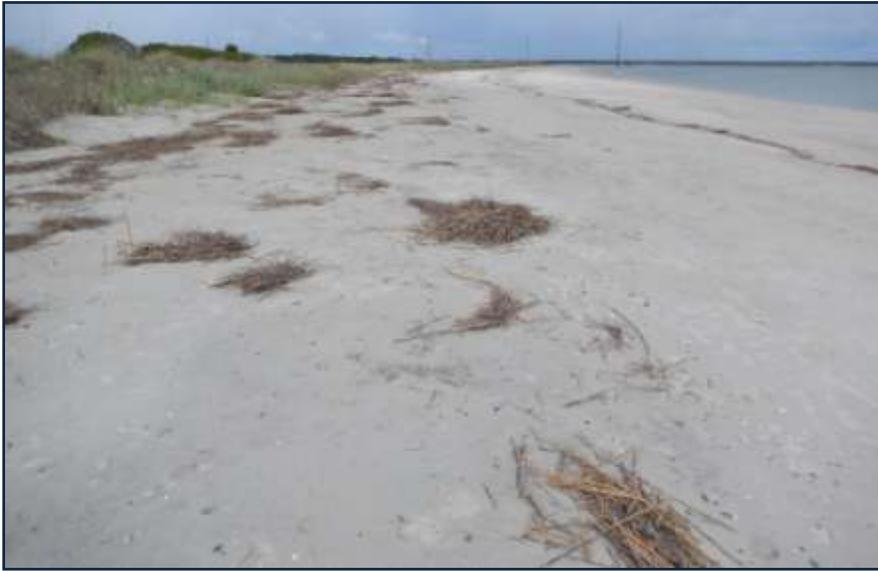
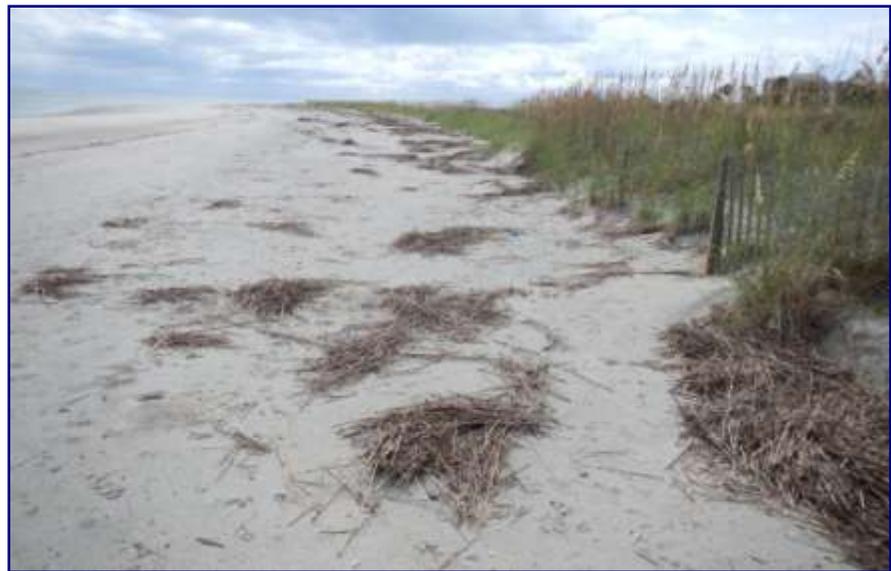
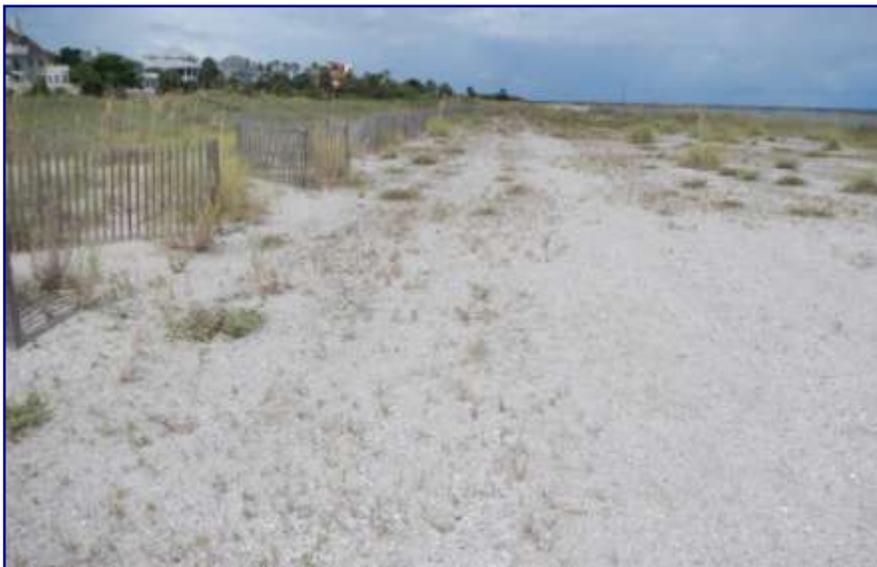
FIGURE 3.6.

[UPPER] Station 348+00 looking inland.

Ground photos of Reach 7 show that vegetation has spread and matured along the 2008 fill area (Fig 3.6). The escarpment which ran along the 17th green prior to nourishment has healed and is now well set back from the water. A substantial amount of wrack (dead marsh grass) has accumulated along the shoreline in this reach. The wrack facilitates dune growth and is a benefit to beach organisms. USFWS generally discourages removal of wrack from the beach.

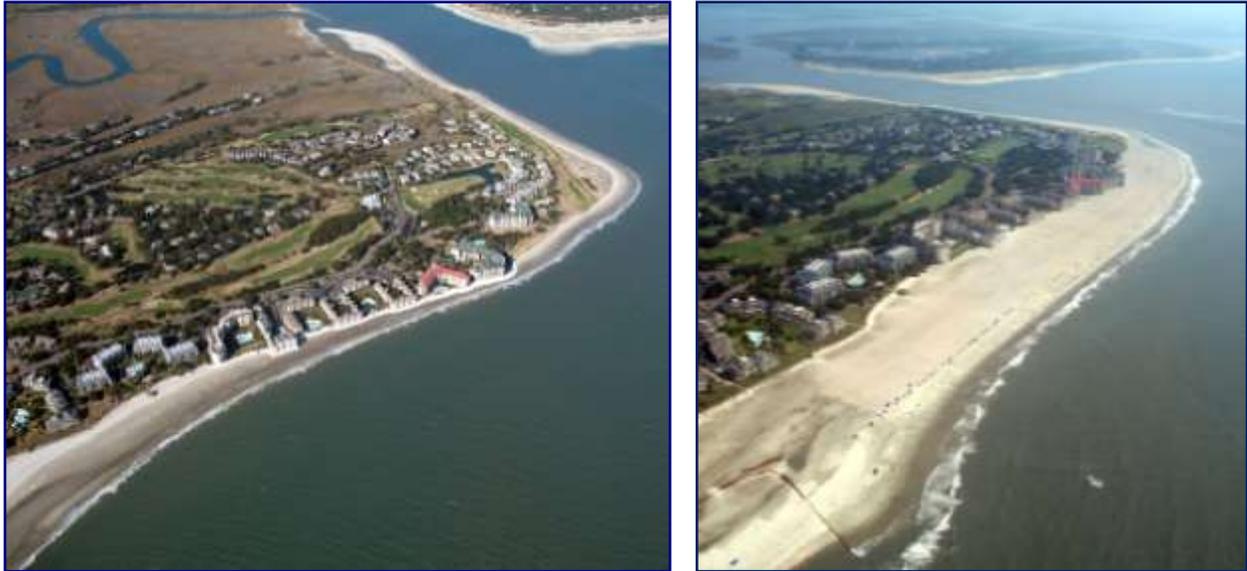
FIGURE 3.7. Reach 6 in December 2007 (upper left), June 2008 near the end of the project (upper right), October 2014 (center right and lower left).

Reach 6 (Fig 3.7, previous page) extends from the Wild Dunes Property Owners Beach House ~4,900 ft northeast to the 18th fairway, where the beach turns into Dewees Inlet (station 280+00 to station 328+00, Fig 3.8). Shoal-bypassing events have highly impacted this area since the island's formation. Depending on the location and timing of the bypass events, the shoreline can change hundreds of feet over a period of several months (Kana et al 1985, Gaudio 1998). As was the case in 2007–2008, the shoreline may encroach on development in this reach when shoal-bypass events are prolonged.

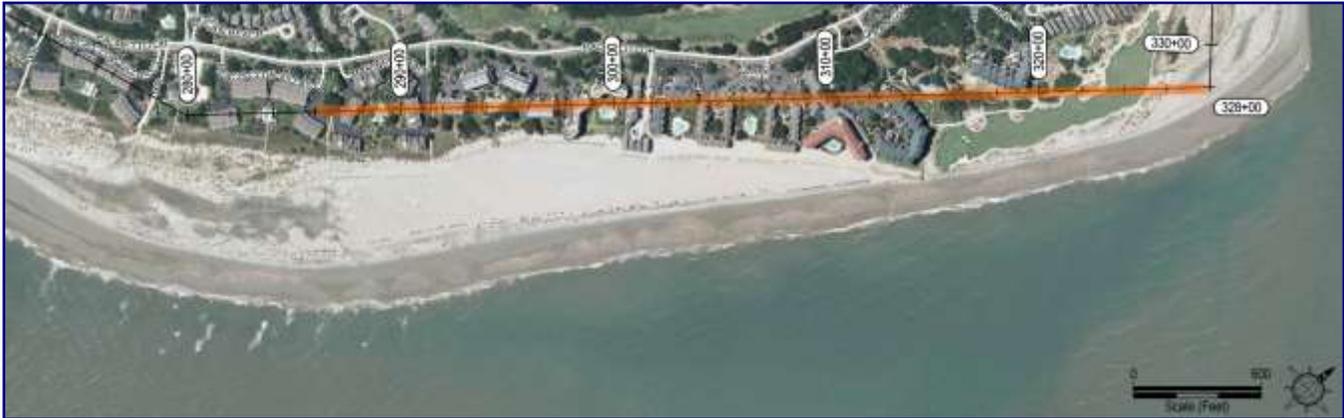
FIGURE 3.8. Reach 6 spans from the Wild Dunes Property Owners Beach House (station 280+00) to the 18th fairway of the Wild Dunes Links Course (station 328+00). The approximate limits of nourishment Reach B are identified by the orange-highlighted bar. [July 2011 aerial image by Independent Mapping Consultants Inc]

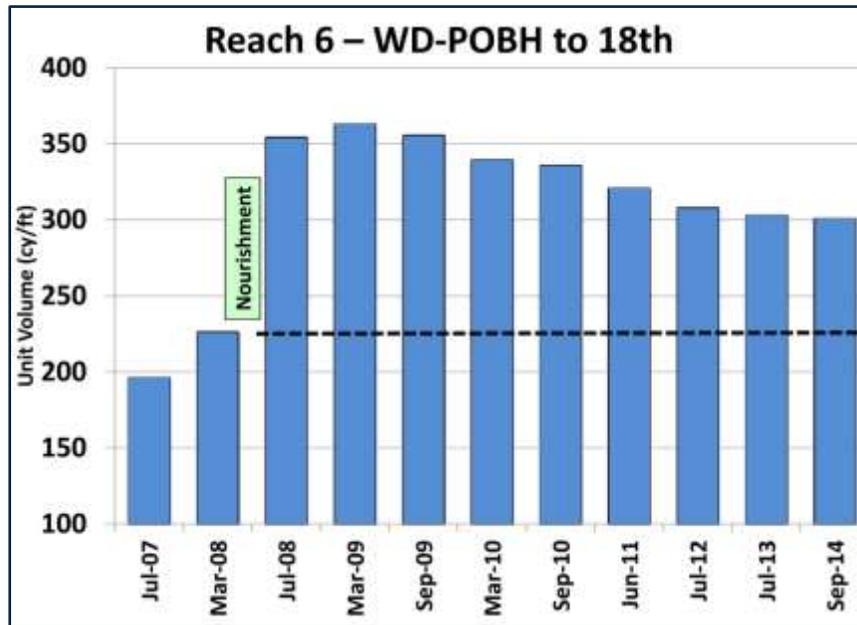
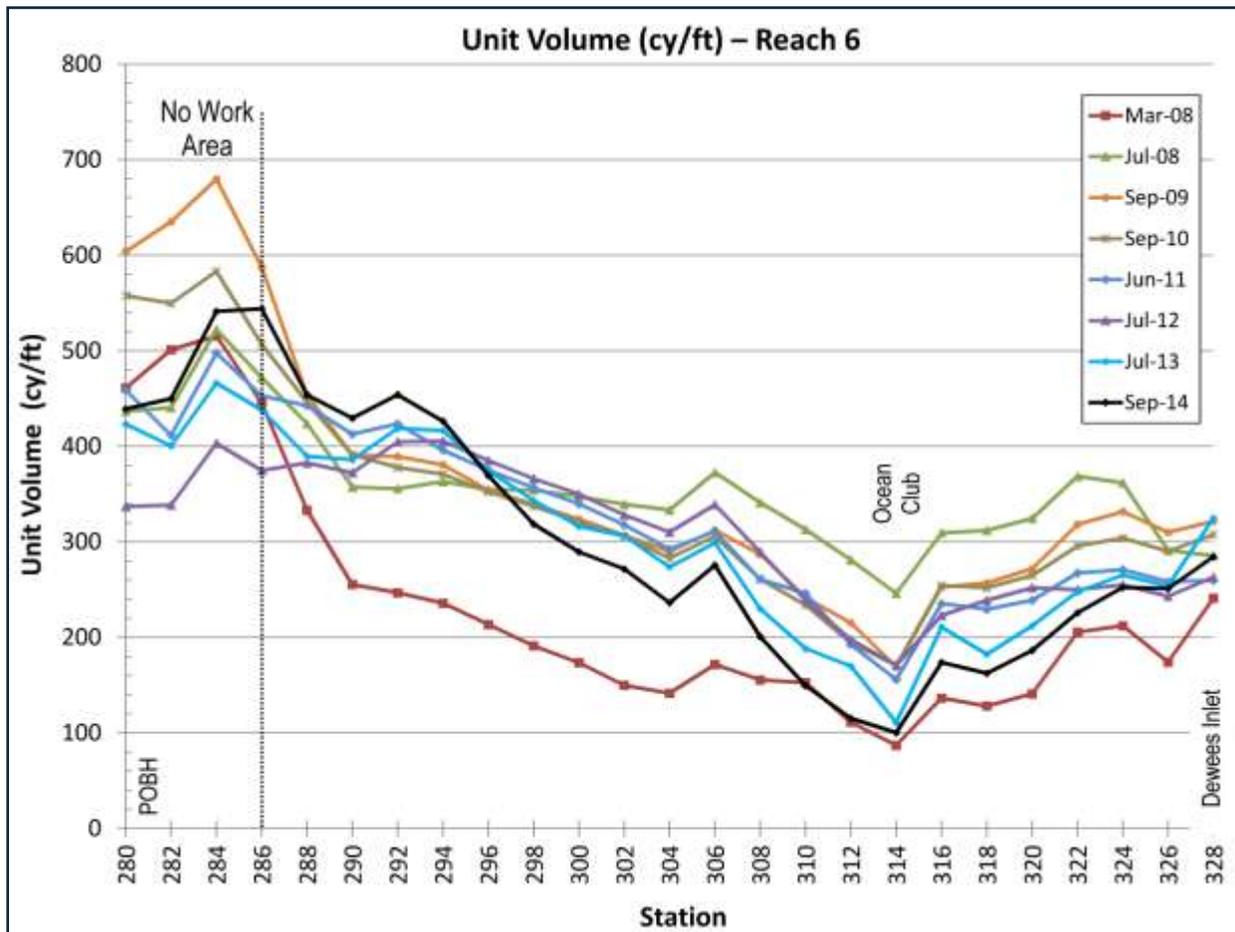
FIGURE 3.9. [UPPER] Bar graph showing beach unit volumes calculated to -10 ft NAVD in Reach 6. Overall, this reach has over 100 cy/ft more sand in July 2012 than in July 2007 (prior to shoal attachment and nourishment). **[LOWER]** Profile unit-width volumes for stations in Reach 6. Erosion has dominated the ends of the reach. The beach was much more stable from 2009 to 2012; however, erosion increased along the eastern portion of the reach over the past year.

Additional sand was needed to supplement the natural sand transport condition. Between March and July 2008, ~628,000 cy of sand were added to the reach through nourishment and natural spreading of sand from the shoal (the design volume for this reach was 550,000 cy). Average profile unit volumes increased from 226 cy/ft to 355 cy/ft (calculated to -10 ft NAVD) (Fig 3.9, upper).

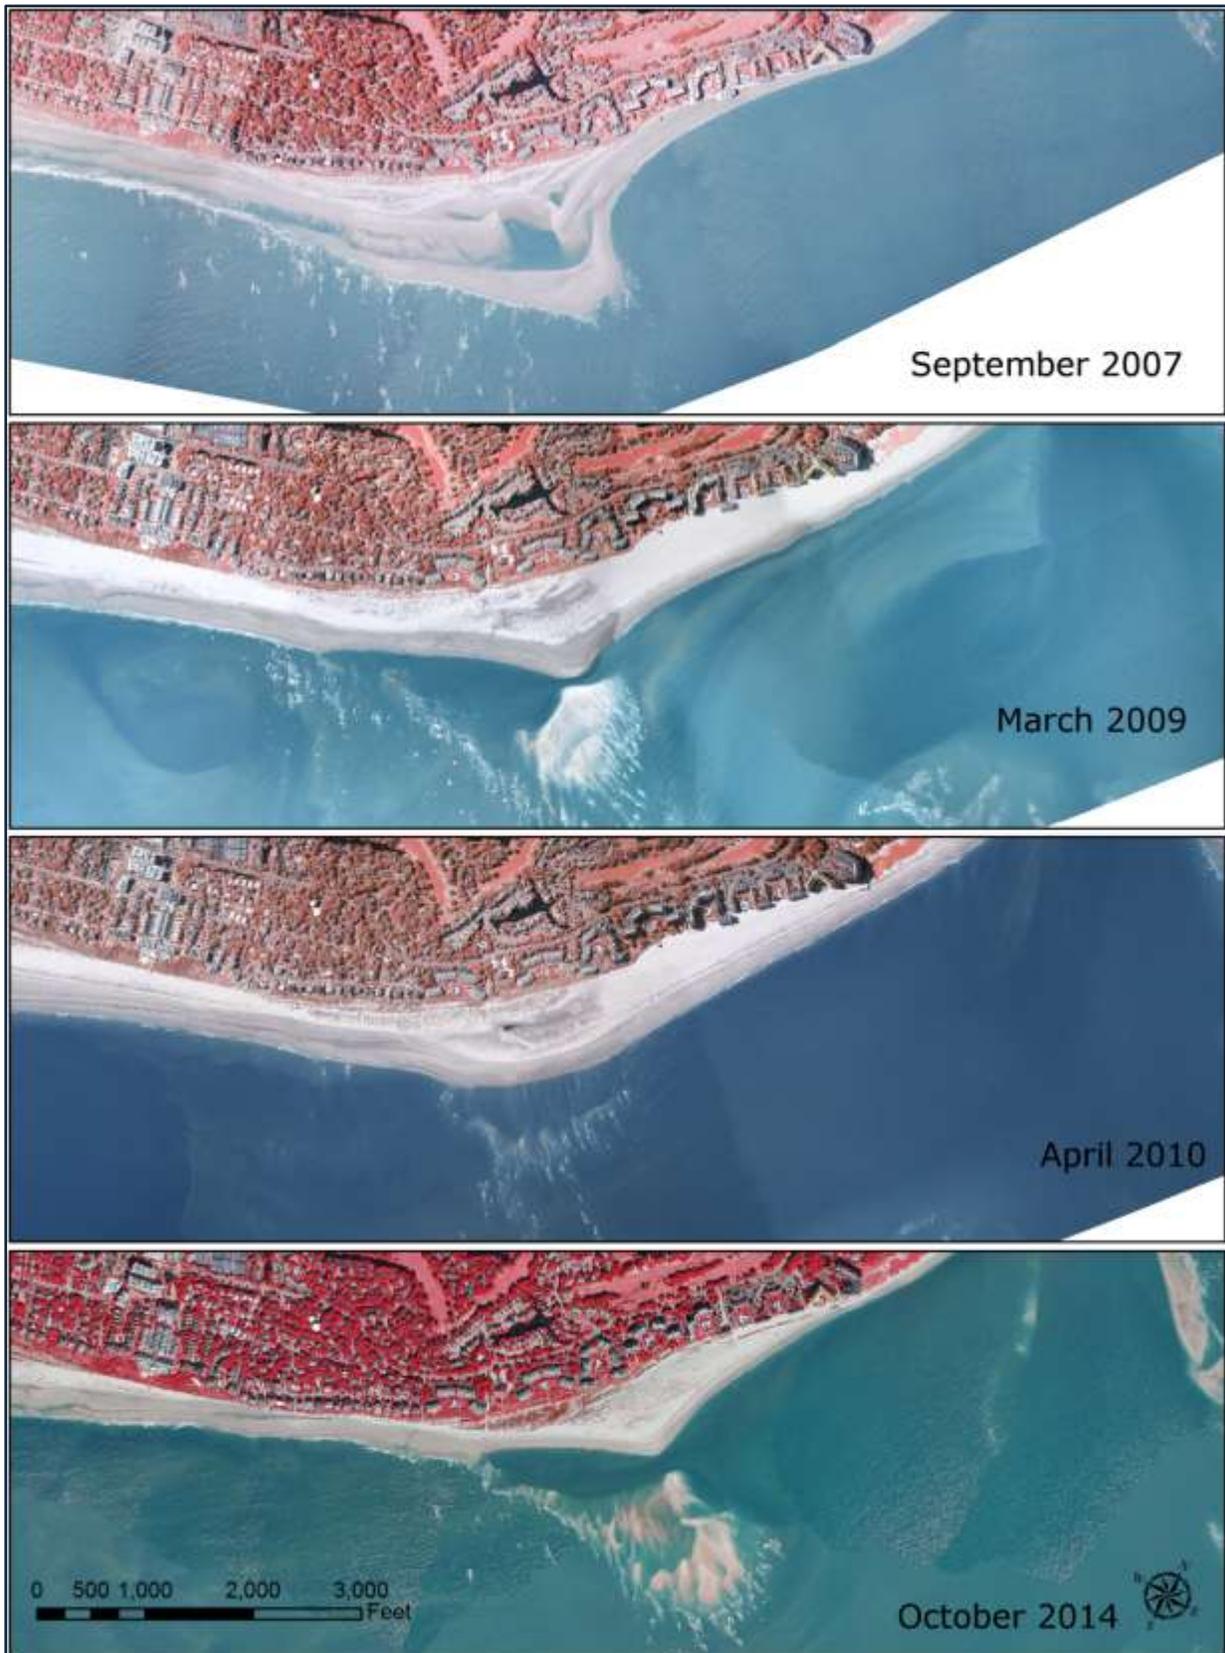
FIGURE 3.10. Sequence of aerial photographs showing four distinct shoal-bypass events occurring between 2007 and 2014. The 2009 and 2010 events were of much smaller scale than the 2007 event or the present event. Images were obtained by Independent Mapping Consultants (IMC, Charlotte NC).
