**2008 BEACH RESTORATION PROJECT
ISLE OF PALMS SOUTH CAROLINA**

**Monitoring Report No 6
April 2015**

YEAR 6 (2014) MONITORING REPORT

Coastal Science & Engineering (CSE)

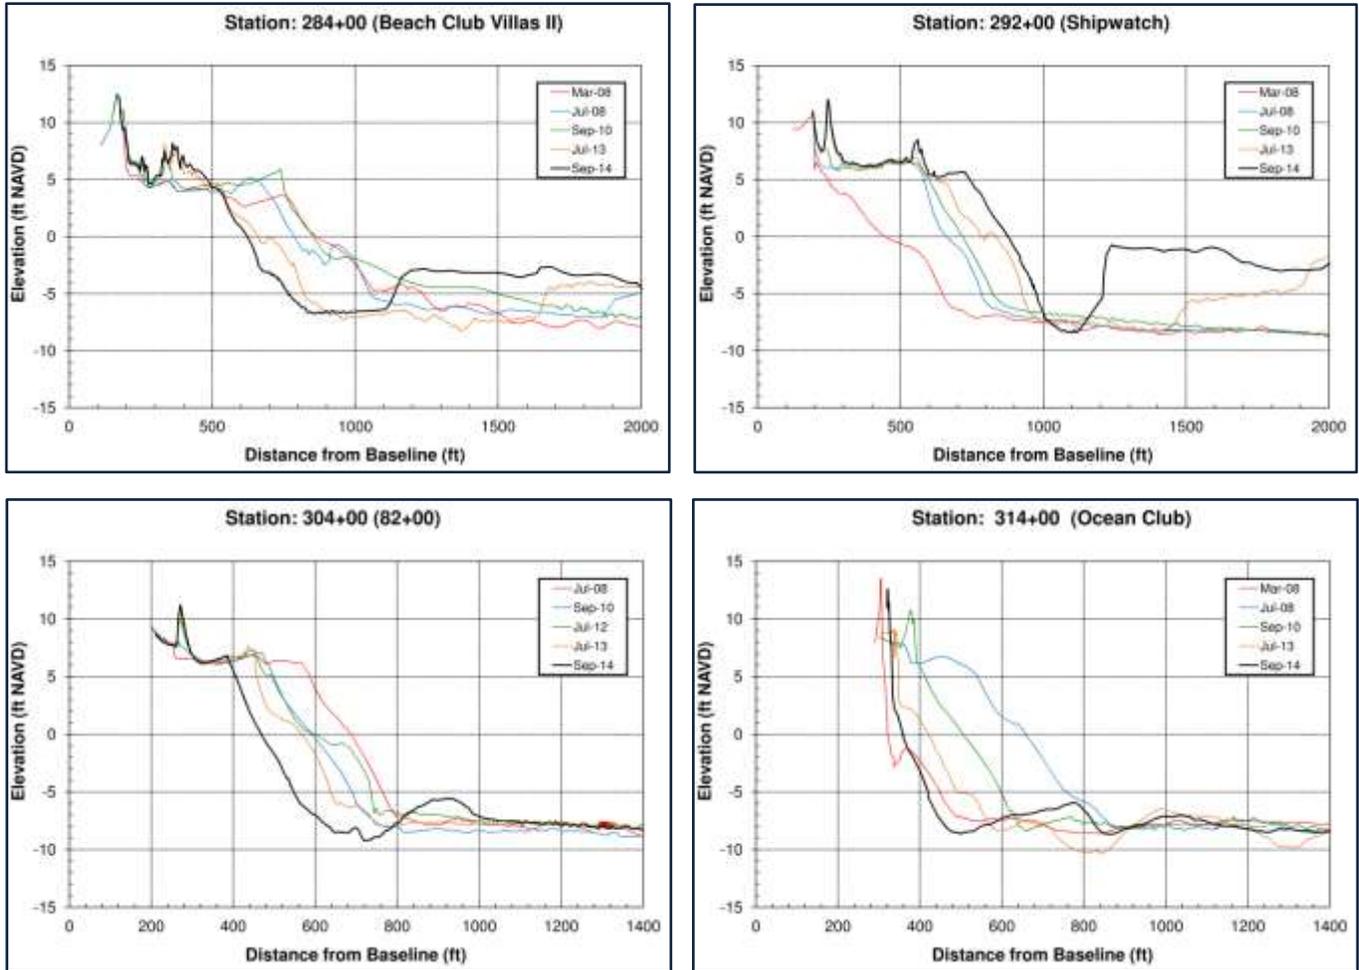
FIGURE 3.11. Profiles for selected stations in Reach 6. Station 284+00 rapidly eroded from 2009 to 2012; however, the berm was stable over the past two years as the shoal moved closer to the beach. Station 292+00 (Shipwatch) has accreted since nourishment. It is directly in the lee of the approaching shoal, which was ~300 ft from the beach in September 2014. Station 314+00 eroded rapidly the first year after the 2008 project and continues to be an erosion hotspot.

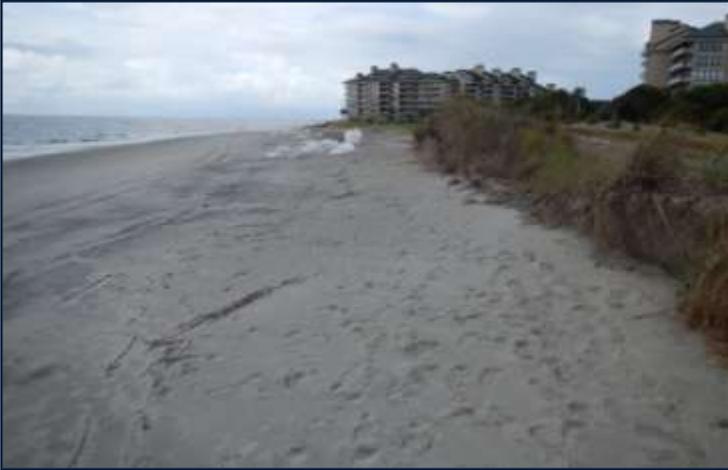
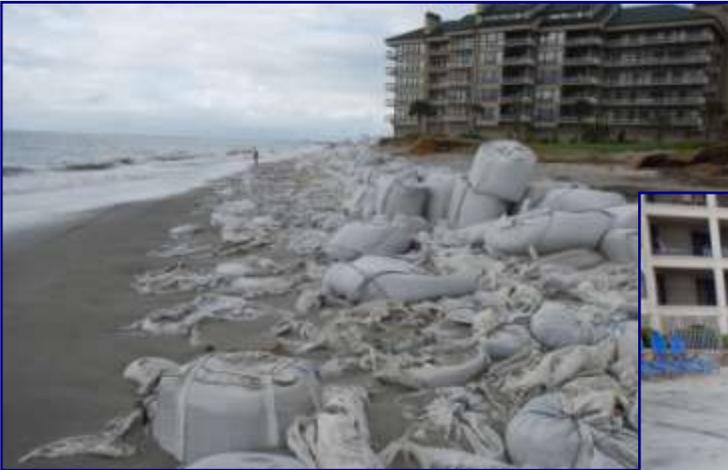
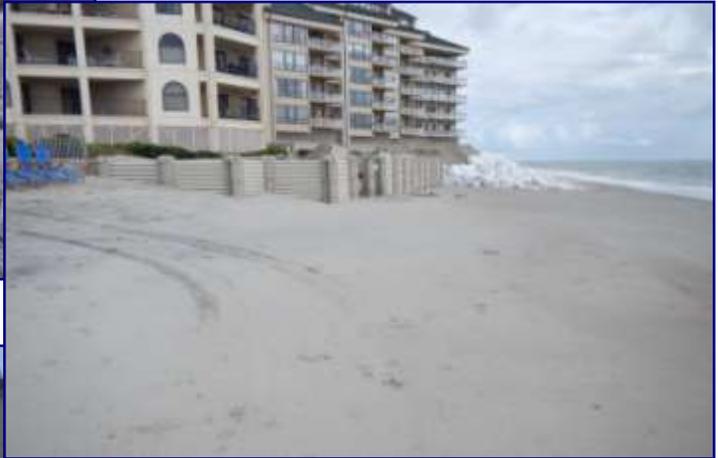
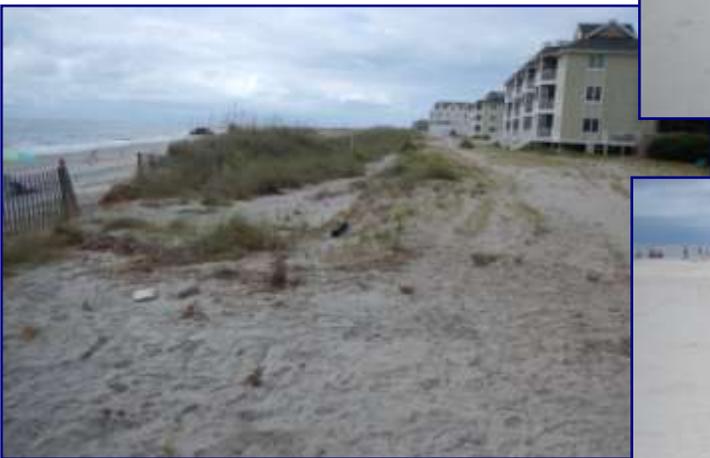
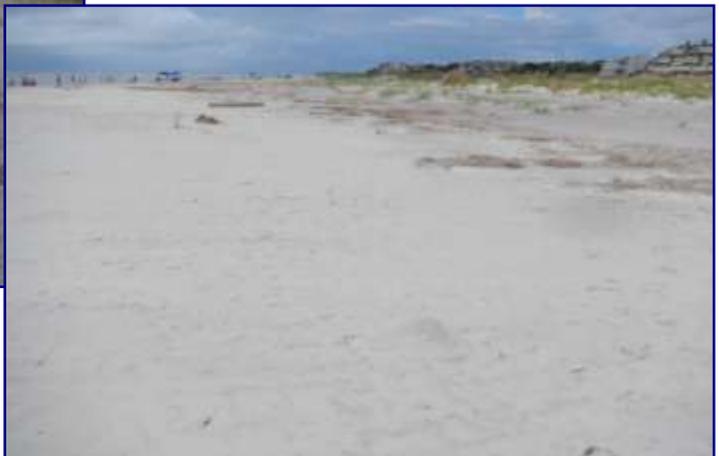
FIGURE 3.12.

[UPPER LEFT] View west from station 324+00..

[LOWER RIGHT] View west from station 292+00 showing the accretional salient (bulge) leeward of the approaching shoal.

Severe erosion has eliminated most of the dry beach near Seascape, Ocean Club, and the 18th hole, resulting in property owners implementing emergency measures which included installation of one-ton sandbags and an experimental wave-dissipation device (Fig 3.12). As of September 2014, most of the sandbag revetment along the golf course had settled or been displaced to the point of it being non-functional. There were also many damaged bags adjacent to Ocean Club; however, newer bags had been placed to reinforce the temporary revetment and provide protection to the structure.

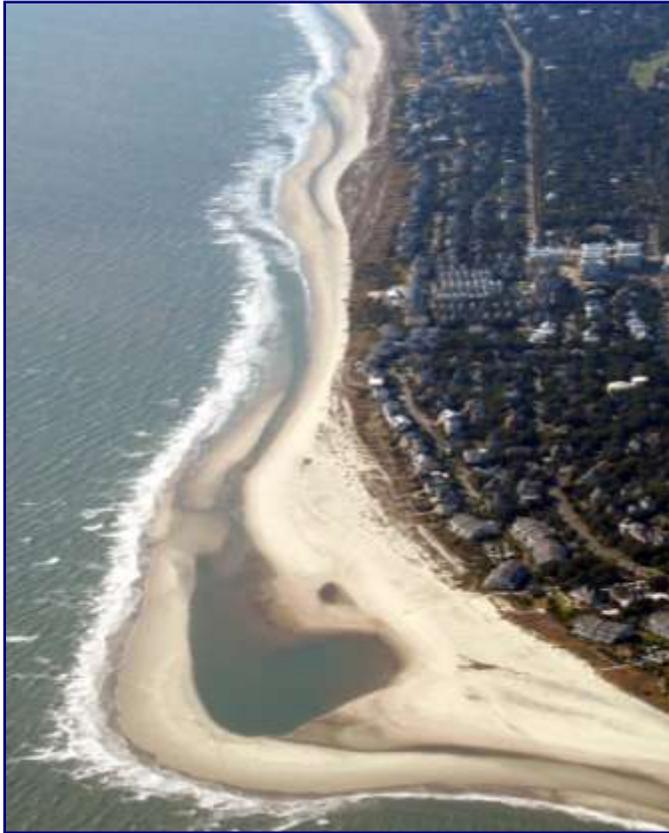
FIGURE 3.13.

[UPPER LEFT]
Reach 5 in December 2007.
[Photo by TW Kana]

[LOWER LEFT]
Reach 5 on 21 October 2014.
[Photos by S Traynum]

[LOWER RIGHT]
Reach 5 on 21 October 2014.
[Photos by S Traynum]

Reach 5 (Fig 3.13, previous page) spans ~6,000 ft between 53rd Avenue and the Wild Dunes Property Owners Beach House and encompasses project Reach A (Fig 3.14, stations 222+00 thru 280+00). Like Reach 6, this area is greatly influenced by shoal-bypass events, especially at the northern end of the reach where the majority of shoals attach to the beach.

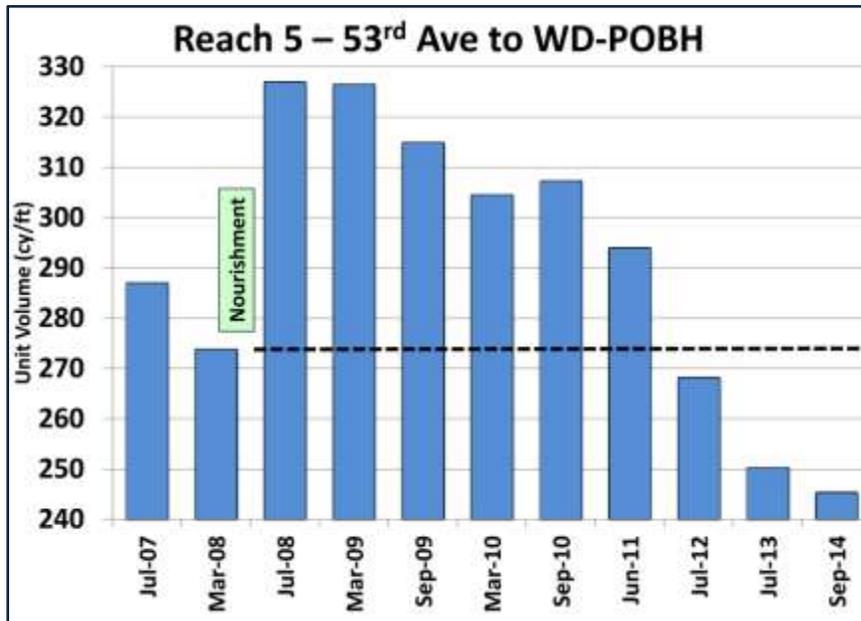
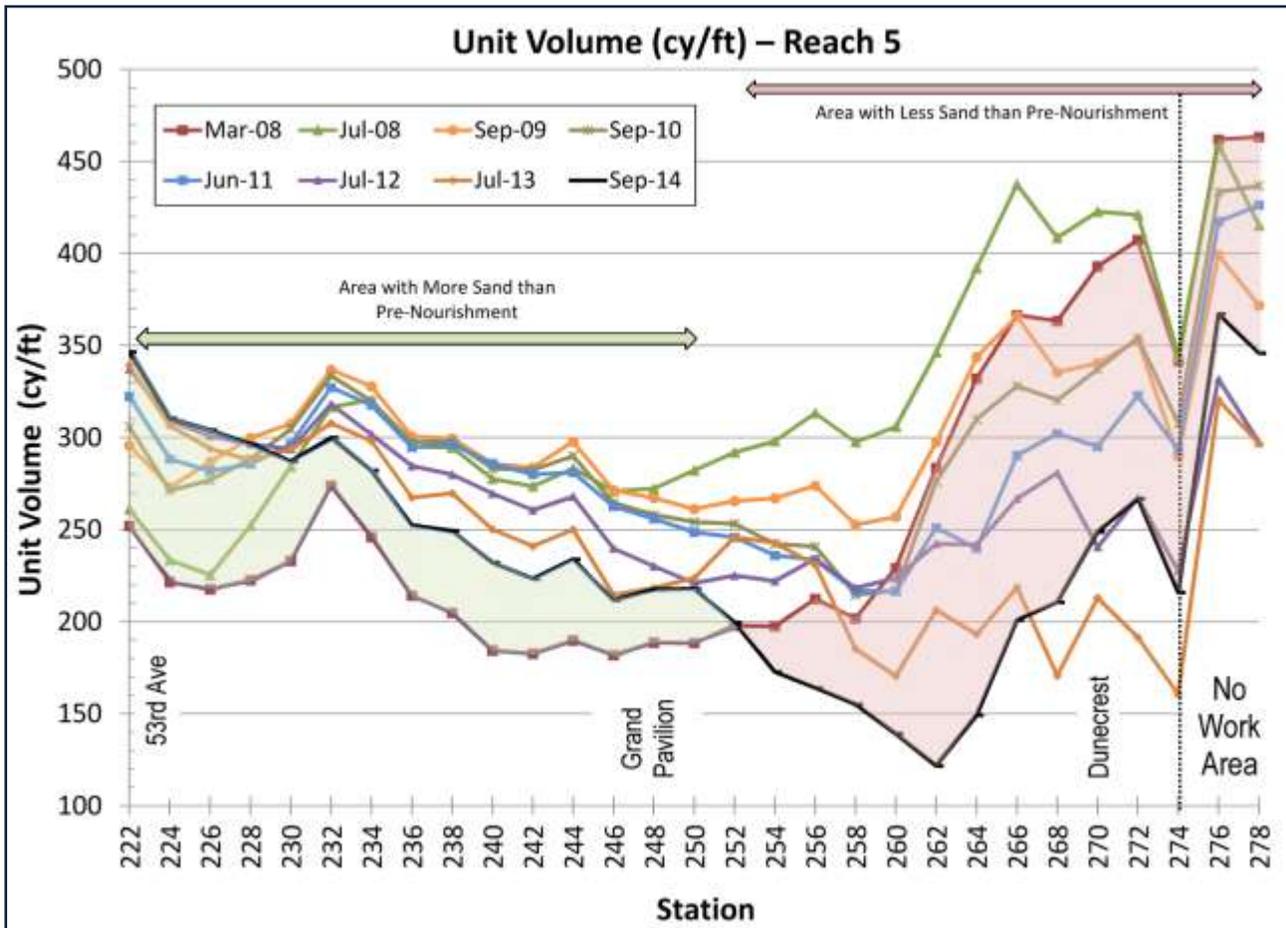
FIGURE 3.15. [UPPER] Bar graph showing beach unit volumes calculated to -10 ft NAVD in Reach 5. While the 2014 average sand volume is less than the pre-nourishment condition, stations 222–252 (3,000 ft of a total of 6,000 ft of Reach 5) still hold ~168,000 cy (56.1 cy/ft) more sand than the pre-nourishment condition. **[LOWER]** Profile unit-width volumes for stations in Reach 5. Erosion has dominated the northern part of the reach (stations 250–278) and is associated with excess sand spreading from shoal attachment events in 2006, 2009, and 2010 and shoal-induced erosion from the present event.

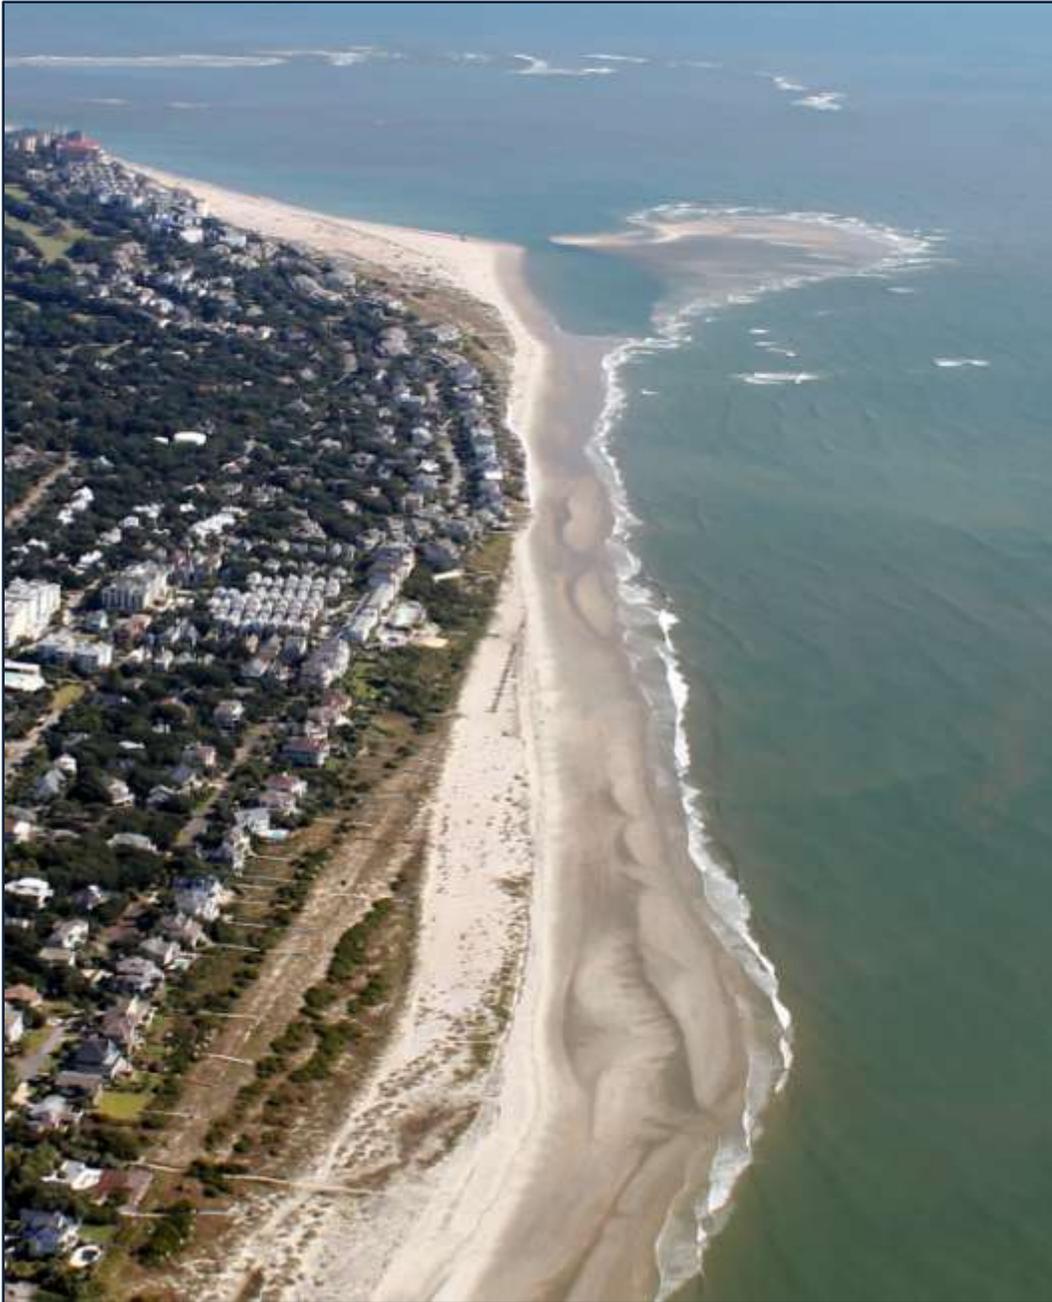
FIGURE 3.16. October 2014 aerial image of Reach 5 showing the approaching shoal at the northern end of the reach and the remaining fill from the 2008 nourishment (bright sparsely vegetated sand in the lower half of the image).

As of July 2012, less sand was present in Reach 5 than was present prior to nourishment in 2008. This net loss was the result of spreading of the excess sand present following the 2007 shoal event at the eastern half of the reach. At that point, the eastern ~1,800 ft of the beach was below the pre-nourishment condition and had lost a total of ~245,000 cy (Stations 260+00 – 280+00) since March 2008 (Fig 3.15). This includes the nourishment quantity of ~45,000 cy added to this area. Over the same time, the western ~3,800 ft of beach showed a net increase of 210,000 cy (including ~270,000 cy of nourishment). Since 2012, the area showing net loss compared to the pre-nourishment condition has continued to expand to the west, and now encompasses the eastern ~3,000 ft of the reach (Fig 3.16).

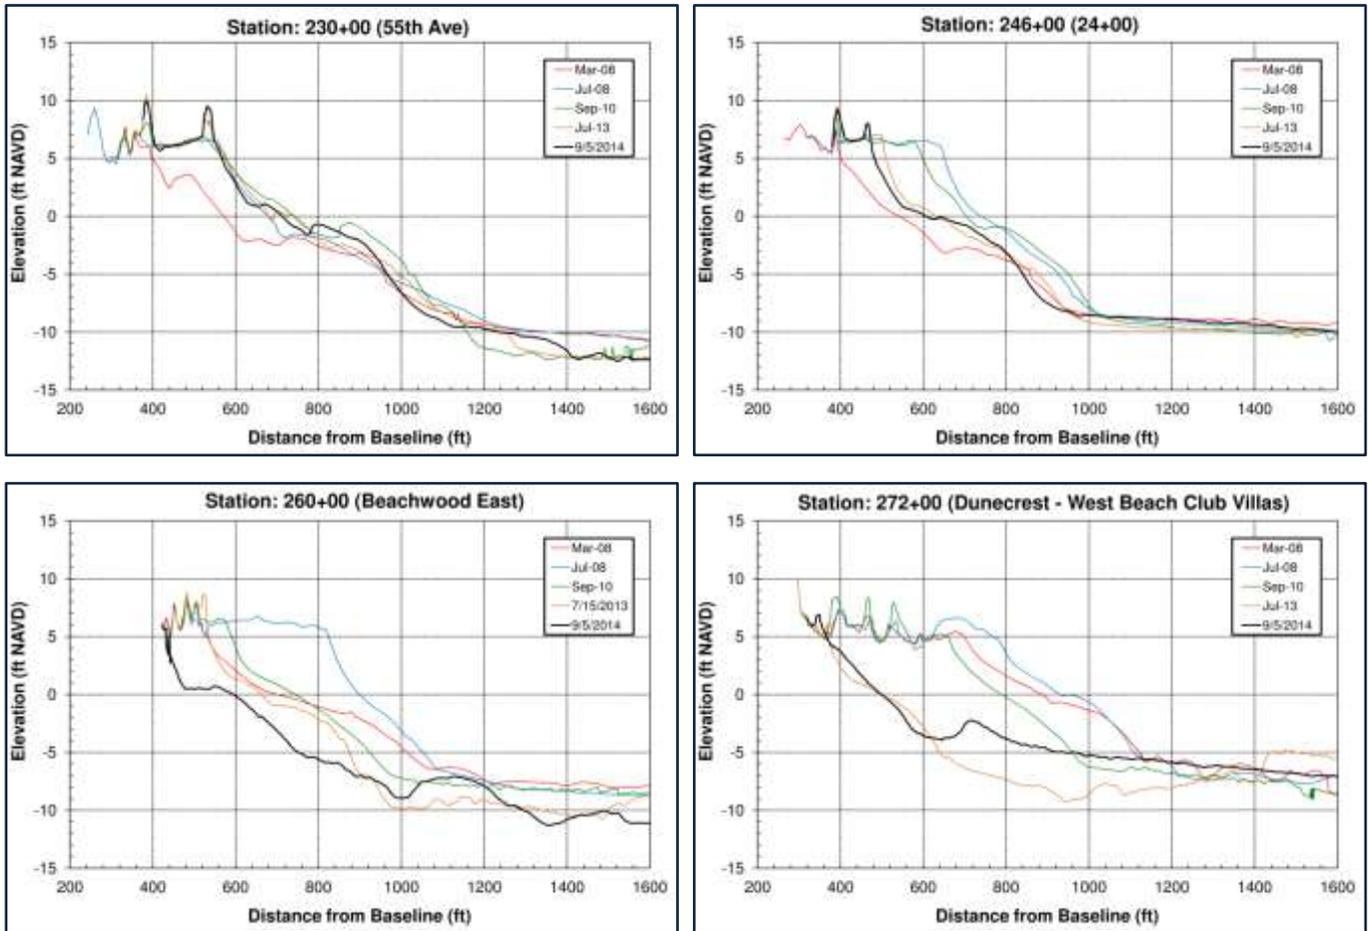
FIGURE 3.17. Profiles for selected stations in Reach 5. Sand is attaching to the beach at various locations along the eastern half of the reach, causing an erosional arc (see text) and isolated sand bars. The western edge of the bypassing shoal is attaching to the low-tide beach at station 272+00.

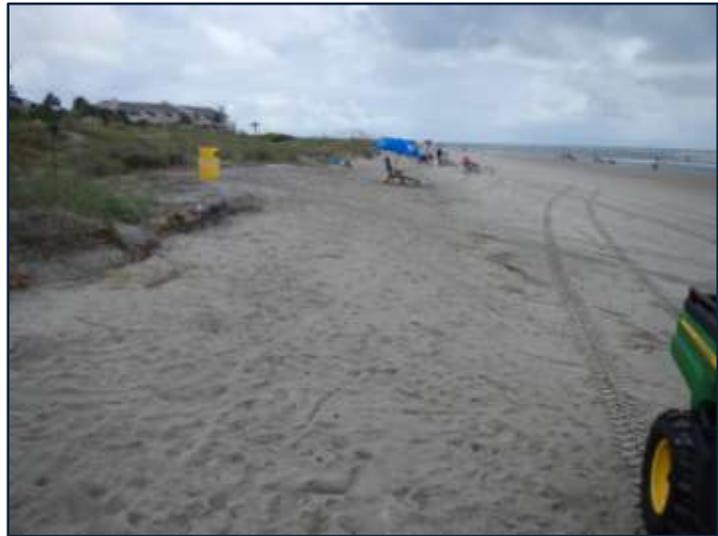
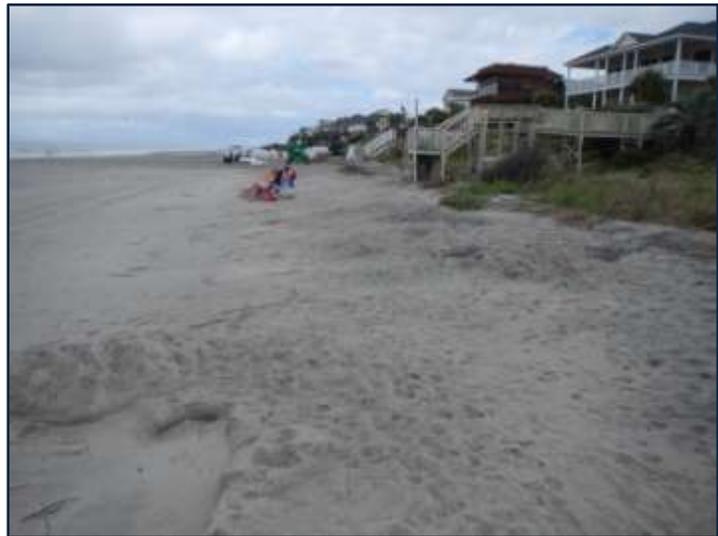
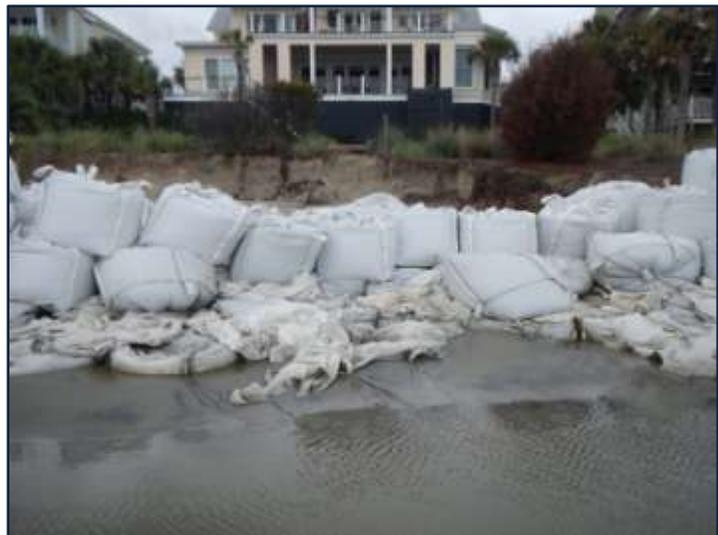
FIGURE 3.18.

Ground photos along various areas of Reach 5 in September 2014.

[CENTER] View west from station 272+00.

[LOWER RIGHT] Sand bags placed as emergency erosion protection Beachwood East.

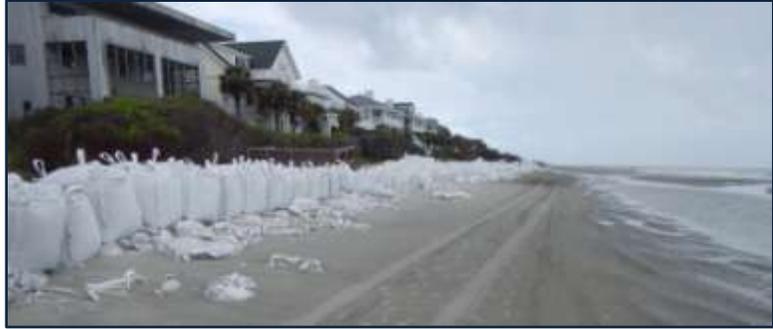
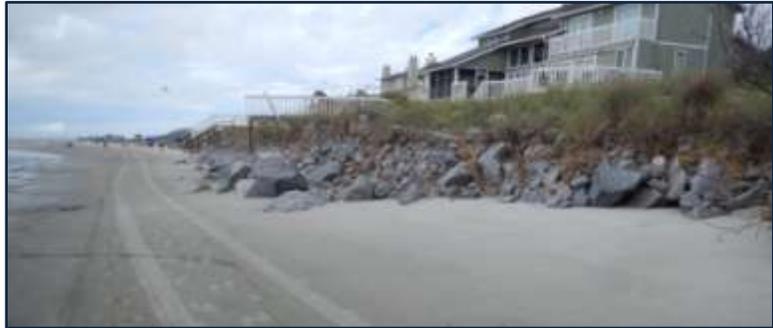
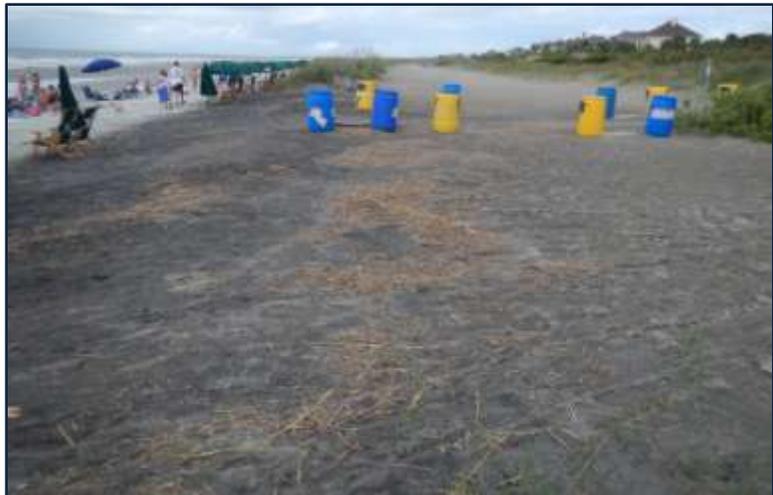
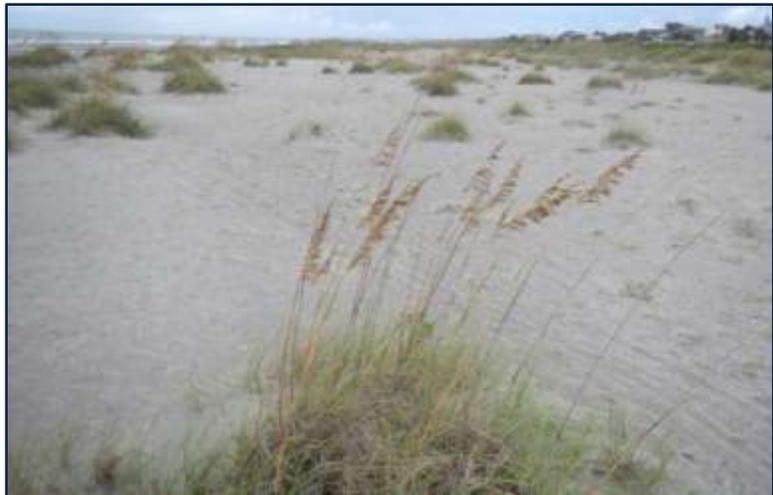
FIGURE 3.19.

Ground photos along various areas of Reach 5 in September 2014.

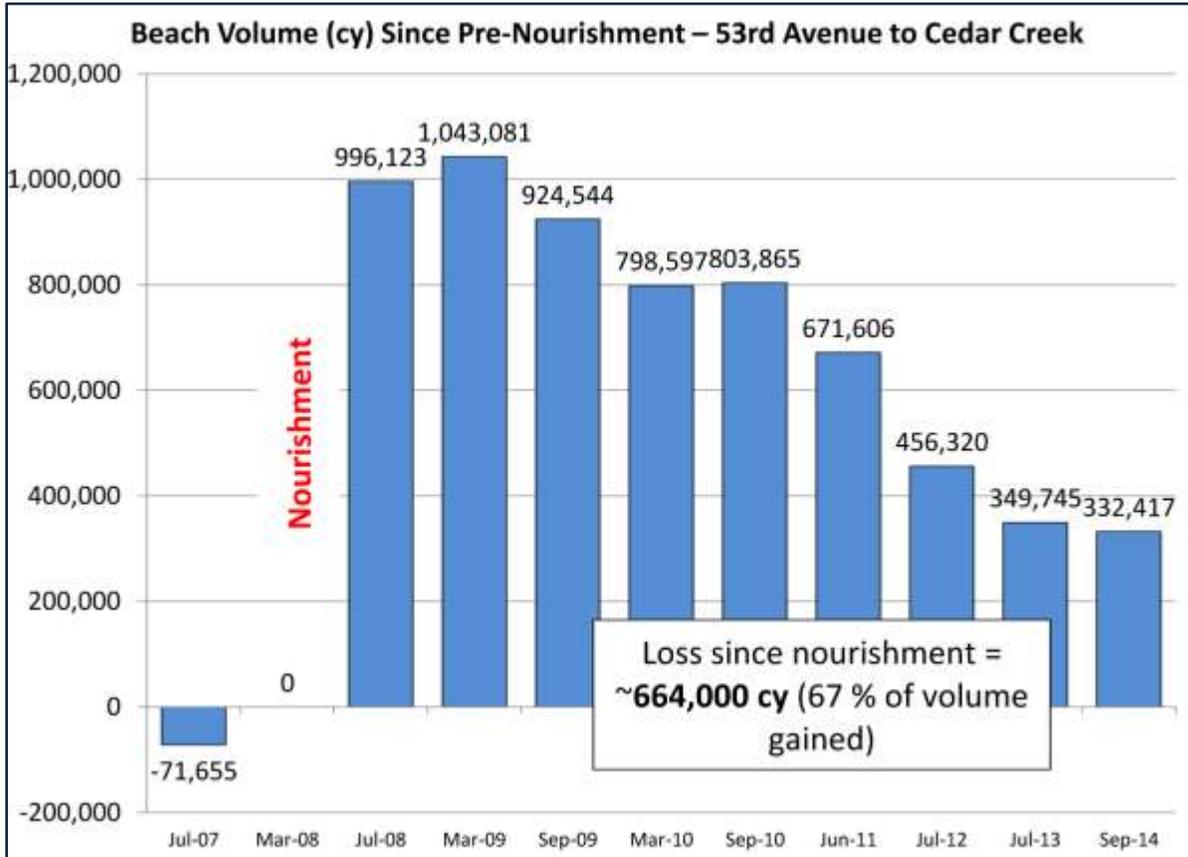
FIGURE 3.20. Beach volume relative to March 2008 (pre-nourishment). The values shown include all areas (both nourished and non-nourished) and do not account for sand accumulated at the turn in the baseline at the northeastern point, which is estimated to have gained over 50,000 cy since March 2008.

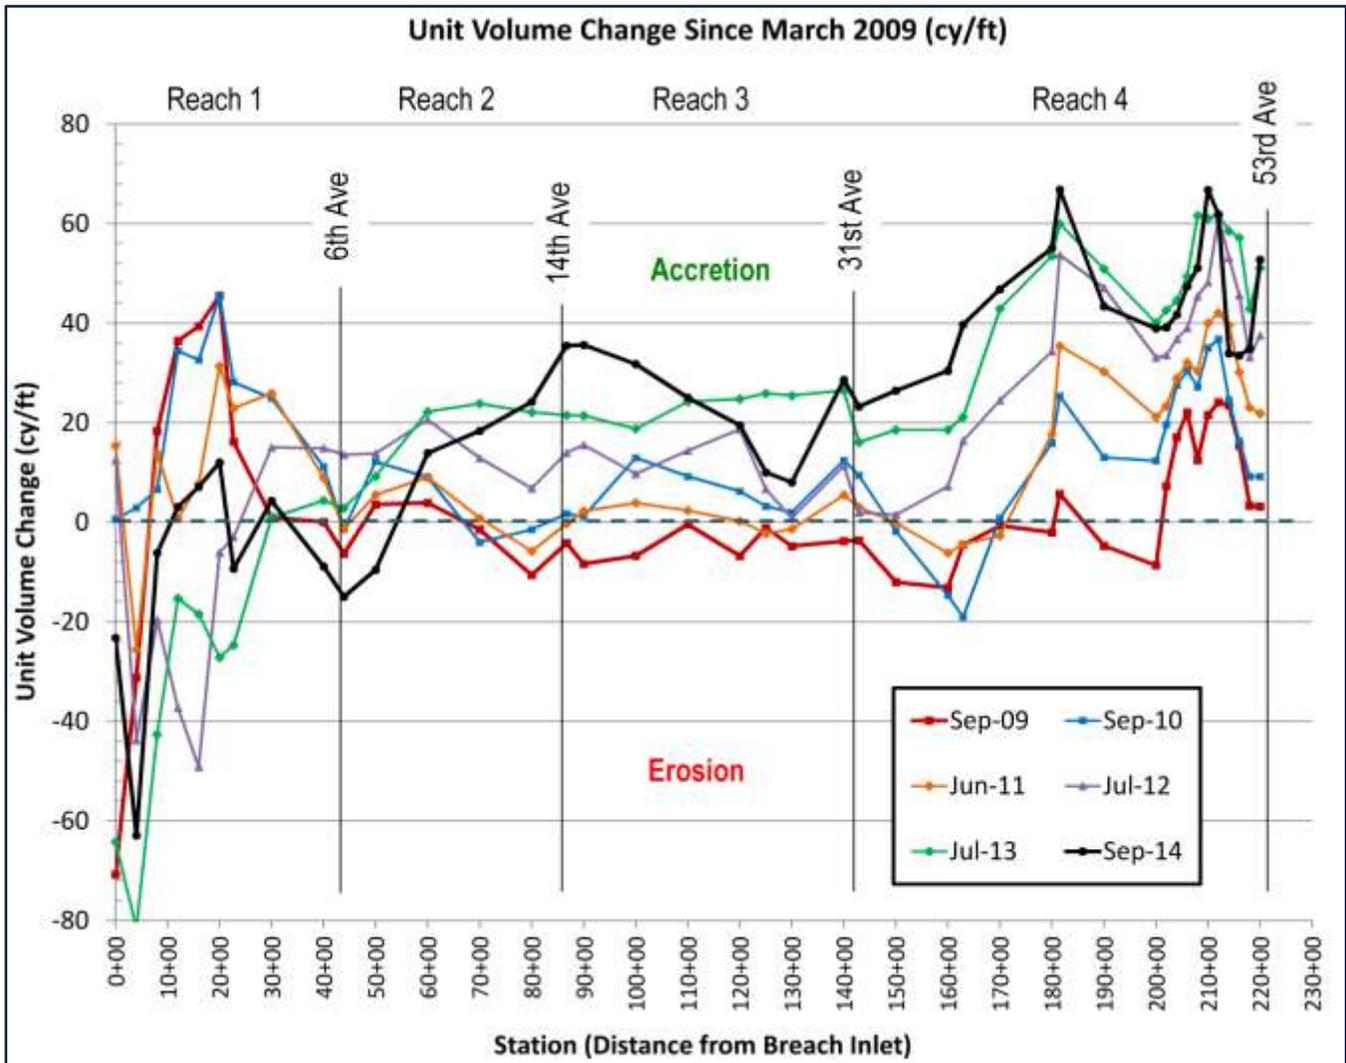
FIGURE 3.22. Profile unit-width volume change (cy/ft) between March 2009 and later dates for Reaches 1–4. CSE established and surveyed profiles spaced 1,000 ft apart within the Isle of Palms reaches and reoccupied monuments surveyed annually by SCDHEC-OCRM. Historically, these reaches have been accretional; however, between March and September 2009, most stations outside of the influence of the inlet or project were erosional. Since September 2009, most stations have shown accretion and are currently healthier than the March 2009 condition (ie - where the black line is greater than zero). The higher rates and westward sequence of accretion along Reach 4 illustrate the downcoast spread of nourishment sand from Reach 5. [Volumes are relative to the March 2009 condition.]

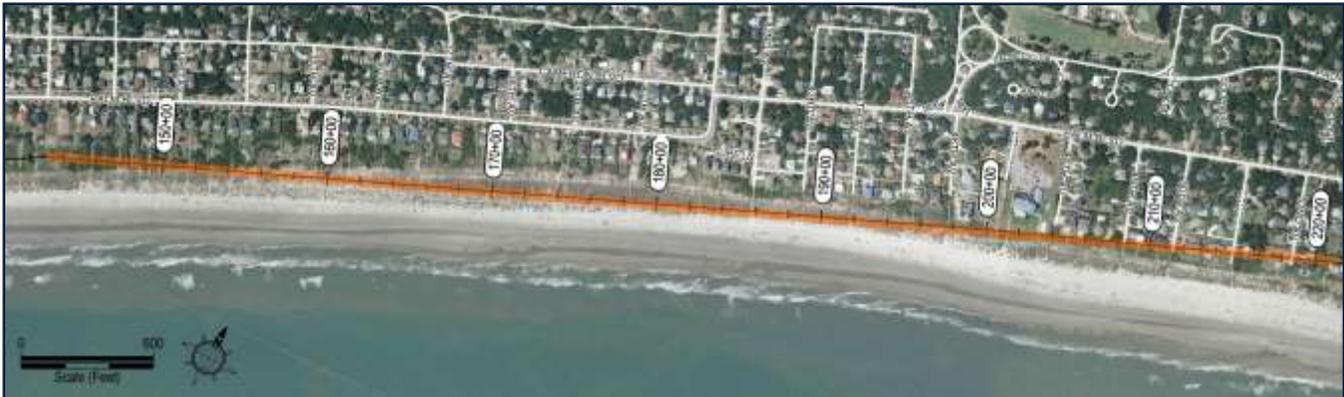
FIGURE 3.23. Reach 4 – stations OCRM 3140 (31st Avenue) to CSE 222+00 (53rd Avenue) – noted by the orange-highlighted bar.

Reach 4 spans 7,910 ft between 31st Avenue and 53rd Avenue (stations OCRM 3140 to CSE 222+00) (Fig 3.23). Being immediately downdrift of the 2008 nourishment project, it should, therefore, benefit from losses of nourishment sand from the project area. Reach 4 was stable from March to September 2009 and has accreted between each monitoring event since then (see Table 3.2).

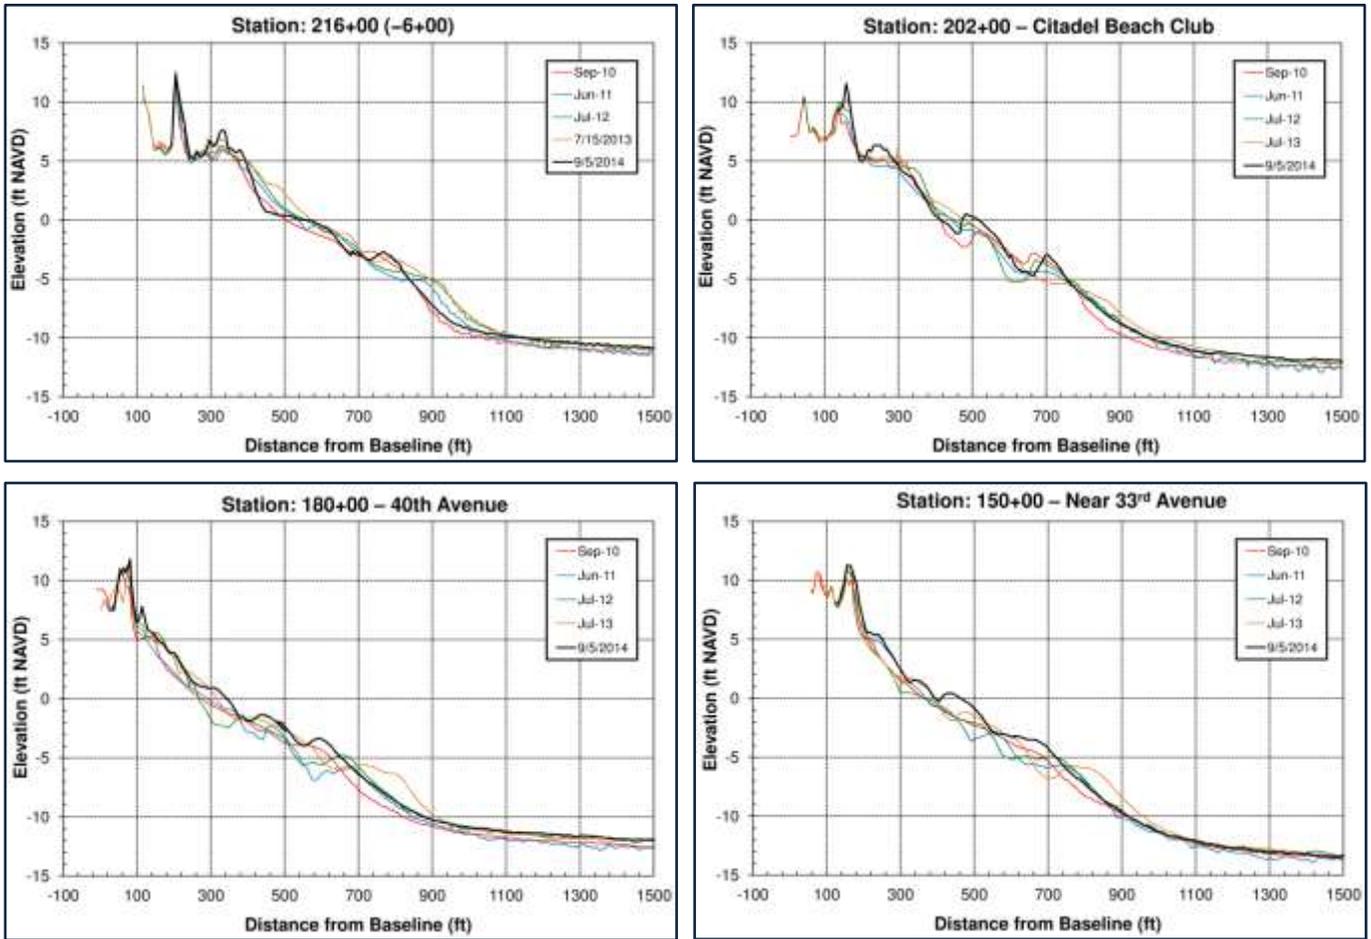
FIGURE 3.24. Profiles from Reach 4 stations 216+00 (51st Avenue), 202+00 (47th Avenue), 180+00 (40th Avenue), and 150+00 (33rd Avenue)

Over the past year (2013–2014), the western half of Reach 4 (31st–42nd Avenues) accreted while the eastern half (42nd–53rd Avenues) was generally erosional. Volume change averaged +8.3 cy/ft from 31st to 42nd Avenues and -6.4 cy/ft east of 42nd Avenue. The erosion observed between 42nd and 53rd Avenues is the first significant erosional trend observed over any portion of Reach 4 since 2009. Stations 216+00 and 218+00 (near 51st Avenue) experienced some recession of the dry beach; however, each profile is still ~100 ft wider than the 2009 condition. Remaining profiles within the reach were generally stable or accretional in the upper profile (dry beach area); any losses were in the wet beach or underwater portion of the profile (Fig 3.24).

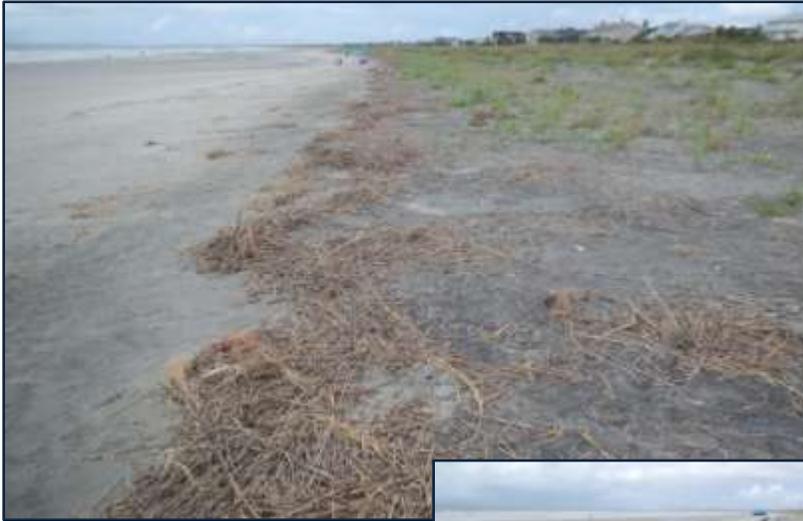
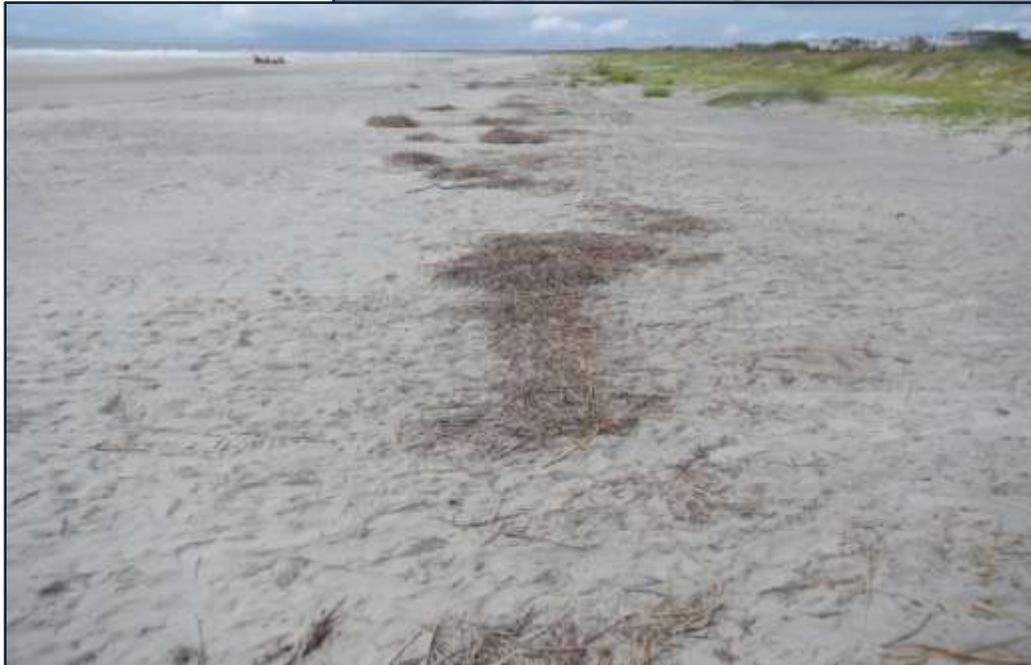
FIGURE 3.25. September 2014 photos from Reach 4. **[TOP]** 53rd Avenue looking west into small erosion arc. **[CENTER]** View west from 44th Avenue. **[BOTTOM]** View west from 36th Avenue showing expanding dune vegetation across a growing berm. [Photos by D Giles]

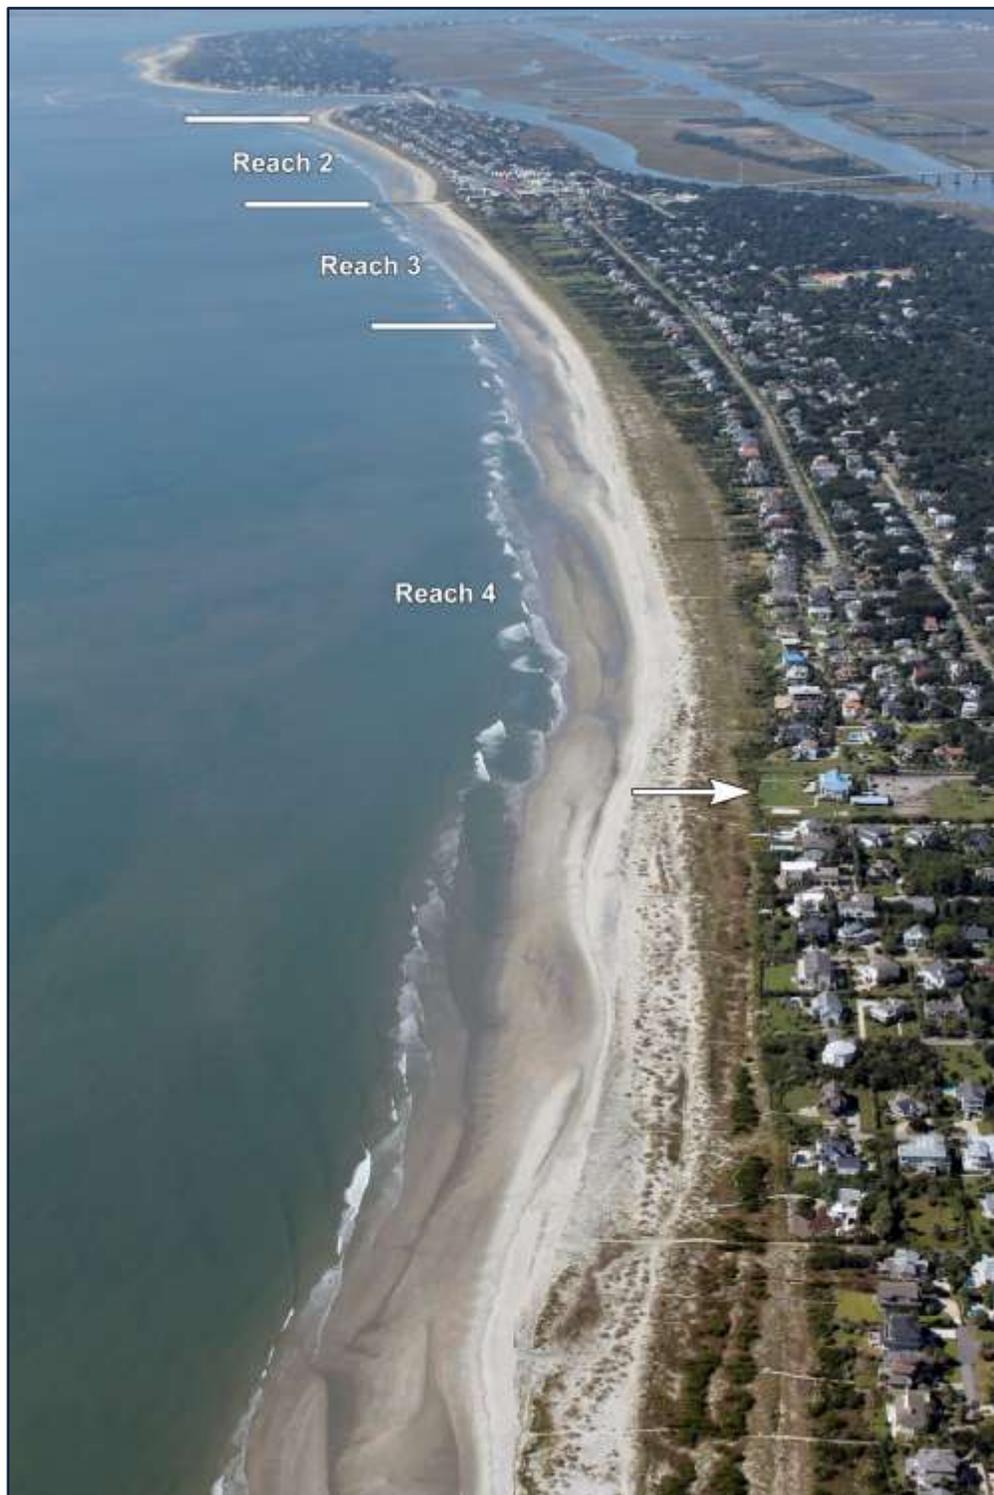
FIGURE 3.26. October 2014 aerial image of the central portion of Isle of Palms. The seawall (arrow) protecting the Citadel Beach Club (exposed in the 1980s) is now buried behind nearly 100 ft dunes. [Photo by SB Traynum]

Historical accretion along this reach (combined with sufficient setbacks for development) has led to a substantial dune system between most structures and the beach (Fig 3.25). As long as there is slow steady accretion, the foredune will continue to build wider and higher, offering more storm protection to property behind the dunes (Fig 3.26).

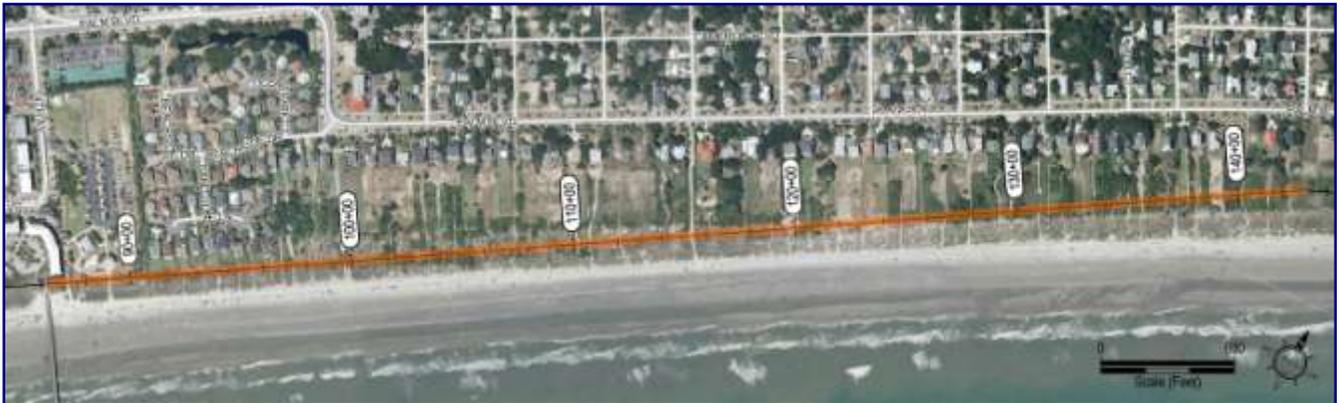
FIGURE 3.27. Reach 3 spans from station OCRM 3125 (pier) to station OCRM 3140 (31st Avenue) – noted by the orange-highlighted bar.

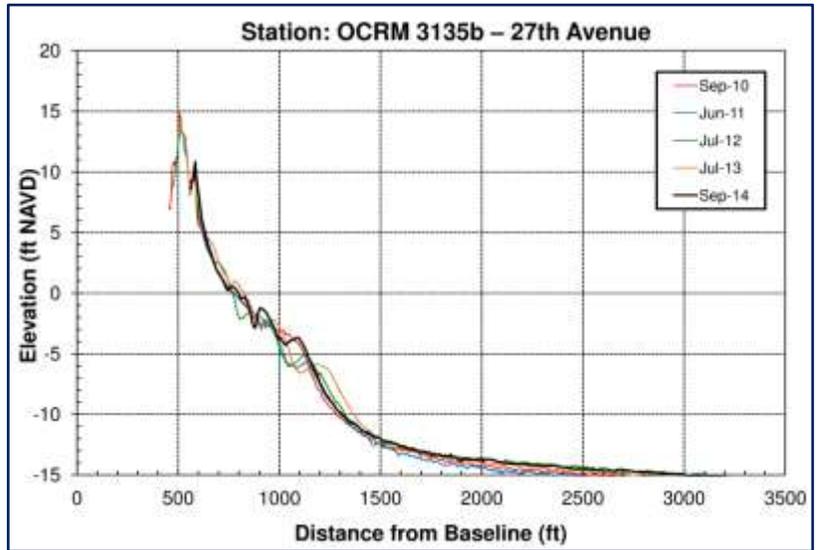
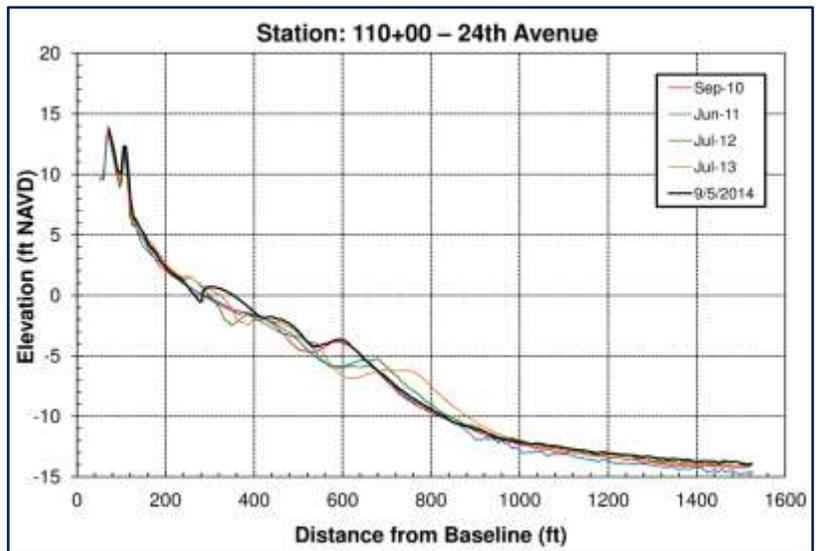
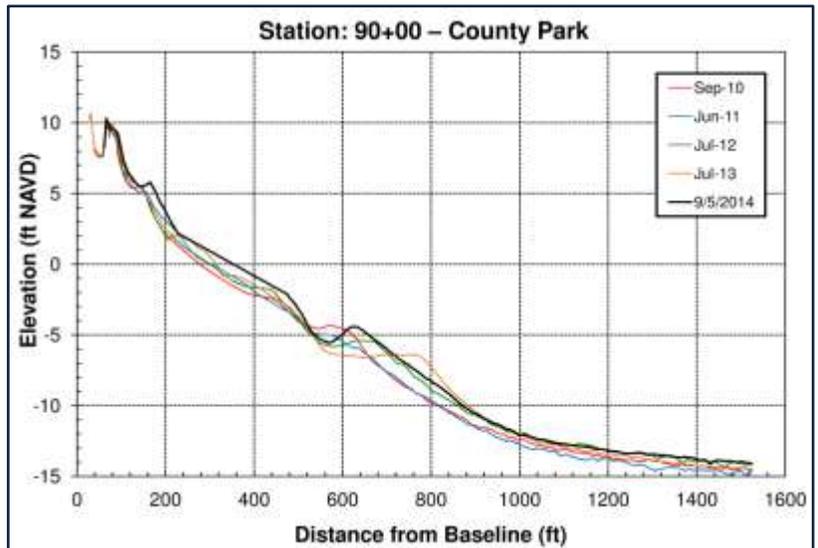
FIGURE 3.28.

Profiles from OCRM station 3135 (27th Avenue) (upper), station 110+00 (24th Avenue) (middle), and station 90+00 (County Park) (lower).
