**2008 BEACH RESTORATION PROJECT
ISLE OF PALMS SOUTH CAROLINA**

**Monitoring Report No 6
April 2015**

YEAR 6 (2014) MONITORING REPORT

Coastal Science & Engineering (CSE)

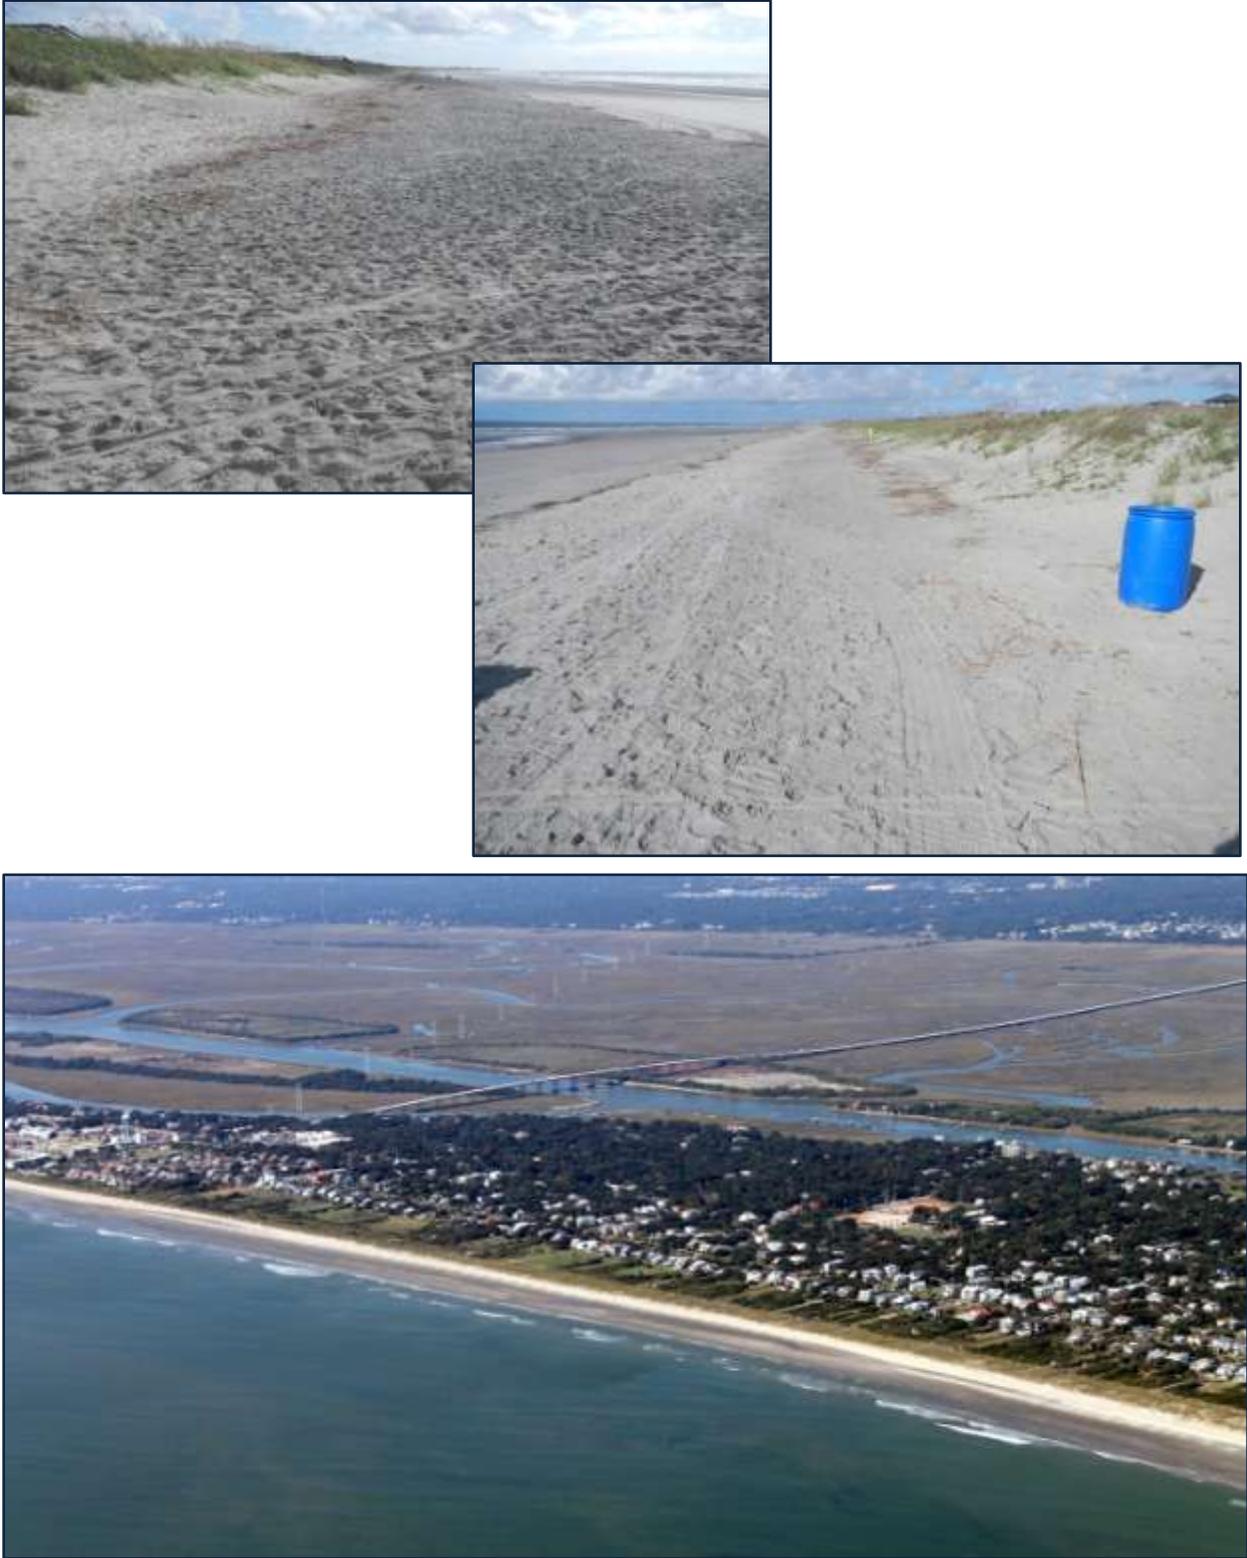
FIGURE 3.29. [UPPER LEFT] View east from 21st Avenue. [UPPER RIGHT] View west from 30th Avenue. [LOWER] October 2014 aerial view of Reach 3. [Upper photos by D Giles in September 2014. Lower photo by S Traynum.]

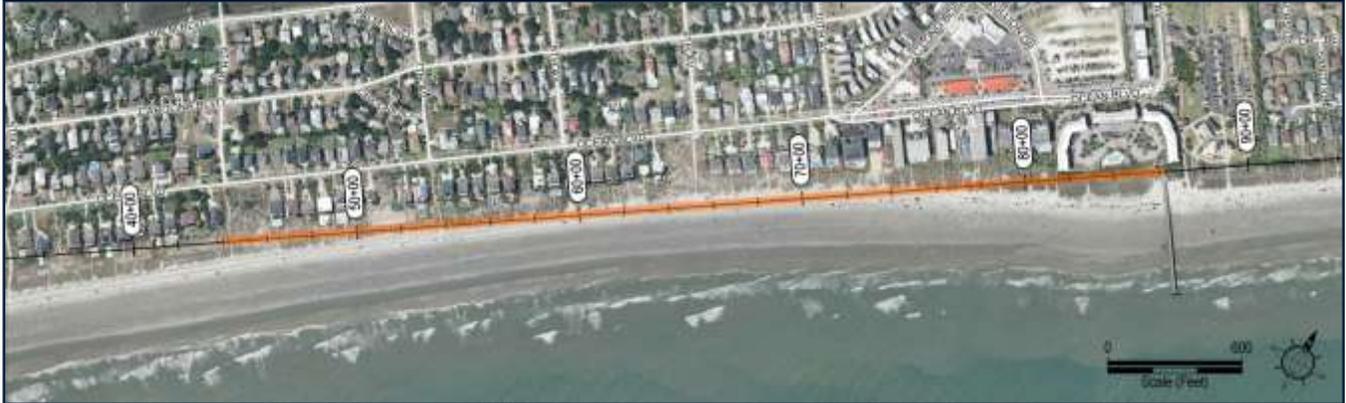
FIGURE 3.30. Reach 2 spans from OCRM 3115 (6th Avenue) to OCRM 3125 (Sea Cabins Pier) – noted by the orange-highlighted bar.

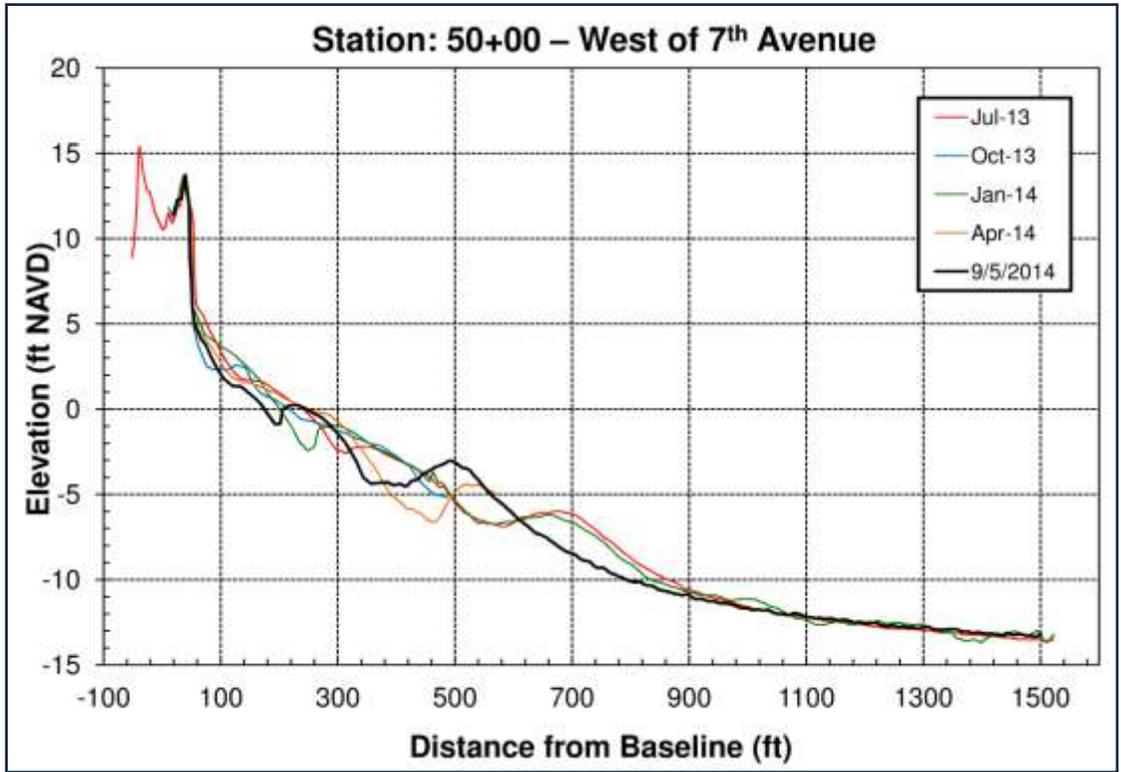
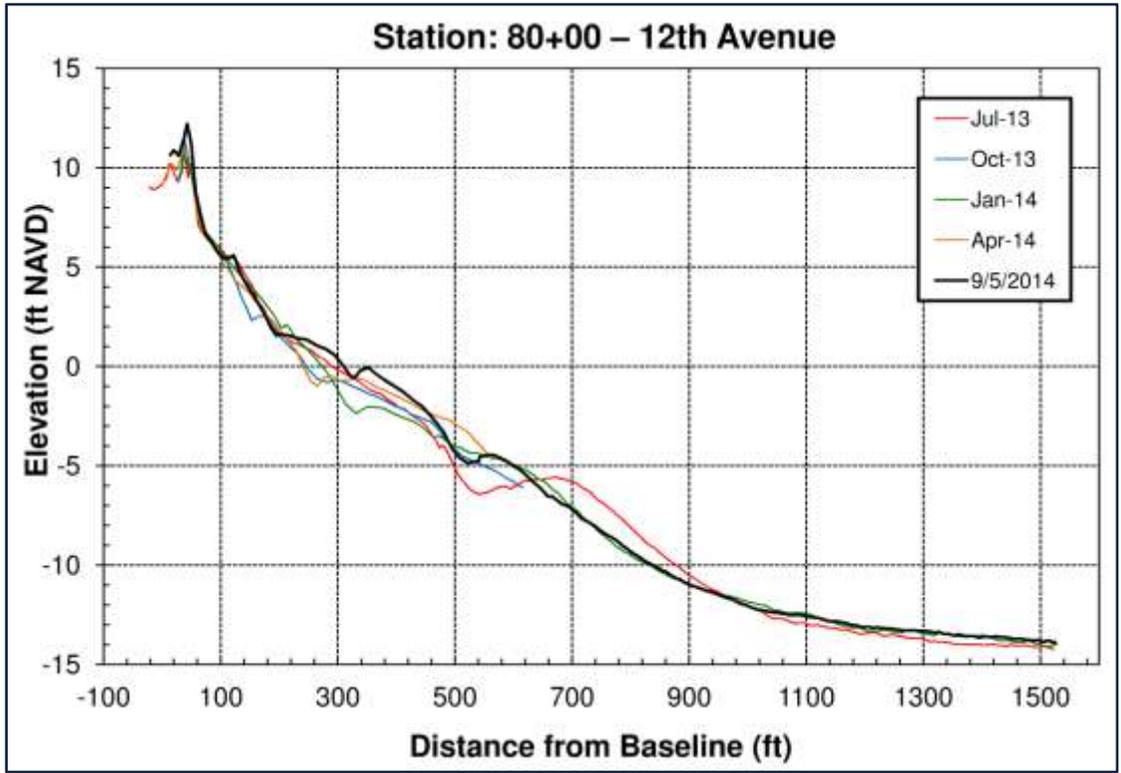
FIGURE 3.31. Profiles from station 50+00 (7th Avenue, upper) and station 80+00 (12th Avenue, lower).

Overall, the reach has gained 52,100 cy since March 2009, an average annual accretion rate of 2.2 cy/ft/yr. OCRM station 3115 and station 50+00 presently have less sand than the March 2009 condition.

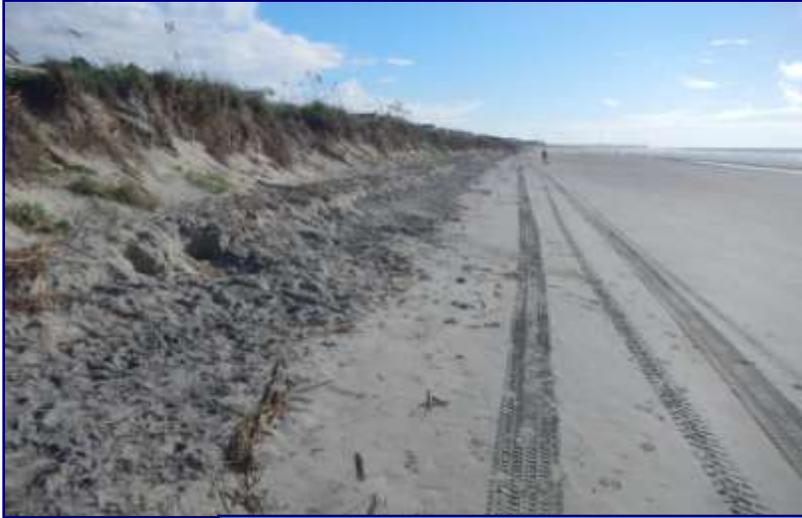
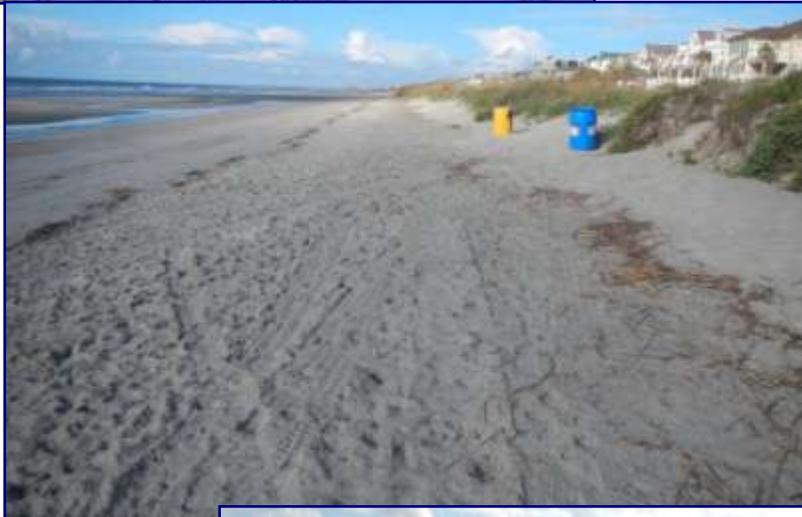
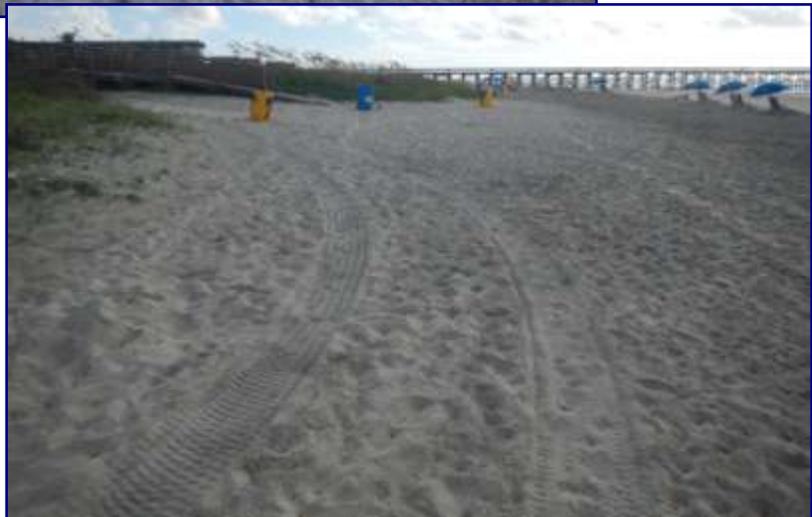
FIGURE 3.32. [UPPER] 6th Avenue looking east. **[MIDDLE]** Station 60+00 near 8th Avenue. **[LOWER]** Station 70+00 looking east near front beach. [Photos by S Traynum]

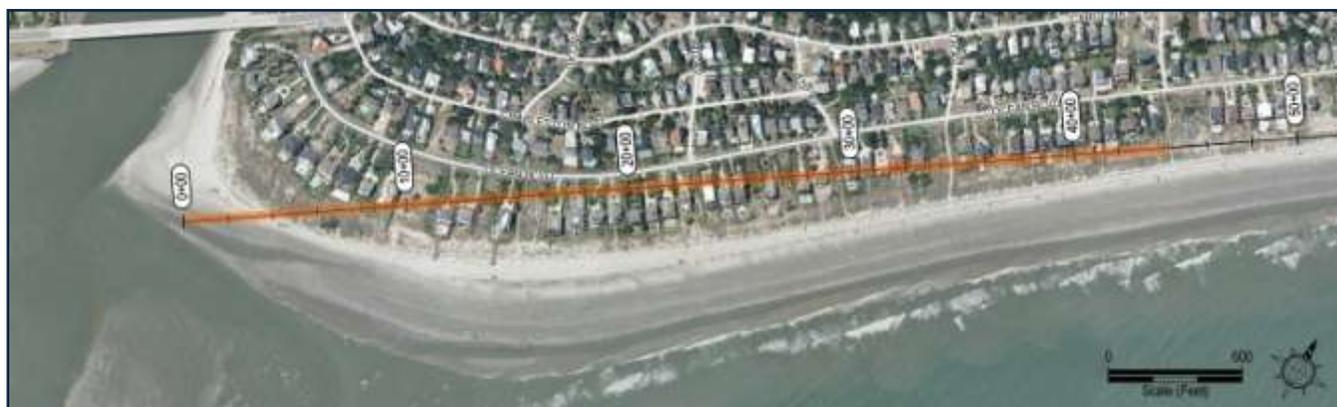
FIGURE 3.33. Reach 1 spans between Breach Inlet and 6th Avenue — noted by the orange-highlighted bar.

Reach 1 lost ~182,000 cy of sand from September 2010 to July 2013, which led to loss of dunes, damaged walkovers, and generally the most eroded beach condition in that area in recent memory. Some areas lost over 100 ft of dune and dry beach width from 2011 to 2013. The erosion was atypical for the reach, which has historically accreted, and generated concerns from property owners. CSE predicted the erosional trend would reverse based on the amount of sand moving in from upcoast reaches; however, additional monitoring was conducted to more closely track the conditions.

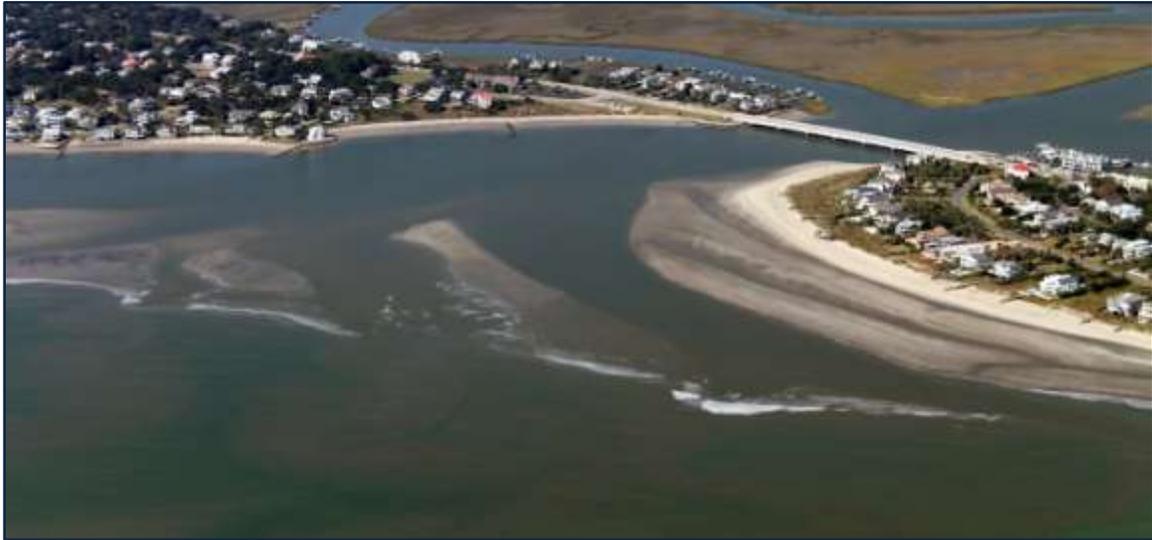
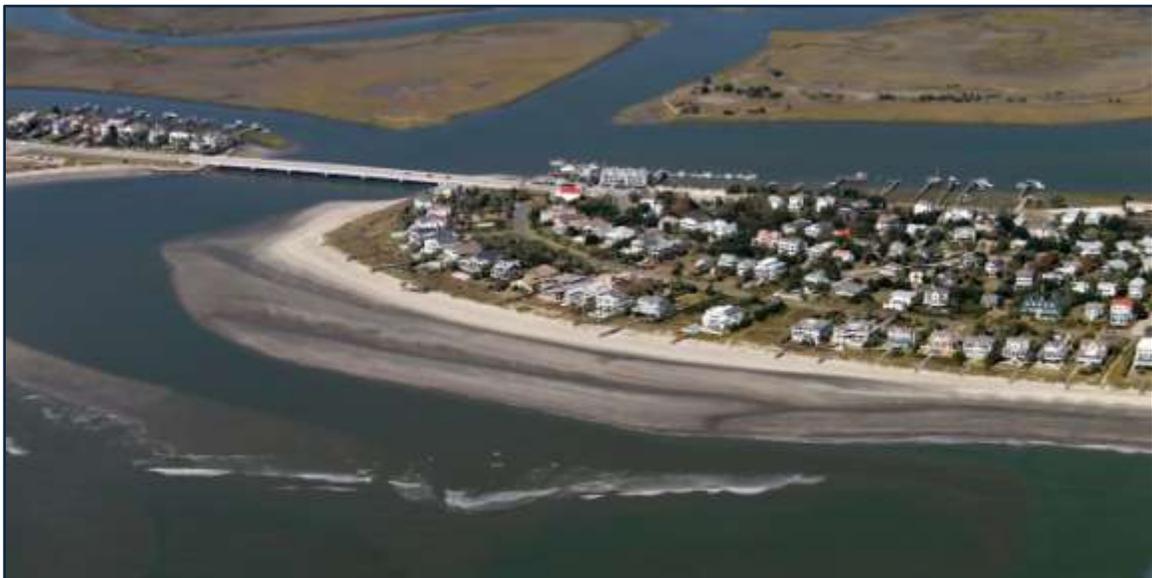
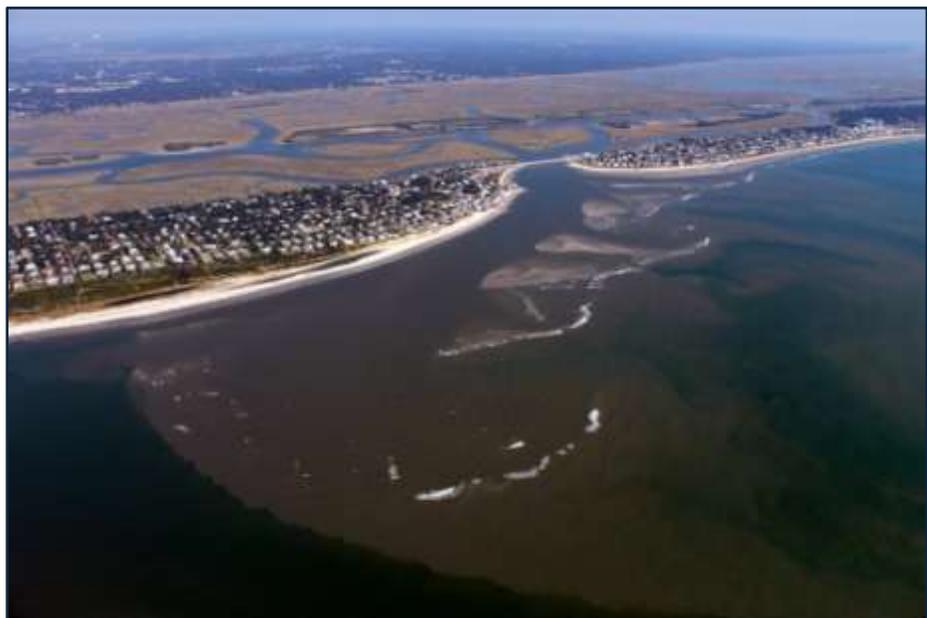
FIGURE 3.35.
October 2014 aerial images of Breach Inlet area.

[UPPER] The marginal flood channel separates the delta shoal from the low-tide beach.

The beach condition near Breach Inlet is heavily influenced by currents and shoals. Net sediment transport to the west causes the main channel to migrate west, over-extending along the eastern portion of Sullivan's Island. Much like Dewees Inlet at the eastern end of Isle of Palms, periodic breaks in the delta shoals allow the main channel to relocate further east, starting the migration process over again (Fig 3.35).

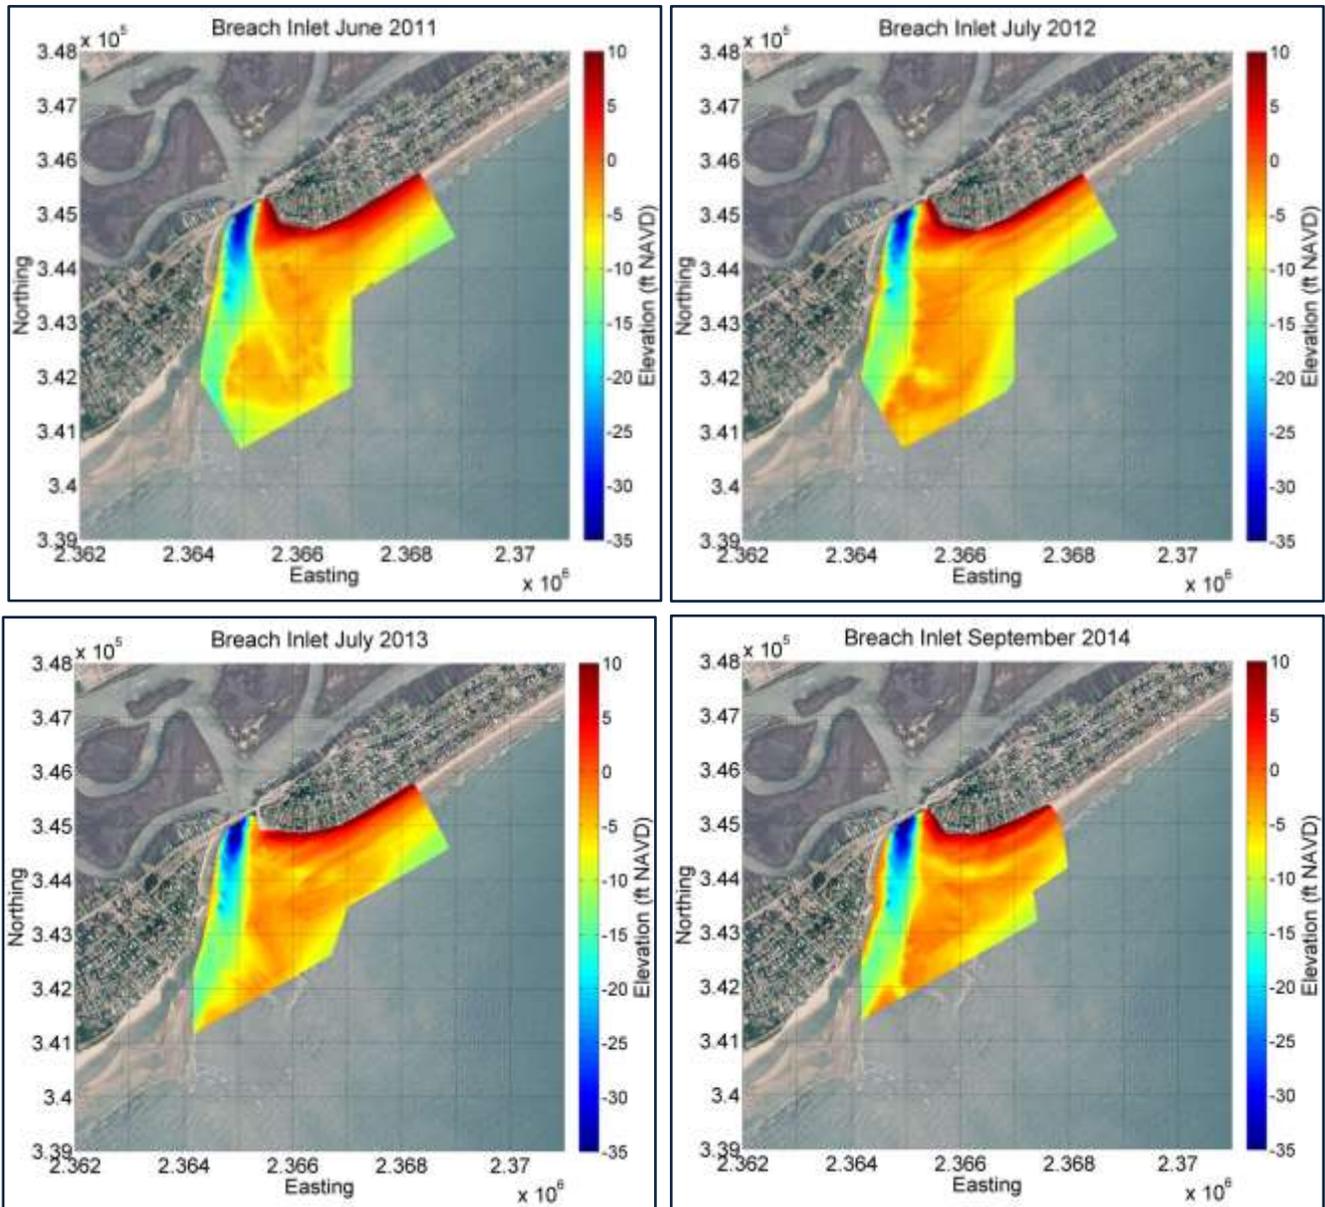
FIGURE 3.36. Color DTMs of Breach Inlet and neighboring IOP shoreline in June 2011, July 2012, July 2013, and September 2014.

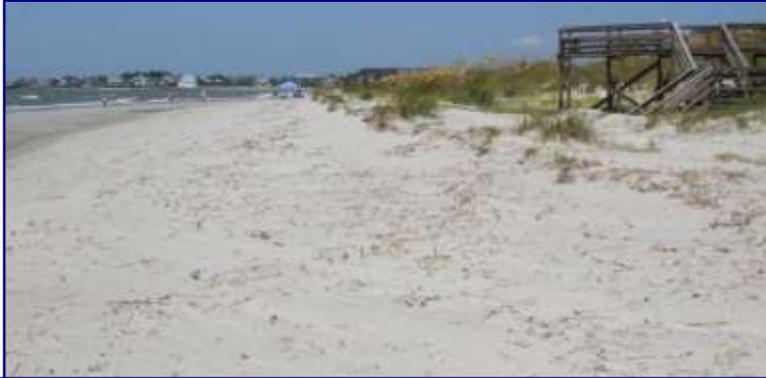
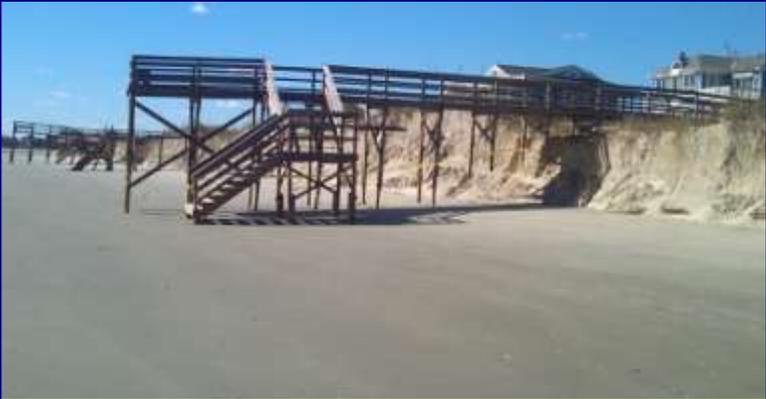
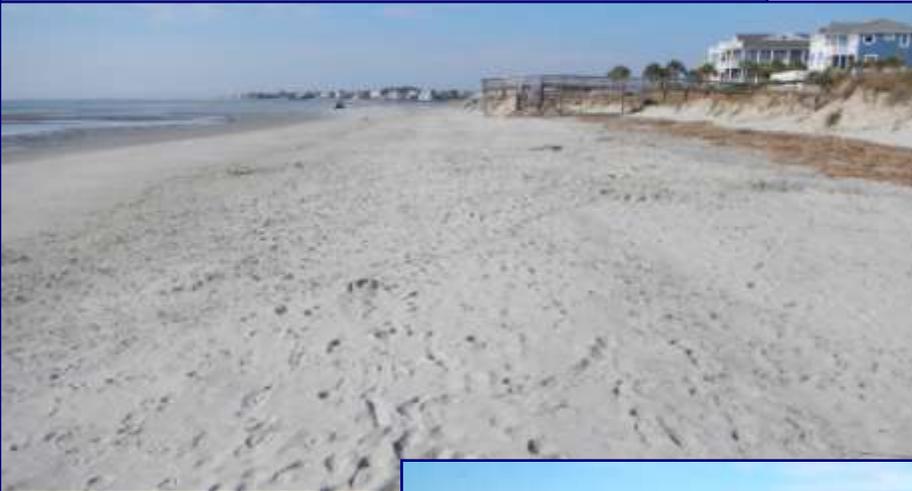
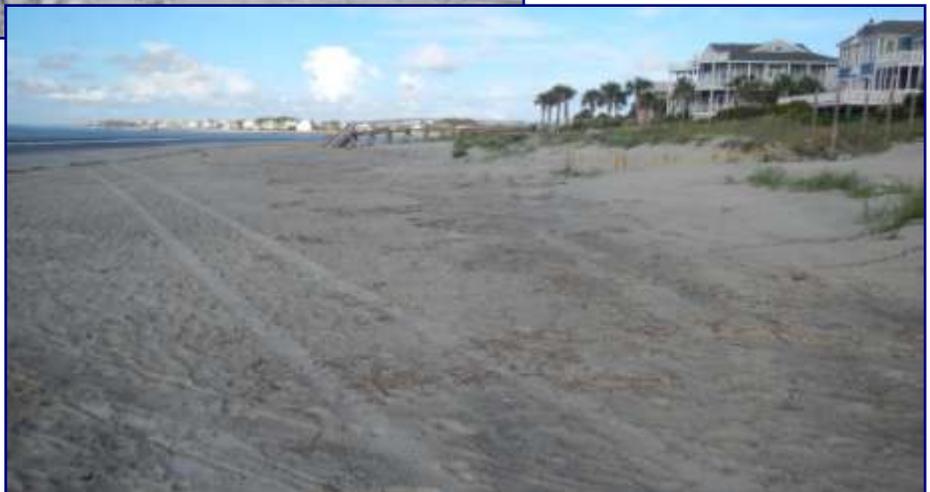
FIGURE 3.37.

[UPPER LEFT] View west from beach access 2 (10 July 2012).

[3rd LEFT] Beach access 2 (October 2013) – Note recovery of the berm and healthy dunes.

[BOTTOM] Beach access 2 (September 2014).

The changes observed near Breach Inlet (Fig 3.37) highlight the dynamic nature of barrier-island shorelines adjacent to inlets. Often, beach condition is driven by short-term events associated with inlet changes rather than long-term erosional patterns. As evidenced by recent changes, decades' worth of accretion can be lost rapidly due to inlet effects. Similarly, a shoal-bypass event may restore a beach which has suffered long-term erosion (eg – Fripp Island, CSE 2013b). While local beach changes due to inlet effects are difficult to predict several years in advance, regular monitoring provides the best method to plan for potential issues and project near-future changes.

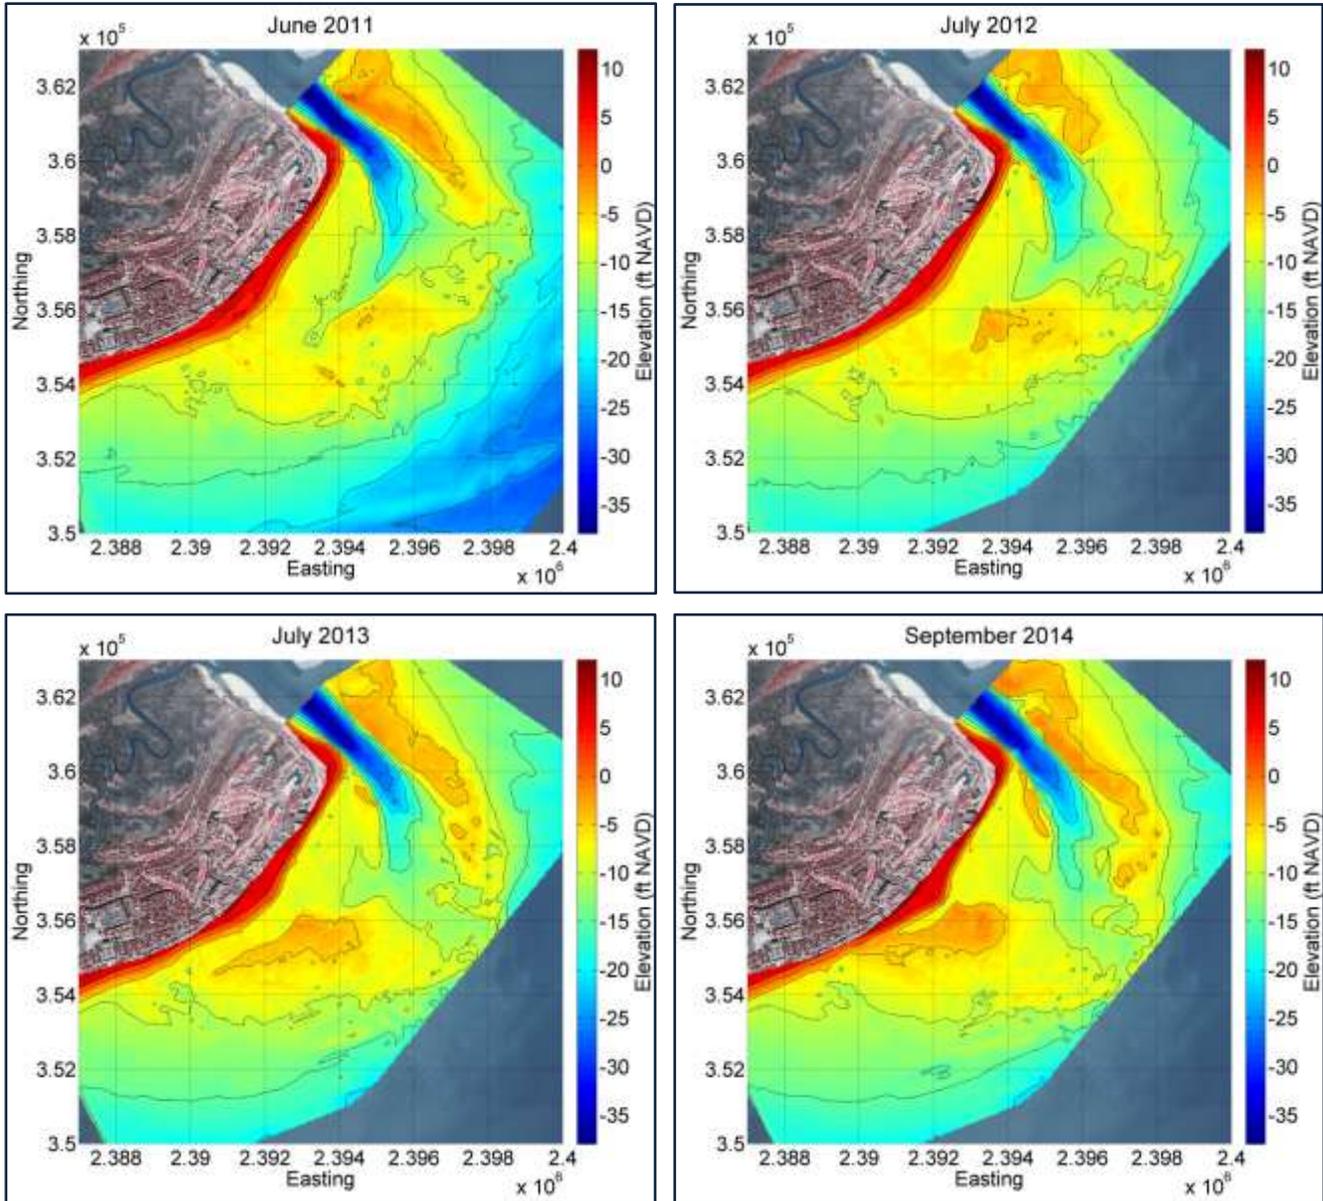
FIGURE 3.38. Color DTMs from the June 2011, July 2012, July 2013, and September 2014 surveys of the Dewees Inlet ebb-tidal delta.

CSE has monitored the morphology of Dewees Inlet since 2007. During the past seven years, a major channel avulsion event shifted the main channel east. Details of the morphological changes occurring from 2007 to 2012 are given in earlier reports to the City (CSE 2010, 2011a,b). The present report focuses on current conditions of the ebb-tidal delta and the impact it is having on the beach. Morphologic changes are highlighted in digital terrain models (DTMs) (Fig 3.38). Section profiles from selected stations are shown in Figure 3.39.

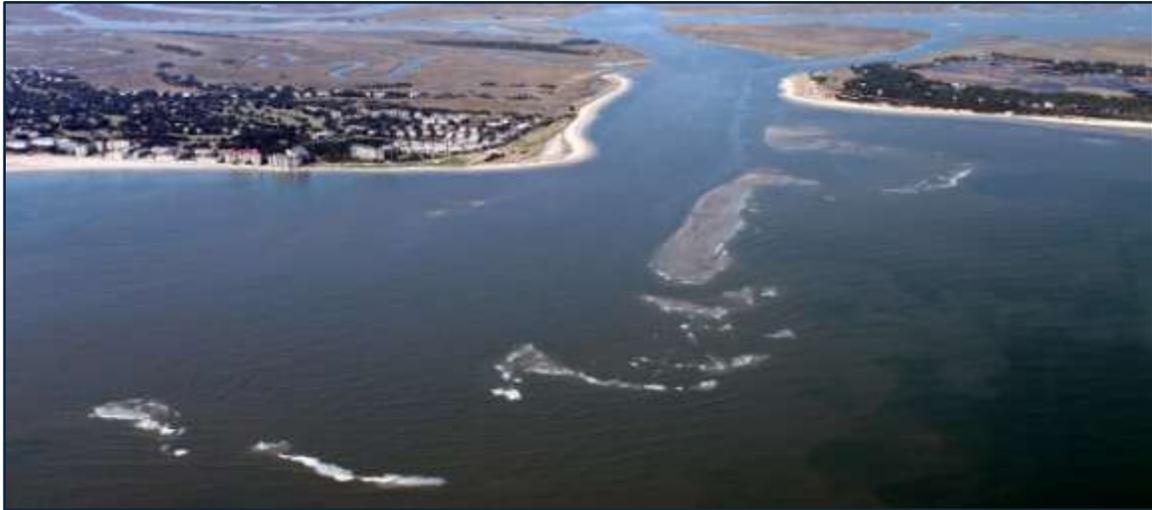
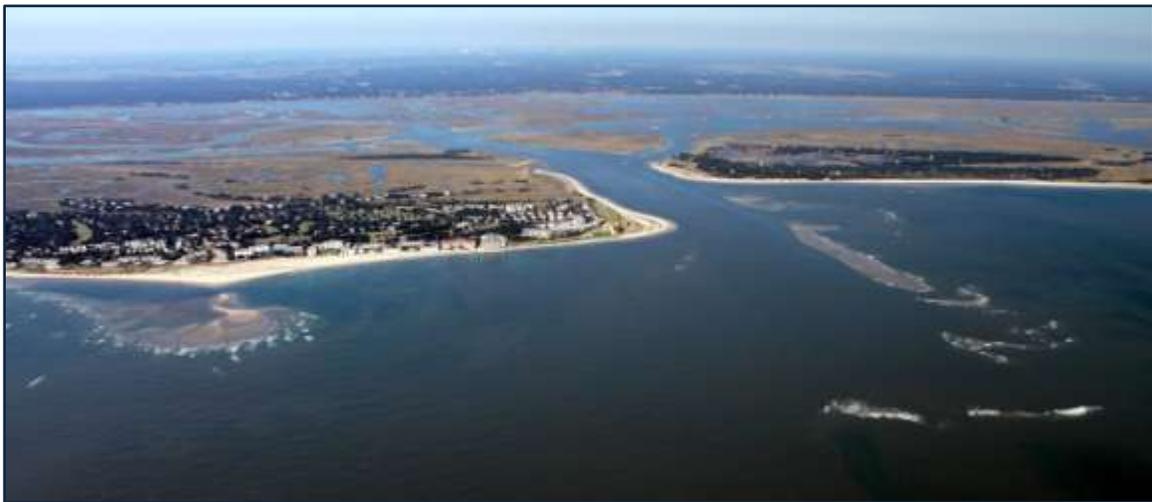
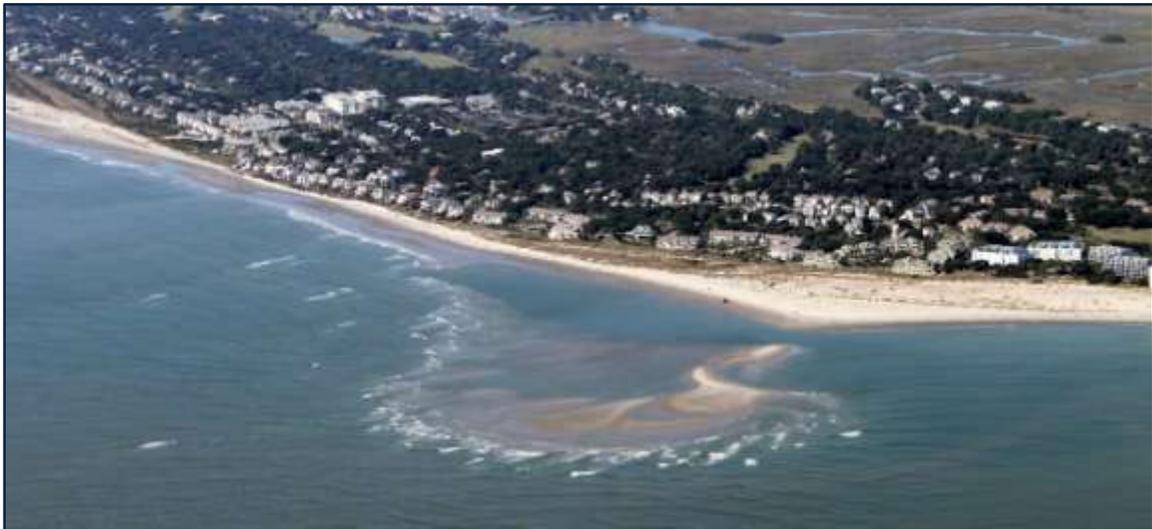
FIGURE 3.40. October 2014 aerial images of the shoal off the northeastern end of Isle of Palms.

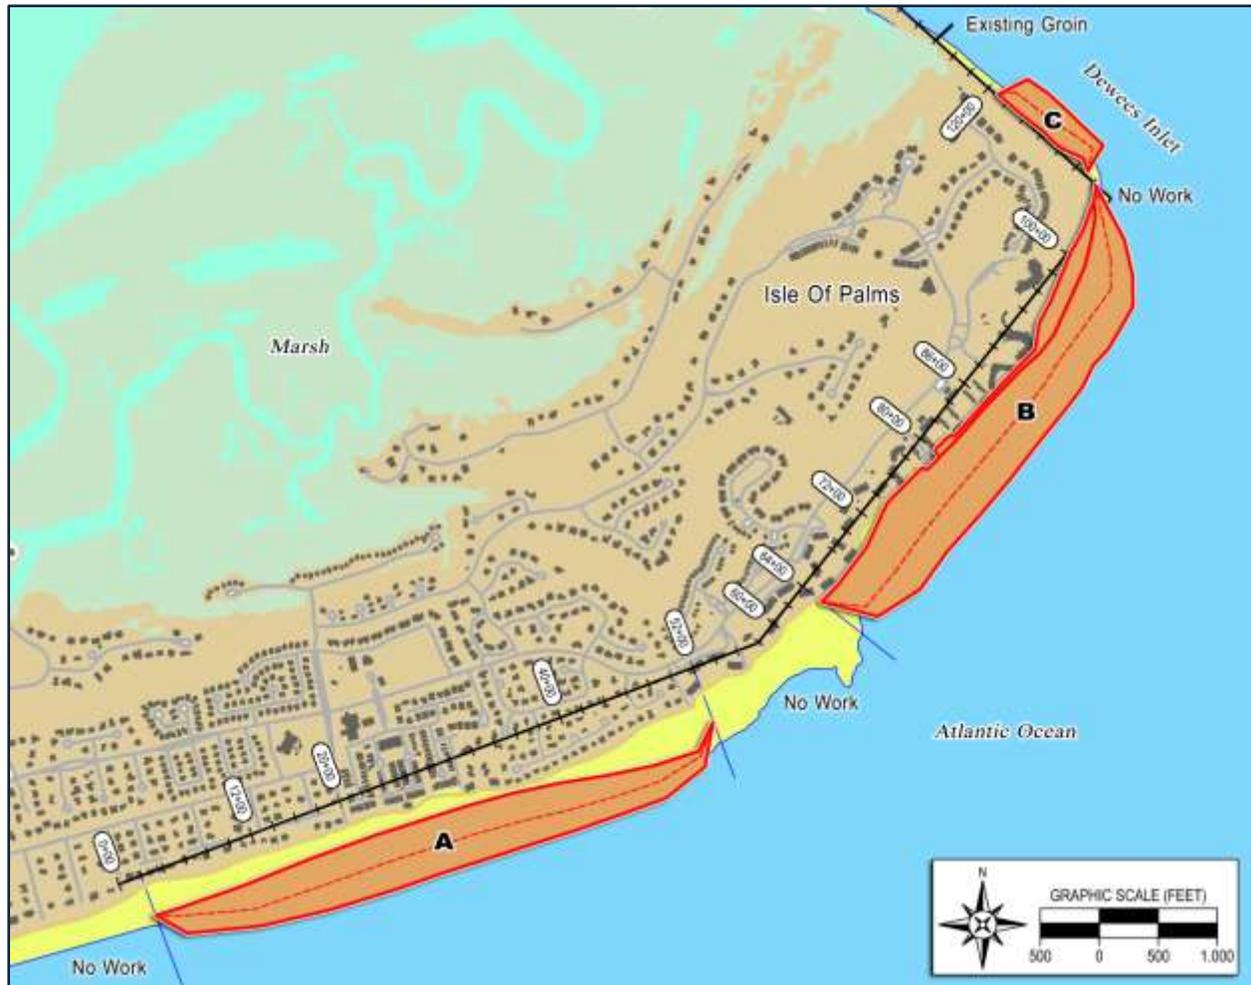
FIGURE 3.42. Reaches for the 2008 nourishment project. The graphic shows the project baseline with 0+00 located at 53rd Avenue (monitoring station 222+00).

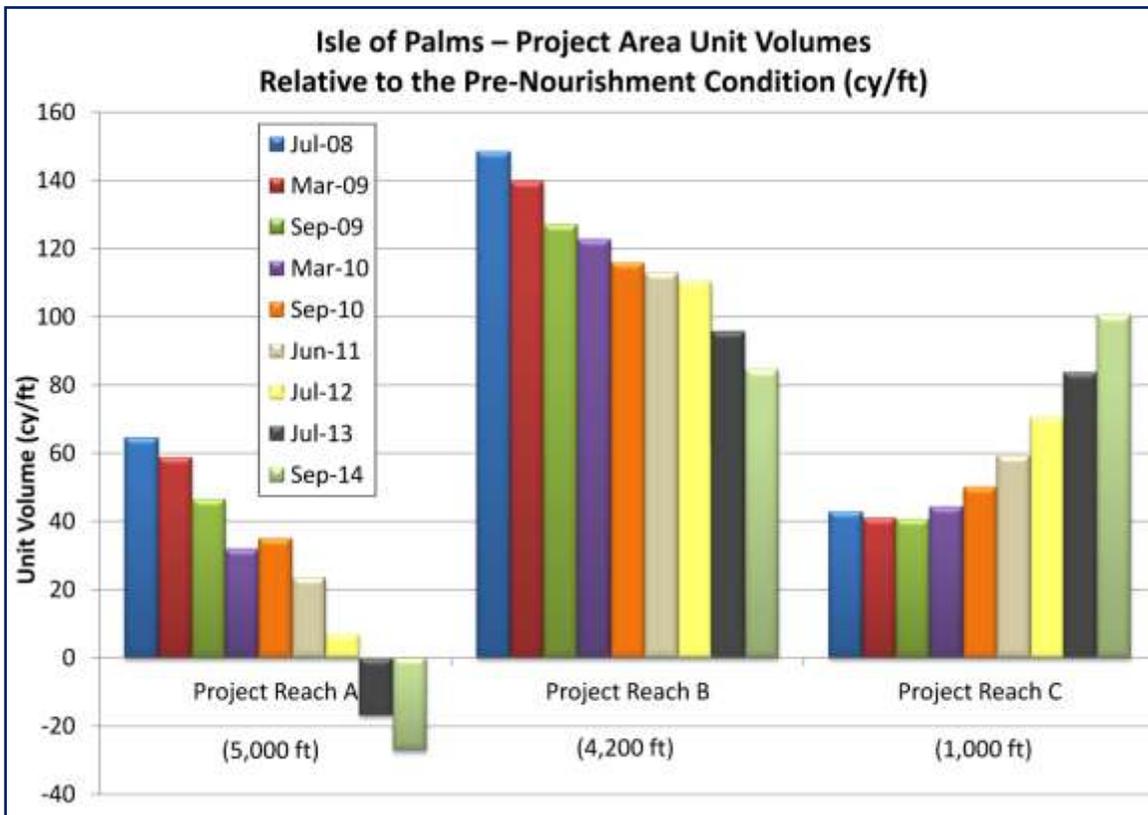
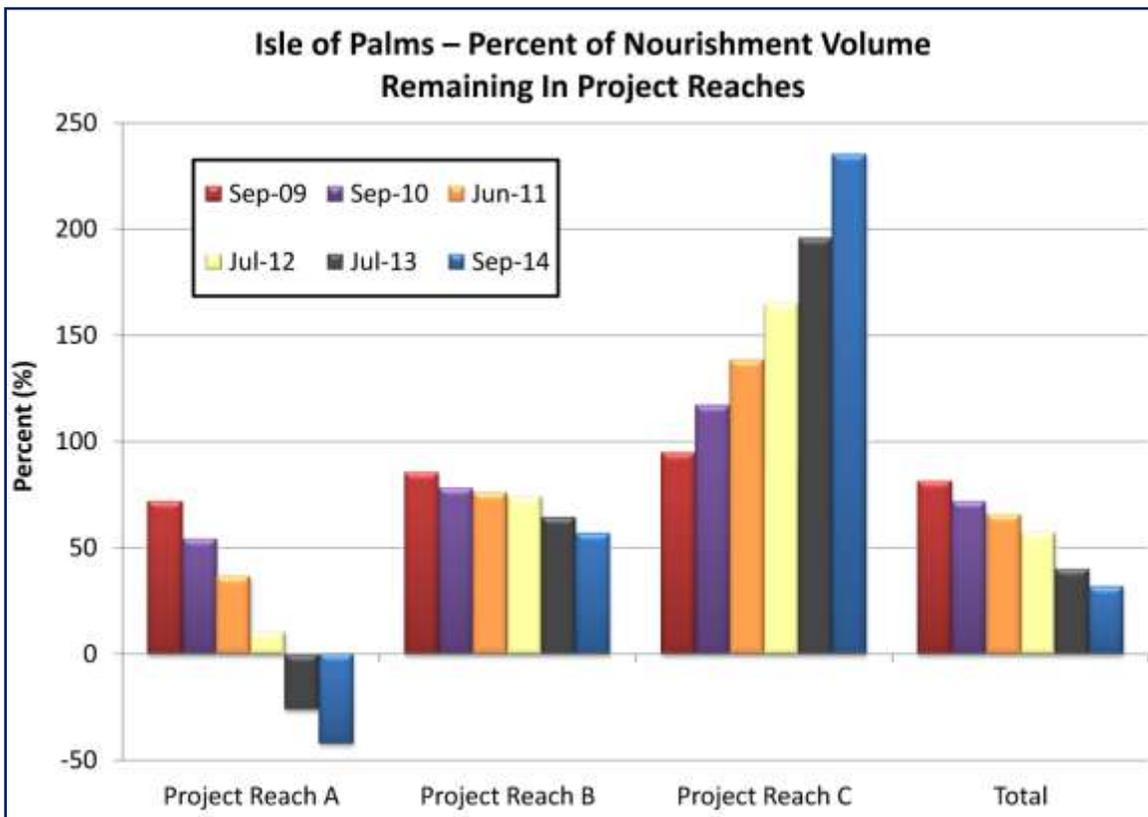
FIGURE 3.43. [UPPER] Project area unit volumes relative to the pre-nourishment (March 2008) condition, which is zero on these graphs. [Note that the project area limits differ from monitoring reach limits.] [LOWER] Percent of nourishment volume remaining in each project area.
