Limited Conditions Assessment

For the Isle of Palms Marina

Isle of Palms, South Carolina

Prepared by: Applied Technology & Management, Inc.
941 Houston Northcutt Boulevard, Suite 201
Mount Pleasant, South Carolina 29464
(843) 414-1040

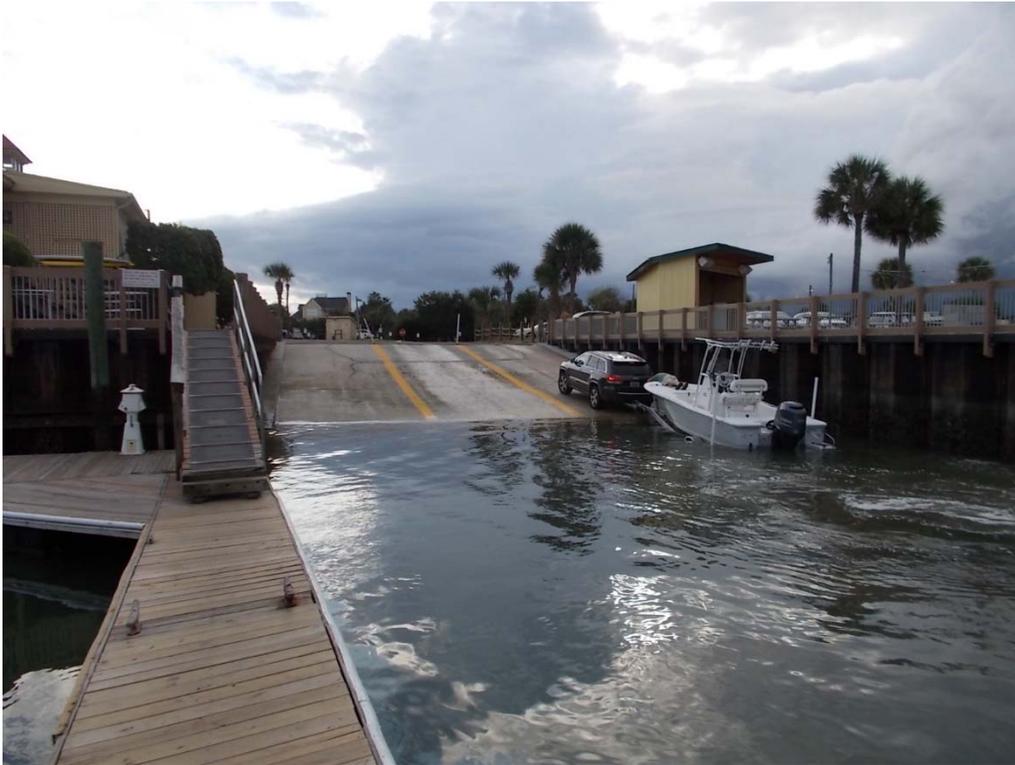
Boat Ramp (Note: previously highlighted conditions of boarding pier and gangway)

The surface of the boat ramp is semi-smooth concrete. With this texture, marine algae growth does occur and causes the surface to become quite slippery for vehicles and patrons. Marina management reports cleaning the growth regularly and hiring professional cleaners at least quarterly to maintain a safe and clean ramp surface. The professional cleaners were onsite at the time of ATM's assessment.

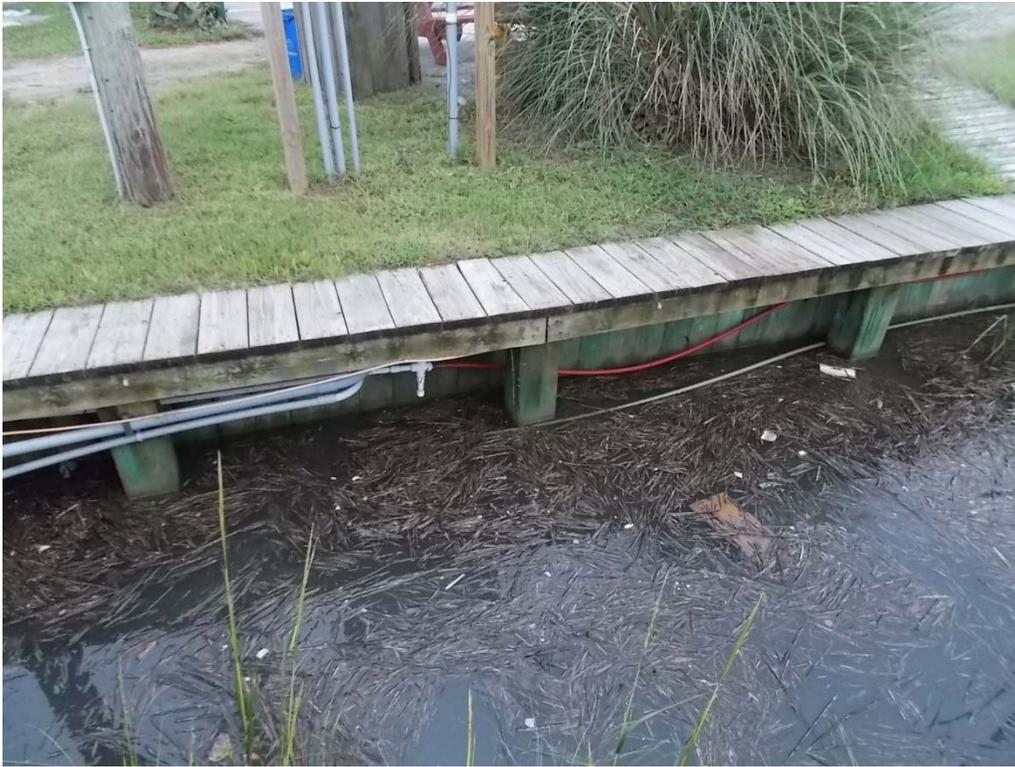
Typical Timber Bulkhead along Intracoastal Waterway

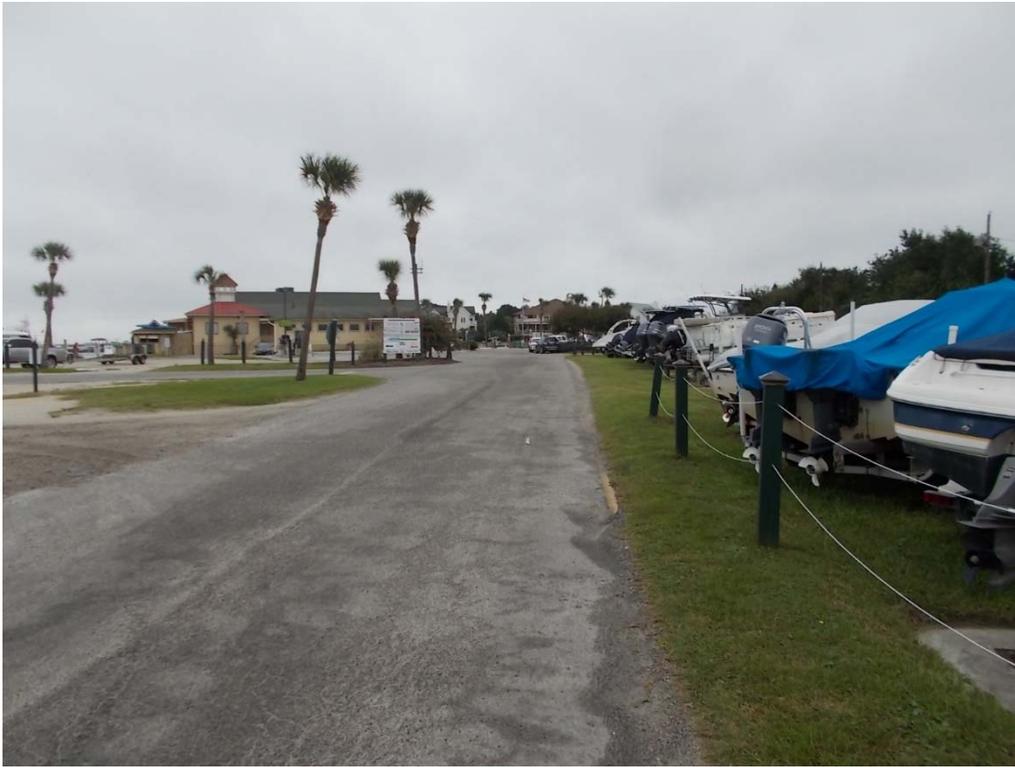
Main Entrance – Asphalt Paving

The entrance road and a substantial portion of the standard vehicular parking at the Isle of Palms Marina is paved asphalt. The asphalt paved main access road and parking spaces adjacent to the marina store and restaurant are in fair/good condition. The asphalt paving adjacent to the watersports dock is in very poor condition.

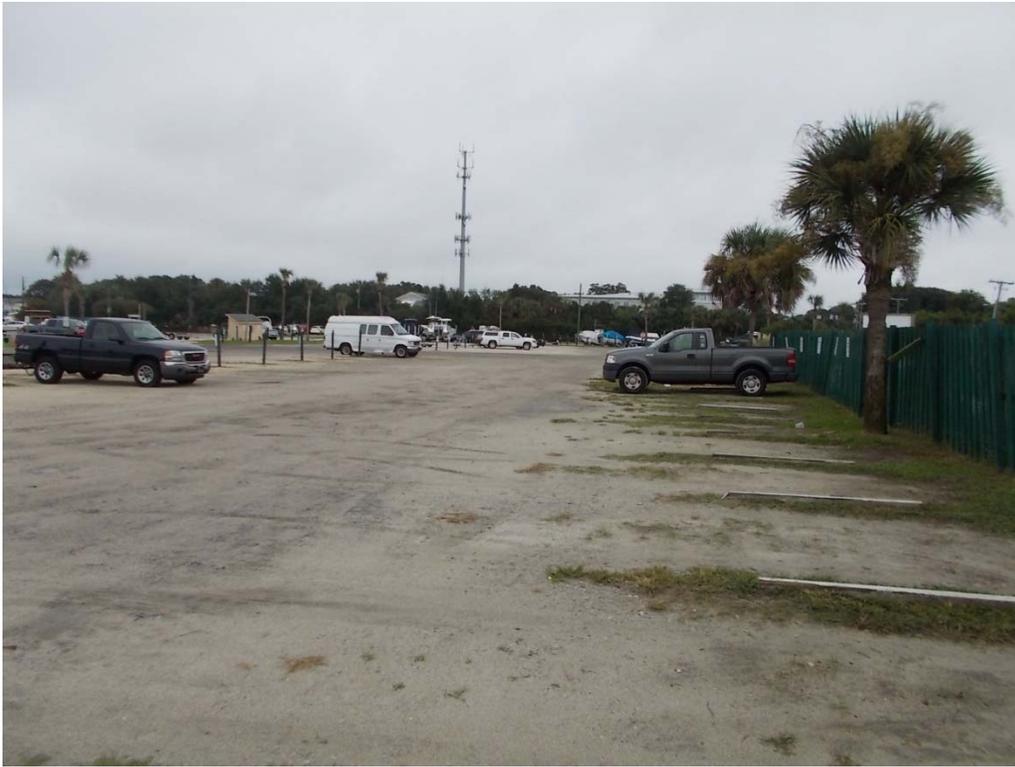
Typical Gravel Parking Area

The majority of the trailer parking areas at the marina are gravel. The trailer storage area parking is gravel also. In general, the gravel parking areas appeared well maintained, with limited degradation/potholes observed, likely due to vehicular traffic and recent rains. The restauranteur indicated two instances of known patron falls and insurance claims in the gravel areas. Most gravel parking spaces are well marked in terms of intended usage (boat and trailer parking, etc.).

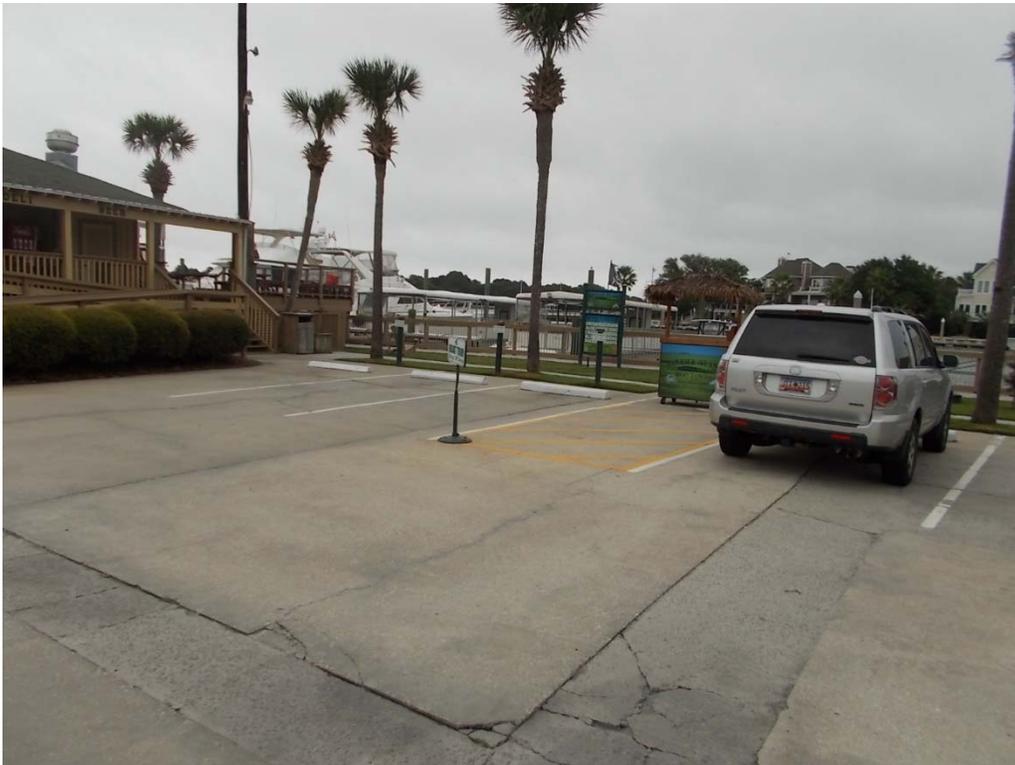
Concrete Parking Area

Limited concrete drive parking spaces are provided adjacent to the marina store and the marina facility (southeast side of the property). These areas are in fair/good condition, with some cracks noted.

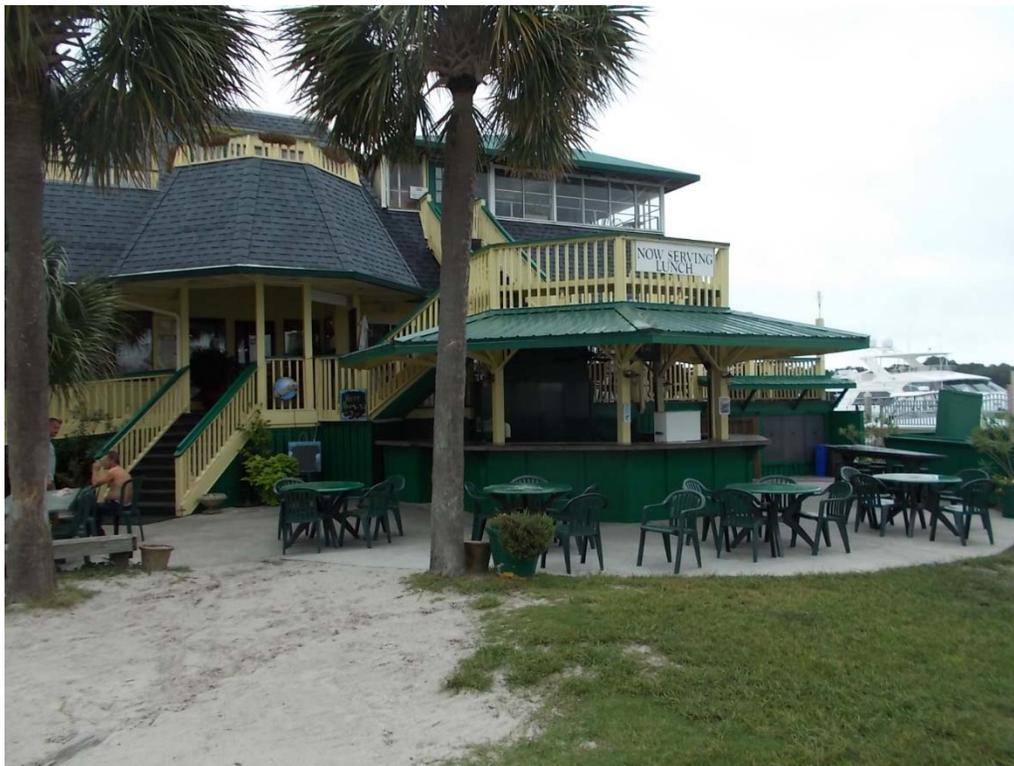
Exterior of Morgan Creek Grill

Ms. Pope describes the building as an "old, but good building." She also related that a lot of maintenance goes into the structure, particularly related to the roof.

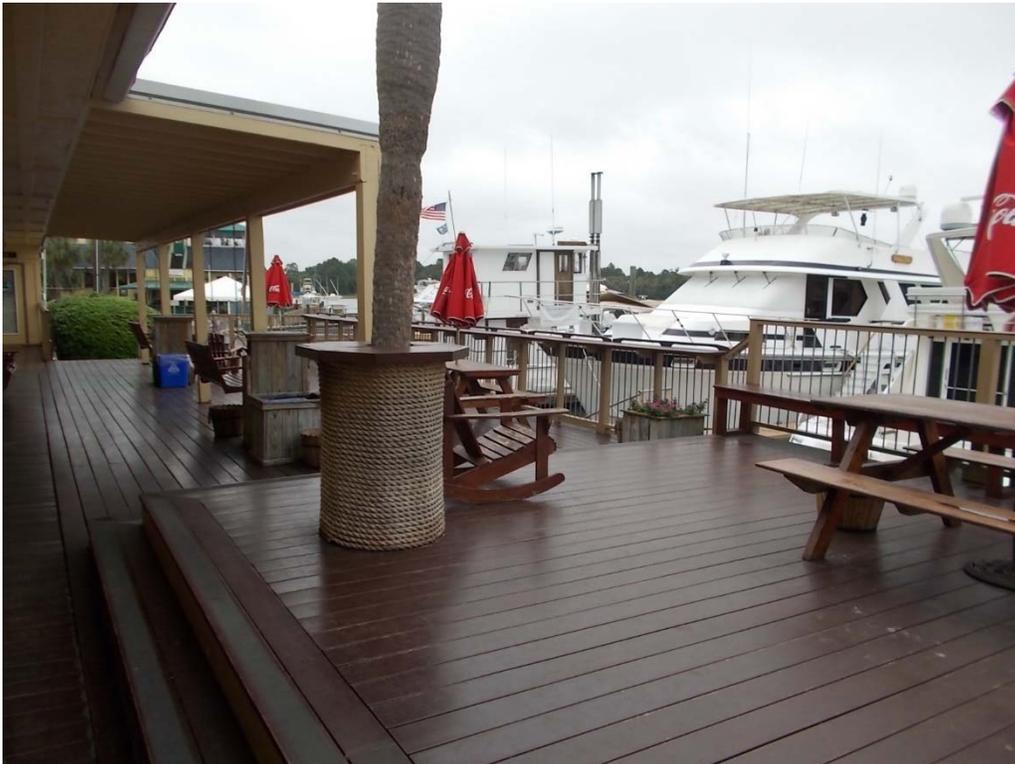
Marina Store – Rear Patio

Since the installation of the steel sheet pile bulkhead along Morgan Creek, Mr. Berrigan has noticed a slight shift of several building elements adjacent to the bulkhead structure. Specifically, the deck adjacent to the building has developed a downward sloping angle (away from the marina store building). In addition, a number of small cracks have occurred in the ceiling and walls of Mr. Berrigan's office, which is located on the Morgan Creek side of the building.

While a detailed structural investigation is beyond the scope of ATM's current assignment, these observations are somewhat concerning. These conditions are generally consistent with Mr. Berrigan's other observation of backfill deposits on the outside/waterside of the bulkhead adjacent to the marina store.
