APPLICANT:
 CITY OF ISLE OF PALMS
 POST OFFICE BOX 508
 ISLE OF PALMS, SC 29451

AGENT:
 COASTAL SCIENCE & ENGINEERING
 PO BOX 8056
 COLUMBIA, SC 29202

DRAWING TITLE: City of Isle of Palms Erosion Assessment
 POST *IRMA* EMERGENCY SCRAPING

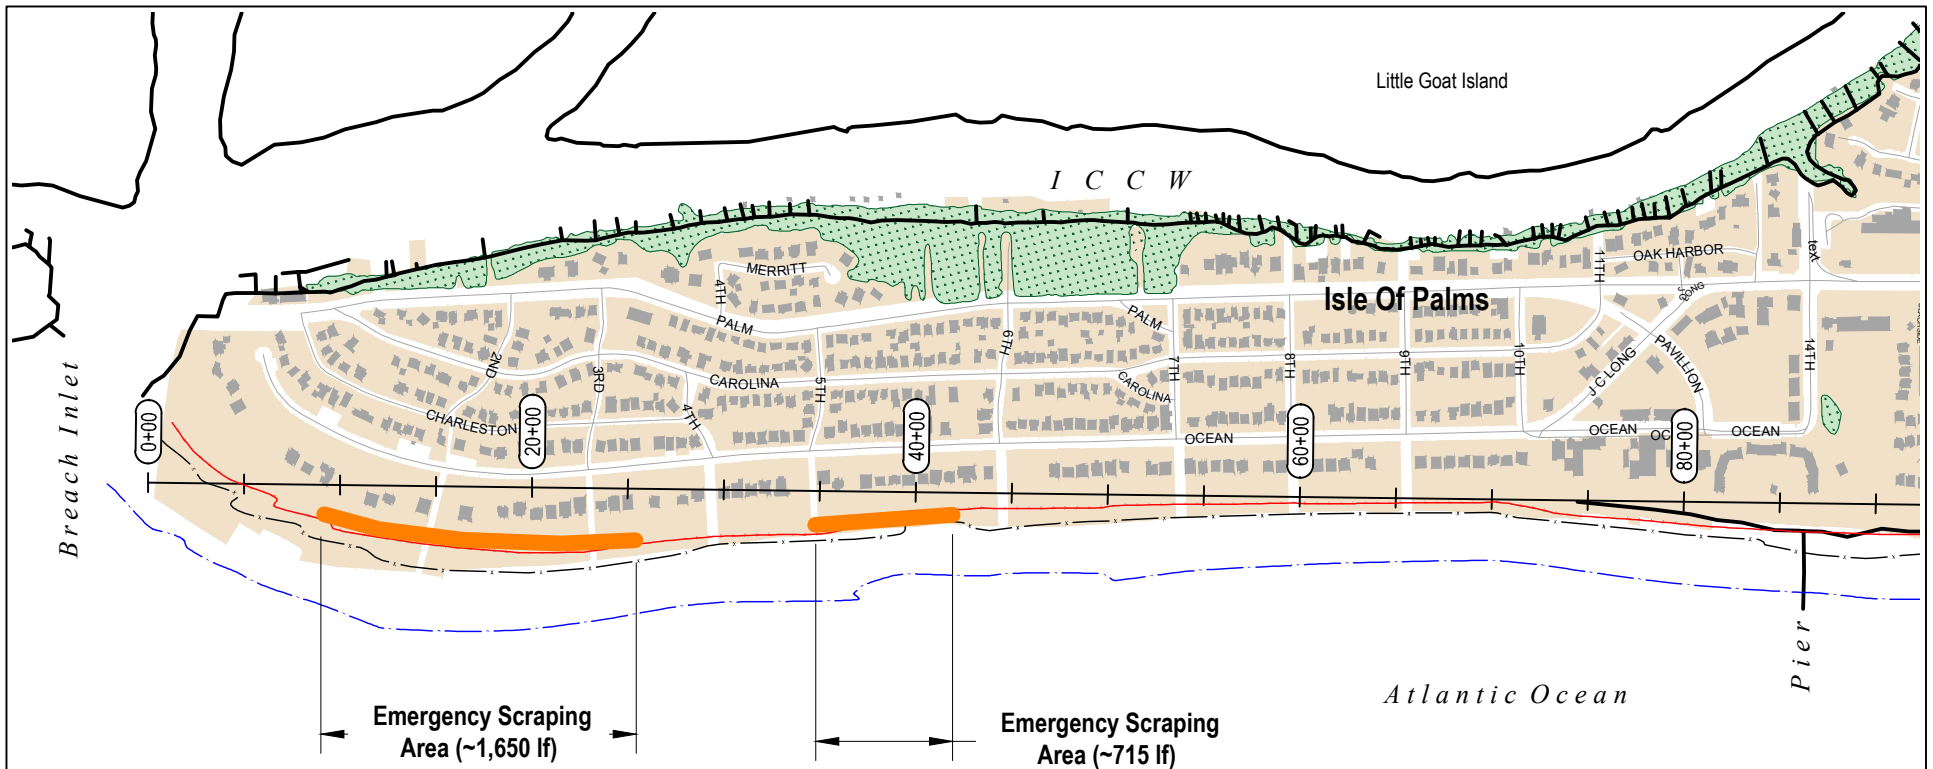
| SCALE: | AS SHOWN | 03 |

- +5' NAVD (Oct 2016)
- - - MHHW +2.41' NAVD (Oct 2016)
- - - MLLW -3.0' NAVD (Oct 2016)

DATUM:
 Horizontal: SPCS NAD '83 (Feet) SC Zone 3900
 Vertical: NAVD '88 (Feet)
 Contours shown based on data collected by
 Coastal Science & Engineering, Inc via RTK GPS 14 Oct 2016
