Building Assessment *for*
MORGAN CREEK GRILL
80 41st Ave, Isle of Palms

City of Isle of Palms

April 11, 2019

SMH
architecture • planning • interiors

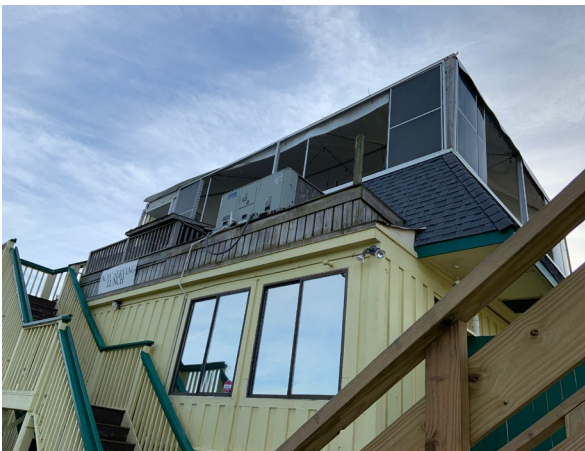
Mansard roofline with tent

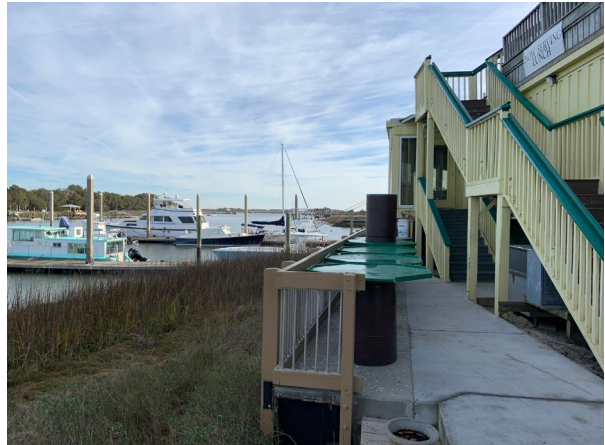
Proximity to bulkhead

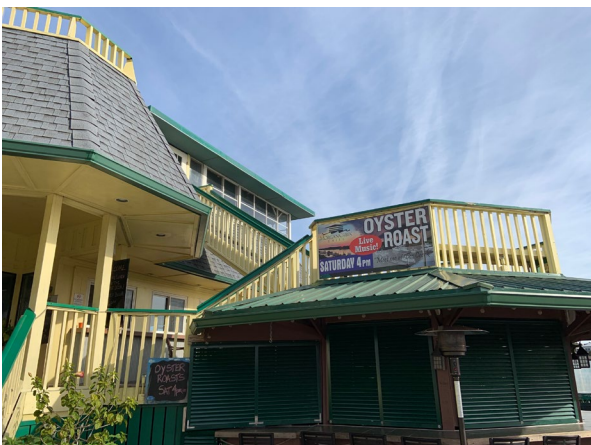
Top of bar is landing for stair to second floor

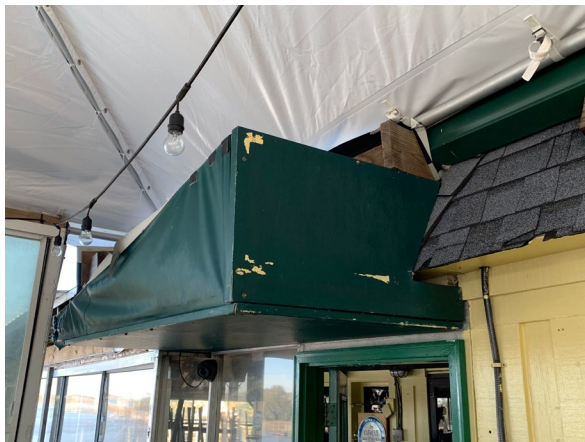
Tent connections

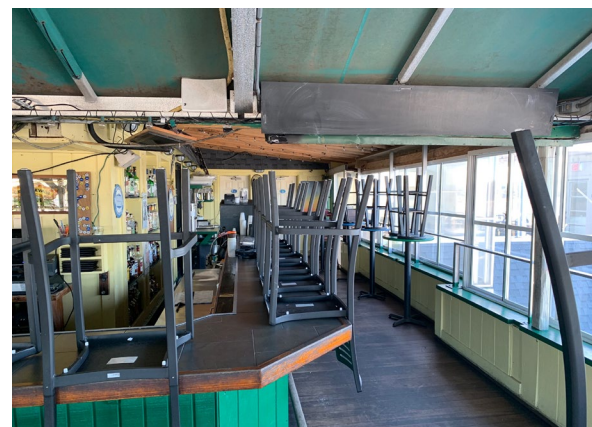
Lean-to connection

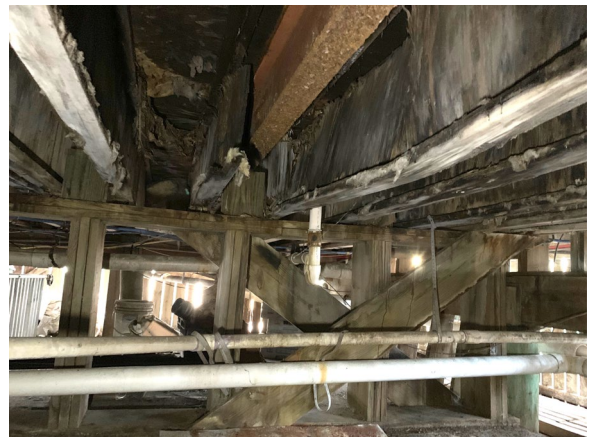
Structural issues at coolers in kitchen

1. Life safety and significant code issues. If nothing else is done, the floor must be replaced under the walk-in coolers and the temporary tents need to be removed or modified so that they meet applicable codes. Those and several other life-safety issues identified in the report should be addressed first.
2. Renovation. Due to the cost of construction restrictions imposed by FEMA requirements, we have provided an "a la carte" menu of individual improvements that can be undertaken provided they stay below 50% of the market value of the building structure. These items would have to be completed within any excess funds after the Option 1 items above are addressed.

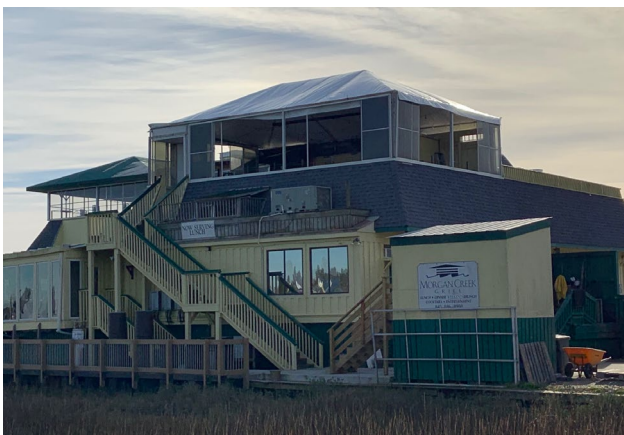
Temporary tents on second floor

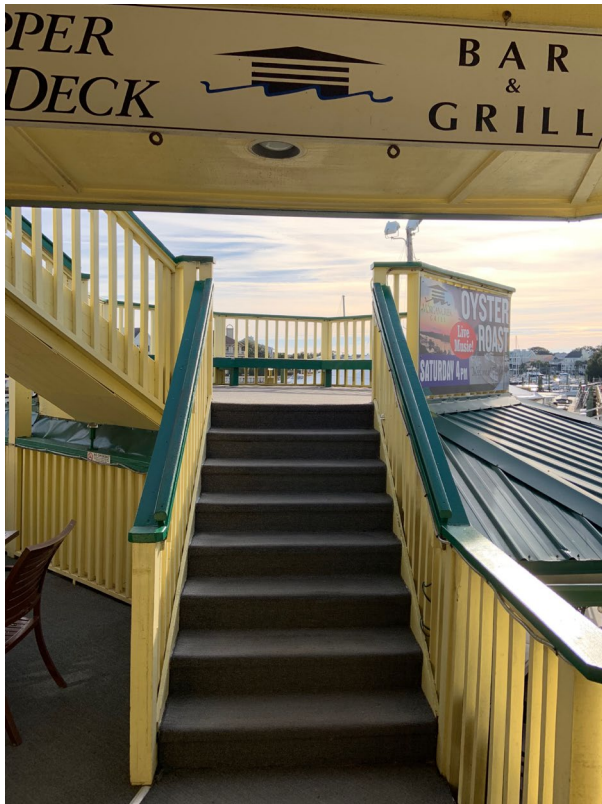
Exterior access to second floor dining.

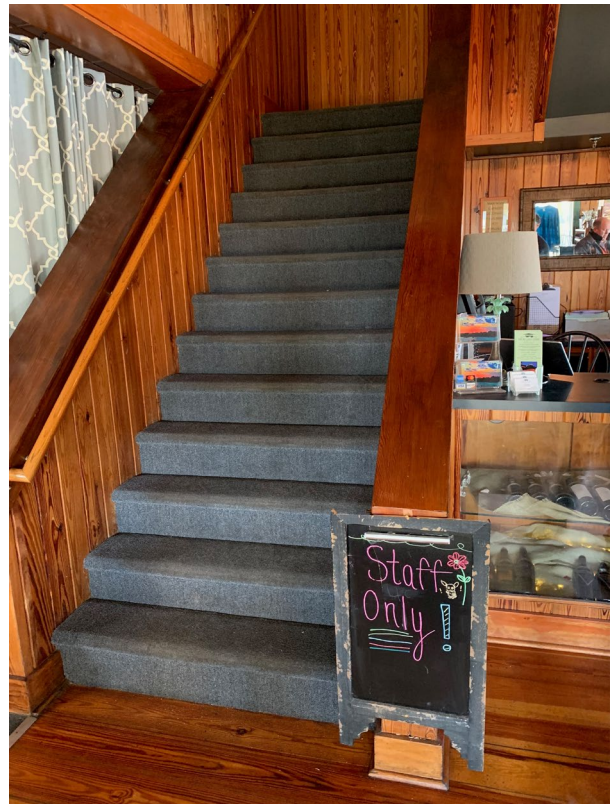
Interior access to second floor dining.

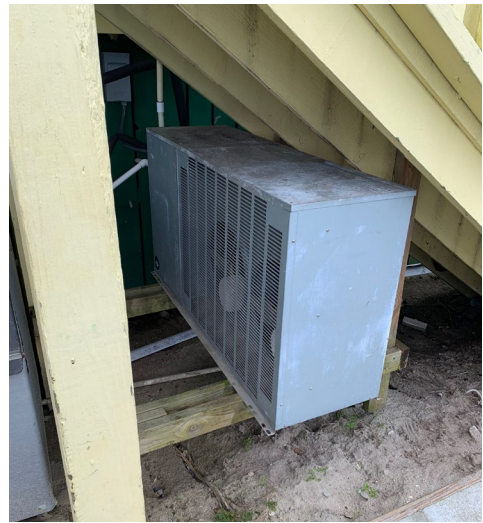
Condenser unit

The above information notwithstanding, the assessment team noted several non-compliant situations that are not allowed to exist in a flood plain. Some assessments will be contradicted by the current Tenant, under the premise that “moveable equipment” may be placed in the flood plain if it can be evacuated when faced with an impending flood event. Such equipment would likely be identified in a Flood Management Plan and the applicability of such equipment would be subject to review and acquiescence by the Building Official.

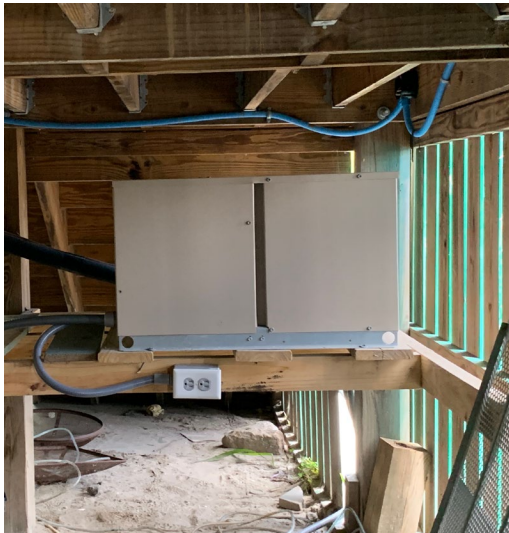
Condenser unit. Electrical outlet

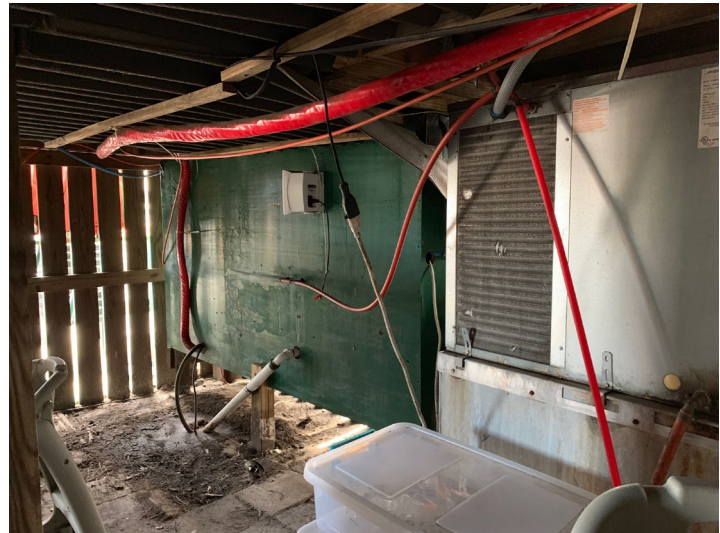
Ice Machine and Waitress service station
view from back side under porch.

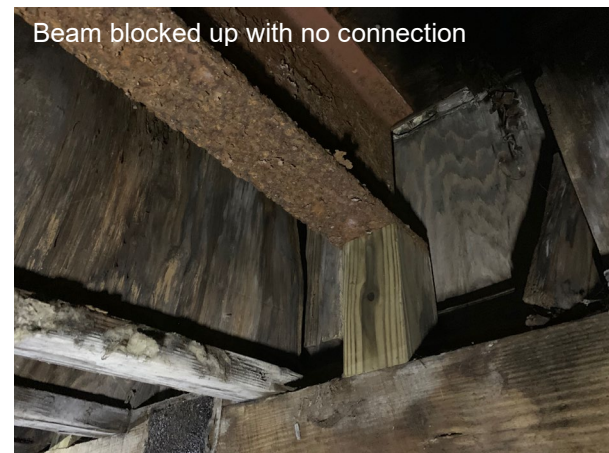
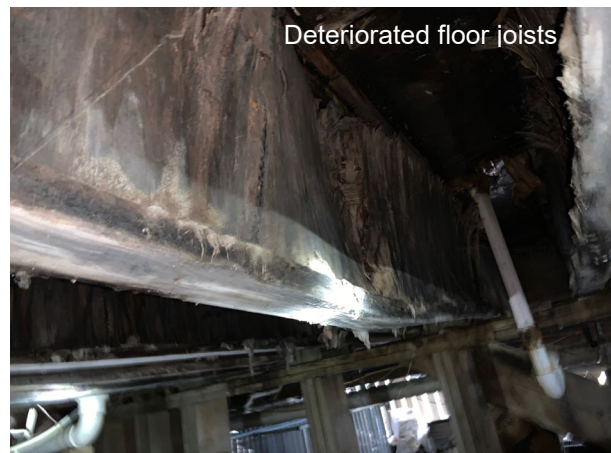
Photos – Structure of floor at walk-in cooler / freezer

This situation requires the immediate attention of the City of Isle of Palms (as Owner), the Tenant, and the Building Official. Condensation at the underside of the cooler / freezer has resulted in the complete deterioration of the plywood subfloor and a number of the wood floor joists. In some instances the plywood and the wood joists are completely gone. A “repair” was undertaken at some point that installed steel beams at the underside of the plywood subfloor. That repair is insufficient and tenuous. It consists of steel beams shored up by 4 x 4 wood blocking, bearing on a wood wall, which bears on an existing slab that preexisted under the restaurant. None of these components are attached or tied to the other in any meaningful way.

Any repair will require the removal of the cooler / freezer, the partial demolition of flooring system in the immediate area, the reconstruction of such flooring system to current engineering standards, and the reinstallation of the cooler / freezer. The reintroduction of the cooler / freezer should take into account the condensation issue and be designed to avoid the problem in the future.

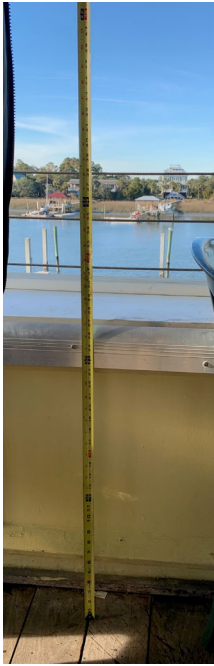
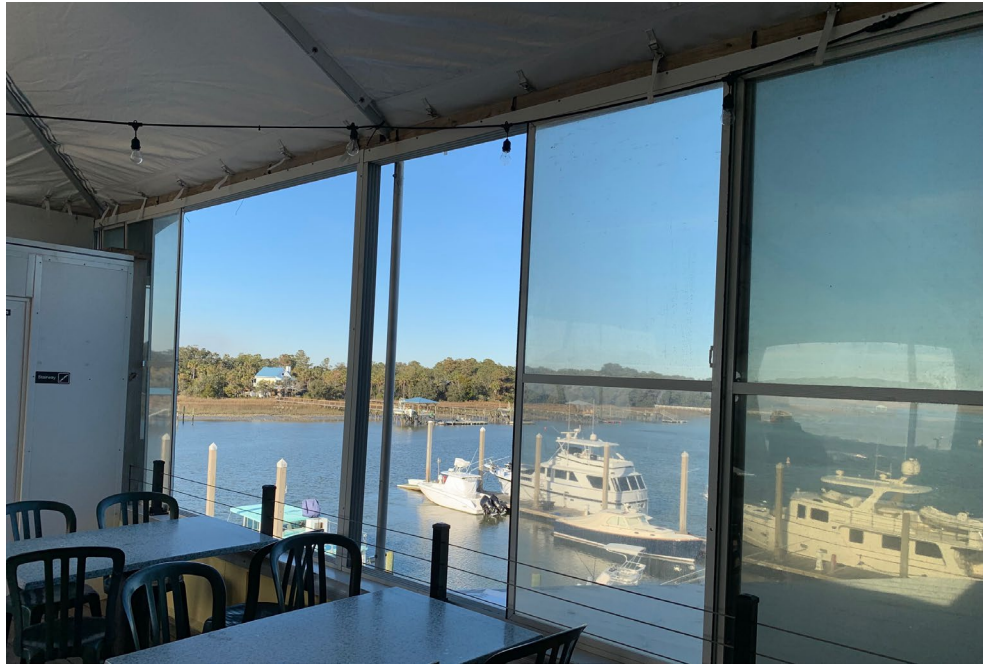
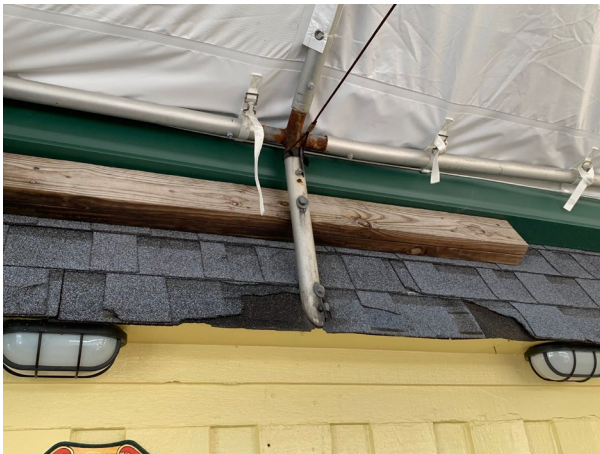
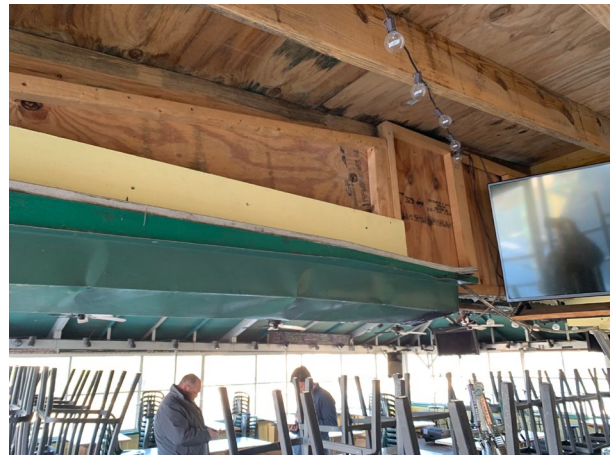
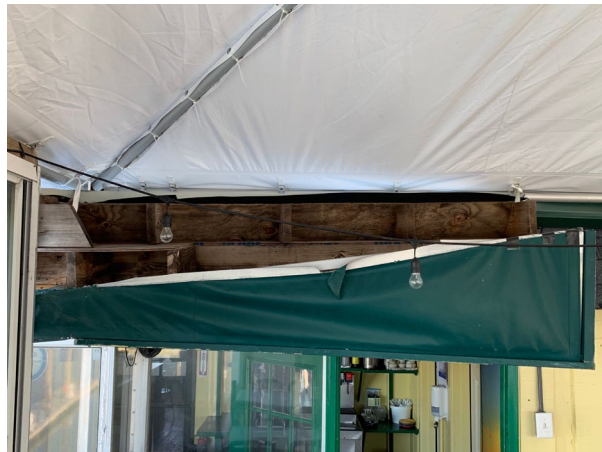
Because the white tent is open, there should be guardrails at 42” above finish floor that prevent the passage of a 4” sphere and meet the structural requirements of 1607.8 in the IBC. The railing / fall protection under the white tent is inadequate and could pose a danger to the public.
